Room 17 18 Data Sheet

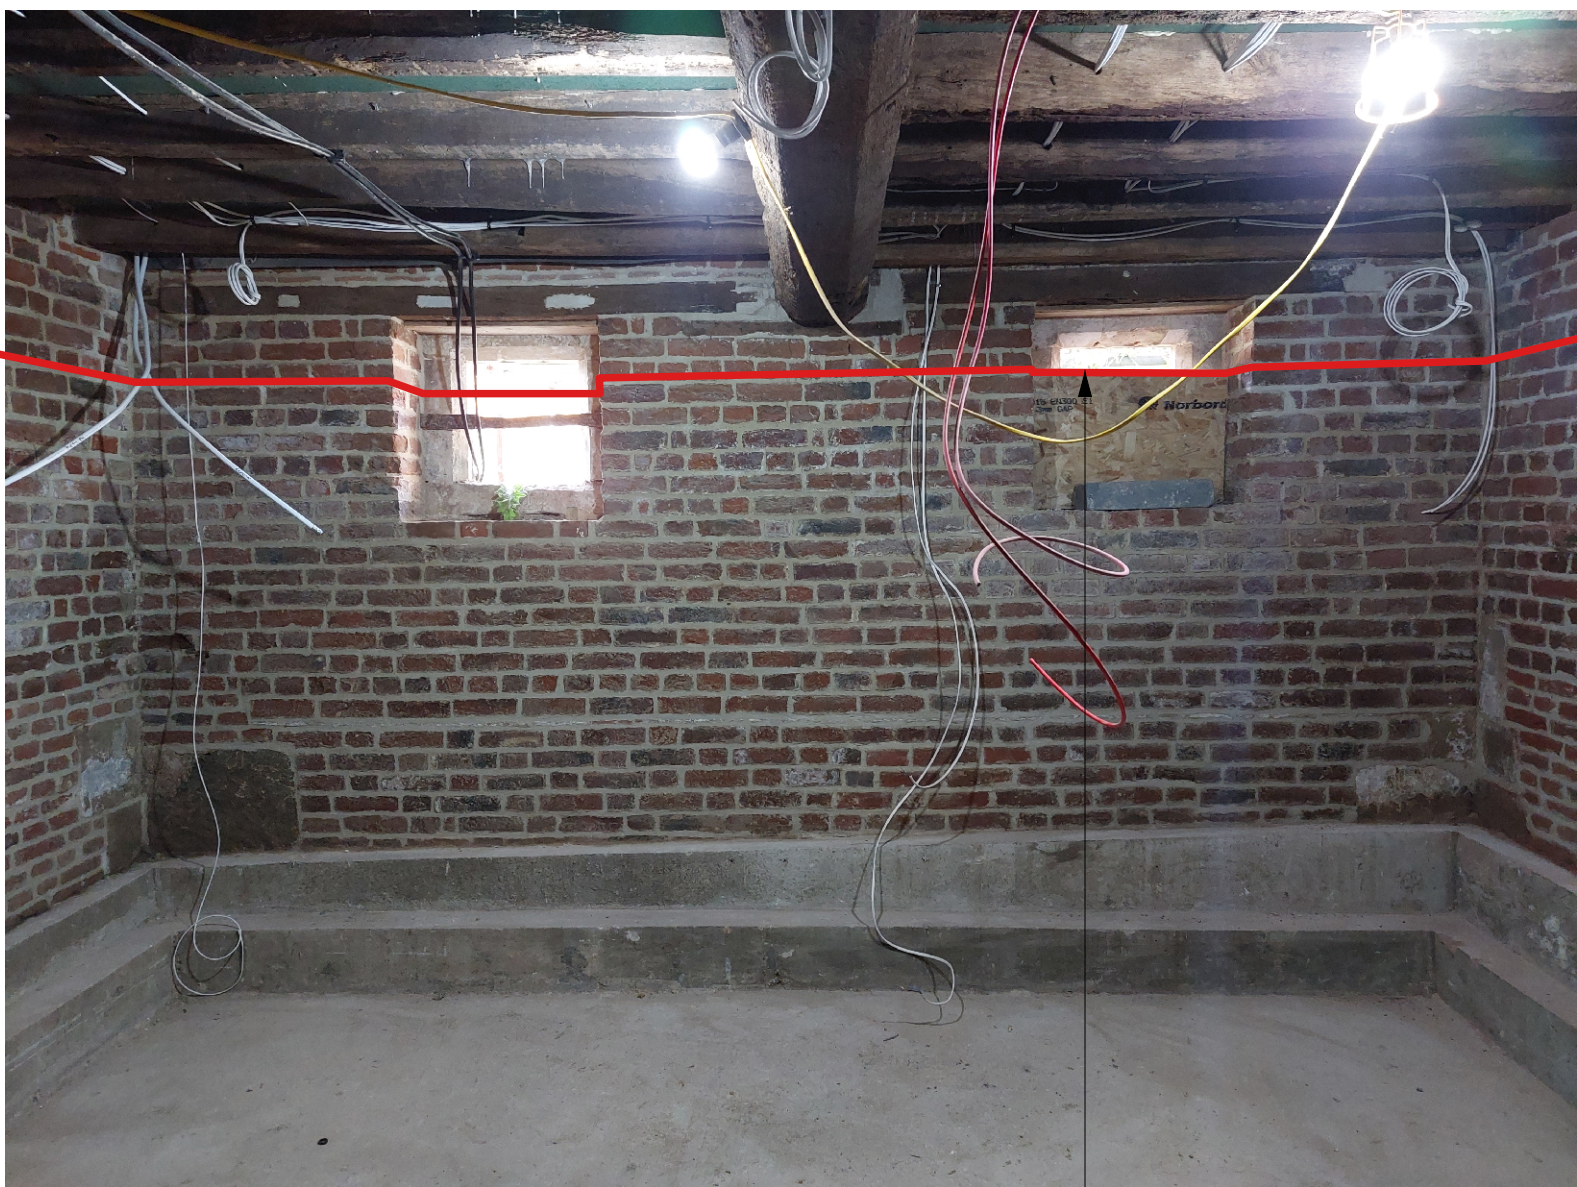
Photograph in-situ room 18

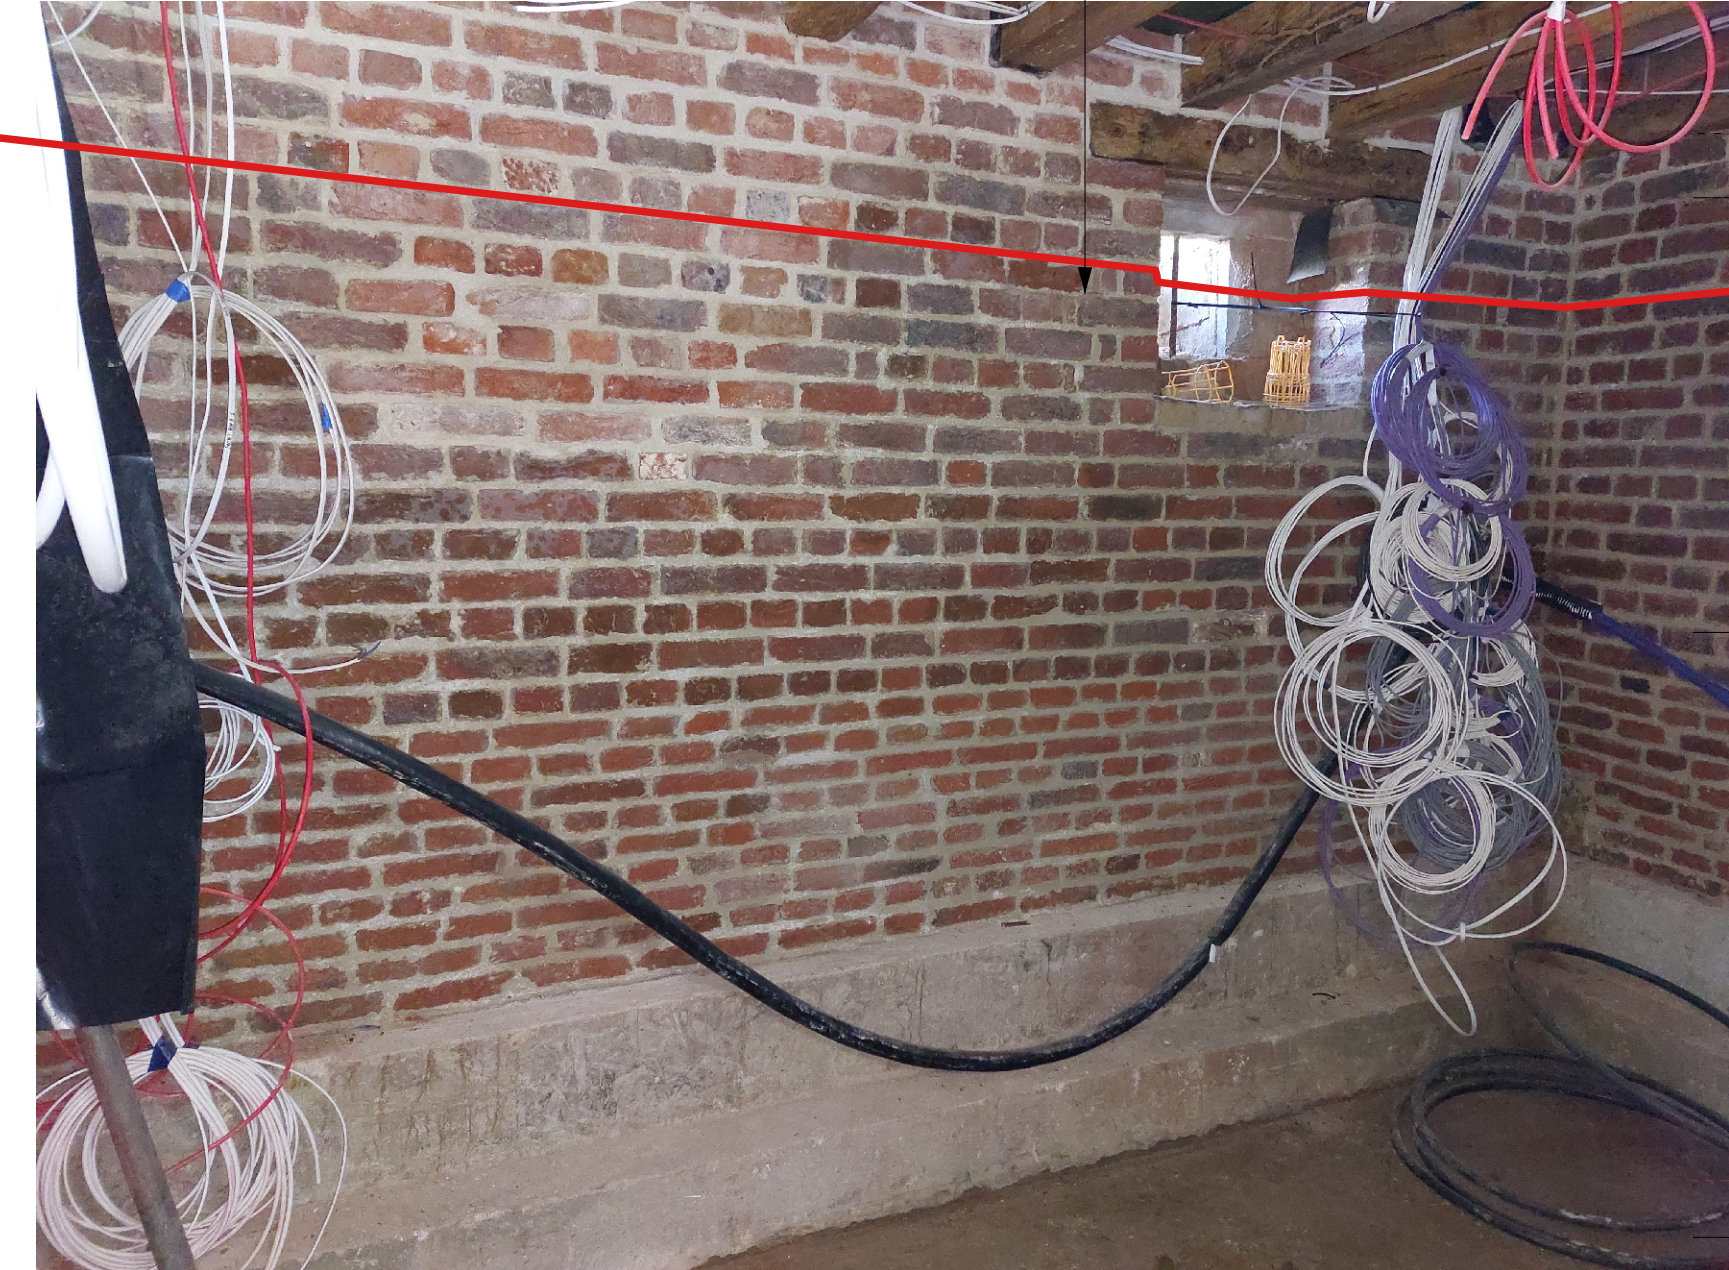
Red line indicates top of dry lining wall: typically, 3 courses below timber lintels

Photograph in-situ room 17

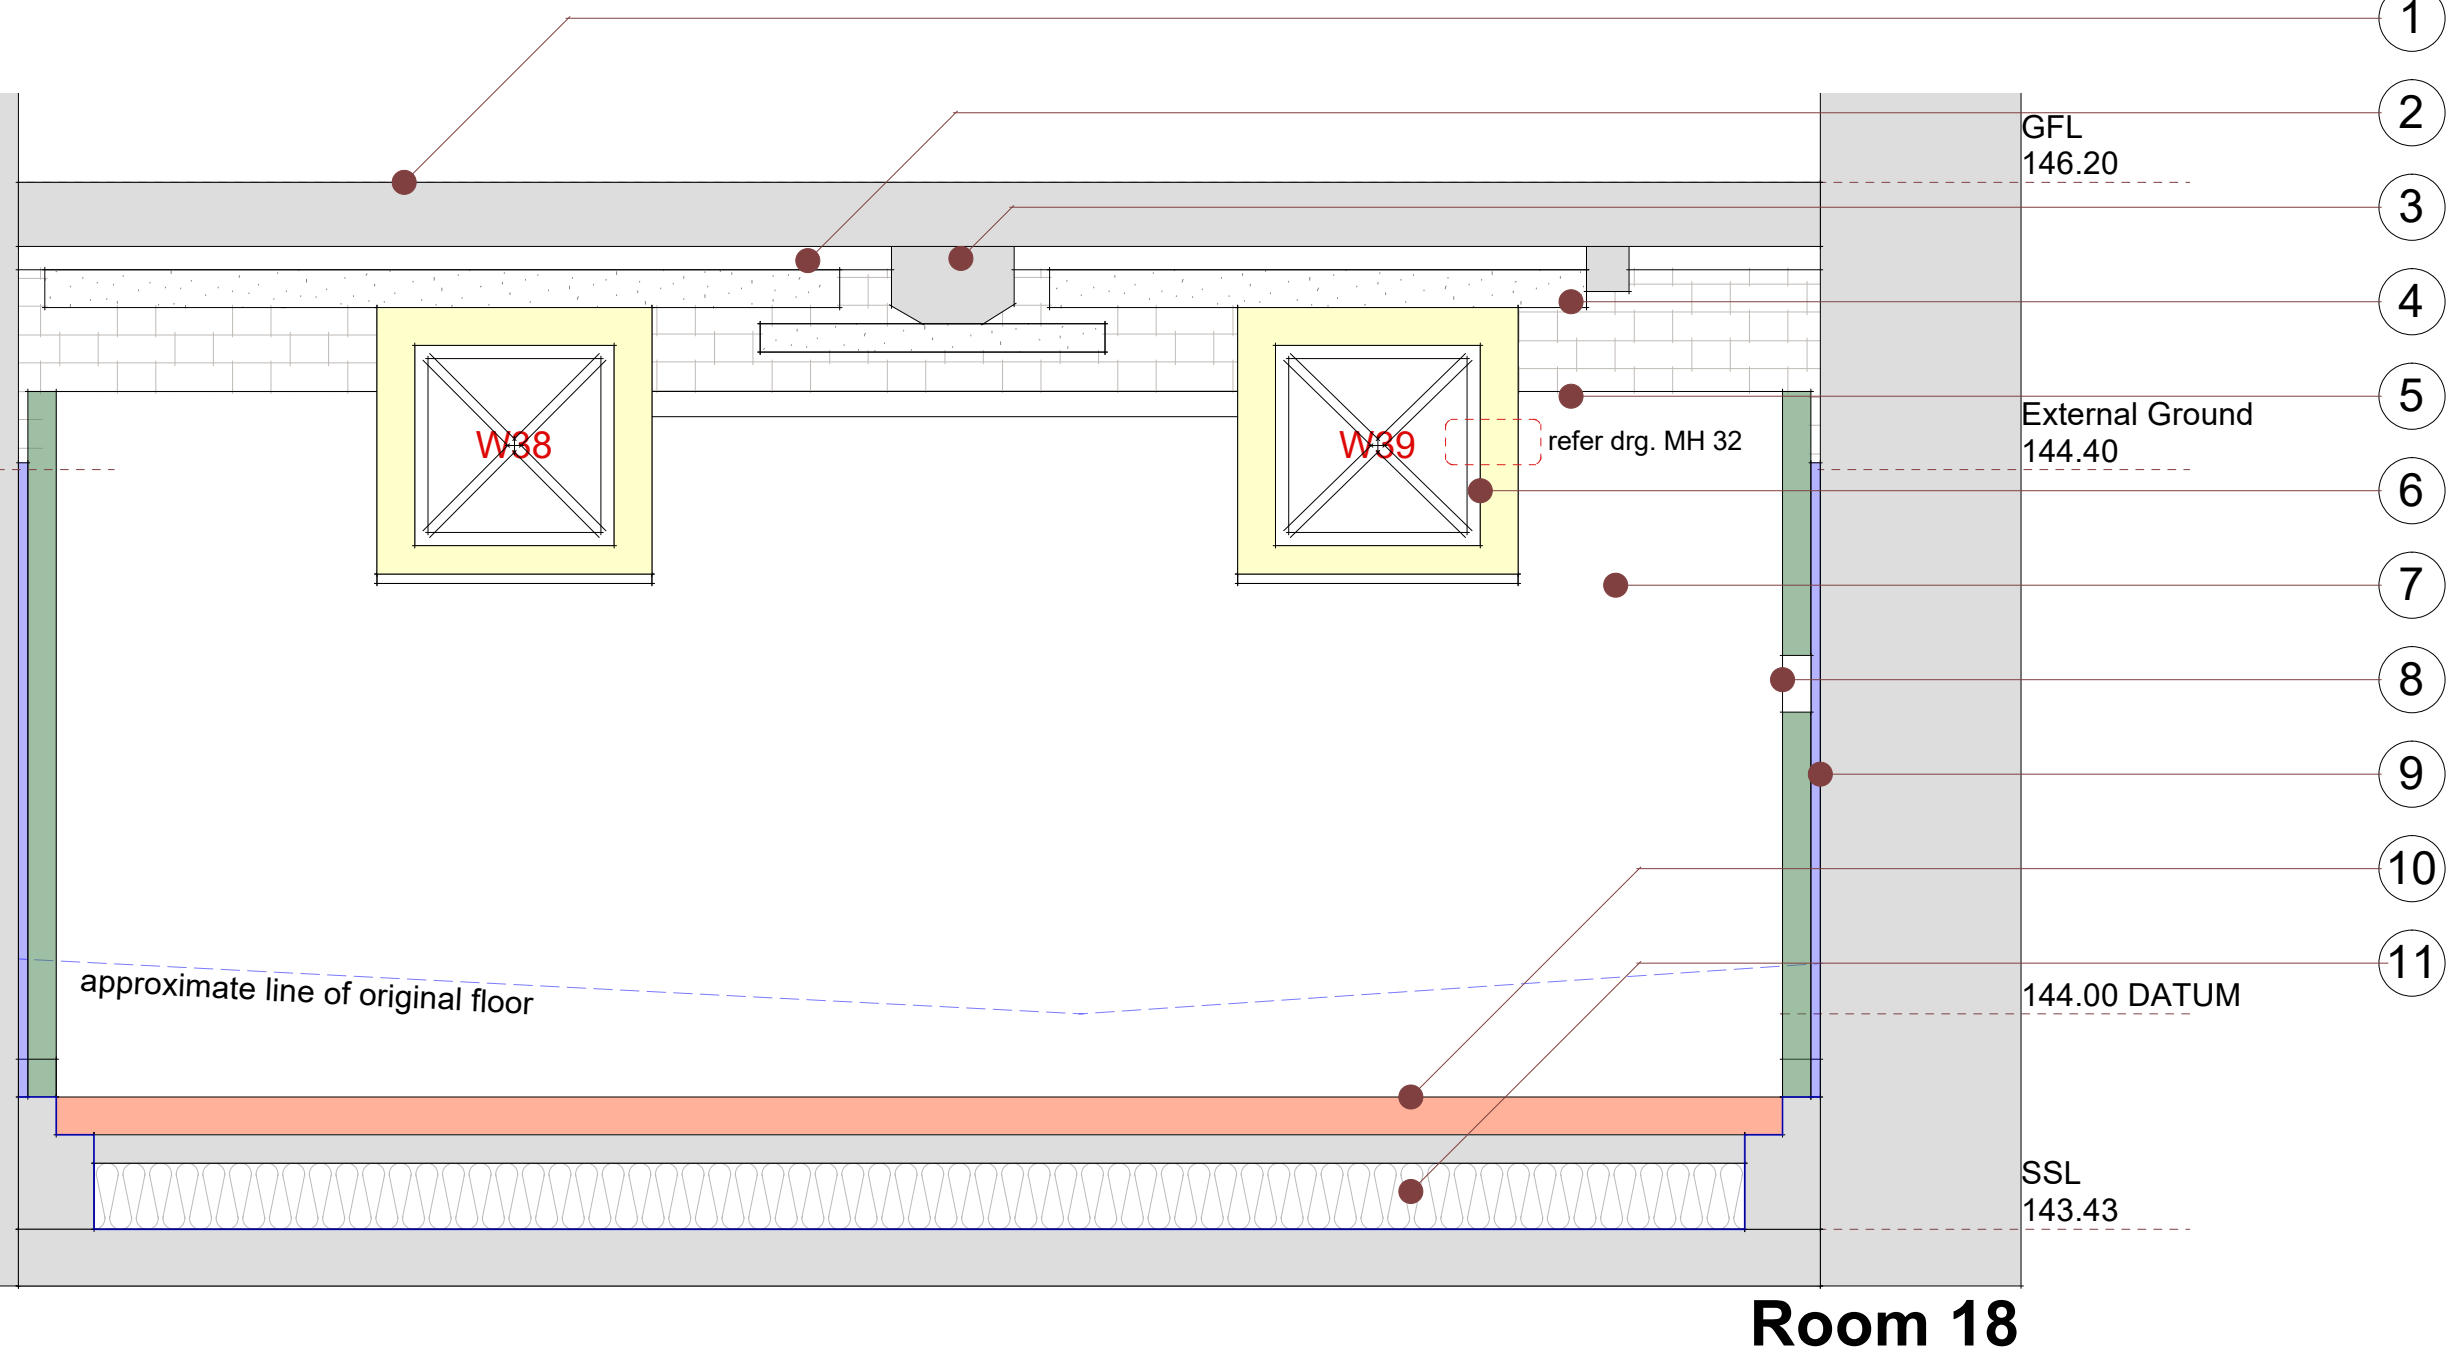
Section on AA

- Ground floor above , FFL indicated.
- Floor joists, new ceilings infilled between.
- Floor cross beams, downstand shown.
- Timber plates, existing, embedded in brickwork over windows.
- Facing brickwork existing, repointed and on clear view above new independent dry lining.
- Window, with existing stone surround indicated. Metal framed single casement opening light. Refer Drg. MH 32
- Self supporting dry lining. Lime render finish on suitable substrate, wall stops 100mm over height of tanking membrane.
- ditto, in section. Square plate inspection access hatch indicated, 150mm opening
- Tanking membrane, details and fixings by specialist . System -08 by MacLennan
- Replaced brick and cobble floor using retained materials. Level to be confirmed.
- New sub wall/floor foundation and slab to engineer's detail, incorporating insulation and screed to support existing relaid bricks.
