**BARNS AT OYSTERS FARM,  
GUTCH COMMON,  
SEMLEY, WILTSHIRE  
SP7 9BE**

**Heritage Statement**

**Bob Edwards**  
BSc. (Hons.) PG Dip. IHBC MCIfA

April 2026

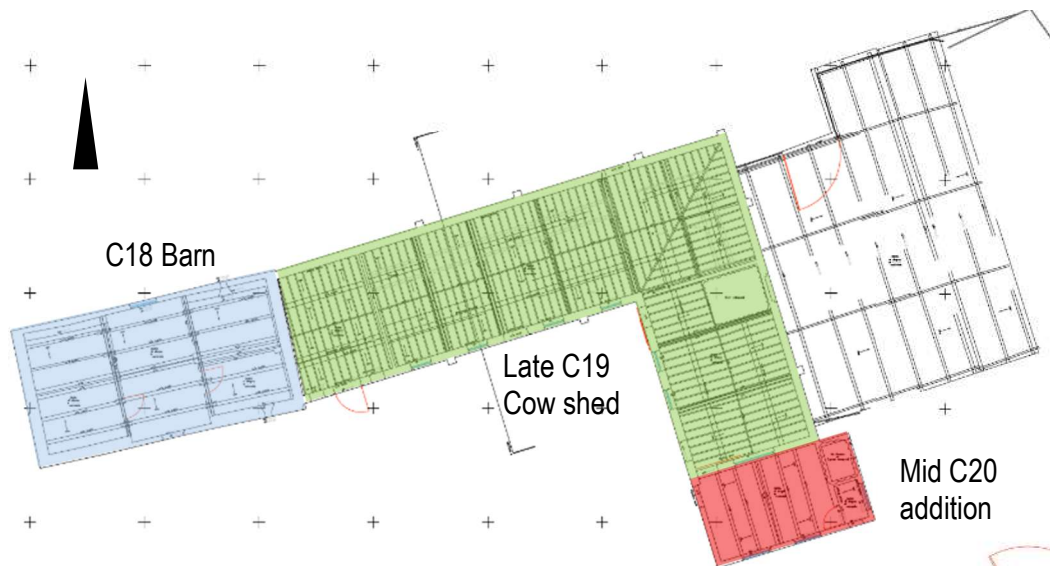
Figure 5 Existing plan showing the principal phases of development.

The farm building range at Oysters Farm is a L-shaped range of three distinct builds (Figure 5). At the west end is a stone-built three-bay barn, the walls being constructed in coursed roughly dressed greensand with brick infill to the central threshing bay (Figure 6). The roof is gabled and covered in concrete fibre sheeting with clay ridge tiles. The eastern bay of the barn retains a narrow, slit opening in both the north and south west elevations, although that to the north is now hidden by a later brick buttress. The ventilation slits to the western bay have been infilled. The west gable elevation is blank and has later brick to the verge, the brick matching the type of brick used to infill the threshing bay (Figure 7). At the north-west corner the stonework is failing; there is a significant crack from eaves to ground level with some missing stone. The eaves line has been raised by two rows of concrete blocks.

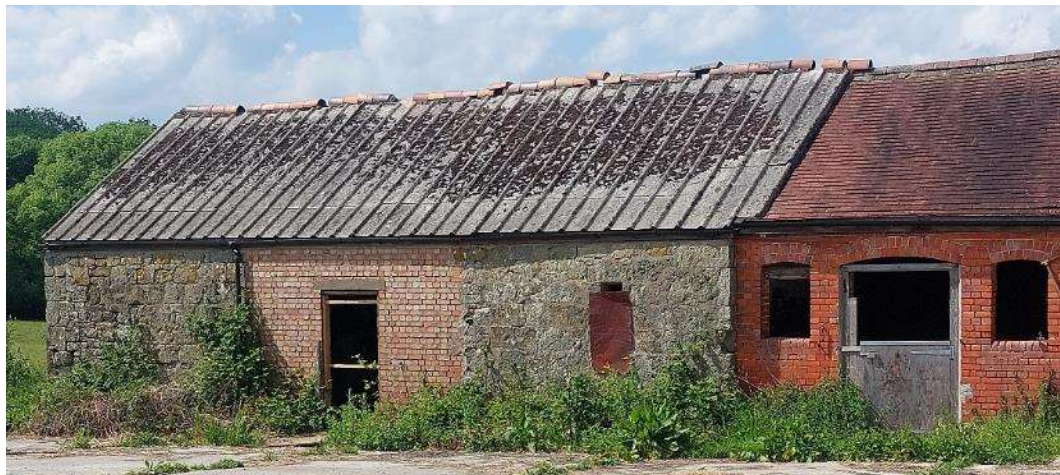
Figure 6 The stone-built barn at the west end of the L-plan range, south elevation.

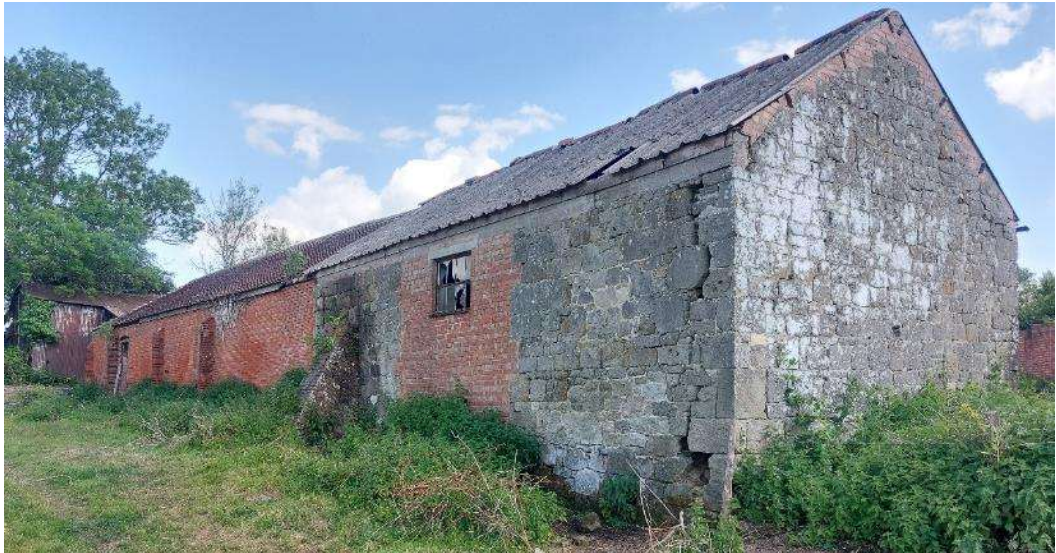
Figure 7 Barn, north and west elevations.

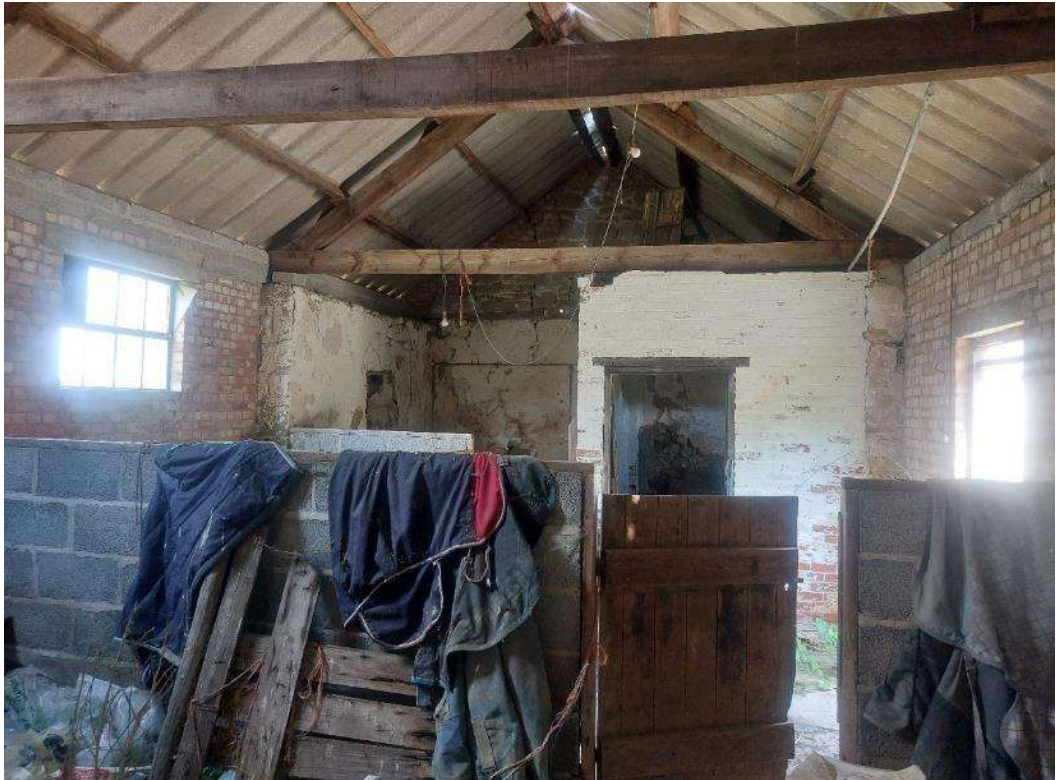
Figure 8 Barn interior facing east.

- 3.2 Internally, the walls of the barn are a mixture of exposed stonework on the south gable and rendered walls to the sides, with brickwork to the infill of the threshing bays. The area is subdivided by a 1.5 m high blockwork wall dividing the southern bay into a loose box and a similar blockwork wall to the western part of the northern bay, creating a second loose box (Figure 8). The eastern part of the northern bay subdivided by an earlier brick wall, rising to eaves level, which is a legend embraced vertical plank door. The two trusses of the roof of softwood and simple triangular trusses carrying softwood purlins with no rafters indicating that the roof was constructed in its present form to be covered in sheet material. The three sets of purlins, including those near the apex are set into later brickwork at the gables of same date as the infill to the threshing bays. The floor of the barn is concrete throughout.

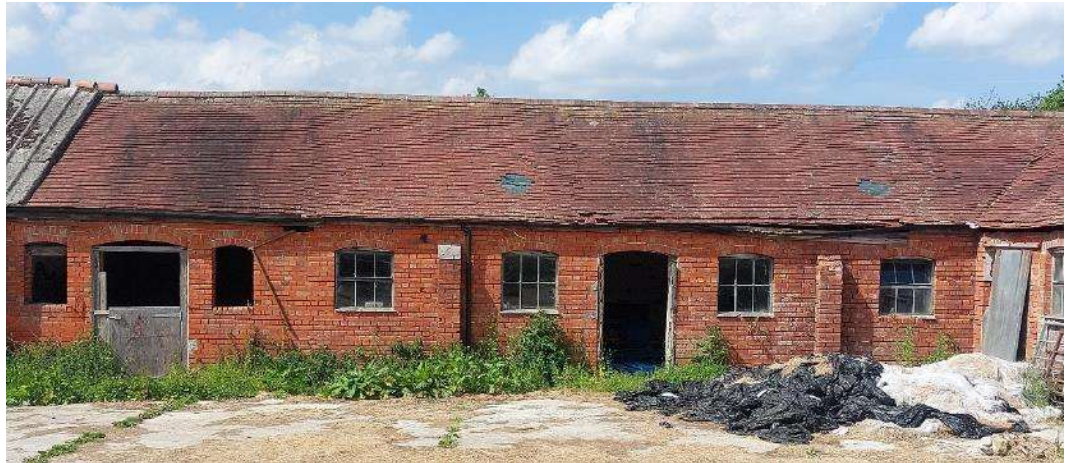
Figure 9 Cow shed range attached to the barn, south elevation.

- 3.3 Attached to the north gable of the barn and set at a slightly different angle is a late 19<sup>th</sup> century cow shed constructed in red brick which returns to the east at its northern end (Figures 9 and 10). The brickwork of this element is laid in English bond. In the east-facing elevation, there are two doors with segmental brick arches over. The southern door has small window openings to either side with bullnose bricks forming the sills. Both of these openings have lost their window frames. To the larger northern part of the range there is second door with two six-pane windows either side, also having bullnose bricks, but with a cement flashing covering his bricks. Two of these windows are of the hopper type with the top three panes tilting inwards, the other two are fixed steel-framed lights. The south elevation of the eastern wing consists of two phases of construction, the western part having a door which was probably converted from a window opening to the left, a blocked door now with a window inset and blockwork below, and a further window with a second door now boys over at the east end. The eastern bay of this range, which has a corrugated cement fibre sheet roof in contrast to the plain clay tile of the rest of range, is built in a Fletton brick laid in English bond with a single door opening with a concrete lintel over. In the gable end of this later bay, there is a blocked door now with a window to the upper part and an eight-pane hopper type window, both of these openings having concrete lintels over.

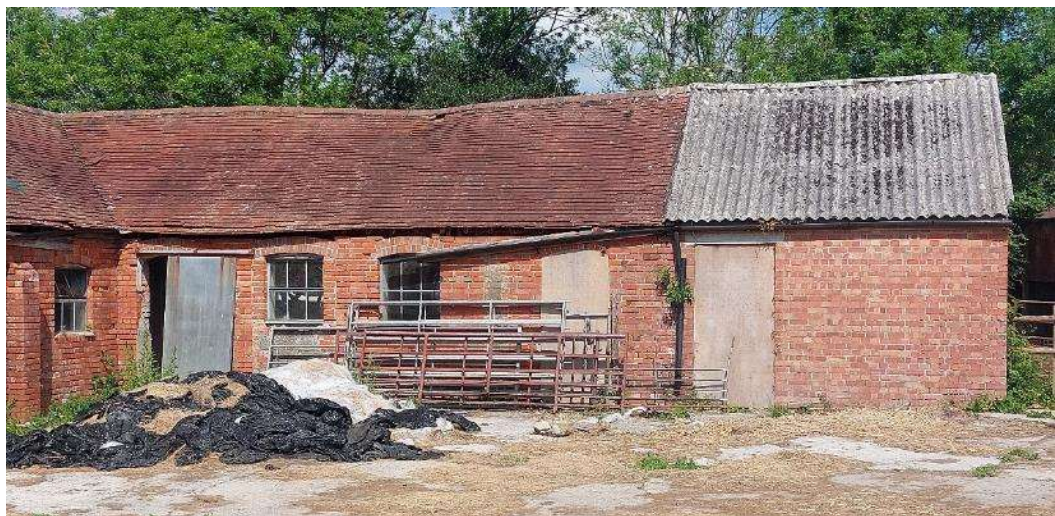
Figure 10 The return of the L-plan cow shed range, west elevation showing the two phases of construction marked by the change in roofing material and brickwork.

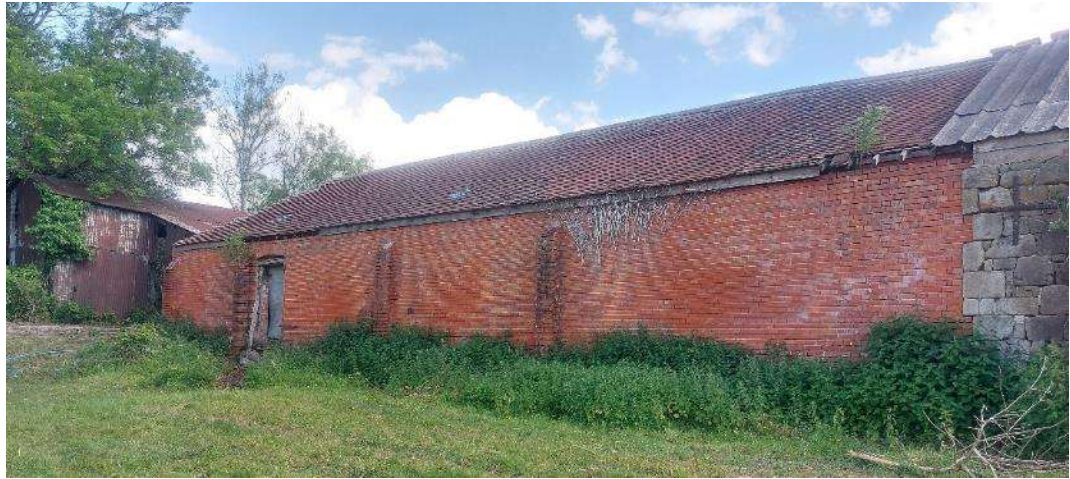
Figure 11 The north elevation of the cow shed range.

- 3.4 The north elevation of the cow shed is of English bond brickwork divided into four irregularly-sized bays by brick pilasters (Figure 11). There is a single door opening in the second bay from the east, the opening having a segmental arch of two rows of header bricks and a high threshold approximately 0.5 m above external ground level. The roof of this section is of plain clay tile, hipped to the east.
- 3.5 The rear, east elevation of the return wing of the cow shed element is also laid in English bond with a door opening that has been infilled with concrete block work. At the southern end there is a lean-to shed forming part of the later addition which has a door and an iron-framed window with a concrete lintel over.

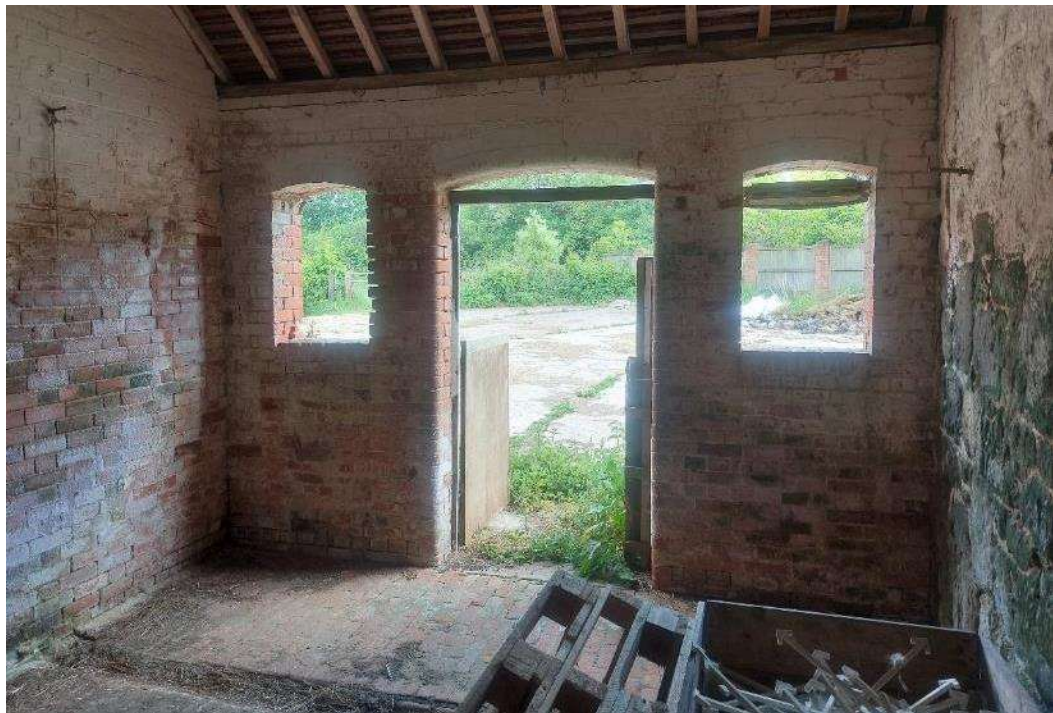
Figure 12 Interior of the stable adjacent to the barn, looking towards the front wall.

- 3.6 The east – west range of the cow shed range attached to the barn is divided into two with a separate stable element adjacent to the gable of the barn which has no internal link to the remainder of the range to the east. There are no fixtures or fittings within this space (Figure 12) although there are sockets in the side walls indicating the presence of a hay rack and probably a manger. The floor is of brick with a drainage gully at the end of the area of the stalls which runs east to west before turning alongside the barn wall to an opening in the front wall. The roof is of softwood with a ridge board and purlins and softwood rafters. The jambs to the door opening use bullnose bricks to the inner corners.

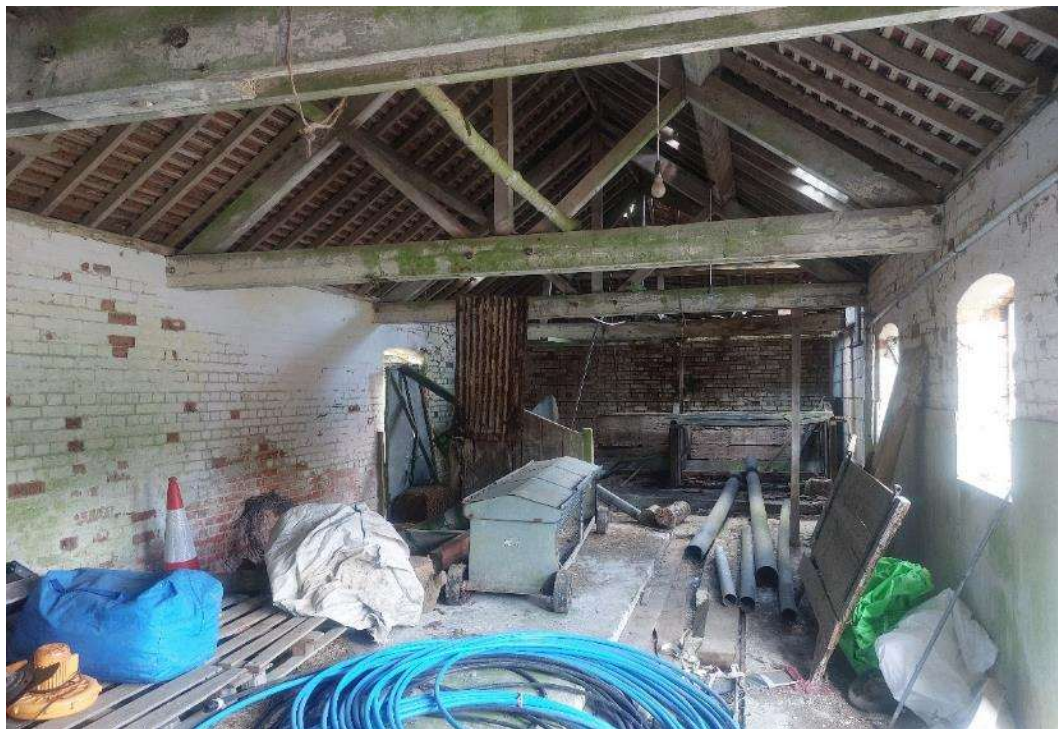
Figure 13 The interior of the cow shed within the main range of the building, looking east.

- 3.7 The northern part of the main range is a former cow shed of six bays in length defined by softwood king post trusses, the tie beams being formed by two 2-inch-thick timbers bolted to either side of the principal rafters and a central block into which the king post is also bolted (Figure 13). There are typical raking struts up to the principles which carry purlins on their backs. The walls are of painted brickwork apart from the lower part of the front wall which has a cement render. The floor is of concrete, probably of mid-20<sup>th</sup> century date, with a concrete manger set in front of a feeding passage that runs along the inside of the rear wall and which returns across the eastern end of the building, the passage being defined by a timber partition with stall dividers at the east end (Figure 14). The north side of these stalls has a rendered blockwork partition.

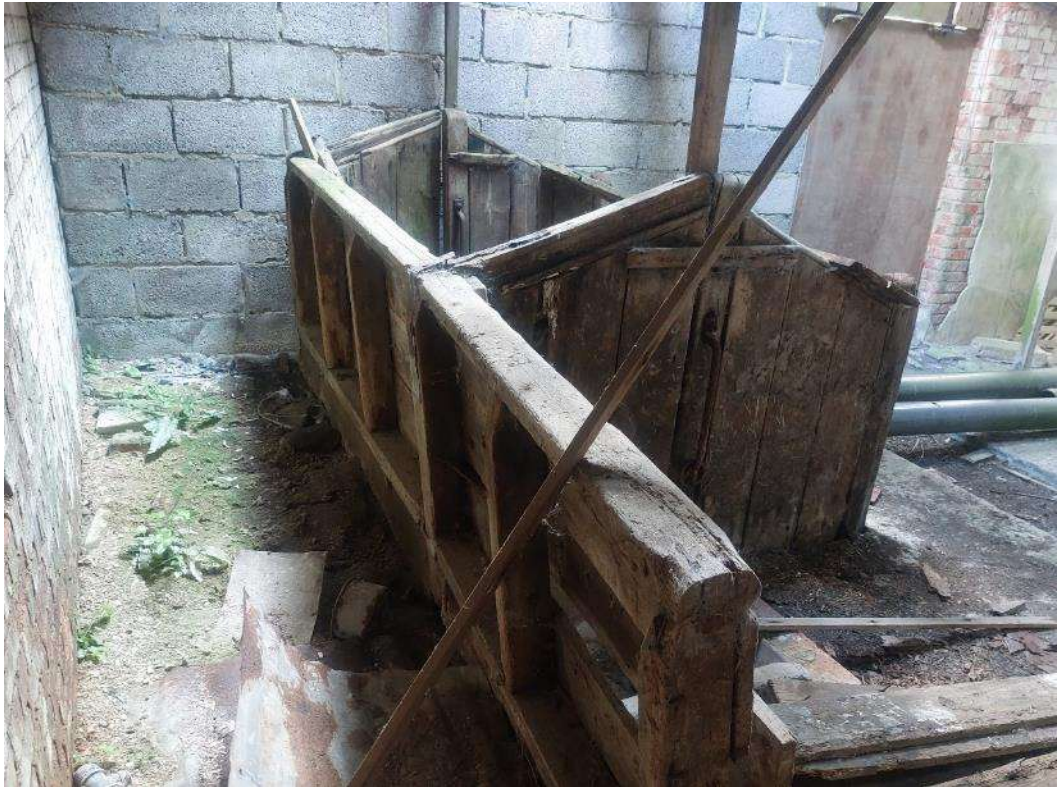
Figure 14 A section of surviving timber stalls with the feeding passage along the inside of the outer wall.

- 3.8 The main range was originally open to the shorter range but the two ranges have been divided by the insertion of a concrete blockwork wall with a door opening that has been boarded over (see Figure 14).

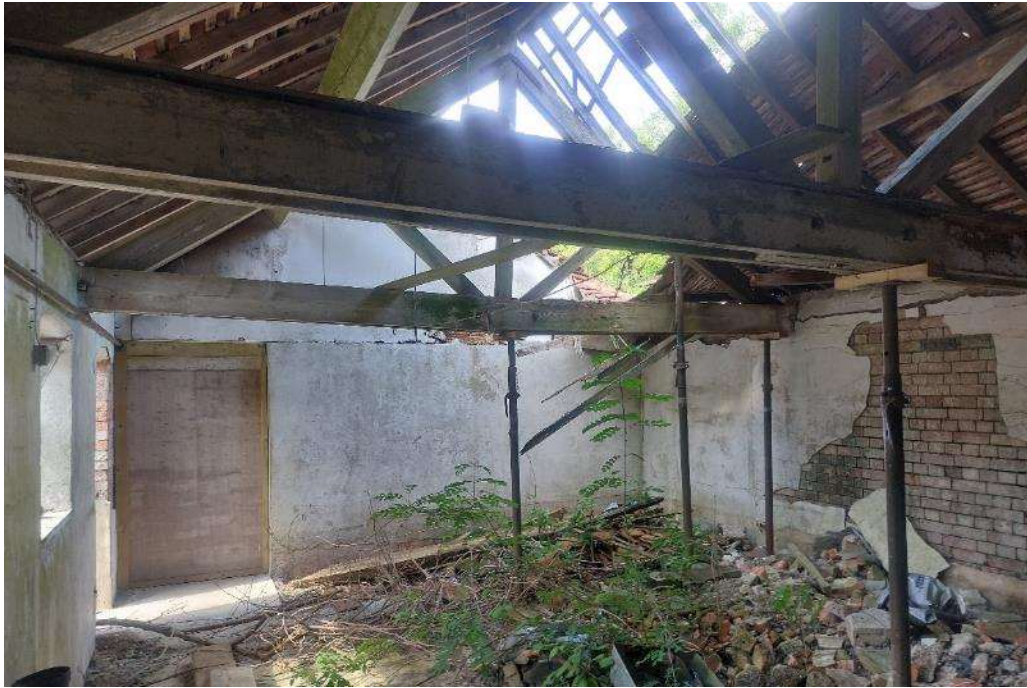
Figure 15 The interior of the east range looking north.

- 3.9 The southern arm of the late 19<sup>th</sup> century element of the range is of three bays defined by the same form of roof truss as in the main range (Figure 15). The walls are rendered although there has been some significant loss of render on the east wall exposing the brickwork. The floor is of concrete. Approximately half of the roof to the east slope has collapsed, and the upper courses of brickwork in the east wall are leaning out significantly. The south wall of this section has a large window opening high level which has chamfered vertical glazing bars with each light having six sections of glazing which overlap under segmental brick arch and there is a door opening into the later bay at the south end. This is presumably an inserted opening.

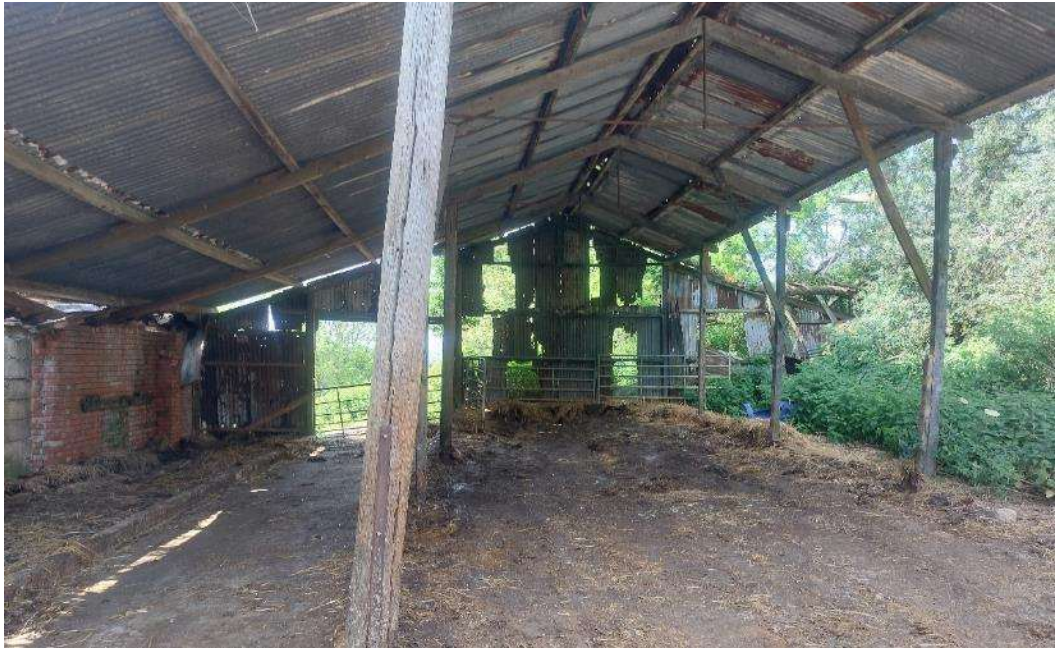
Figure 16 The modern agricultural shed attached to the east side of the L-plan range, facing north.

- 3.10 Within the eastern bay there are no features of interest other than a vertical plank ledged door into the small lean-to on the north elevation.
- 3.11 Attached to the east elevation of the late 19<sup>th</sup> century range is a large part open-sided shed of mid-20<sup>th</sup> century date with several telegraph pole posts and other slim square section timbers, the trusses being metal ties with metal posts to the apex (Figure 16). The roof is covered in corrugated metal sheeting. This structure was originally aisled both sides but the aisle to the east has largely collapsed.

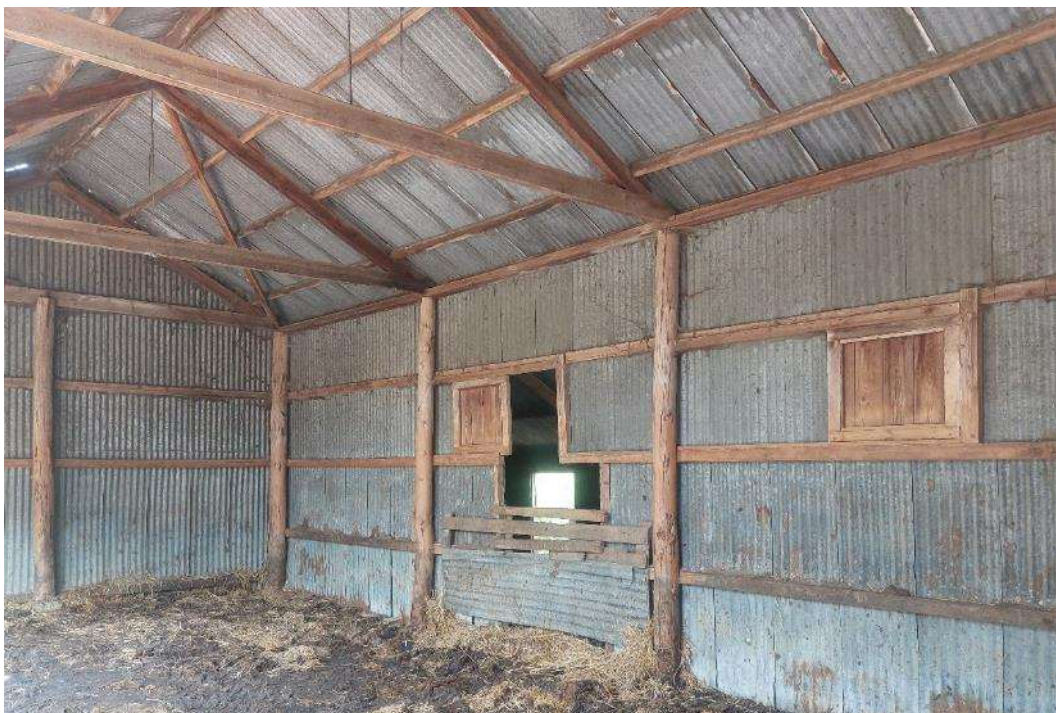
Figure 17 The interior of the modern shed to the south-east of the L-plan range of buildings.

- 3.12 To the north-east of the agricultural range is a further corrugated metal sheet clad shed of four bays with telegraph poles dividing three other bays with one pole missing (Figure 17). The other poles to the end and rear are tree trunks. There is a separate aisle to the south which is set at lower level. In the south wall of the main part of the barn there are three lights with timber sliding shutters.
