# Tottenham House and Estate

## Design and Heritage Statement

Approval of Details Application to partially discharge  
Condition 11 Ref 18/00195/LBC Walled Garden Repairs  
and Openings and Condition B Ref PL/2024/09243

### **Structural Engineer's Statement - Spine Wall Reconstruction**

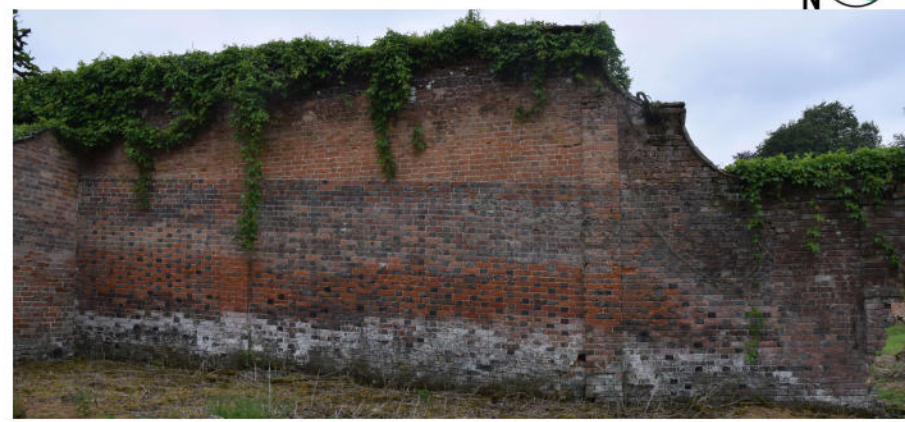
Figure 7 - Historic Walled Garden (Historic Photograph)

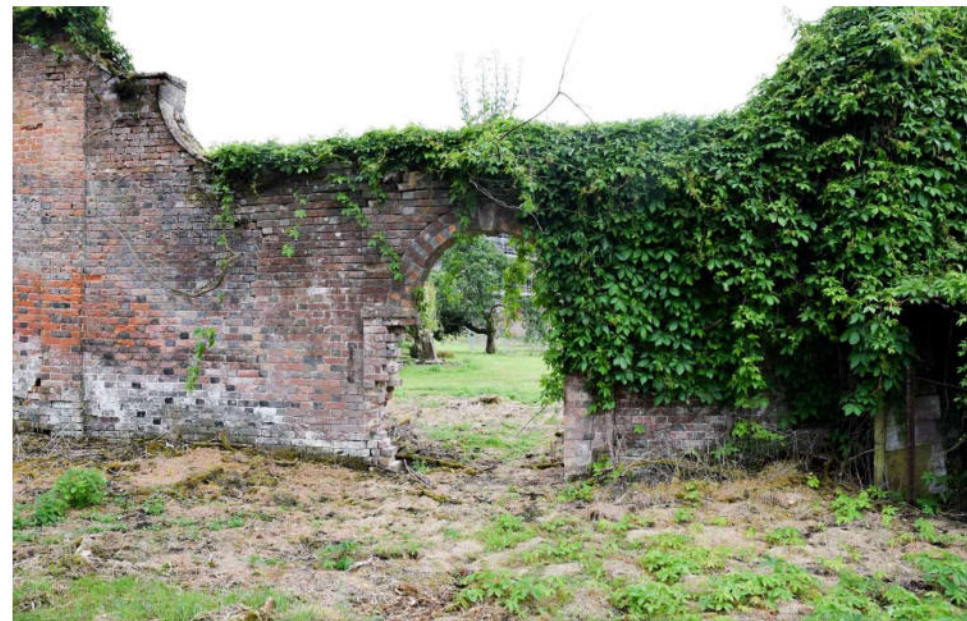
Figure 8 - Historic photograph of opening 2

- 3.6 There was also a larger arched opening in the center section of the wall on the line of the historic pathway axis running north south between the historic fountain pond in the south section and the feature plinth in the North section . The available photographs, taken in 2021, show this opening to be in very poor condition. We can also see that the arch and the brick work around it have been rebuilt at some time in a different brick to that in the adjacent wall- with a distinct jagged vertical construction joint and mismatched brick coursing due to the different size of the bricks used. It is also notable that it is a common arch, not gauged as the original opening near the west end of the spine wall. All evidence suggests that this central arch and this section of the wall have been rebuilt at some stage and the work is not of the quality of the rest of the original wall. Please see the photographs on Drawing Number 3122 220.1

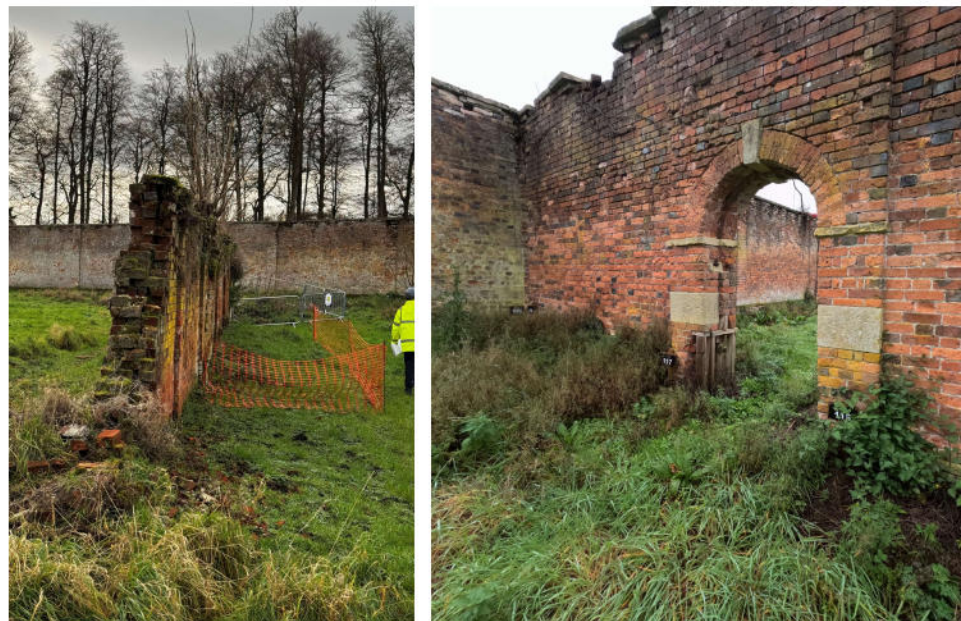
Figure 10 - Historic photographs of Spine Wall, Opening 3 on RHS

- 3.8 Located near the east wall, there was only evidence of the edge of the opening extant in the existing survey - and this now covered under the consented Pool House North and South elevations. See Drawing Ref No:3122 021 A

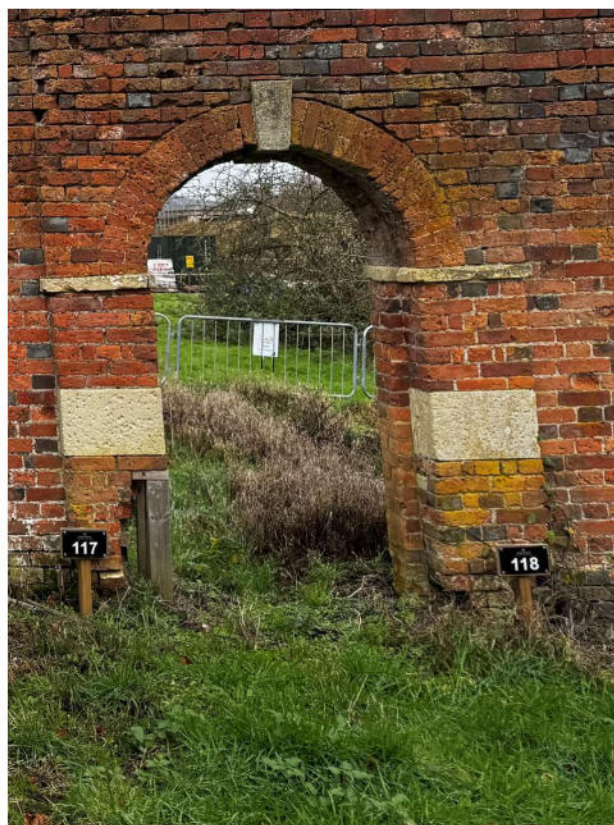
Figure 15 - Existing Opening 1

- 3.5 A round topped arched opening built within a thickened section of the spine wall near the west perimeter garden wall. We can see this in recent photographs taken in 2024- with original gauged red brick voussoirs, stone string course, key stone and stone hinge pintle support blocks. The opening is rebated with the remains of wrought iron hinge pintles which would have supported a gate within the opening. (See Photos XXXXX )

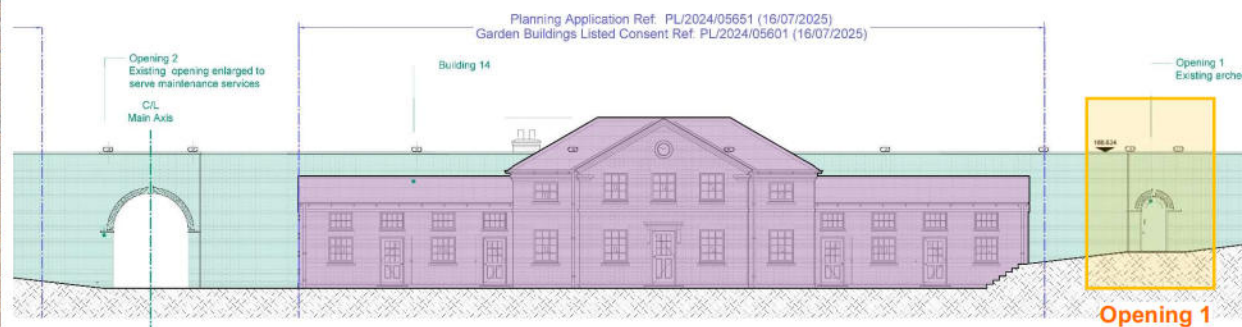
Figure 16 - Opening 1: North Elevation

- 4.6 **Opening 1 West arched opening**  
Opening 1 will be carefully reconstructed incorporating the original stone hinge support blocks arch springing point stones and keystones- with new gauged voussoirs to match the originals which were decayed.
- 4.7 A new gate will be manufactured for this opening using the principles established with the wooden gates in the external walls with similar ledges and stiles and L shaped hinge straps.

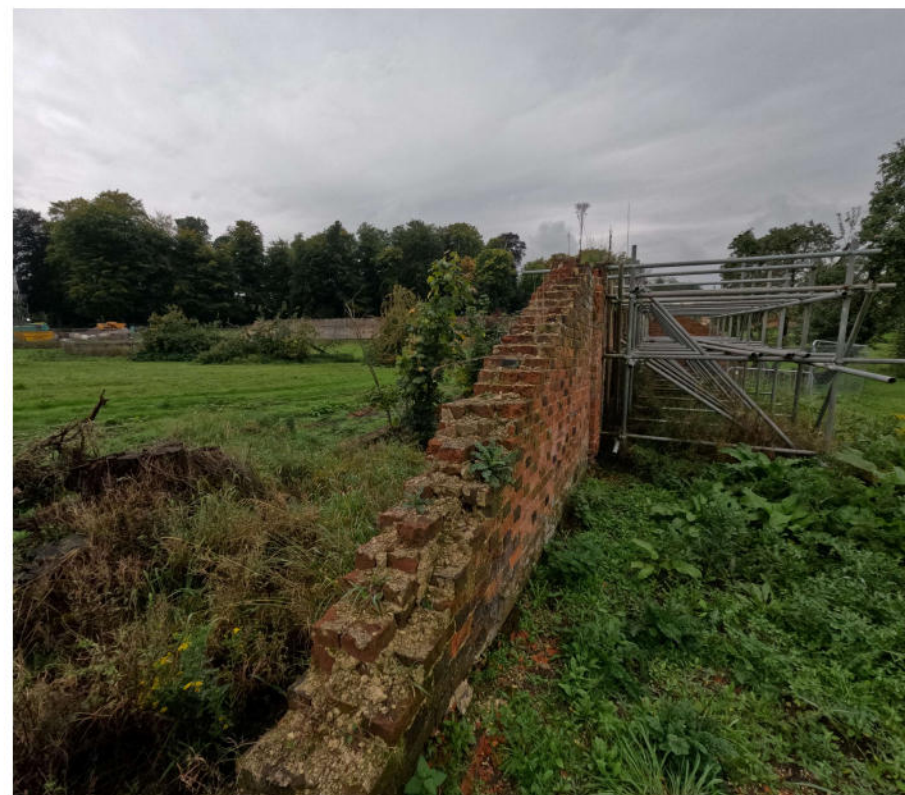
**Figure 21** - Existing spine wall brickwork

- 4.14 Although there is evidence to suggest that some original sections of the wall may have been a full chequer board pattern when constructed- there are also areas evident where the pattern is diminished or not visible.

- 4.15 It is therefore proposed to reconstruct the wall in accordance with the 50% Chequerboard pattern in accordance with Wall Type C as shown on Adam Architecture Drawing No: THW001-ADA-XX-XXDR-A-0346B which has been consented as part of the external garden wall repairs, and of which there is a sample built on site. The Brick size will vary slightly from that stated to match those bricks in the Garden buildings and the Pool House.
