**Heritage impact assessment  
(including design, landscape and access)  
at  
The Compasses Inn  
Lower Chicksgrove  
Tisbury  
SP3 6NB**

This statement is written, on behalf of the owner, Mr B. Maschler, in support of a planning and listed building application for works to 2 buildings – a Grade II listed pub and a curtilage listed barn, in the pub's car park, within this Area of Outstanding Natural Beauty covering The West Wiltshire Downs and Cranbourne Chase , as follows:

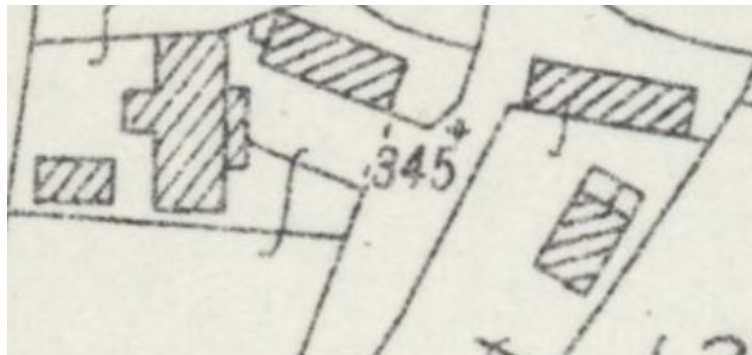
Fig.4. An extract from the 1925 Ordnance survey map

As can be seen from the 3 O/S extracts, there have been alterations, extensions and removals of parts of buildings over the previous 130 years. A significant building was removed from the west side of the Inn, or partly incorporated into the later extension and a building in the present carpark removed entirely.

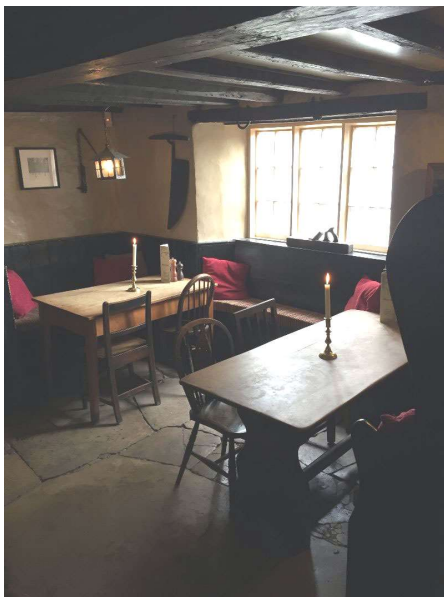
The significance of The Compasses Inn lies in its architectural and historic interest as an example of a village cottage, constructed of rubble, local stone under a thatched roof. Inside, surviving original features, on the ground floor, include the oak ceiling beams, exposed oak joists, random stone flagged floor and ingle nook with bressummer, which all add to the character of a cosy pub interior. Modern C20th additions, to the rear, using different materials, have not detracted from the character or its significance.

Fig.6. The interior of the Inn

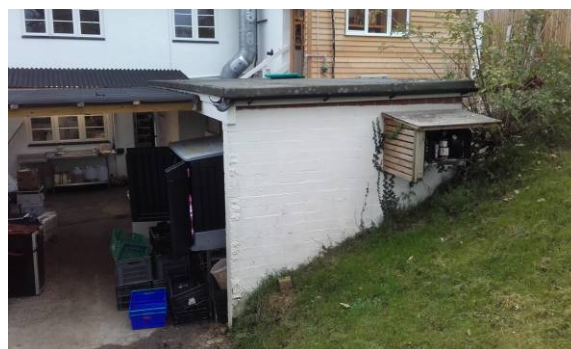
To the west at the rear of the Inn is a new blockwork, flat-roofed store which contains the chilled foods and drinks for the kitchen and bar. A covered pergola allows access from the kitchen to the stores in all weathers. Due to the location of these elements, they do not harm the setting of the Inn or its significance.

Fig. 8. A view of the west side showing the drink and cold store.

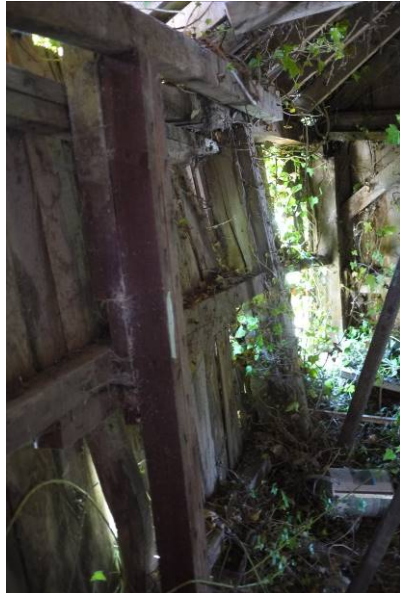
The barn is a useful visual stop to the north end of the carpark but is now in a parlous condition, albeit, capable of repair and re-use. The deflection of the roof and the lean is due to long-term lack of maintenance. Mainly, the structural problems are to be found in the later addition to the original structure. Framework is a mix of oak principals under a pine roof structure. External walls are clad in vertical plank-on-plank, now much affected by rot and insect attack. The roof is covered in Bridgewater clay pantiles. Underpinning is a red hard clay brick which has been either removed in places or has tilted outwards, due to the outward lean of the building.

Fig. 9. The internal south west corner showing props.

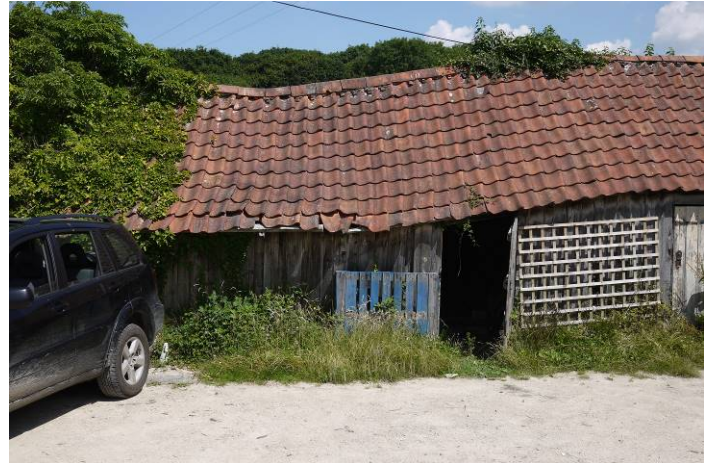
Fig.10. The west end showing the sagging roof.

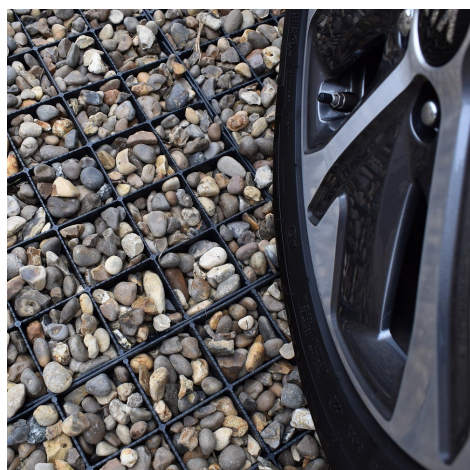
The carpark will be re-levelled and the surface covered with re-cycled plastics grids, filled with gravel. This material will allow drainage direct to the sub-strates and avoid water run-off to the village street. The grid will retain the gravel. Once laid, discrete markers will be laid to ensure tidy parking arrangements.

Fig. 11. View of the surface of the carpark.

The carpark is on the east side of the road and in poor condition. The loose gravel surface has been washing away, resulting in a pitted surface. The east side of the carpark is defined by a thick, tall hedge of mixed species.
