# Heritage Impact Assessment

Dairy Cottage,  
Grange Farm, Dukes  
Lane, Maiden  
Bradley

May 2026 | Project Ref 12039A

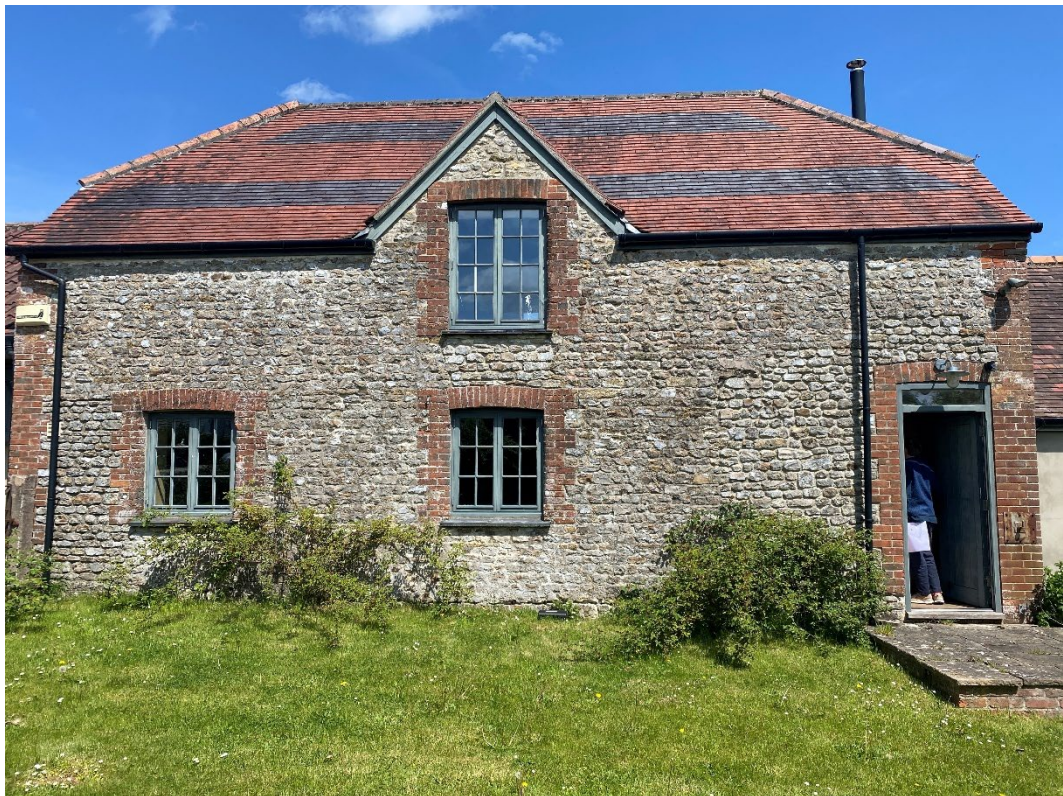
*Figure 3: The main part of Dairy Cottage*

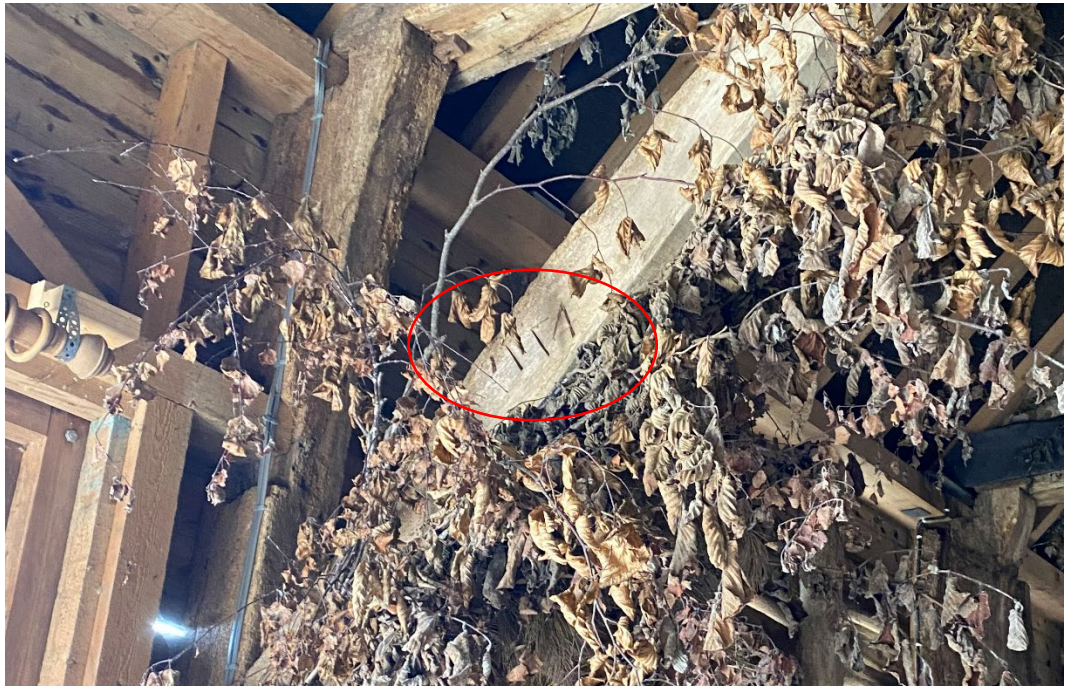
*Figure 5: Carved date '1774' on a brace adjacent to the south western threshing door, the '7's are carved backwards.*

**2.11** Though the 18<sup>th</sup> century records have not been consulted the main barn on the site bears a date carved into one of the braces adjacent to the western doors, though the '7's are backwards, the date 1774 is clear – this would not be unreasonable for a construction date based upon the style of the carpentry, but the possibility that it marks another event or factor for the farm's occupants remains a possibility. It is very close to the supposed acquisition by the Dukes of Somerset in 1779 perhaps reflecting investment in the estate.

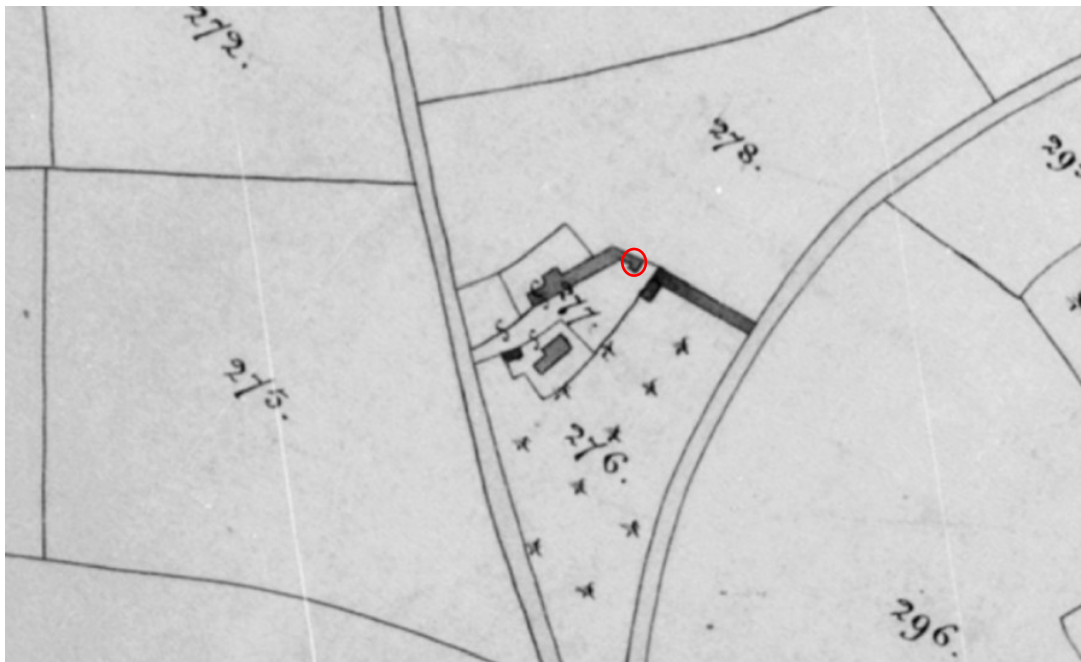
Figure 7: 1840 Tithe map, Dairy Cottage indicated

**3.7** Ranges of buildings to the north and north east define a yard and then apparently extend to the road – it is noted that this map is the only one to show structures here, all other maps indicate this narrow strip to the east as an access – there is the possibility that the map is simply not accurate or has mistakenly ascribed structures here rather than a drive. Access from the west between the farmhouse and northern buildings is established now from a track shown running past the group to the west. Plot 276 is recorded in the apportionment as 'orchard', 277 is the 'House, buildings and fold' and 278 to the north is 'barn ground'. Dairy Cottage would appear to be in place, at least in part by this point, again the proportions appear not overly accurate.

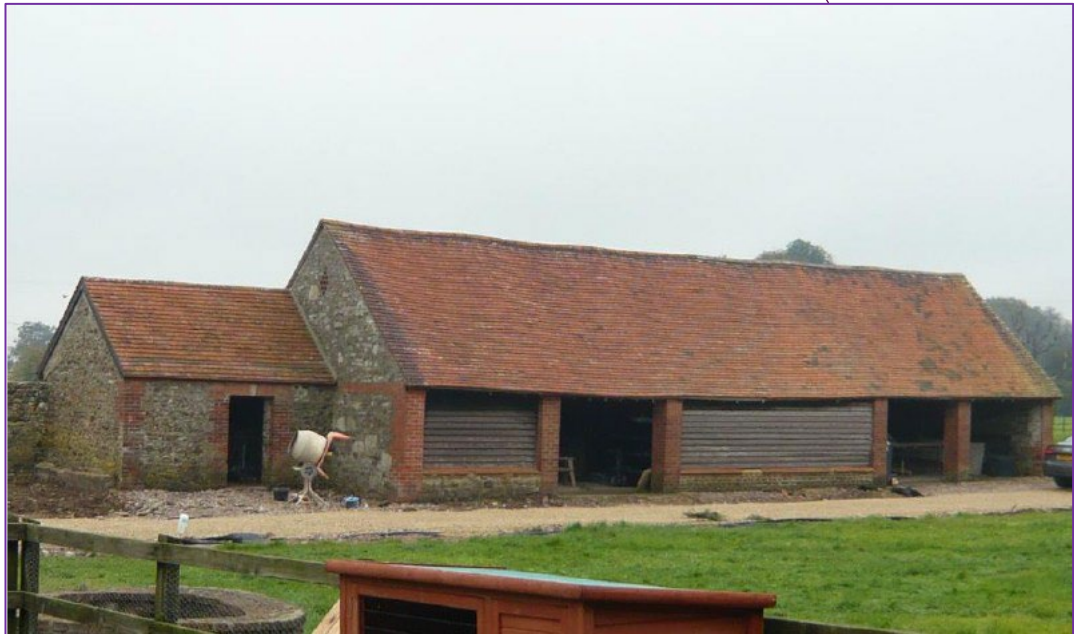
Figure 11: The southern range in 2014 prior to conversion (Elaine Milton Heritage and Planning, figure 26, p.19)

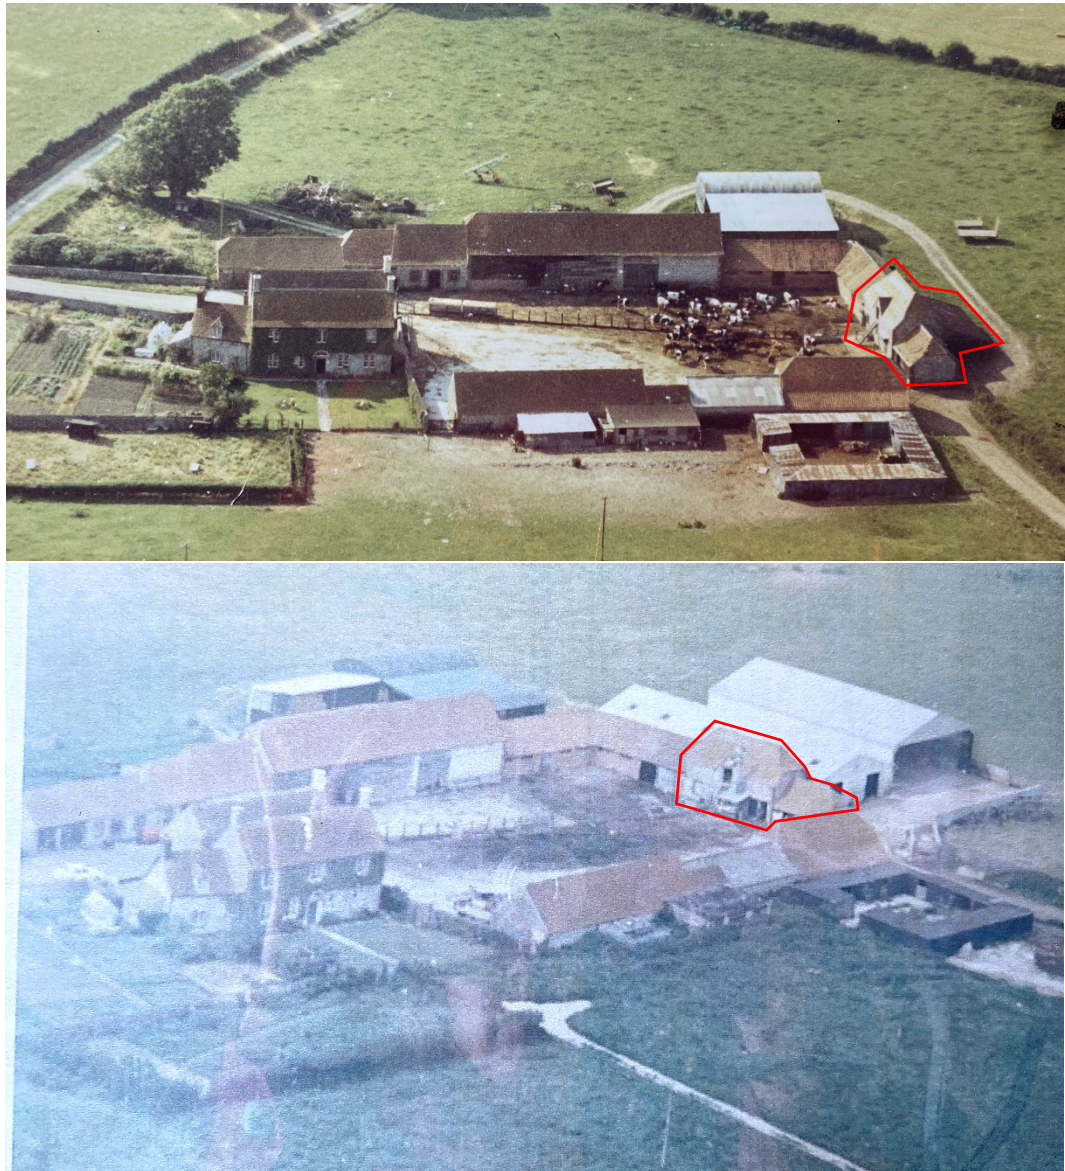
*Figure 13: 1980s photographs, when the farm was still in active use. Note cows in yard, additional structures to the south and north, and then to the north east, firm access from the north east and north west. A path reinstated to the southern front in the lower one, no longer present.*

**3.14** Dairy cottage is discernible in these with a large opening in the ground floor – evidence for which is visible today in a change in stone bonding and pointing. The hayloft is accessed only by a ladder and the lower portion of the building also appears to be open sided. In the first the lean to structure remains on the back of the building, apparently a corrugated tin cladding. By the second, it has been replaced with two large format modern barns.

**5.10** The menage located to the east of Dairy Cottage is a feature added to the site in the last decades of the 20<sup>th</sup> century (compare figures 13 to 32). While it illustrates a generally equestrian/agricultural use to the wider site in recent years it is not in and of itself a positive feature of the setting of the listed building. Its north western edge is defined by an entirely unremarkable concrete block wall which does not positively reinforce the traditional materiality of the historic farm group. Its removal and restoration to open grassland is a positive aspect of the proposal.

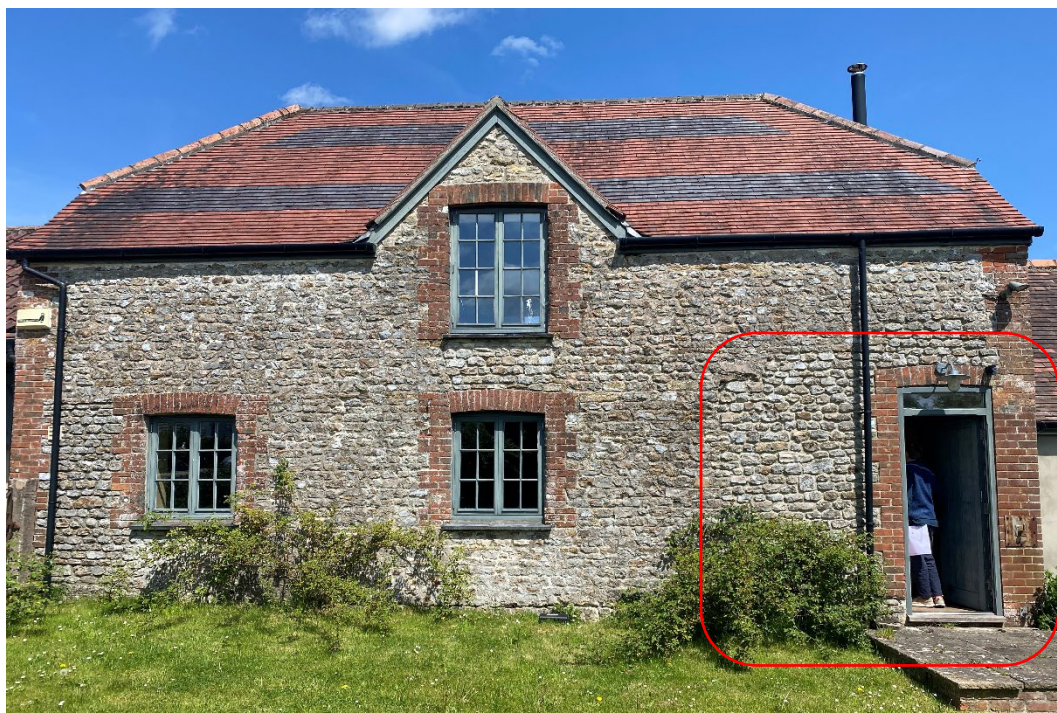
*Figure 17: Front elevation note slightly different stone character in area of former opening.*

- 5.6** The proposed new front window sits within the former wide opening at ground floor level which remains legible in the building today (see Figure 17). It has been previously consented but never built out. The proposal has already been agreed and its construction now, following a further consent, will have no greater impact on heritage values and will not affect historic fabric, but the modern walling which blocked the former opening.
- 5.7** New windows into the kitchen will see the removal of small portions of the rear wall of this structure. Though this fabric is ostensibly historic dating to the late 19<sup>th</sup> century, it contains no overt evidence or illustration of past function. The ability to

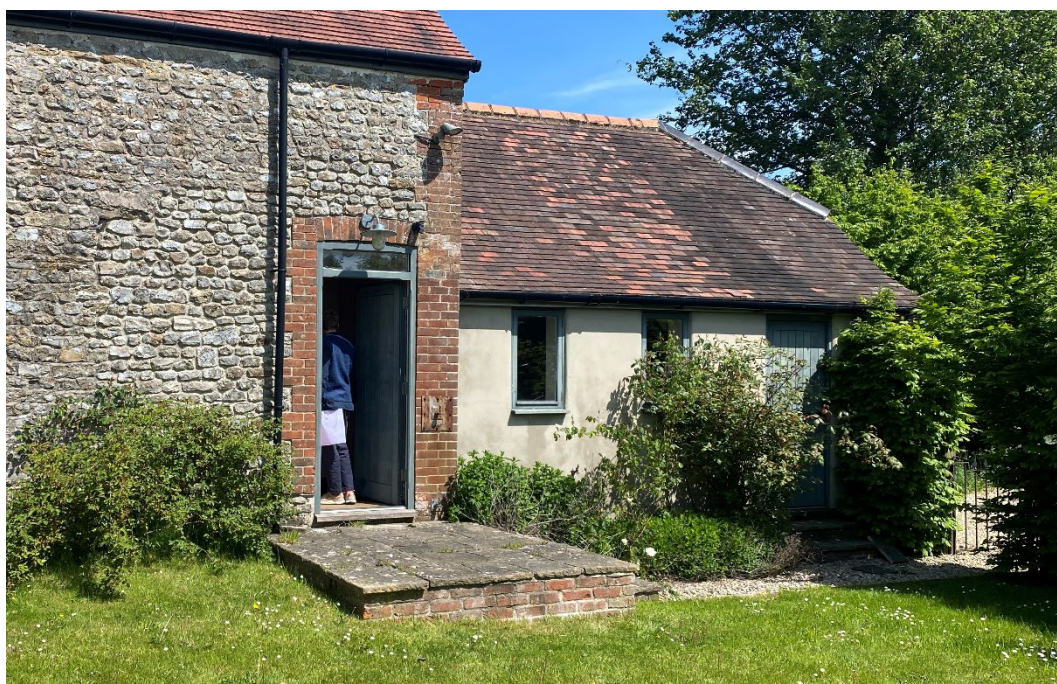
*Figure 18: The lower portion, perhaps historically a bull house.*

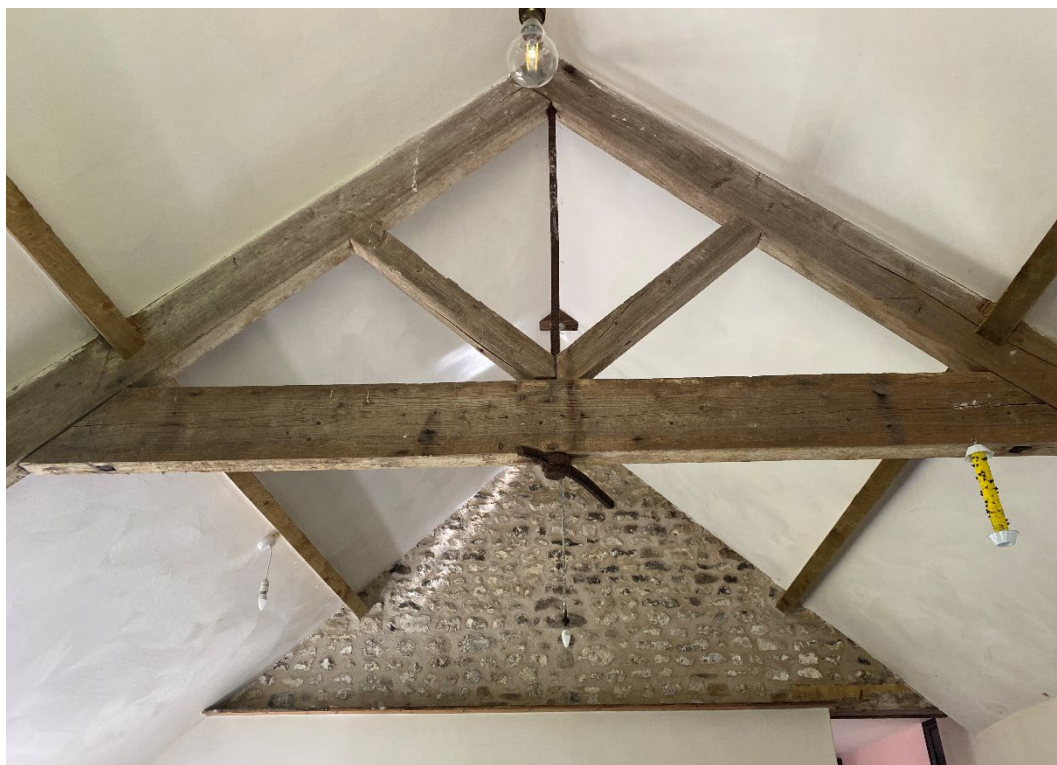
*Figure 19: Interior with exposed roof truss in the lower portion.*

**3.20** Dairy Cottage today has echoes of its past use in the footprint and overall material character but its conversion over the period between 2014-16 has seen the interior comprehensively altered. It retains no internal clues to its past use as a stable, hayloft and possibly bull house though elements of the roof trusses are exposed in parts. The following images illustrate the building today.

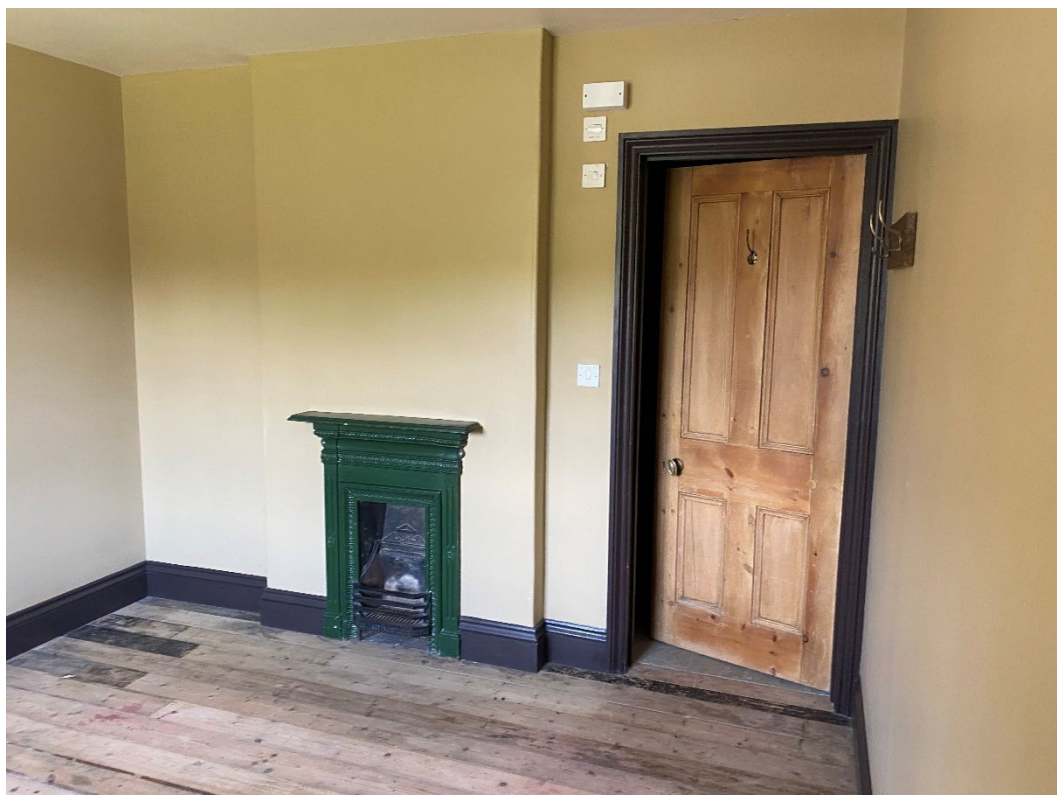
*Figure 20: Ground floor room. Broadly appropriate Victorian grade and door style utilised in conversion.*

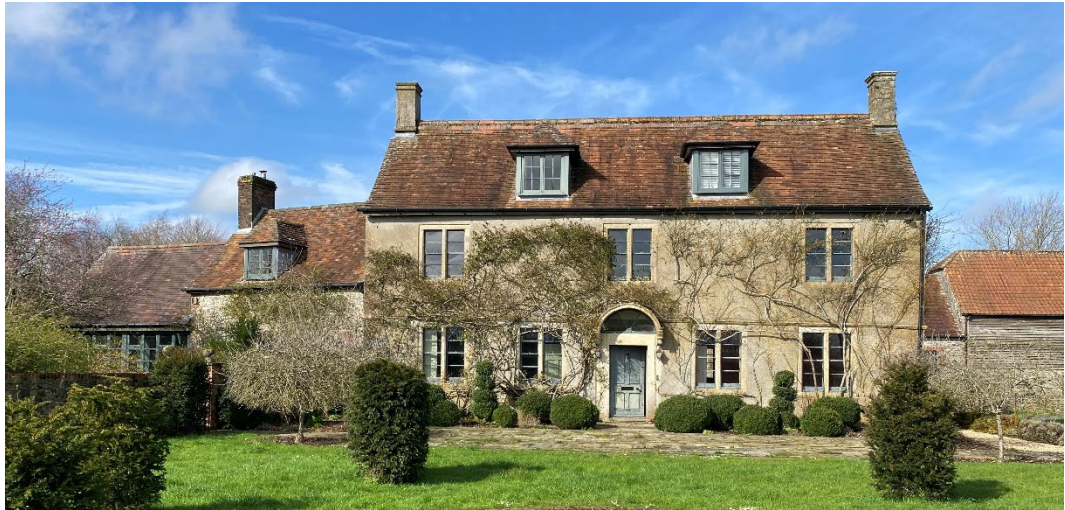
*Figure 22: Formal southern frontage, stonework concealed by render.*

**4.5** Irrespective of the date of the windows themselves the openings and symmetrical nature of the north and south facades has a distinct sense of regularity and a gentle approach to achieving a 'polite' architectural appearance rather than a wholly vernacular aesthetic – the southern front in particular with its formal hood over the doorway, stone window frames and string course as well as the rendered finish to conceal the local stone.

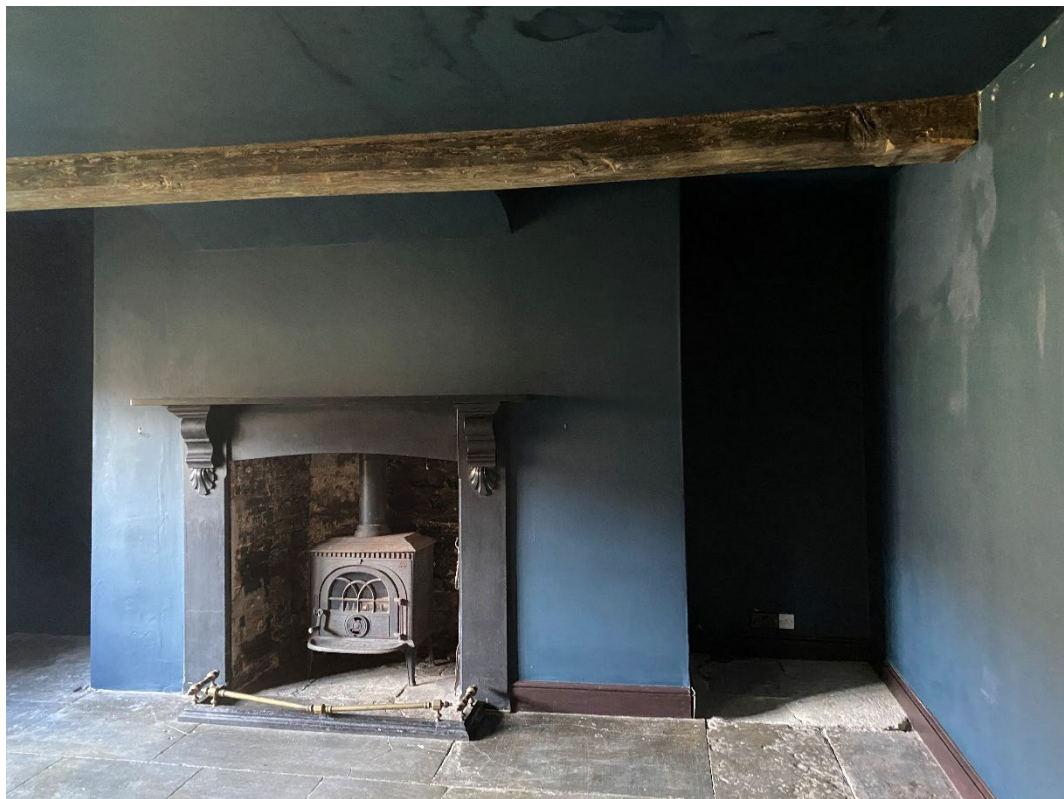
*Figure 24: Robust slate fire place surround in ground floor space, likely authentic and in situ.*

**4.6** Internally much about the finish is modernised and altered but the overarching planform of the building appears to remain broadly as built – or at least the sense of a central access hall between the north and south doors, a stair in the southern half of the house, and four principal rooms to each floor. The north west corner which did not have a fireplace until 2015 appears to have been less significant and perhaps was always more subdivided. The three historic 'room' spaces each feature a stack, though many of the fire places have been replaced. There are some 19<sup>th</sup> century grates and surrounds, these authentic features are important survivals which actually contribute to historic values. The well worn stone flooring in the main part of the house is also likely authentic at least in places.

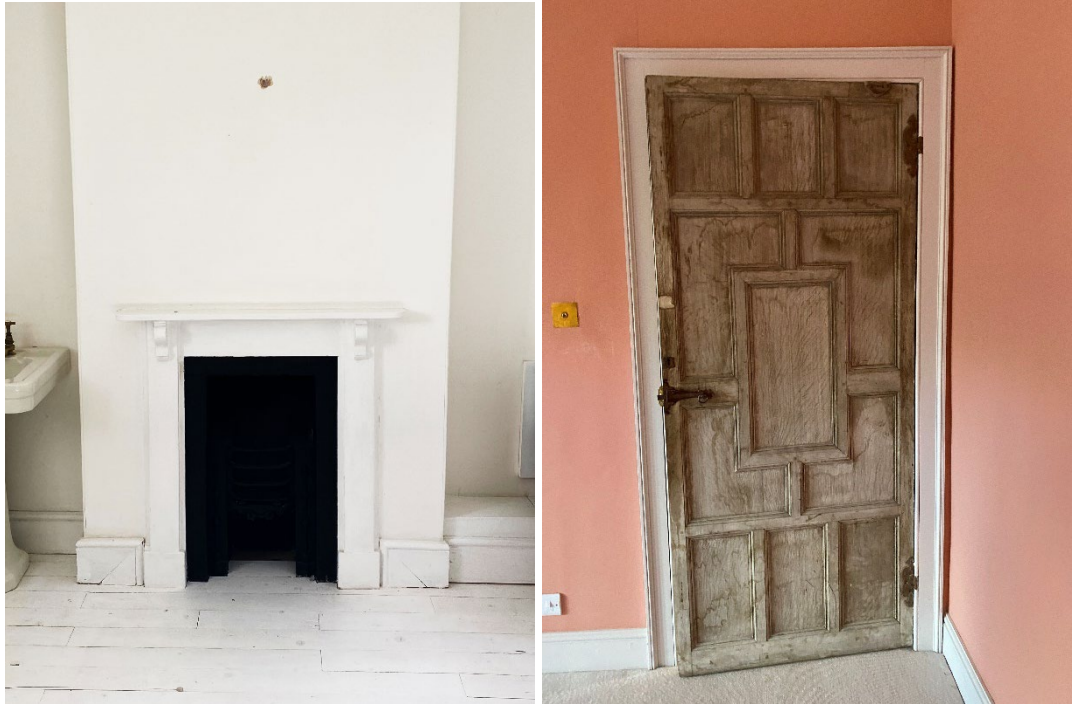
*Figure 25-26: Small iron grate and simple surround in western portion, ornate imported door in main first floor space.*

**4.7** Other features such as the stairs have been replaced or heavily re-worked. A whole series of doors and some ancient panelling, although ostensibly authentic period features are not thought to be original to the building, they are not in keeping with any other element of its internal finish or character and do not contribute to actual heritage significance. The small square panelling now seen next to the new stack in the north western room was recorded in 2014 in the north eastern corner (Elain Milton Heritage Statement, Figure 11, p.10), even then its originality was questioned.

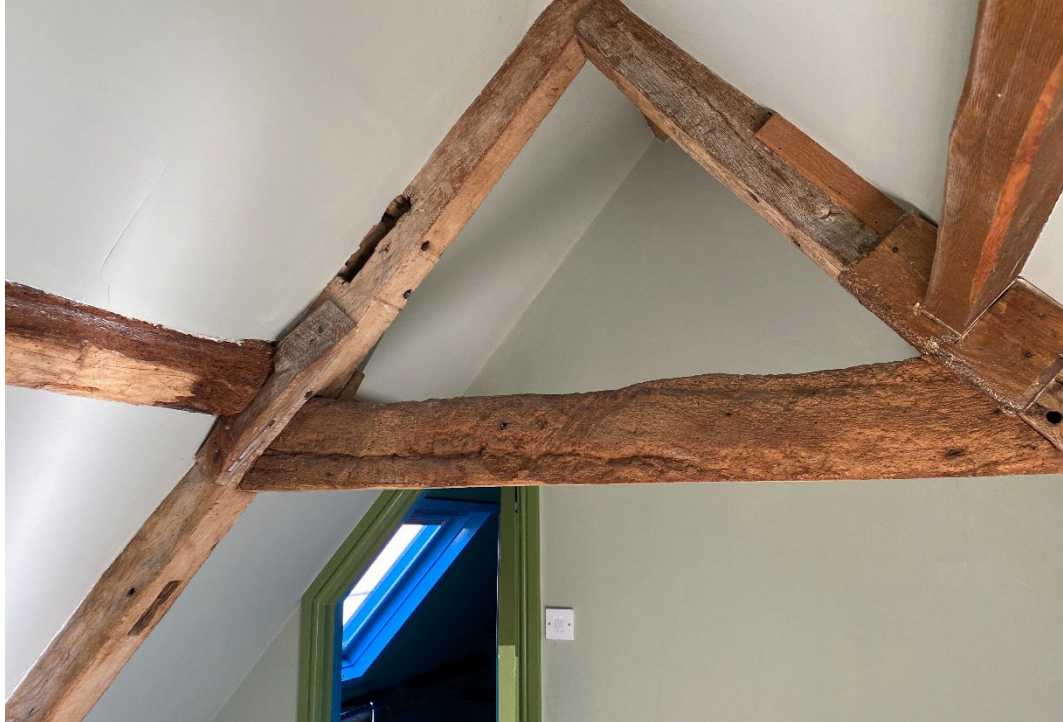
*Figure 27: Exposed roof truss showing empty mortices from the altered form.*

**4.9** The broad structural elements including the solid mass walls of the main envelope and the roof structure have some historic and architectural significance and certainly contribute to an understanding of local vernacular materials used to create a slightly more formal appearing dwelling. The roof structure has been heavily altered in the early years of the 21<sup>st</sup> century with both halves of the roof seeing interrupted purlins to insert dormers, and raised collars to allow head height.

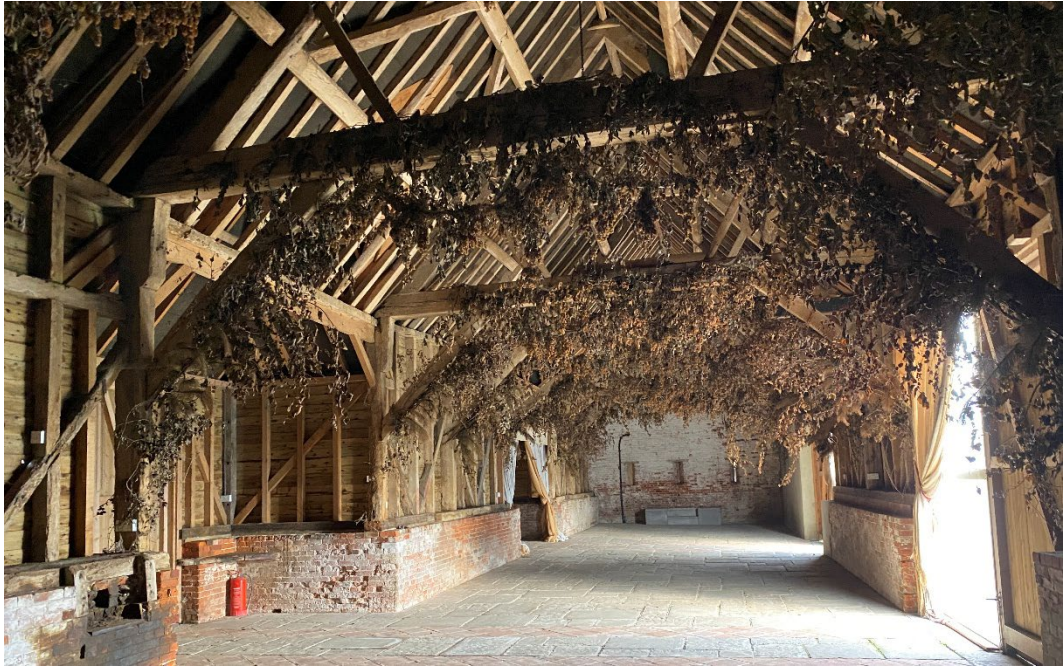
*Figure 28: The barn, modern repairs and a floor but with strong historic architectural interest.*

- 4.11** The outbuildings also have architectural interest, particularly where they survive with a reasonable degree of historic authenticity and surviving historic material.
- 4.12** The barn has the highest interest, it is a striking building on a monumental scale and although there are clearly later changes and repairs (the northern porches are almost entirely reconstructed) it retains a considerable amount of historic timber frame and its open space with opposed doors that directly inform and give evidence to its historic use as a threshing barn.

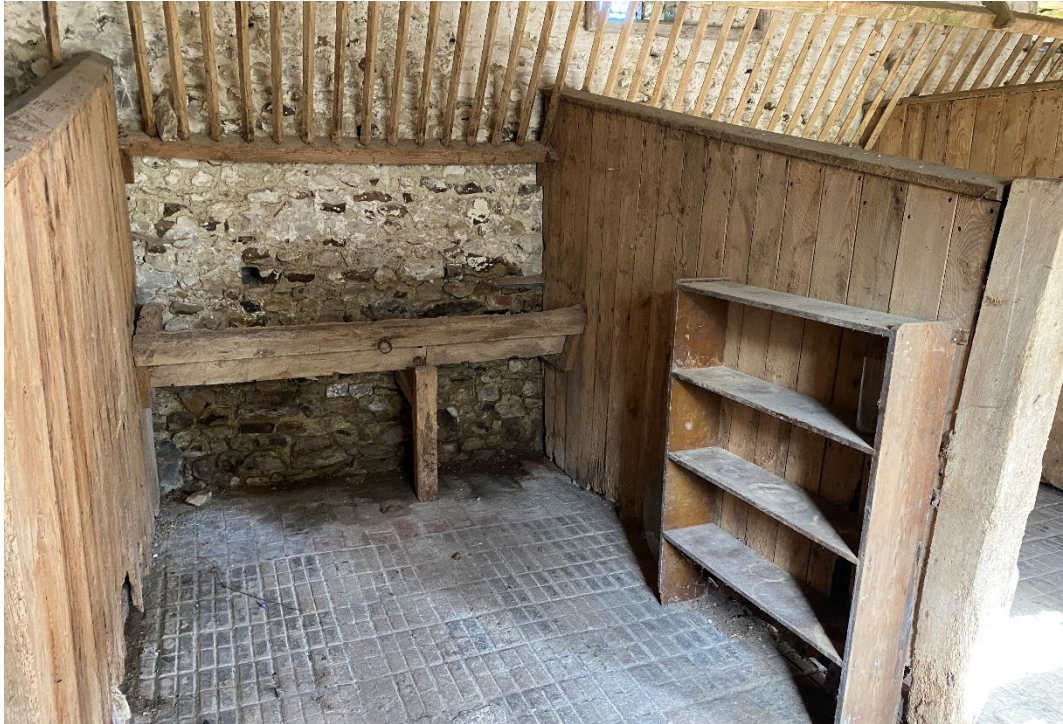
*Figure 29: Simple but functional stall dividers, trough with tether ring, hay rack and moulded block floors and ventilation grilles.*

- 4.13** The adjacent stable to the west retains stall dividers, a cobbled floor with integrated drainage channel, simple hay manger and trough and ventilation holes. These features though not ornate, and almost certainly 19th century rather than 18th century in date, but they directly contribute to the evidence for equine accommodation in the past at a time when horses were critical for both personal transport and power for pulling carts and possibly machinery such as ploughs, or driving threshing machines in the pre-industrial age.

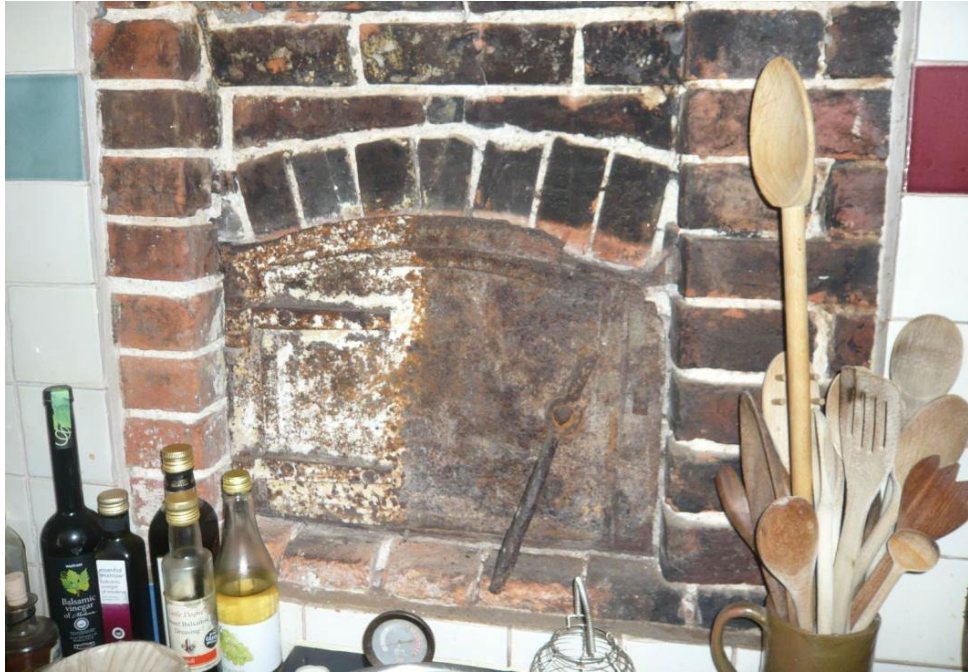
Figure 30: Former bread oven door as recorded in the 2014 Heritage Statement (Elain Milton Heritage and Planning, Figure 13, p.11) no longer present in the building.

- external appearance which reflects a degree of status and ostentatious approach to the design of the farmhouse with semi formal facades and attention to detail;
- Subtle internal features such as chamfered beams which reflect a desire to express some interior decoration in the fabric of the building itself;
- the ongoing presence of chimney stacks and fireplaces which illustrate traditional heating technologies (the surrounds themselves are mostly replaced and thus of limited interest and authenticity); a bread oven was recorded in the 2014 heritage statement but this appears to have been removed (it was not seen during the March 2026 site visit)

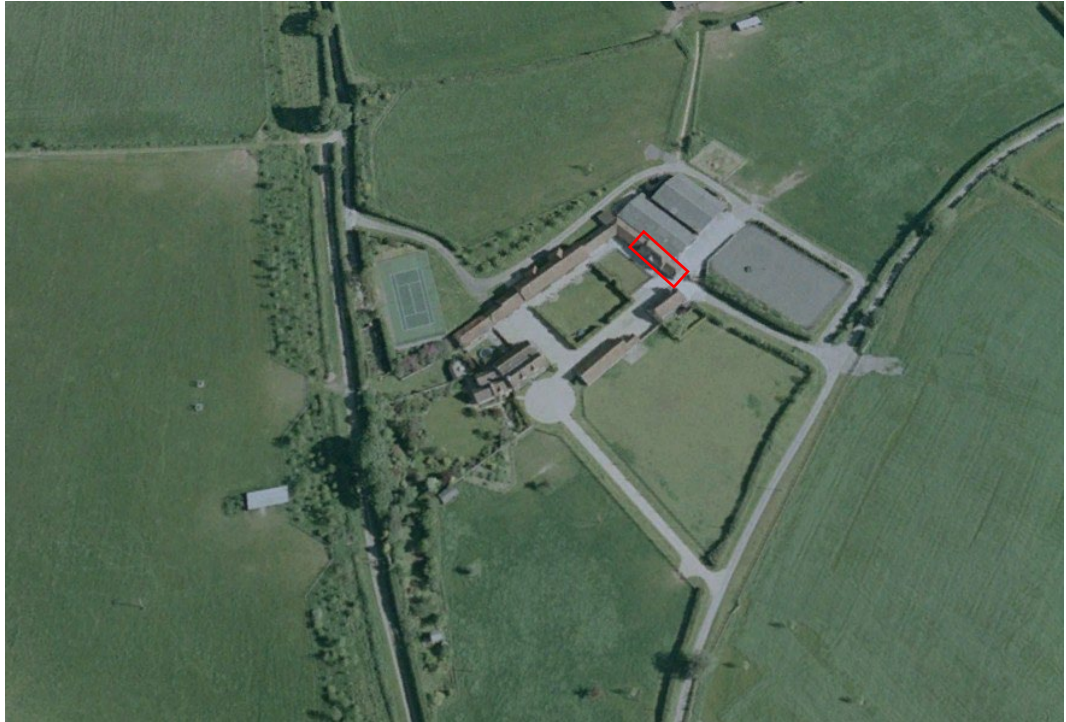
*Figure 32: 2001 Google Earth, drive and turning circle in front of the house extended from that depicted in the 1980s photograph (section 2).*

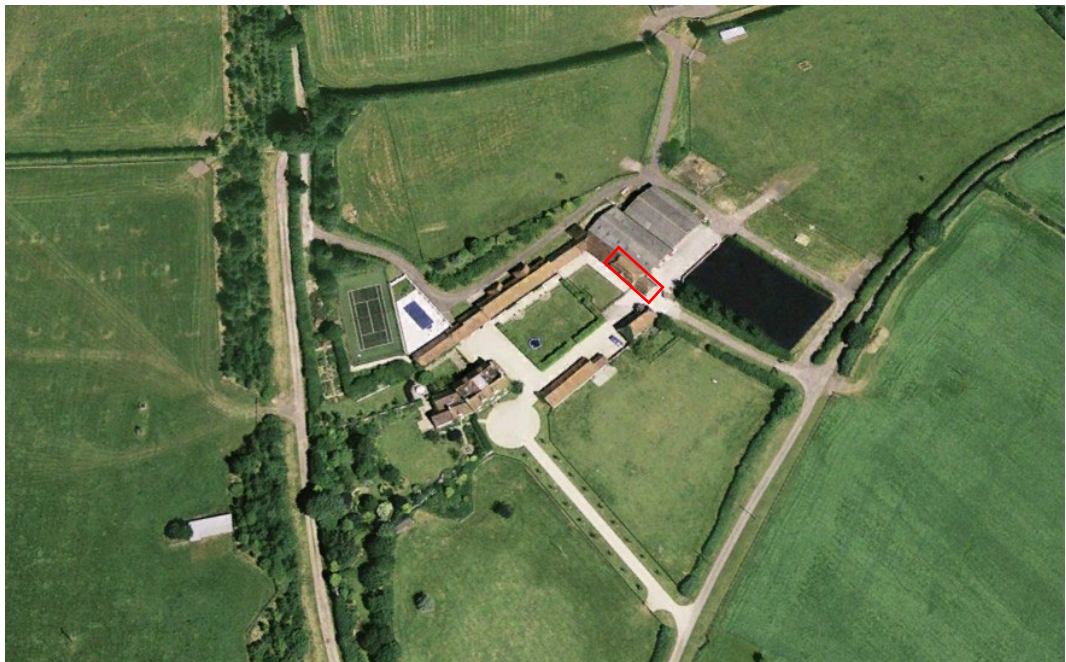
*Figure 33: 2005 Google Earth, a swimming pool constructed east of the current tennis court. Track to the west is divided from the drive slightly. Apparent terrace or patio areas west of house.*

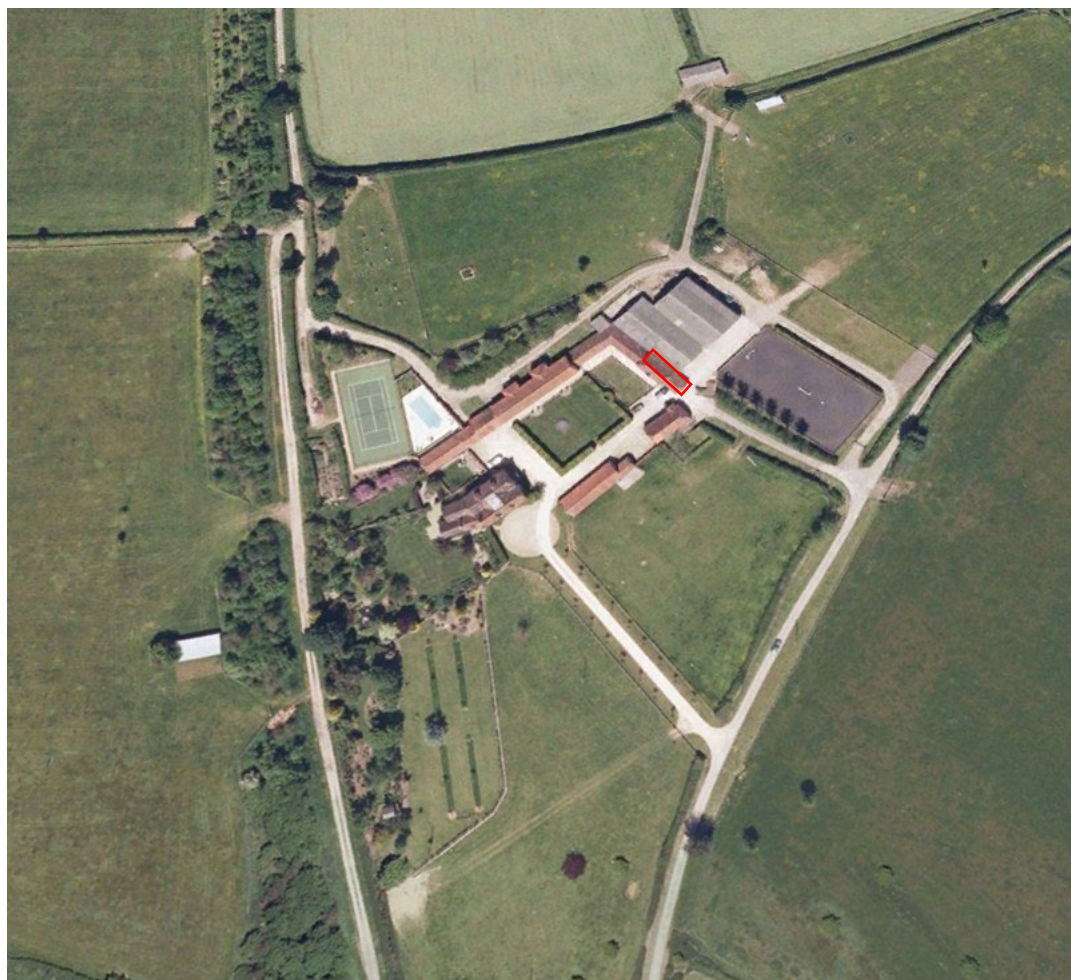
*Figure 34: 2009 Google Earth. Additional enclosure south of the house, note driveway division from track more pronounced.*

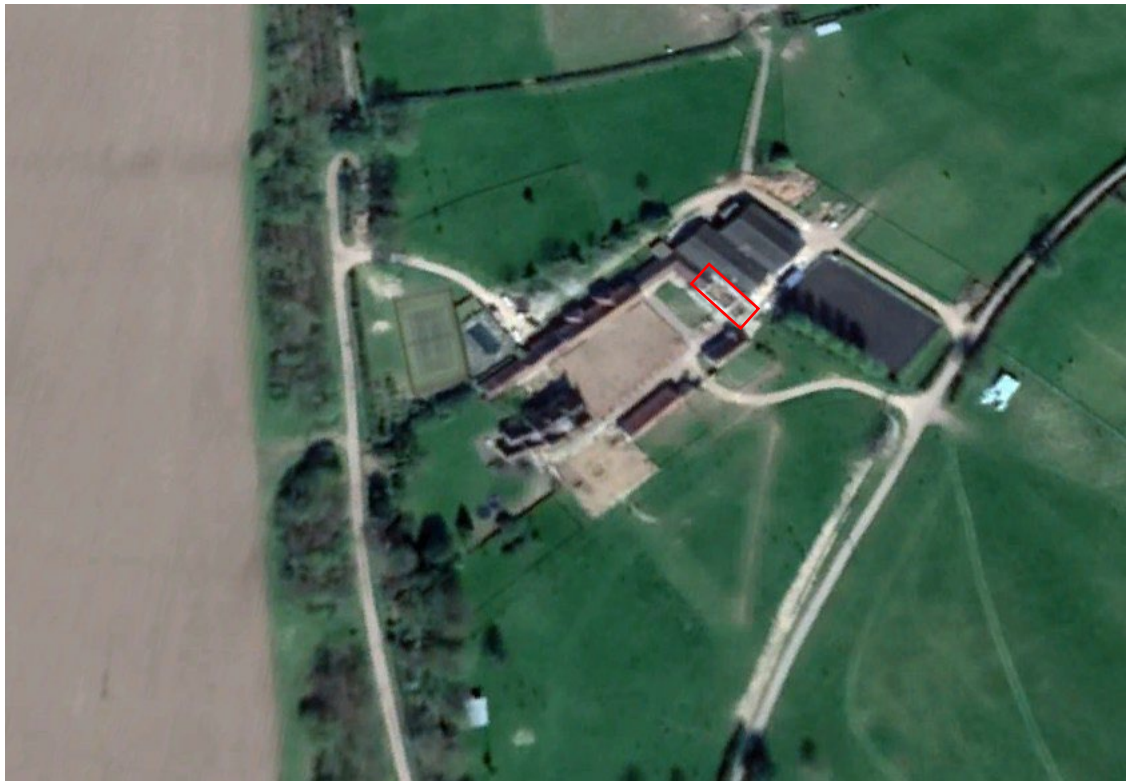
*Figure 35: 2017 Google Earth. Drive to the south of the house has been removed. New route to the central area of the southern range of farm buildings. Removal of terrace west of house, and loss of an earlier garden division here.*

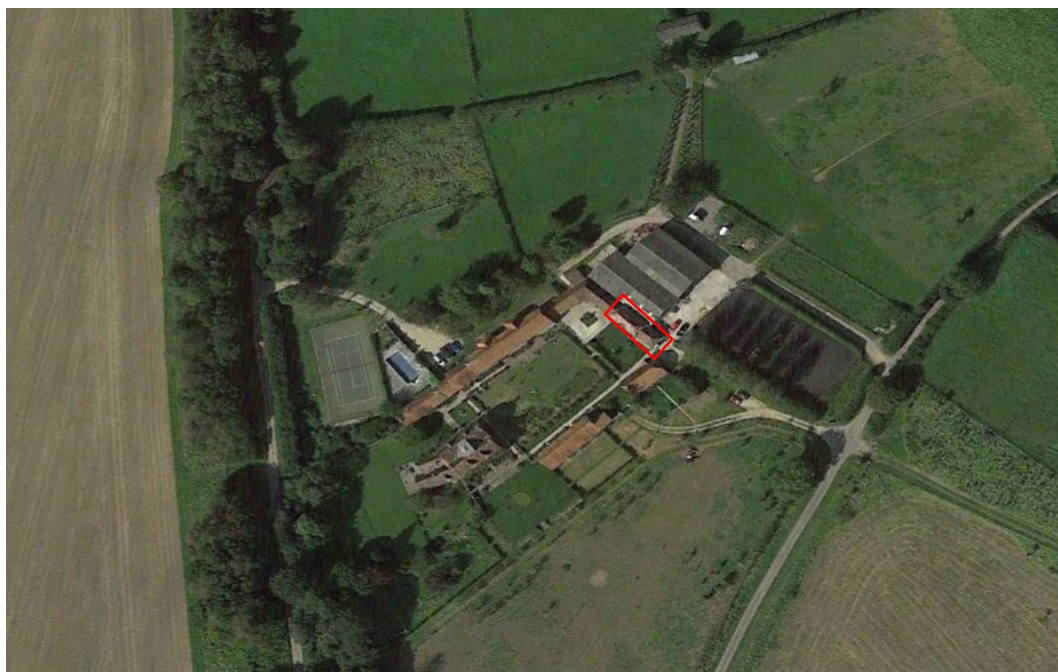
*Figure 36: 2019 Google Earth. New square garden enclosures to the south, signs of additional tree planting. Pool still present.*

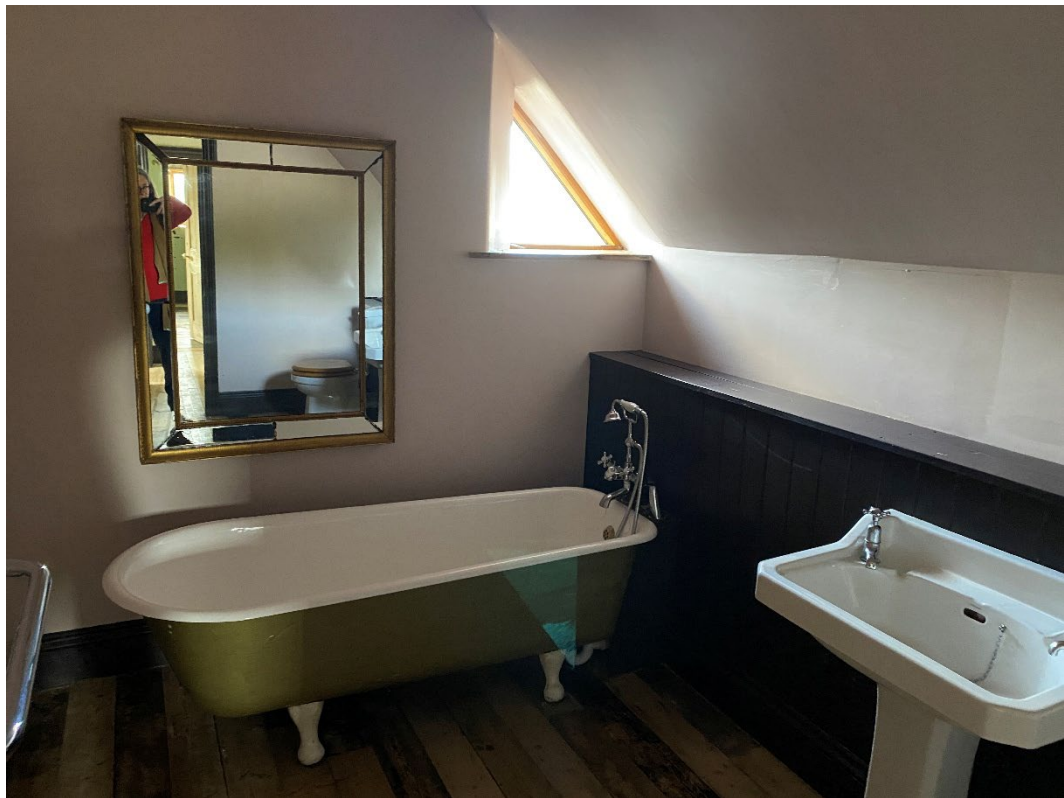
*Figure 37: The existing bathroom to be renewed and adjusted. Note comparative darkness which will be alleviated through two small conservation roof lights.*

- 5.5** The new skylights will fall within the rear roof slope. They will not impact upon the appearance of the building from within the yard or the way that it is experienced or understood within the group. They are conservation rooflights and can be inserted in a sensitive manner preserving any primary historic roof structure if it is present – the first floor area’s roof is not currently exposed. The roof finish today appears renewed from external inspection, and it is highly likely that the whole was relaid at the point of conversion with insulation provided.

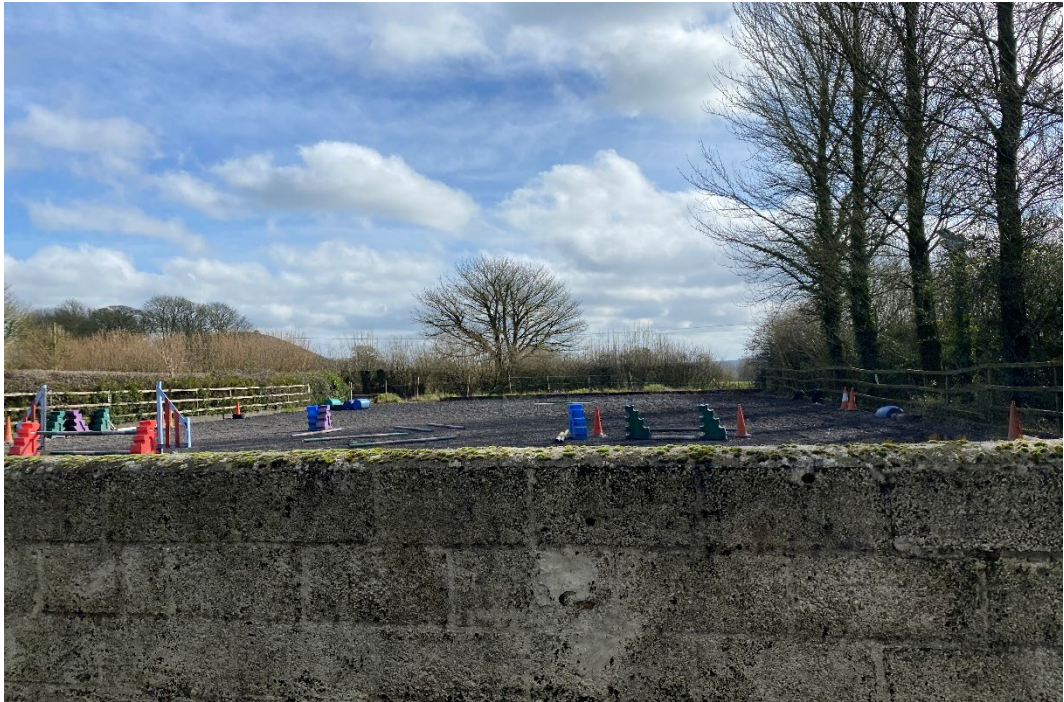
*Figure 38: The modern menage to the east of Dairy Cottage, note concrete block wall in near ground.*
