## APPLICATION FOR LISTED BUILDING CONSENT OFFICER DELGATED REPORT

| <b>APPLICATION REFERENCE:</b> | PL/2026/03362 |
| <b>DESCRIPTION OF WORKS:</b> | Conservation repair and alterations to roof turret (Roof Slip D) at Longleat House. |

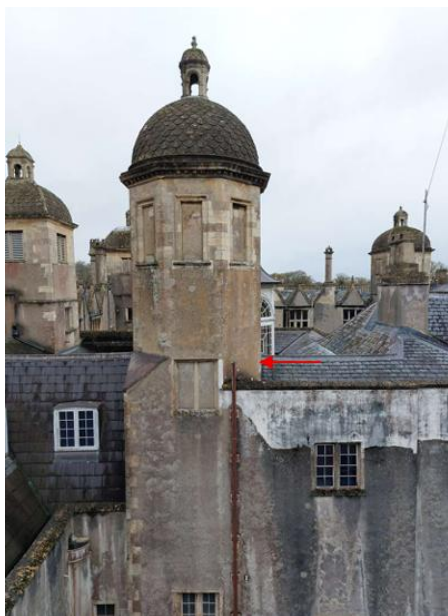
The repairs relate to roof slip D which is one of the three octagonal lantern and stair turrets within the east courtyard of Longleat House, and believed to have been designed by Robert Smythson. It originally provided access to the roof, however, the staircase was removed (date unknown) and as such, it is no longer 'in use'.
