# Lowden Manor House, Chippenham

## Heritage Statement and Design and Access Statement

Submission Document - Listed Building Application

Designscape Architects

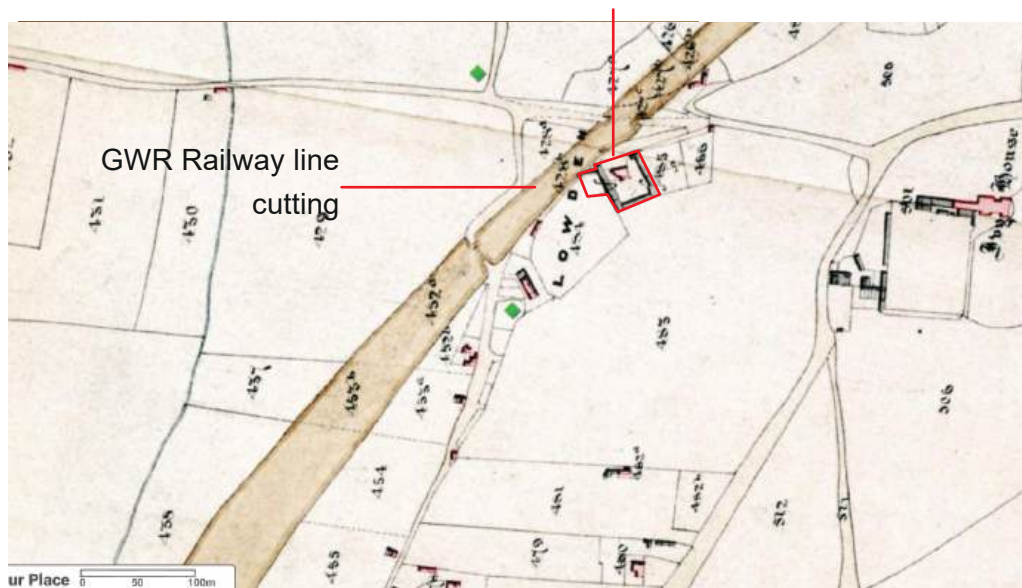
1840s Wiltshire Tithes - 'Know your place'. Note the Great Western Railway cutting is prominent - the line opened in 1840

The southern extension identified on the 1840s Tithe map appears to remain the same although it may have been replaced with a more significant extension. The quality of the 1840s map makes it challenging to confirm this.

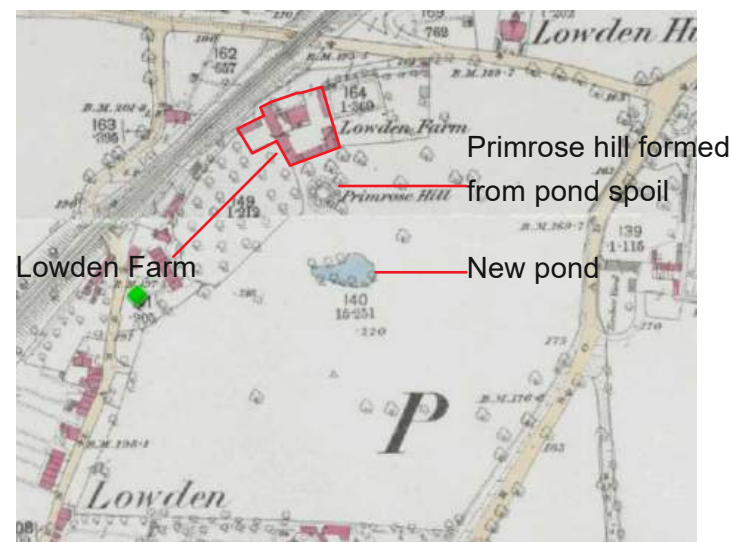
1844 - 1888 OS 25 "1<sup>st</sup> Edition" - 'Know your place'

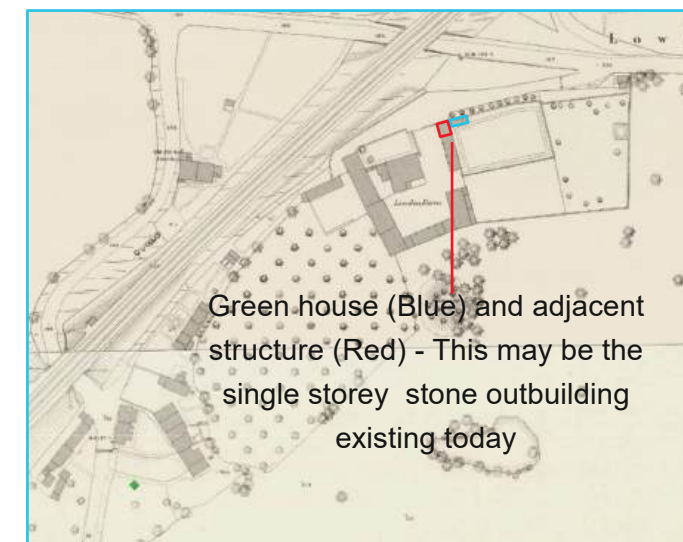
1879 - 1888 Town plans - 'Know your place' - No clear changes made from 1844 - 1888 - Map shows farmstead in greater detail

It is noted that structures in the place of both the greenhouse (Now in neighbouring land) and the stone store that exist today (In the walled garden - Under the ownership of Lowden Manor today) in the walled garden that remains today is identified on the 1879 – 1888 Town map.

The structure containing the farmstead to the eastern side is demolished, seemingly to provide direct access from the farmstead to the eastern walled gardens to the East (This new opening is indicated as a gateway in later maps). The same is true of structure to the west of the farmstead to provide a new access route to the adjacent western

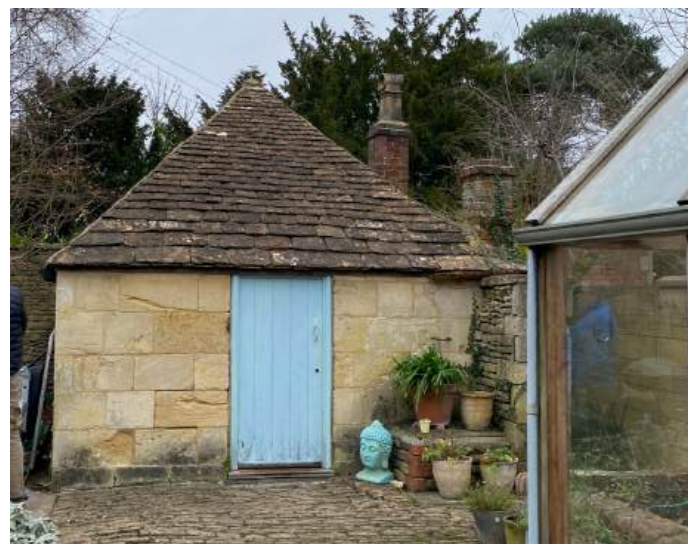
Existing stone outbuilding as existing today

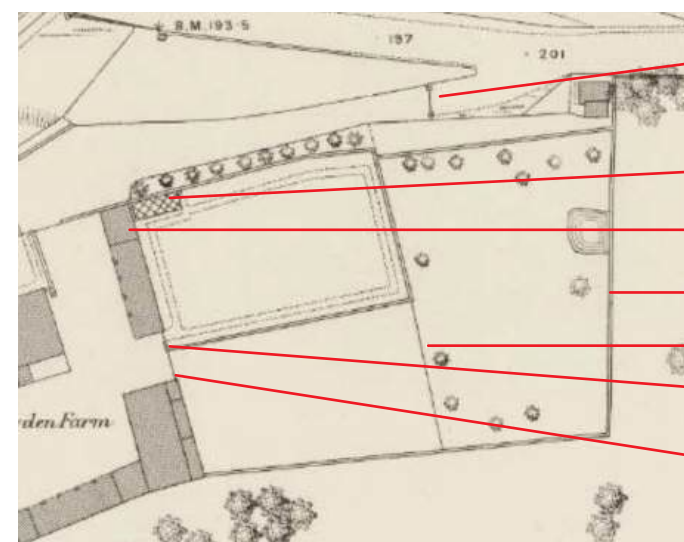
1879 - 1888 Town plans - 'Know your place' - division of gardens to the East

The eastern walled gardens remain divided into three segments over the 19<sup>th</sup> Century in the same format as the earlier 1840s Tithe map. However, the 19<sup>th</sup> century maps provide greater detail to the circulation and means of access to and from the farmstead and the gardens. The (1879 – 1888) map, which out of all the 19<sup>th</sup> century maps included in this statement, shows the most detail and indicates the north most of the walled gardens was accessible by a narrow gate from the eastern side of the original farmyard. This gate leads to a path around the inside perimeter of the garden wall allowing access to the green house and growing beds central to the space. Immediately adjacent to the south of the single gate, was a larger gate opening allowing access into the other two walled

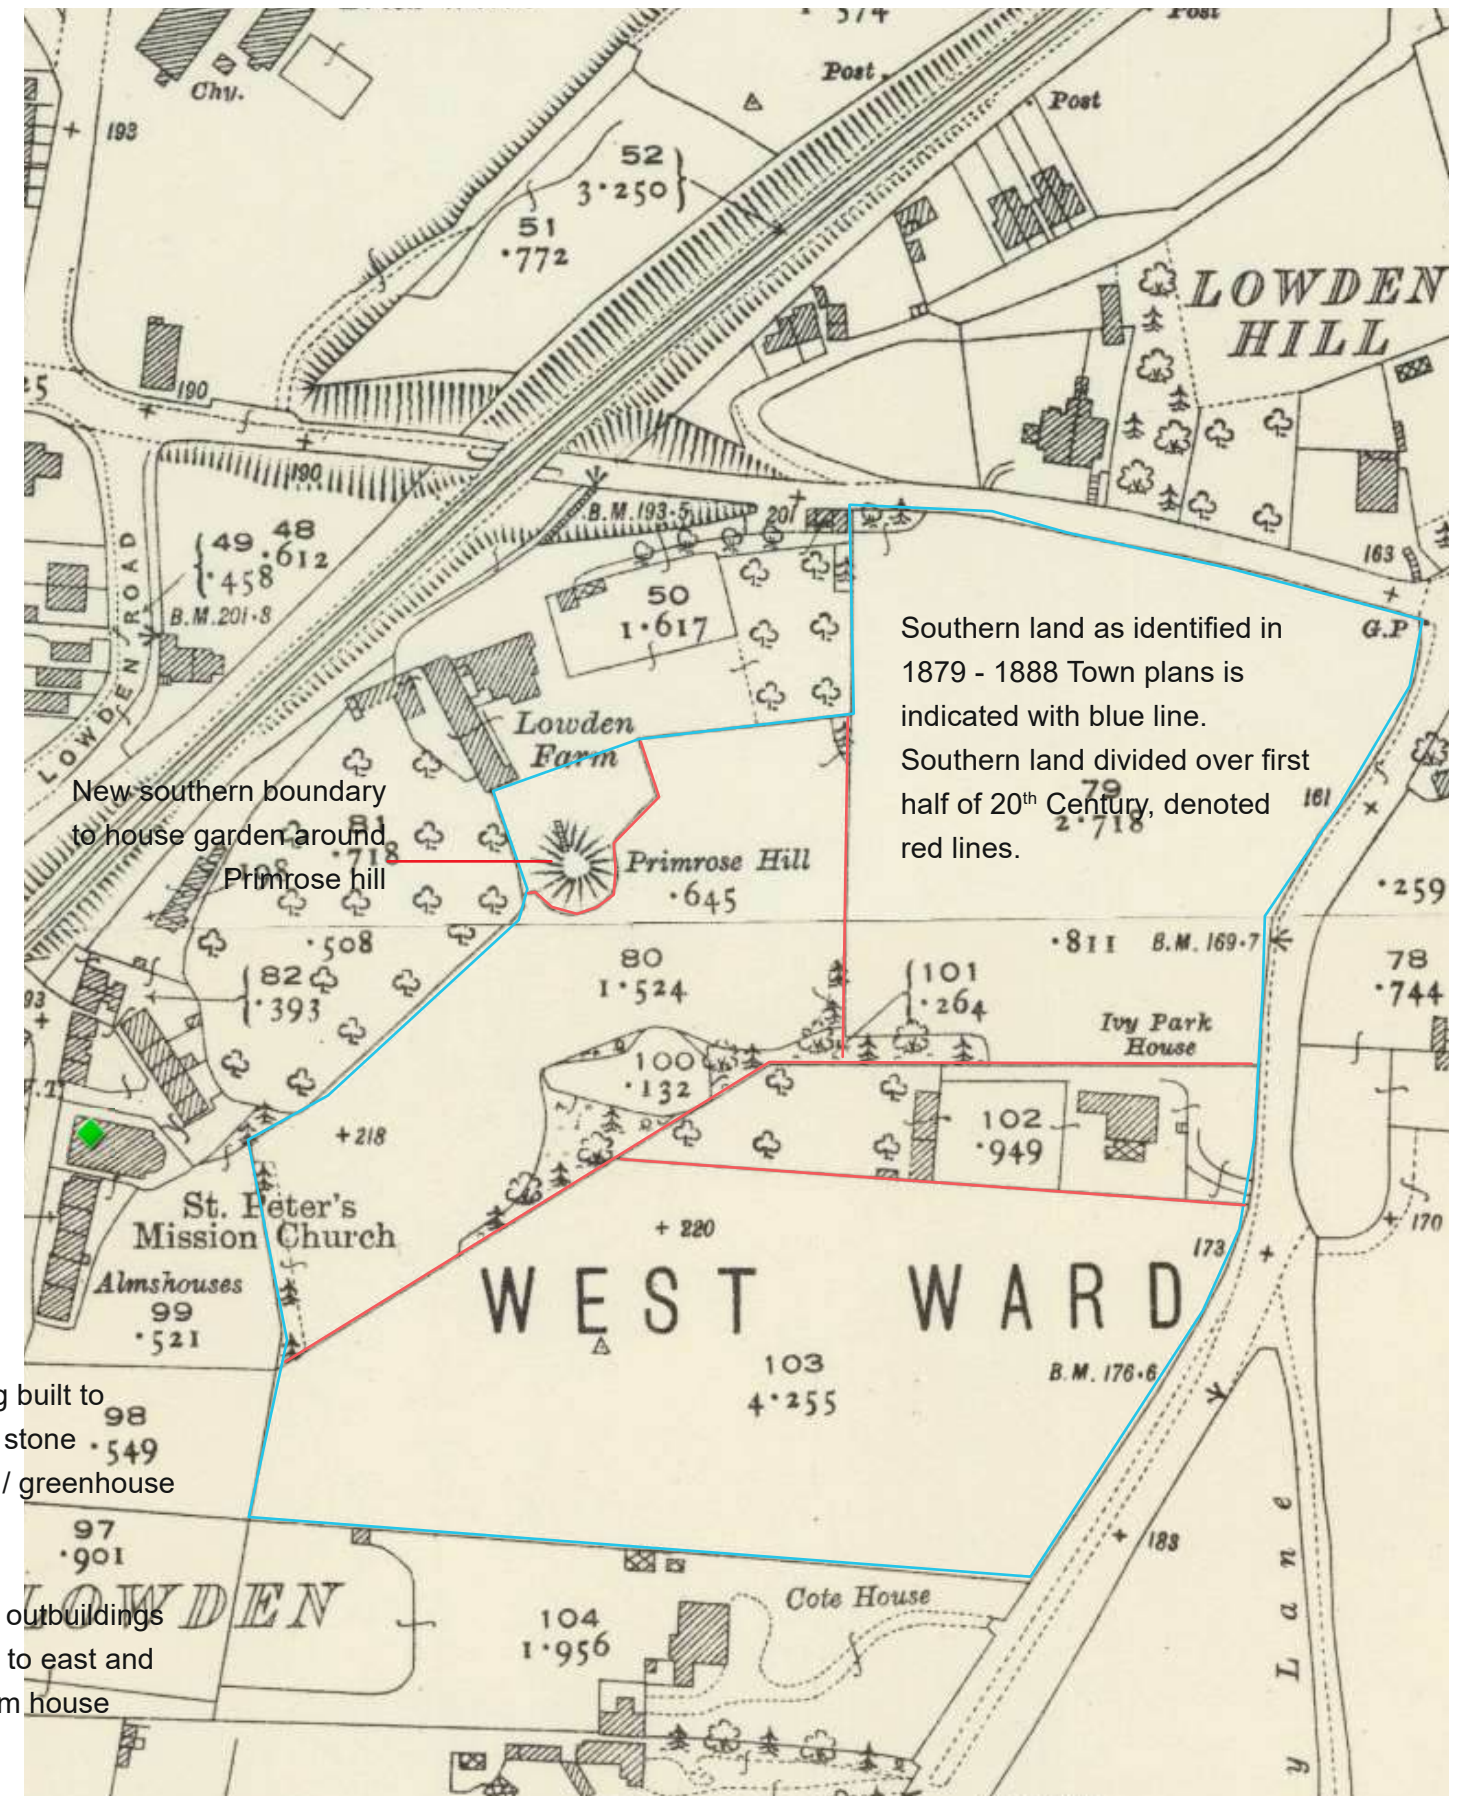
1898 - 1939 OS 25 '3rd Edition' - 'Know your place' - Map shows farmstead in greater detail

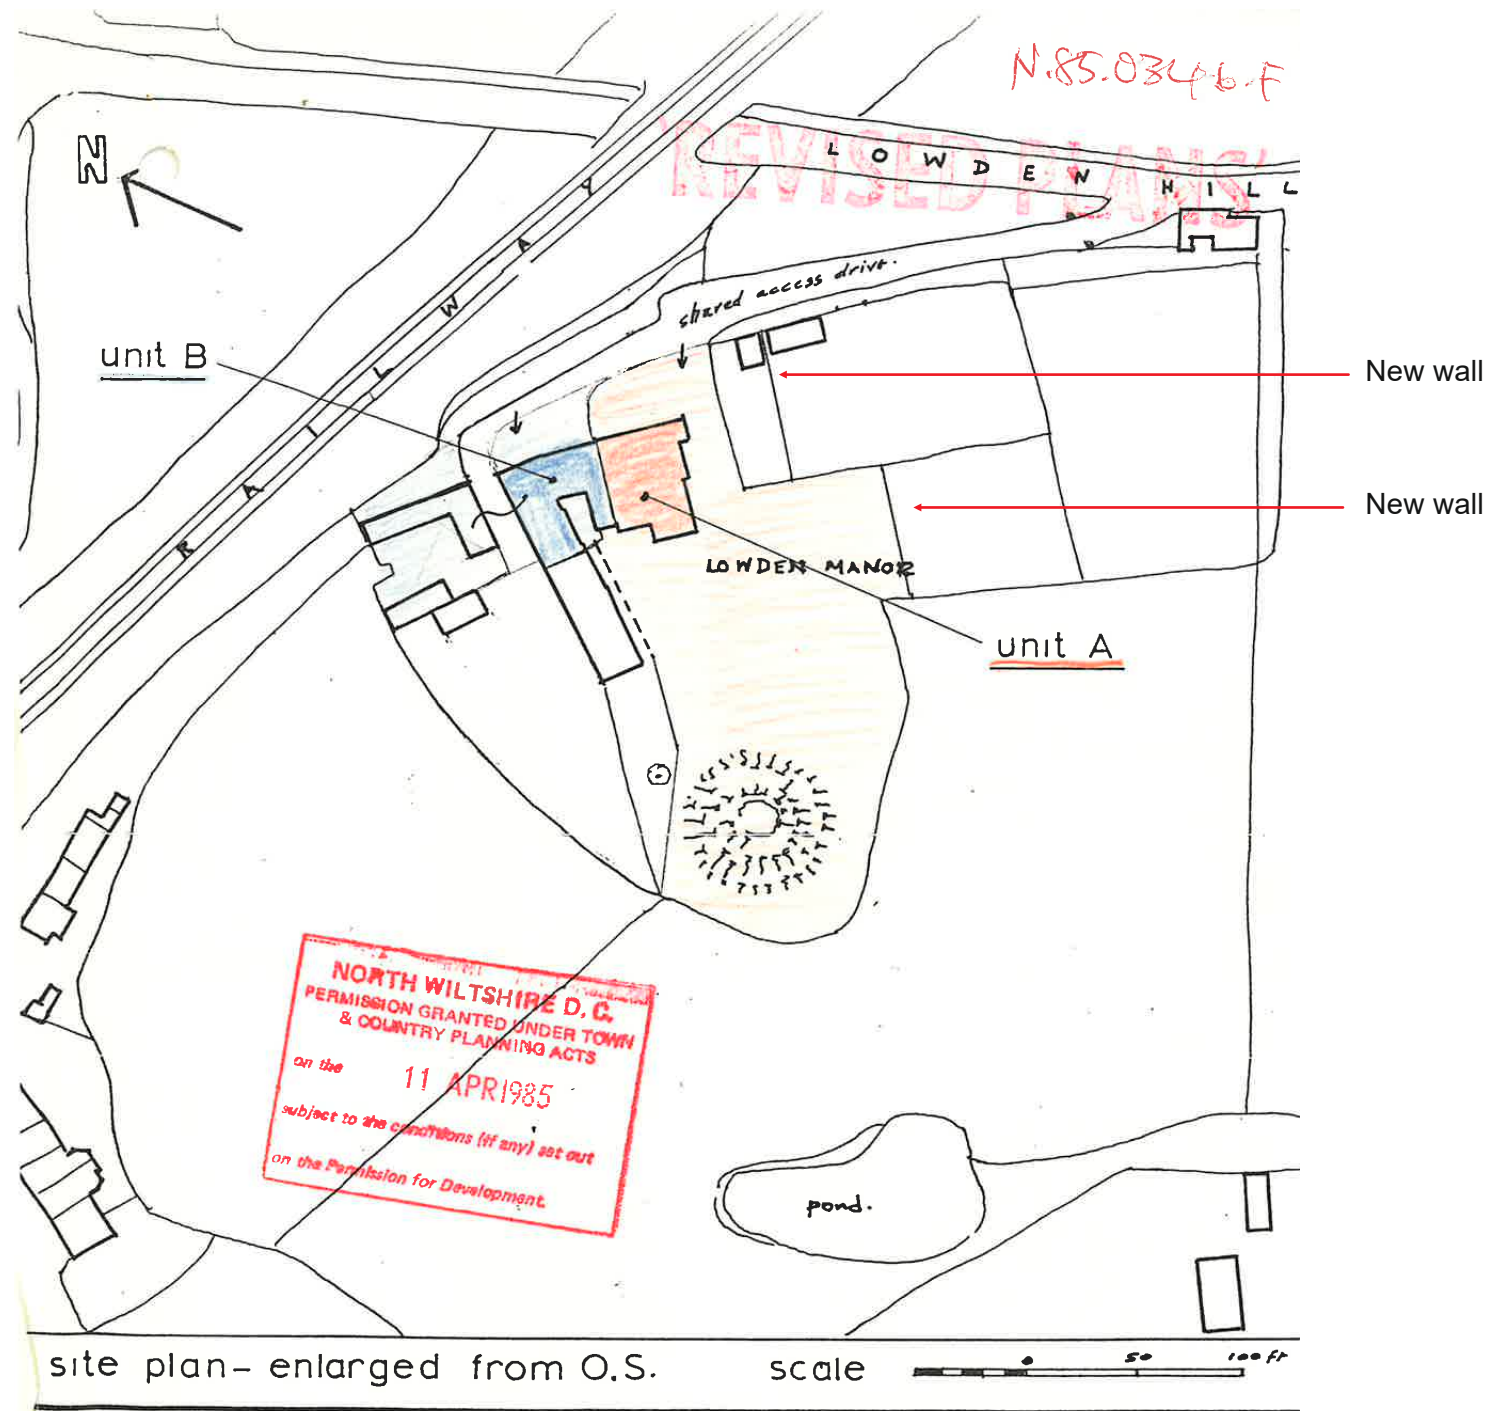
LOWDEN MANOR.  
Lowden Hill. Chippenham.

David Pugh — swindon 643690  
plan no:- 845.50.4a

Alterations to the boundary included:

- Construction of a new brick boundary wall in the former walled garden adjacent (East) to the original position of walling that enclosed the farmstead to the east.
- New walling bounding the eastern side of the garden (South of the remaining walled garden).
- Division of house (Doorways blocked off)

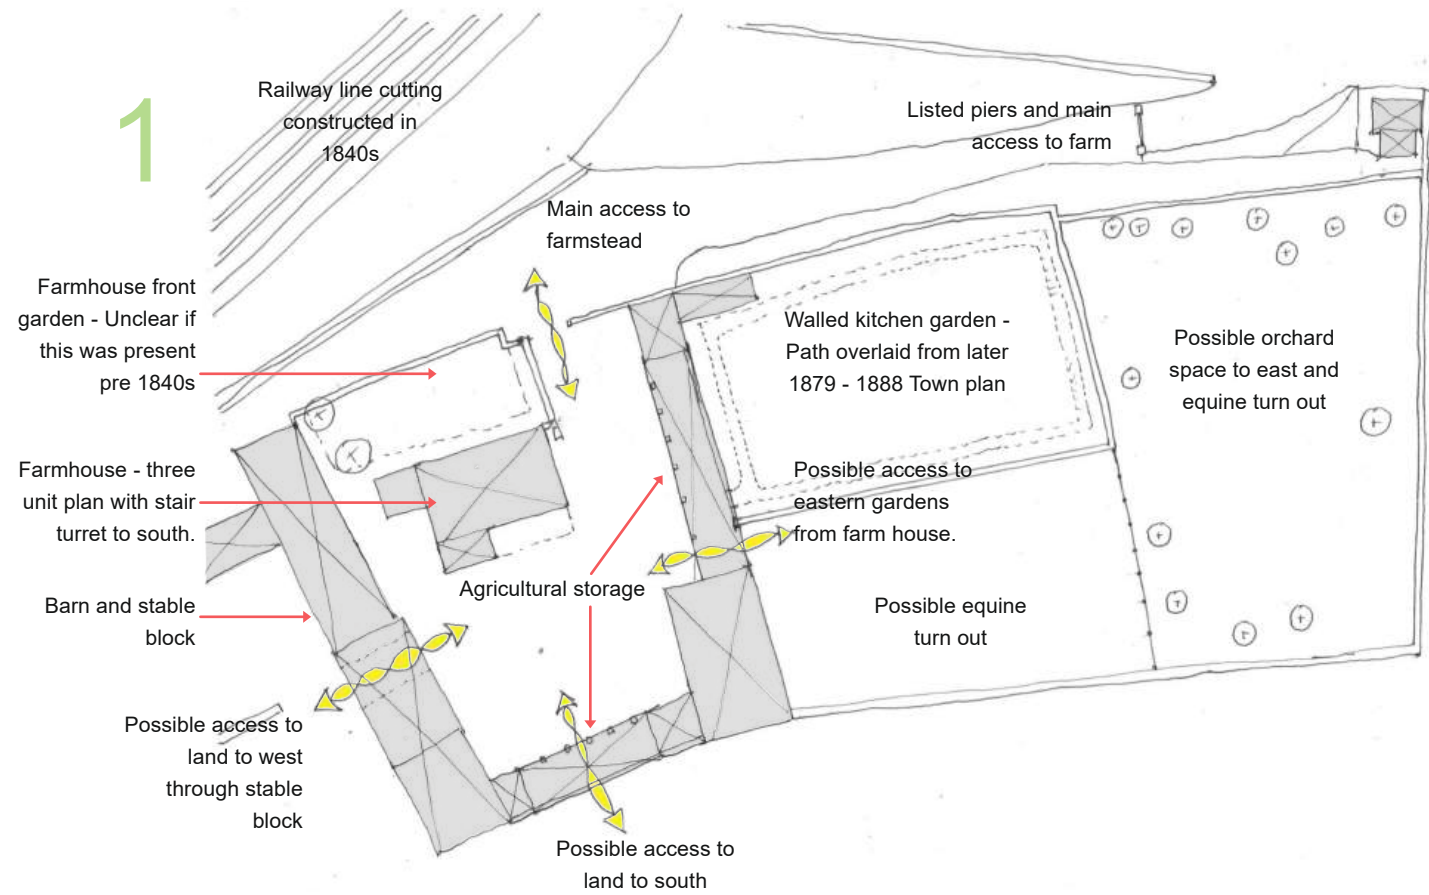
1

Sketch based on 1840s Wiltshire Tithes - 'Know your place'.

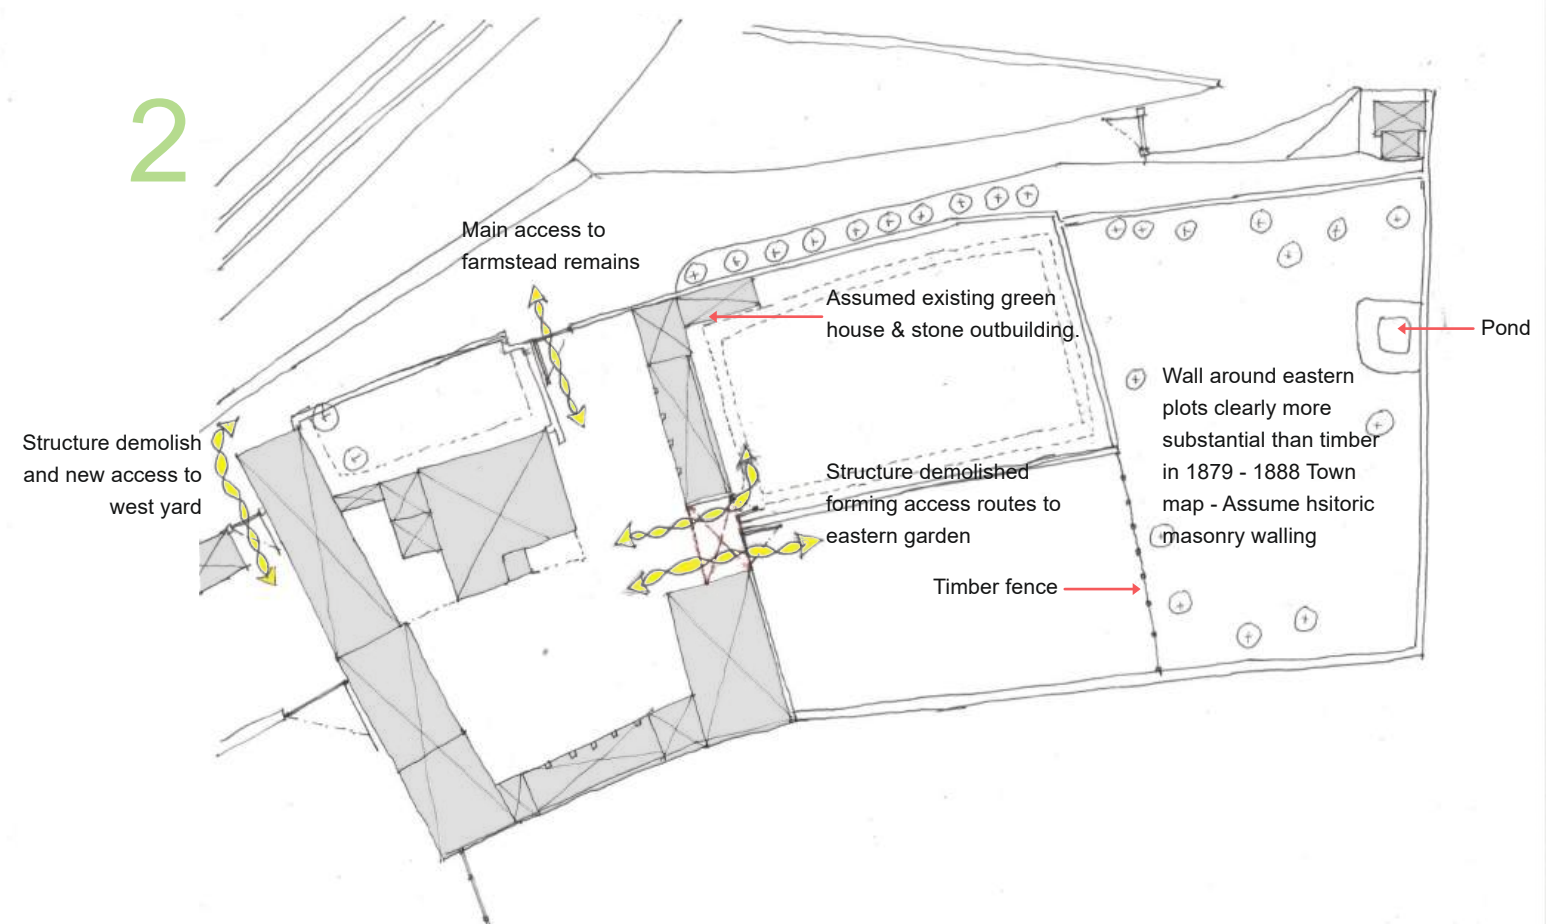
2

Sketch based on 1844 - 1888 OS 25 '1st Edition' - 'Know your place'

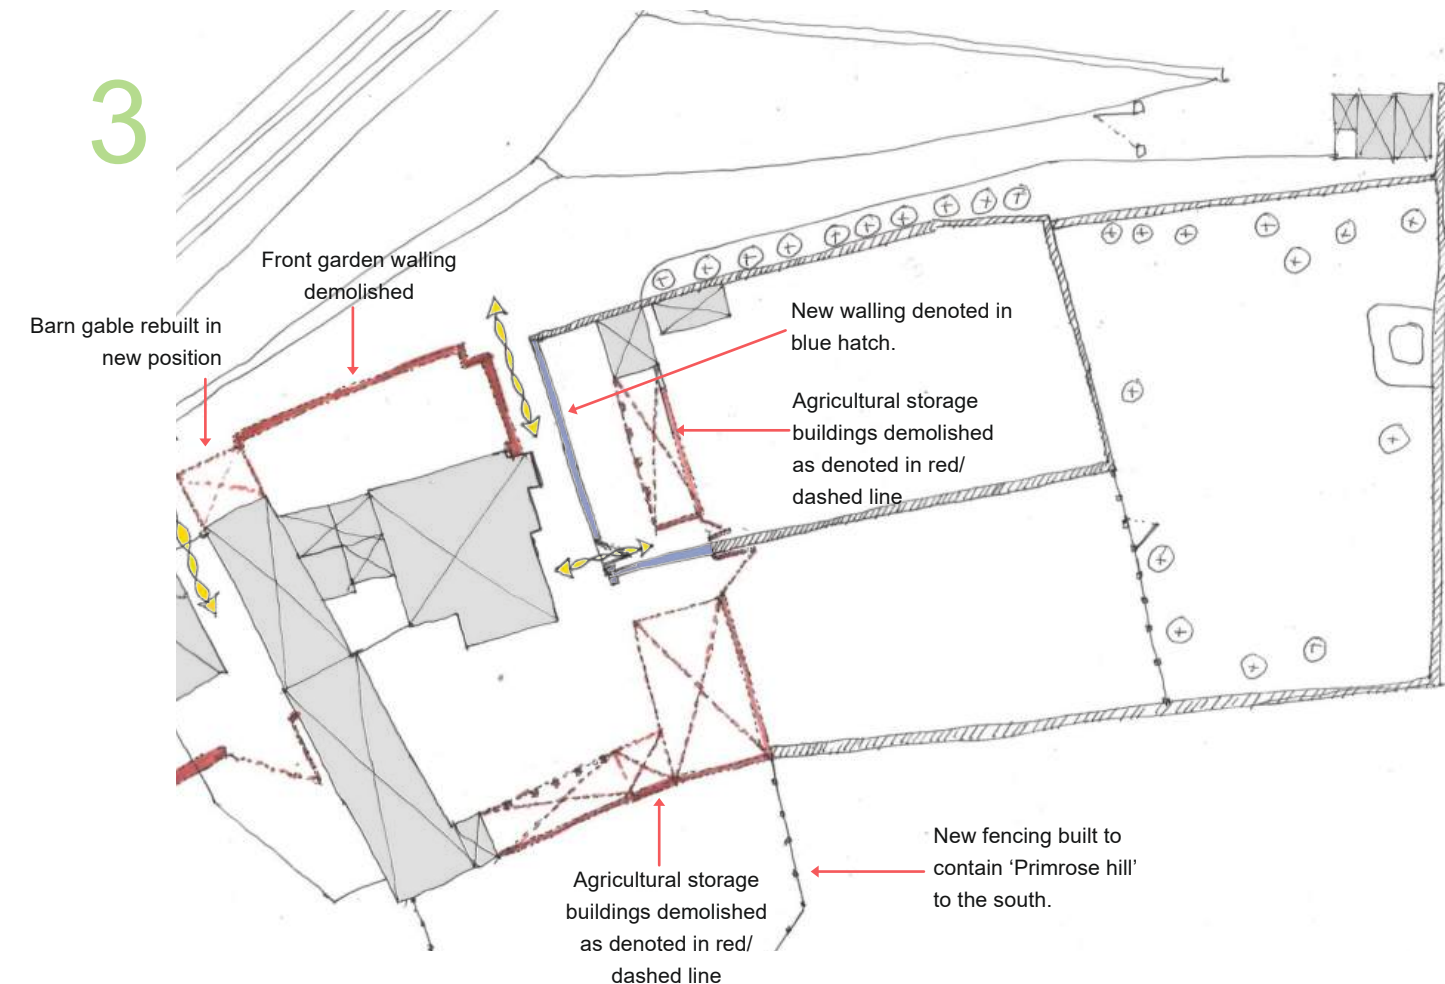
3

Sketch based on 1898 - 1939 OS 25 '3rd Edition' / 1915 Proposed works drawing- 'Know your place'

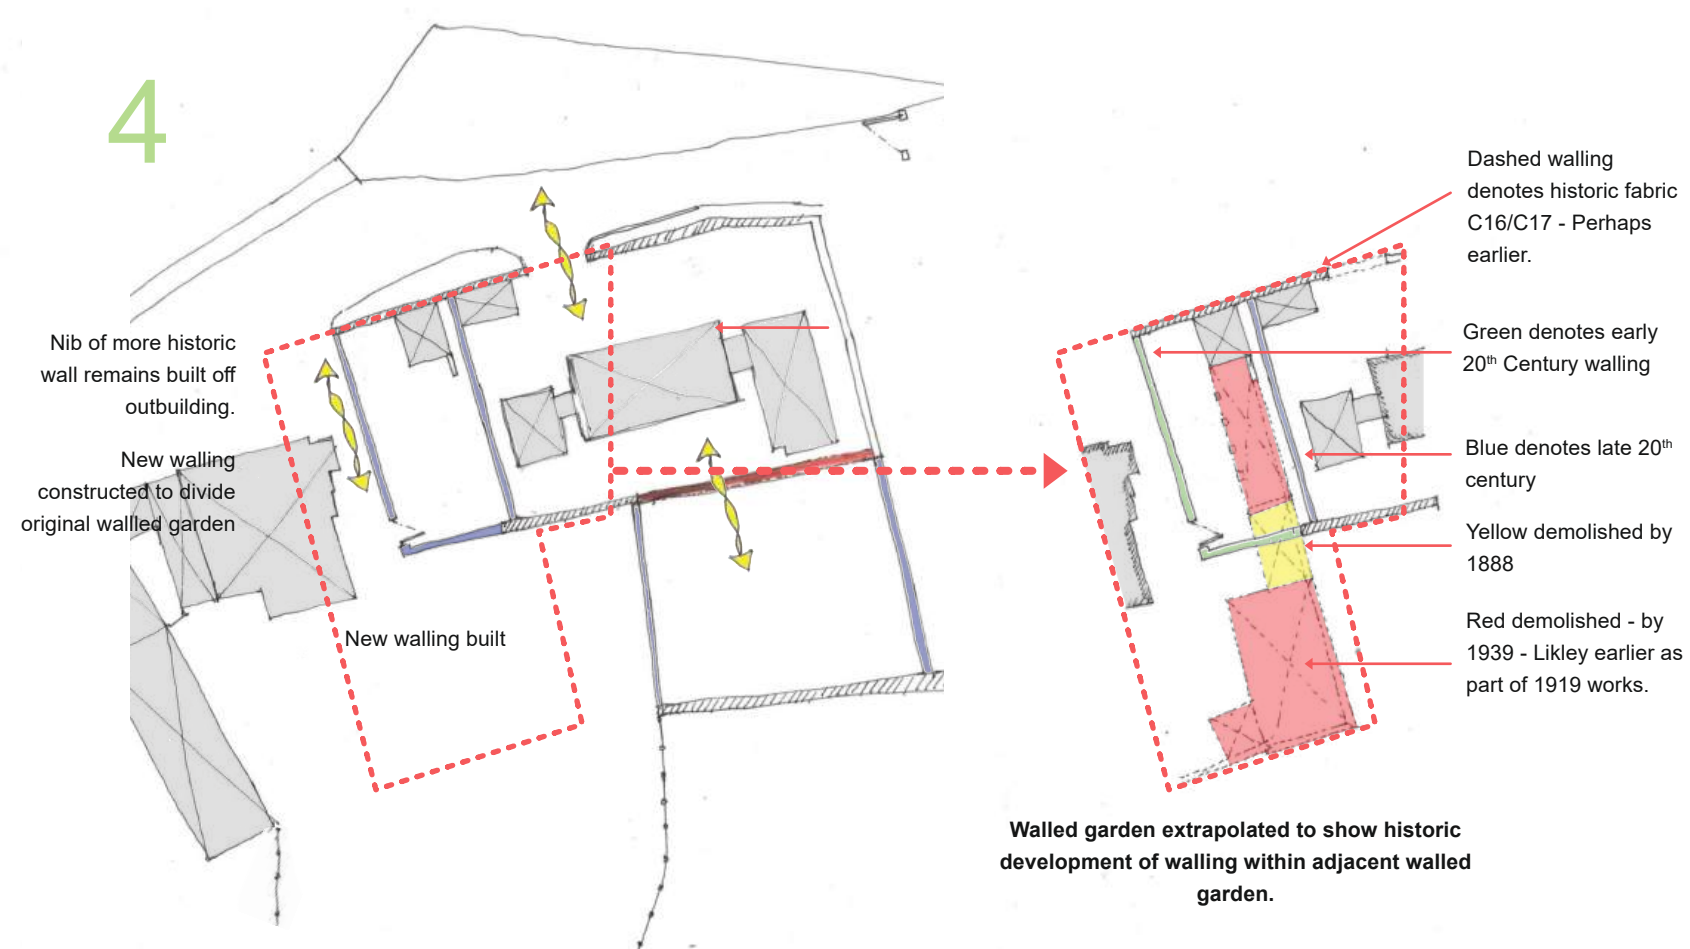
4

Sketch based on 2025 survey of the dwelling / 'Know your place'

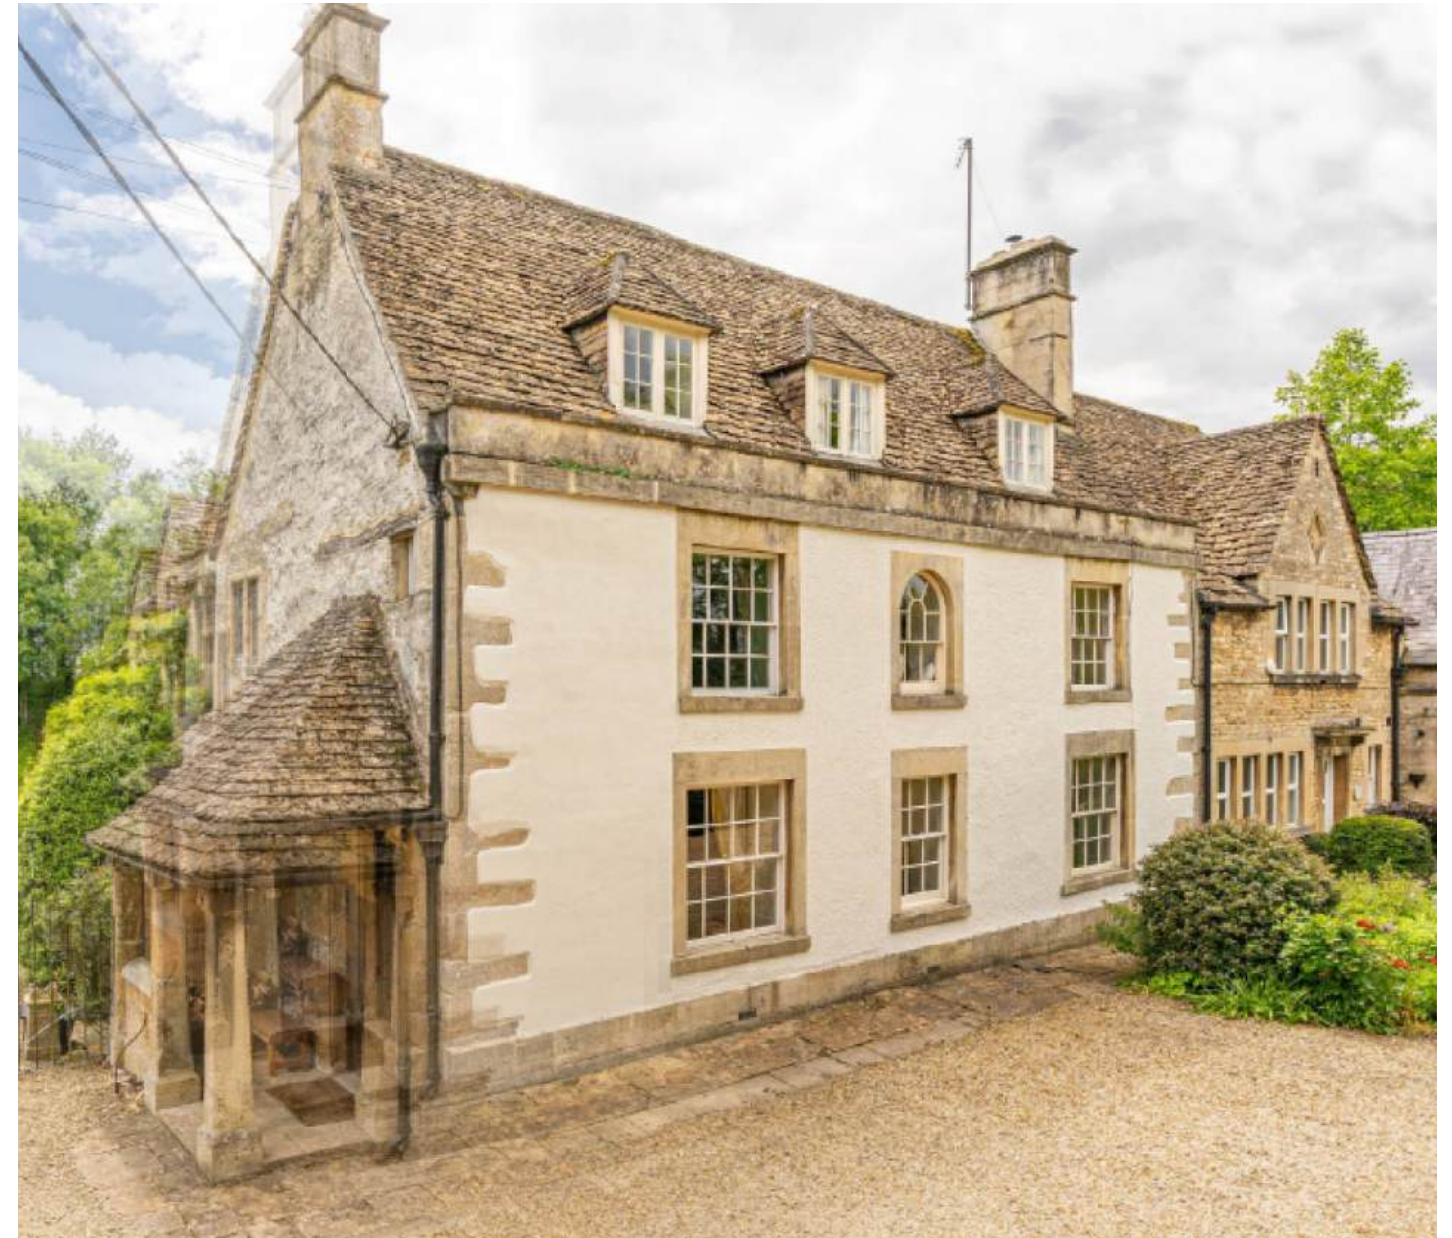
Site photo - North elevation showing 'Gentrified facade' with sash windows - See also three dormers above.

It is noted from the photographic study that the front (North) elevation was “gentrified” at some point. The facade unique to the rest of the house is characterised by “8 over 8” / 6” over 6” sash windows set in simple stone surrounds with chamfered profile edges. The sash windows and parapet gutter construction indicate that this façade was a later addition than the dwellings C16/17 origin, likely constructed Circa Queen Anne 1702-1714 / or early Georgian period. It is also noted that early sash windows can be found on buildings in England dating back to 1685 (History of English House Nathaniel Lloyd) implying the possibility that the facade could date back to earlier than Queen Anne / early Georgian .

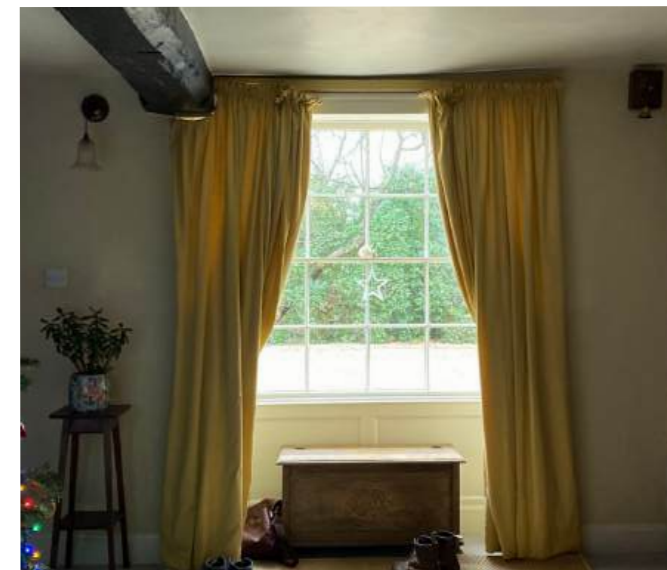
Primary beam mismatched to later opening for sash window

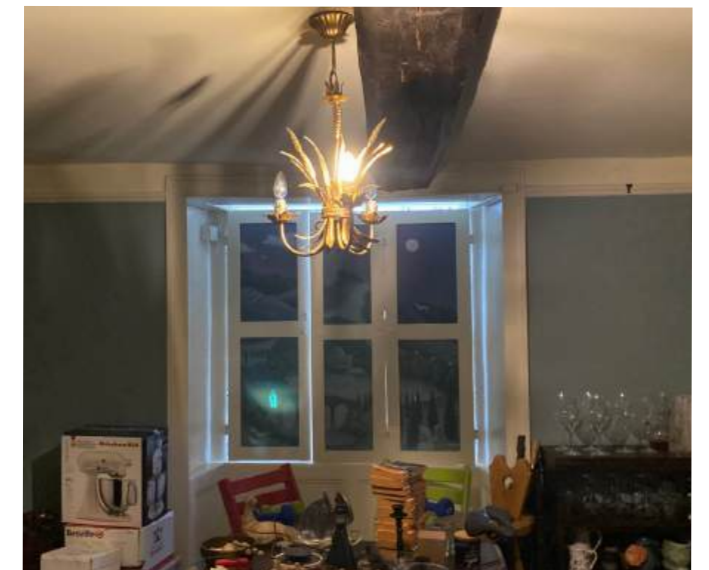
Primary beam mismatched to later opening for sash window

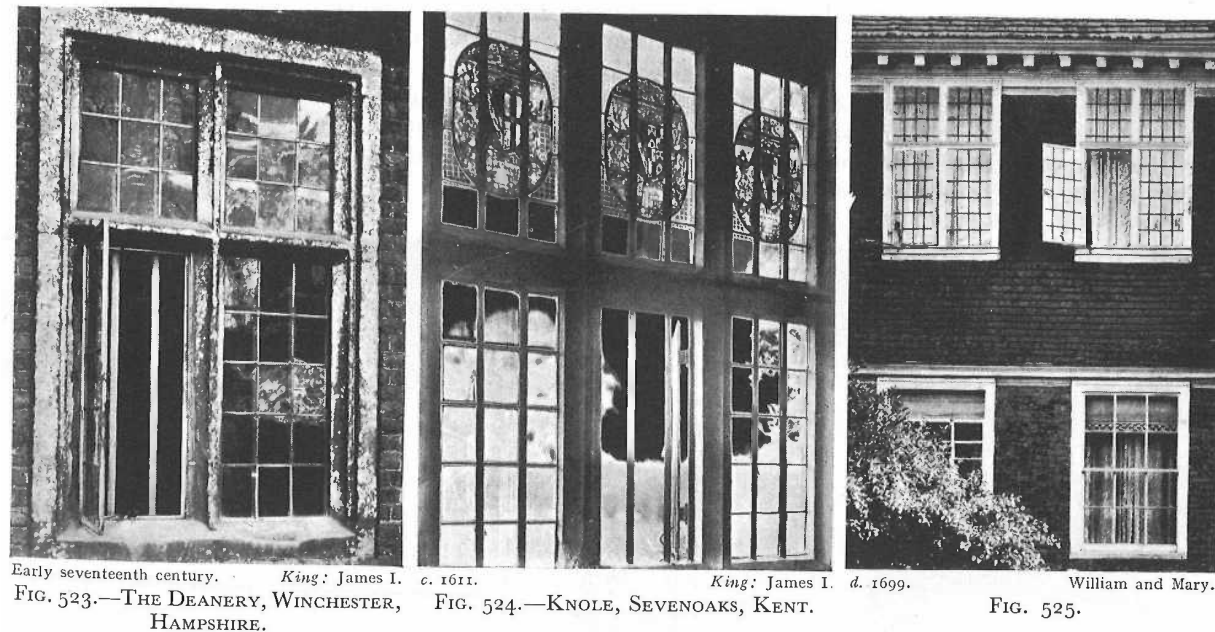
FIG. 523.—The four-light mullioned and transomed window of the seventeenth century was superseded by the sash window towards the close of that century. First constructed of stone or brick, it was latterly made of wood. The illustration is of a window with hollow chamfers; other examples had the ovolo moulding (Fig. 521), and some the splayed chamfer (as Fig. 499), whilst others again had mullions of square section, slightly rounded at the angles.

FIG. 524.—The interior of a window in the gallery. The mullions have hollow chamfers.

FIG. 525.—The upper window frames are of wood, the design of which was the last phase of mullioned and transomed frames. These began to be superseded by sashed frames c. 1685. The lower windows have had the casements removed and sashes substituted. The mullioned windows have their upper lights slightly taller than a square, the latter being a proportion usually avoided.

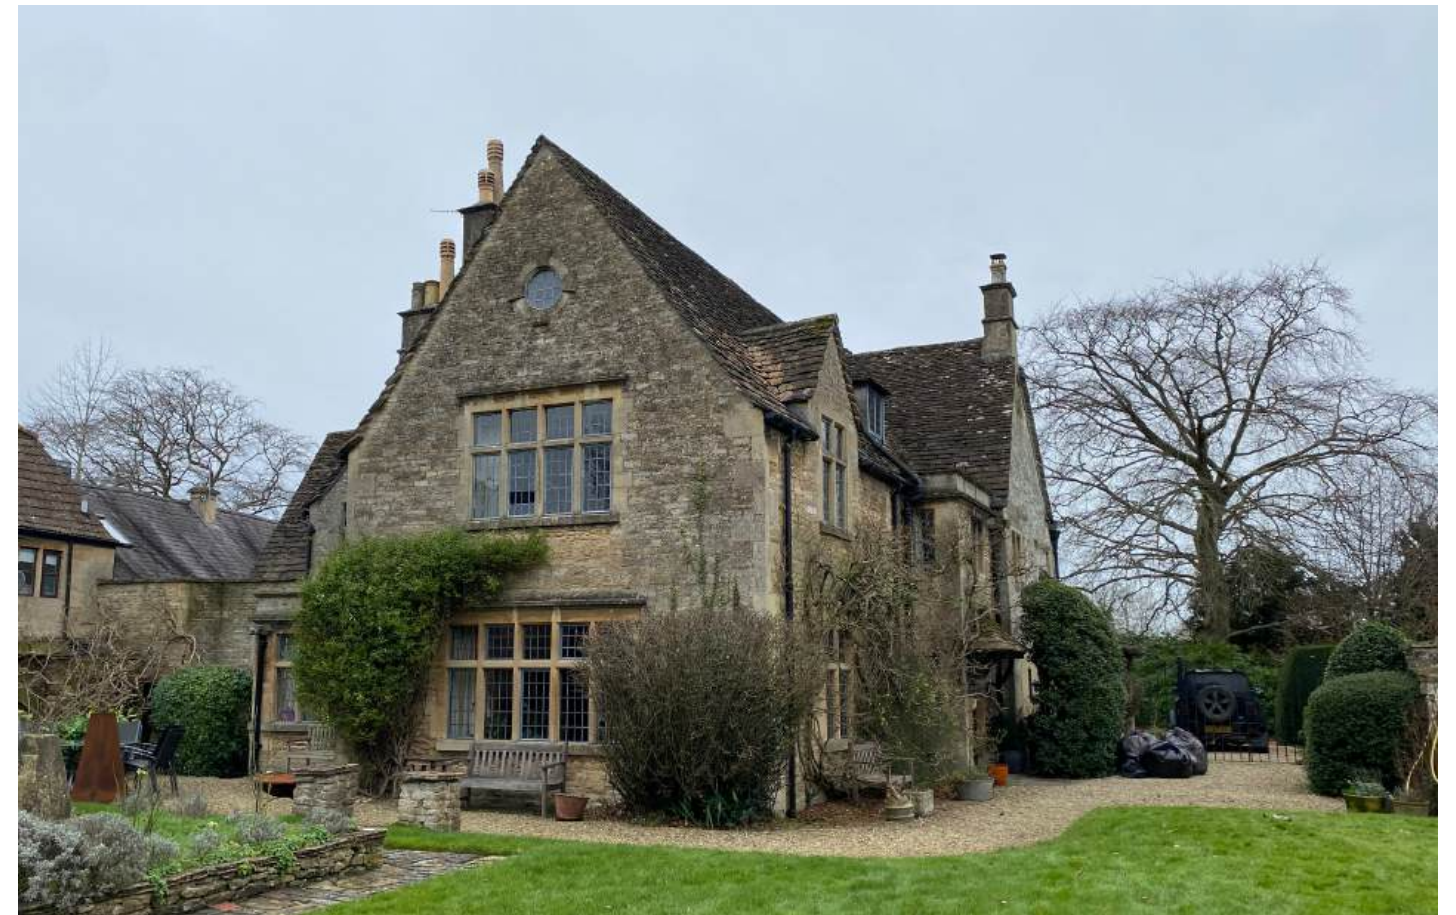
Site photo - South elevation

In the Early 20<sup>th</sup> Century, significant work was carried out to the house in an “arts and crafts” style. This included an additional two-story extension to the south elevation forming a second, south facing gable end, adjacent to the earlier extended stair turret. A single-story bay window extension was also built on the south elevation and a two-storey flat roof extension is constructed to the east. The flat roof extensions are characterised by simple decorative corning / parapets – Investigations on site confirm these flat roofs are of more modern construction, built from concrete with Asphalt covering. Both southern extensions are characterised by identical 10 light stone mullioned and transomed windows formed with ovolo profiled stone members at ground floor level - At first floor level the master bedroom is served by 8 light stone mullioned and transomed windows formed with openings of identical proportions to the windows below. The windows themselves are a combination of inward opening casement windows, fixed and inward opening bottom hinged windows with curved guides in some places.

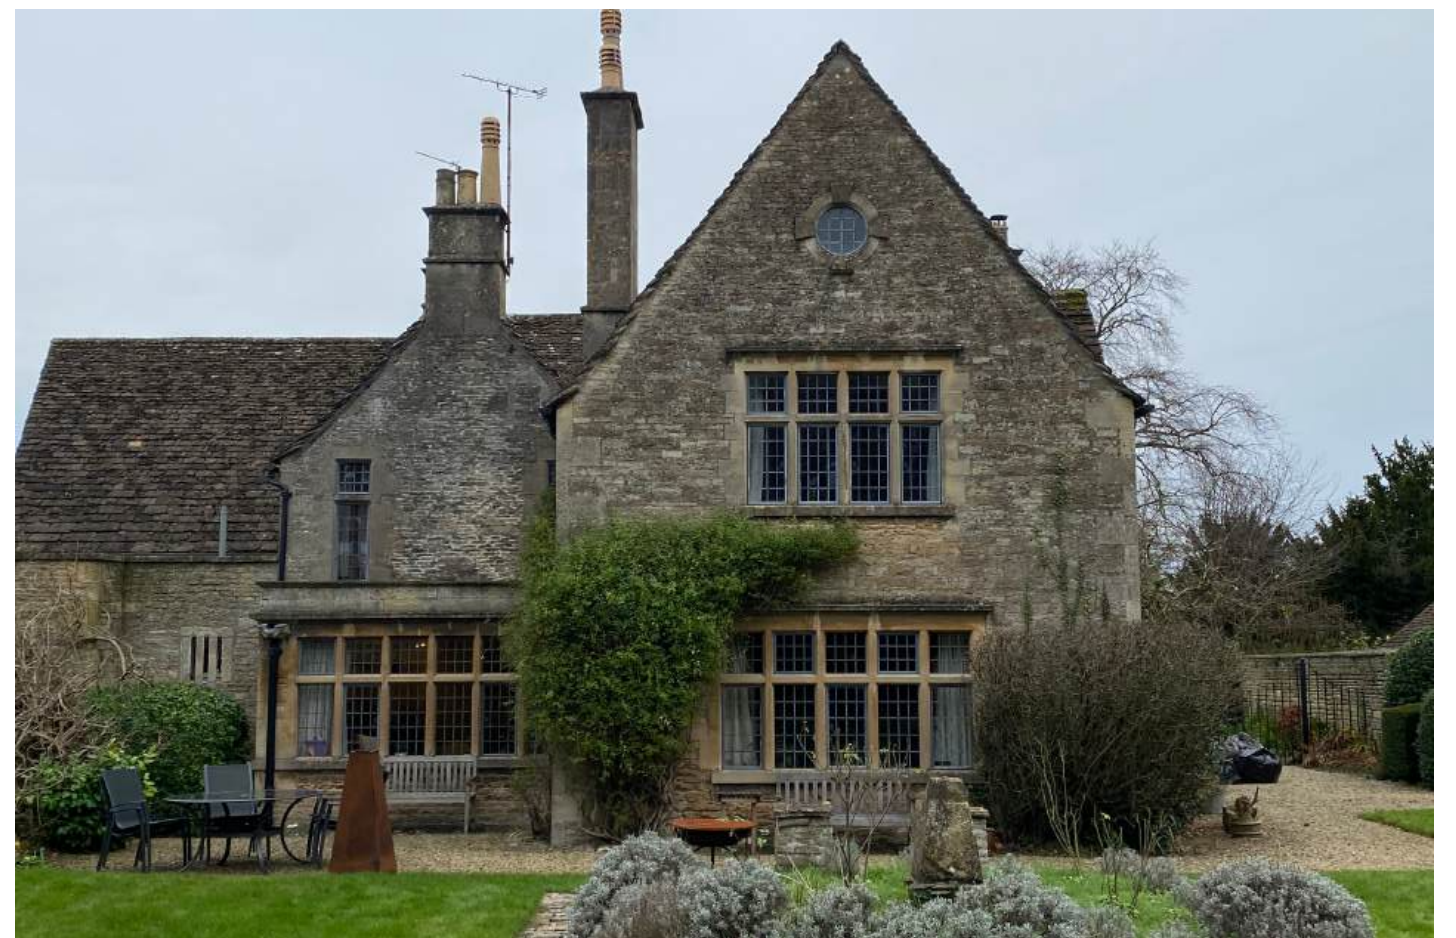
Site photo - South elevation
