# Lowden Manor House, Chippenham

## Heritage Statement and Design and Access Statement

Submission Document - Listed Building Application

Designscape Architects

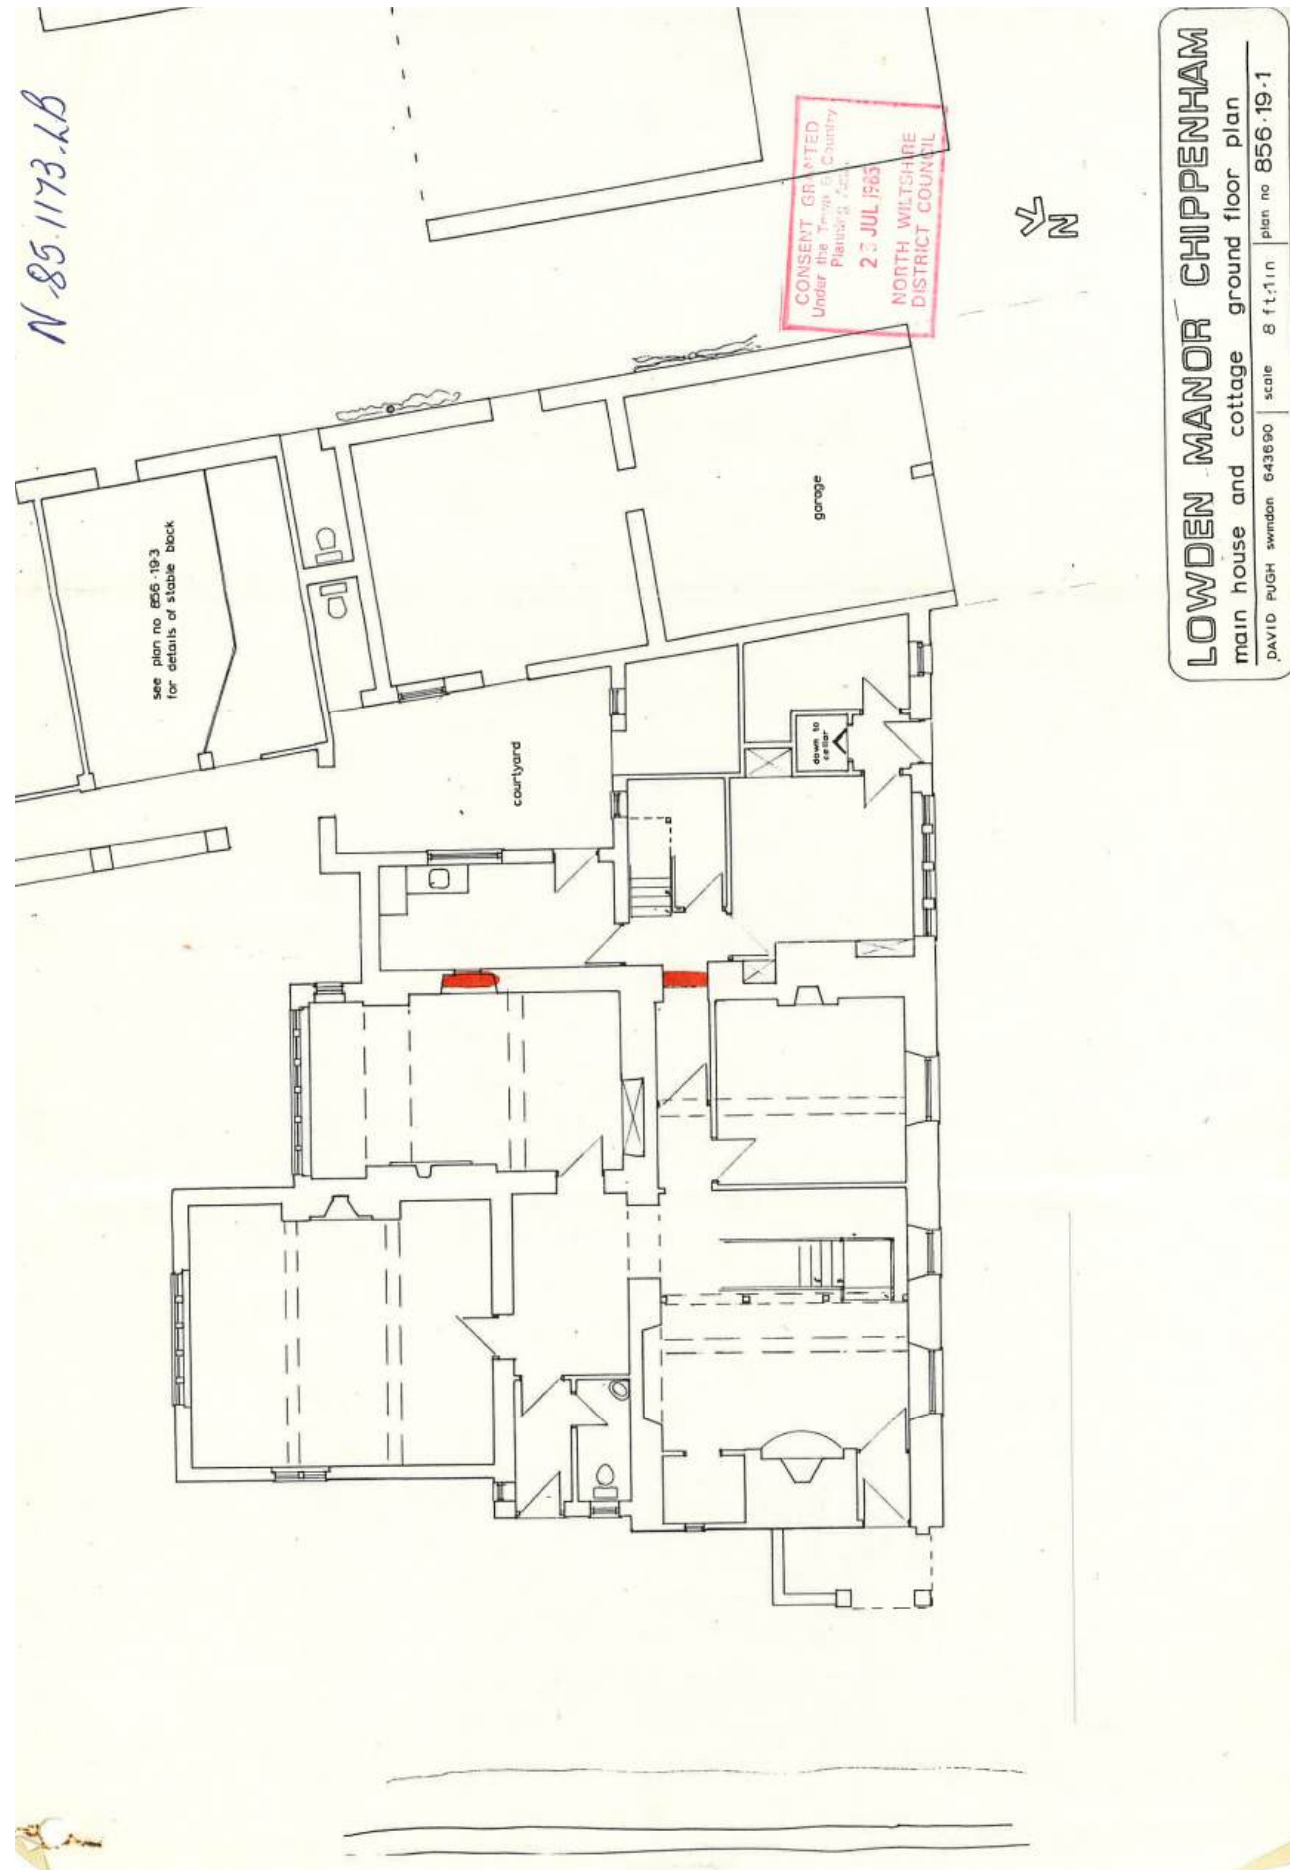
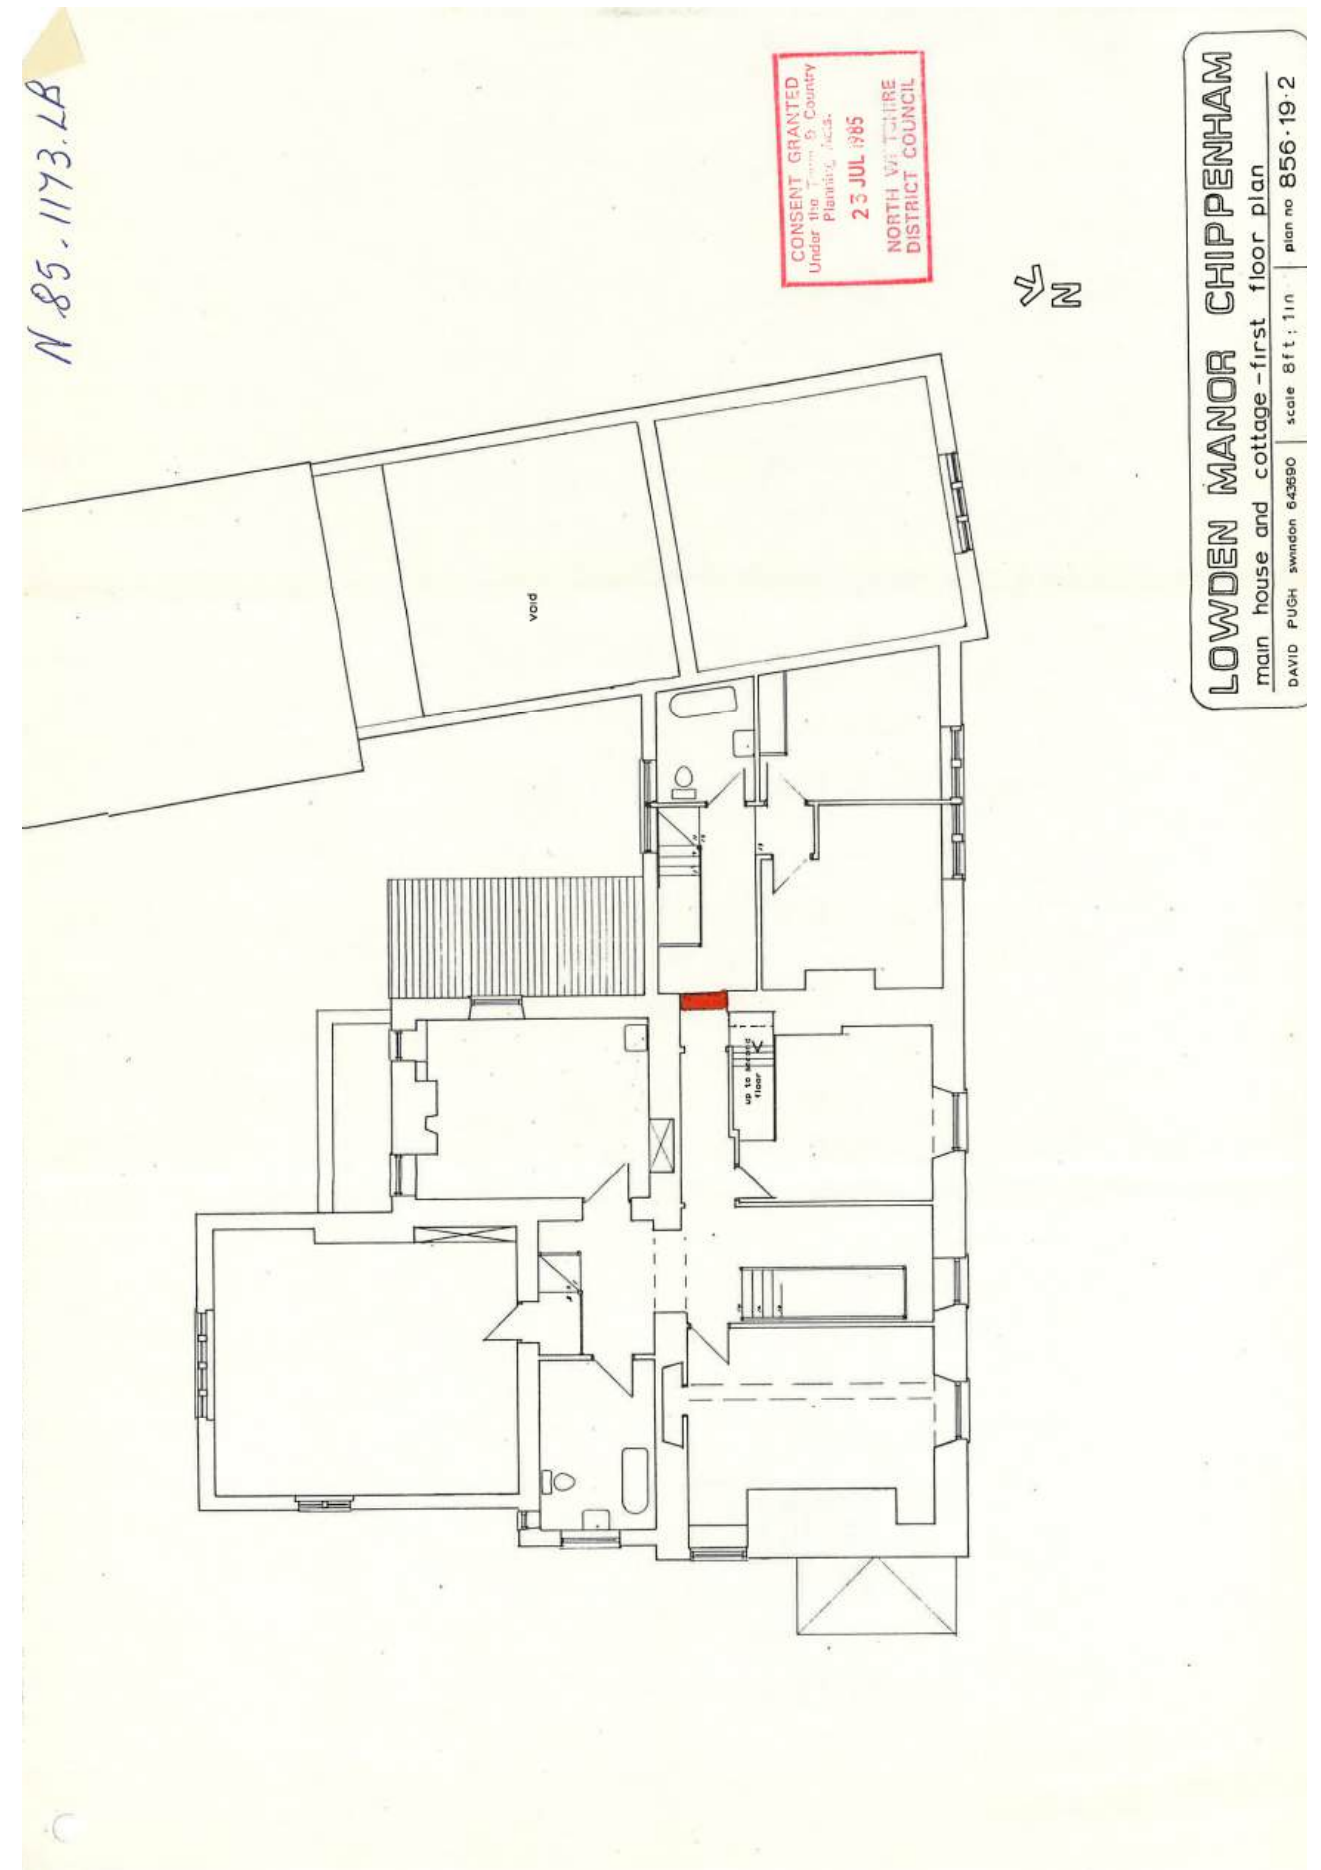
1985 - Approved Planning drawings showing changes made to subdivide the house.

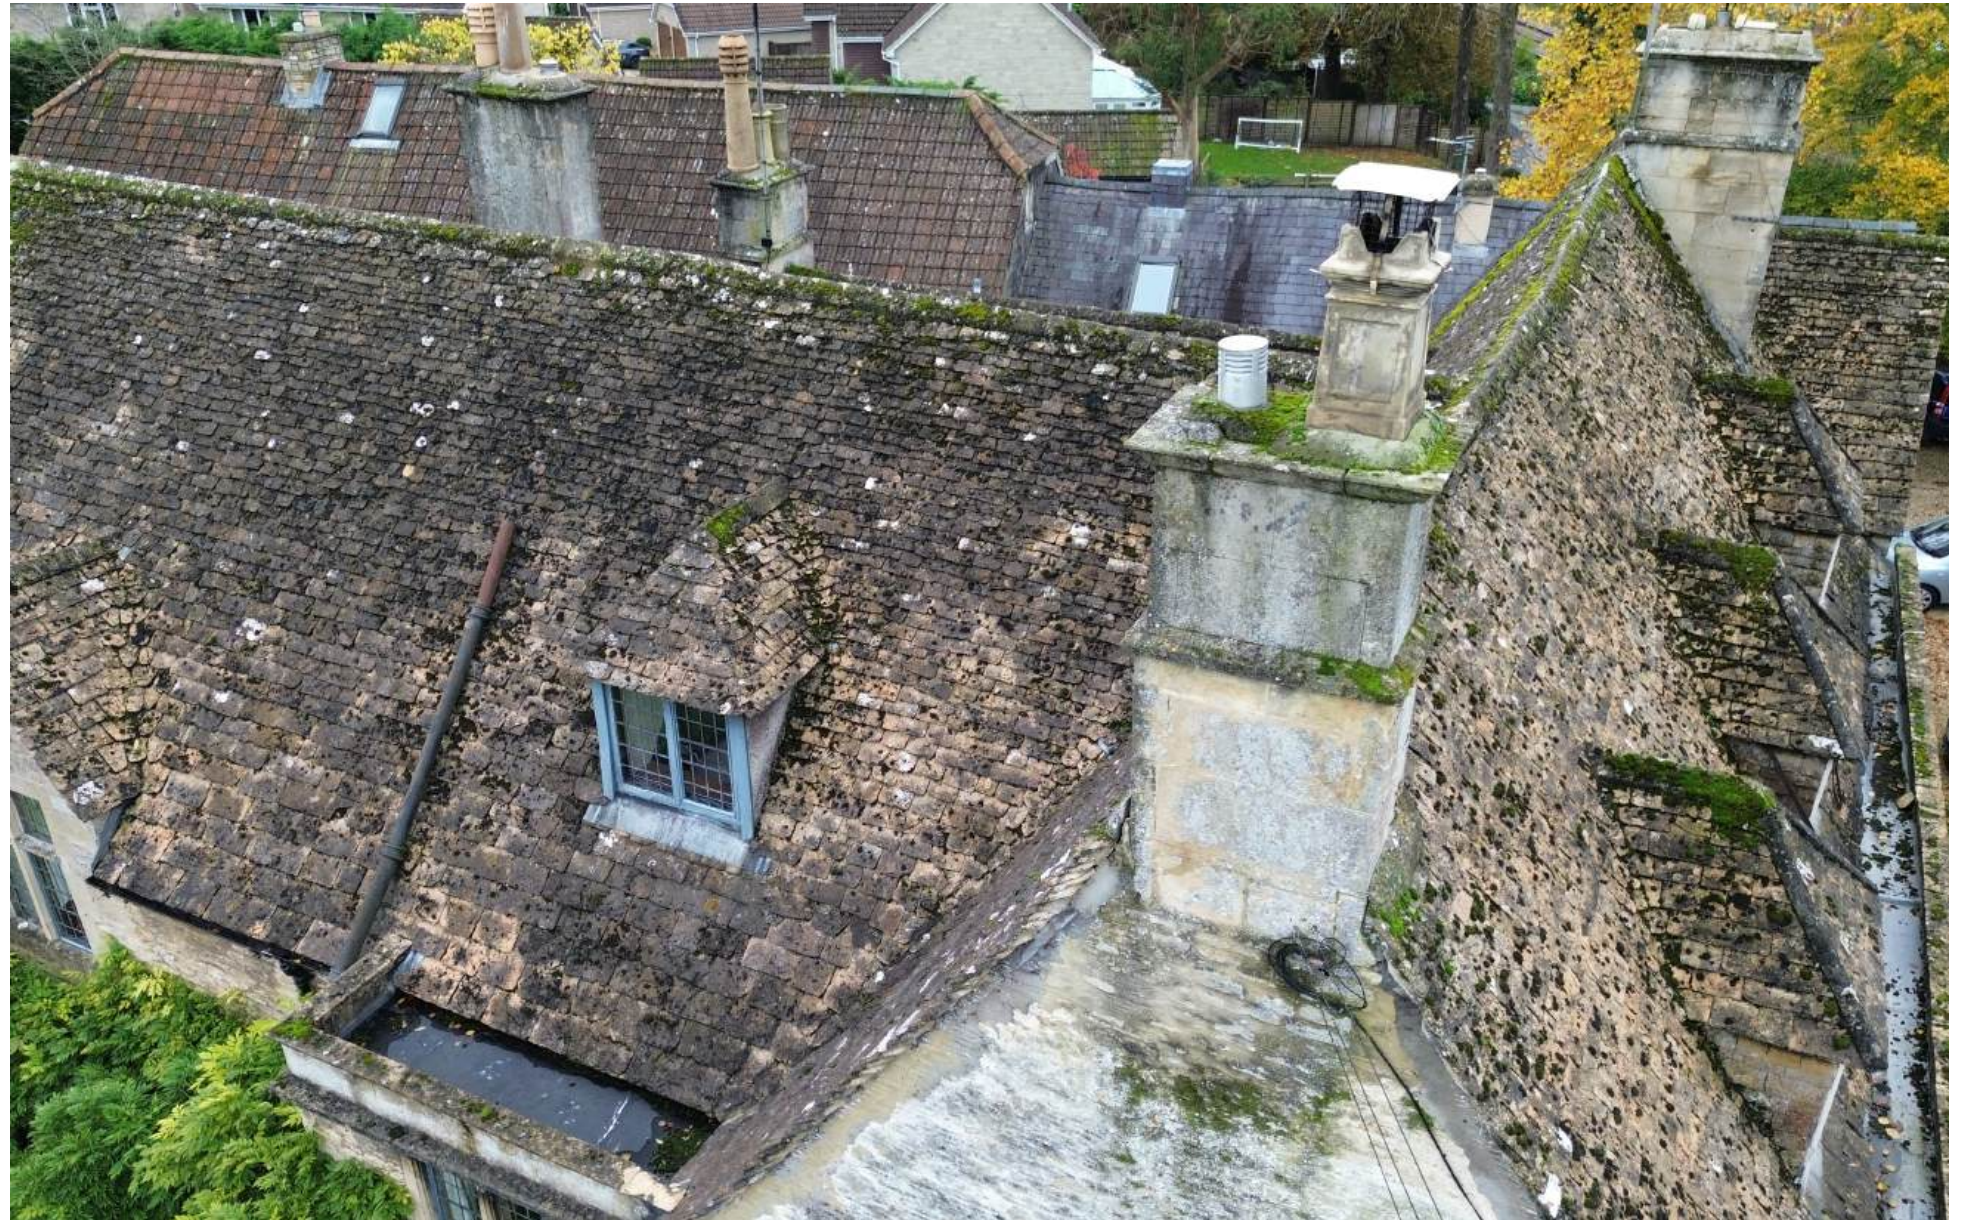
North and East wing roofs. Roofs beyond in slate and clay tiles were formerly part of owden Farm - separated in 1980s.

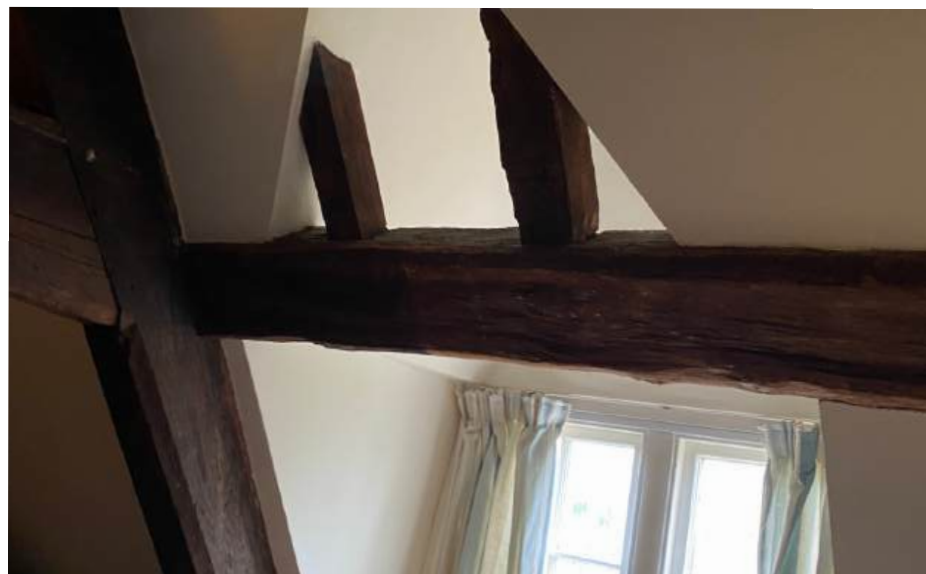
The North (Front) wing roof has a very old roof structure, but modern plasterboarded interior

The Northern "front" wing of the house is plasterboarded with modern plasterboard and skim, polythene VCL is installed below the common rafters and a very limited amount of insulation is installed between the common rafters under the traditional lime "torching". It is clear over this area the insulation has been installed from below - Perhaps as part of the 1985 works to divide the house. Above the second floor bathroom a flat ceiling has been installed on ceiling joists - Limited insulation has been installed over these joists.

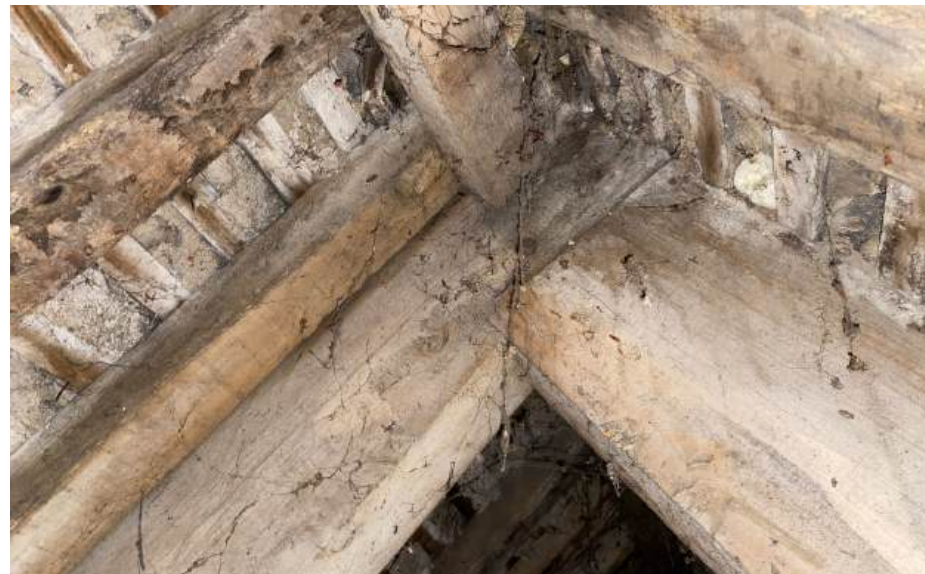
South West (rear) wing roof - Lime torching and iron pegs failing

Where it has been inspected and where the rafters are not boarded out, the existing roof coverings over the original plan form and earlier southern extension appear to have been done earlier than the 1919 southern extension. The pegs used over the southwest rear wing uses iron pegs, where the main roof over the original three unit plan uses oak pegs, suggesting the roof coverings were replaced at different times. The pegs are now - particularly in the South West rear wing - very badly corroded and the tiles are beginning to slip and are hazardous. The roof over the original three unit plan and southwest rear wing is failing and in need of immediate renovation.

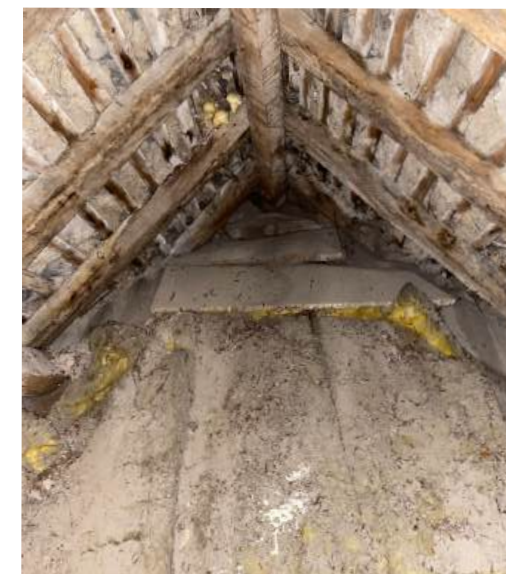
South West Wing - emergency repairs using expanding foam.

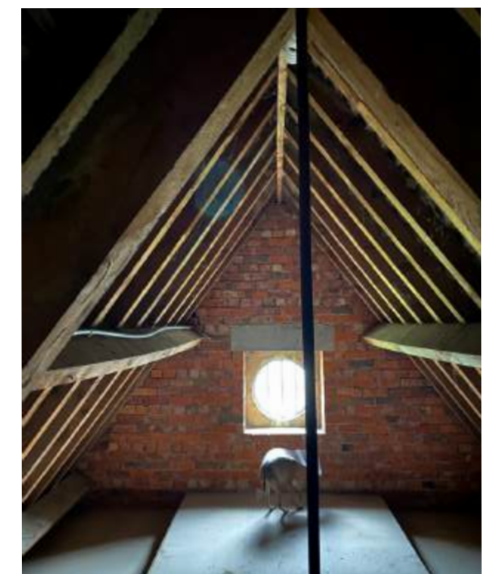
South East Wing - 1919. Roof failures limited to ridges - but the roof is at the end of life.

The remaining roof area over the later 1919 south east rear wing is in better condition for the majority, with the exception of the ridge tiles. However considering the life expectancy of a stone tile roof is around 100 years, replacing the coverings of this roof would be advisable as part of the works. Note that the tiles are held on with iron (sometimes galvanised) pegs over the extension.

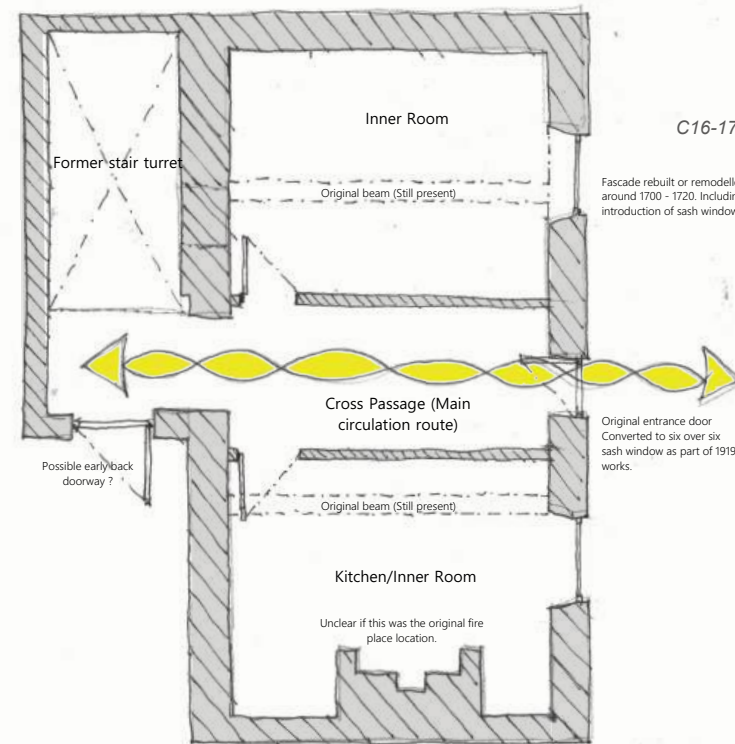
C16-17: Typical 3 Unit Cross Passage Farmhouse Plan form - Ground floor

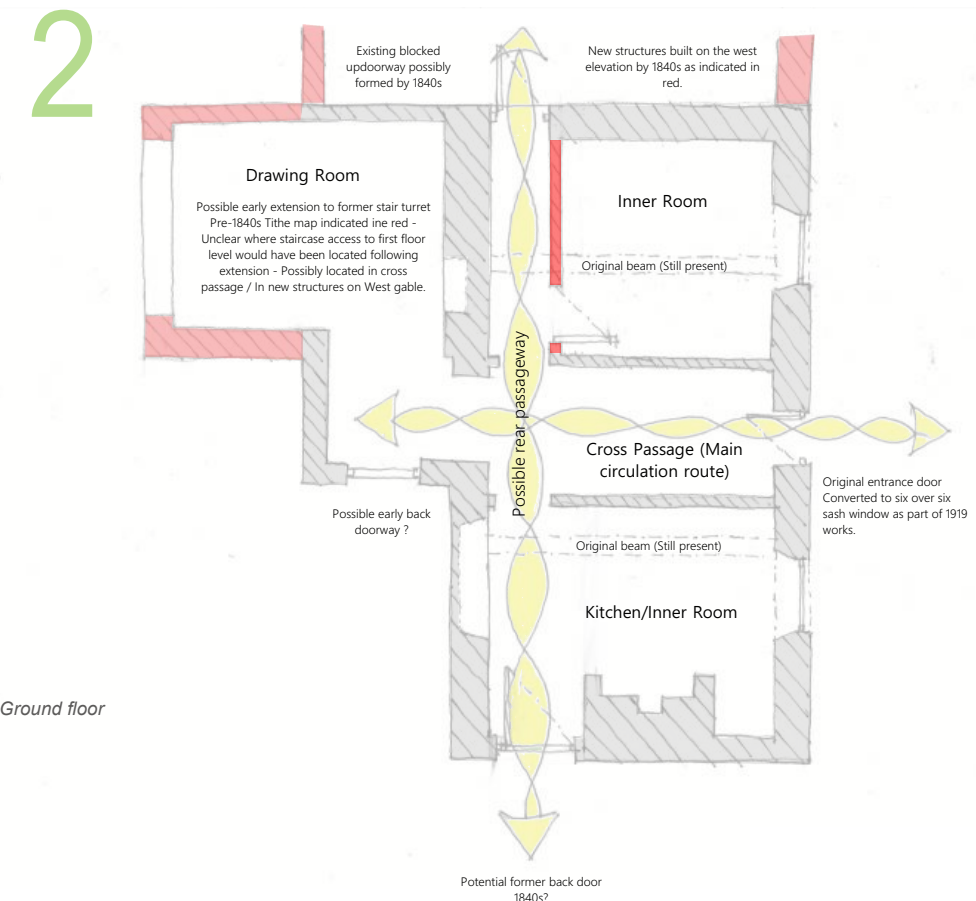
1840- 1888 Plan form development - Ground floor

As noted it is not clear when the dormer windows were added to the front of the house but they would appear to precede the C20th works, even though the current window frames are late C20th. The front roof is interesting with much earlier - C16th-C17th trusses and purlins clearly built prior to the

The southern extension identified on the 1840s Tithe map appears to remain the same although it may have been replaced with a more significant extension. The quality of the 1840s map makes it challenging to confirm this.

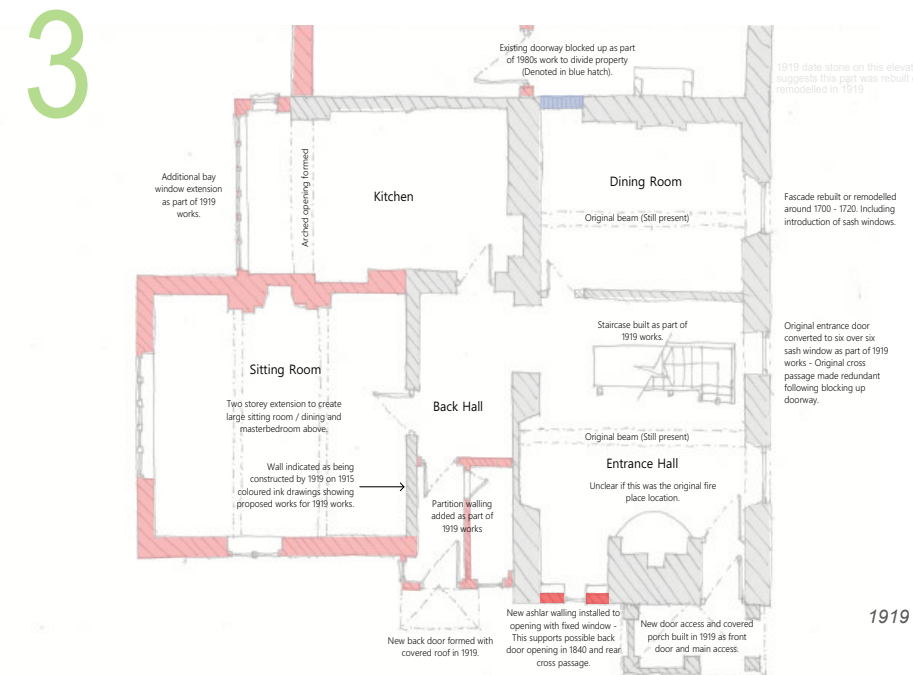
1919 - 2025 Changes made in 1919 / 20 picked out in red - Ground floor.

- Existing doorways between western extension blocked off in division of house

Although It is noted that the changes that were made at this time were not built in exact accordance with the 1919 drawings (See drawings PP 14) , it is clear to see the intentions, and then see the actual changes that were made to the house on site.

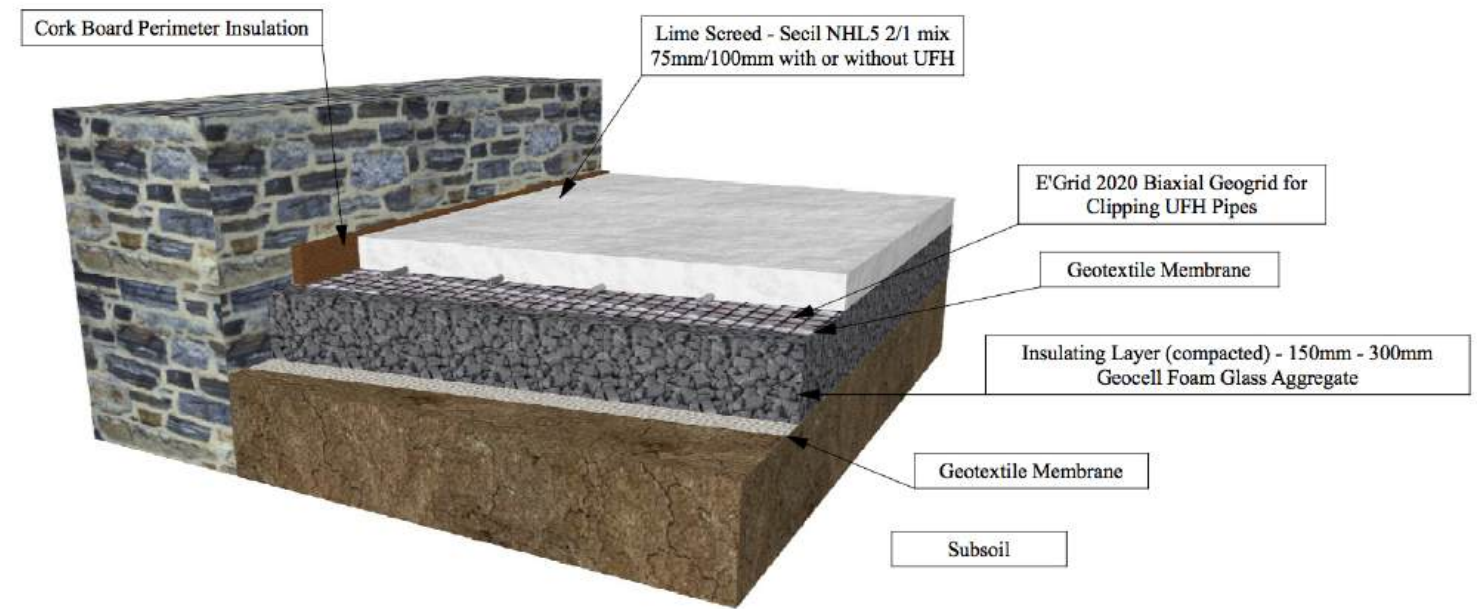
Mike Wye - Limecrete and Geocell foam glass and replacement ground floor construction for R001 / R006 / R007

Works will involve the replacement of the existing, more modern ground floor construction in R001 / R006 / R007. It is intended that the existing floor constructions be replaced with a breathable limecrete flooring solution as identified (Mike Wye system), that will improve the thermal performance of the dwelling but in a sensitive manner. The new floor areas will include low temperature Underfloor Heating which will be more comfortable and beneficial for the fabric of the house ( more stable temperature).

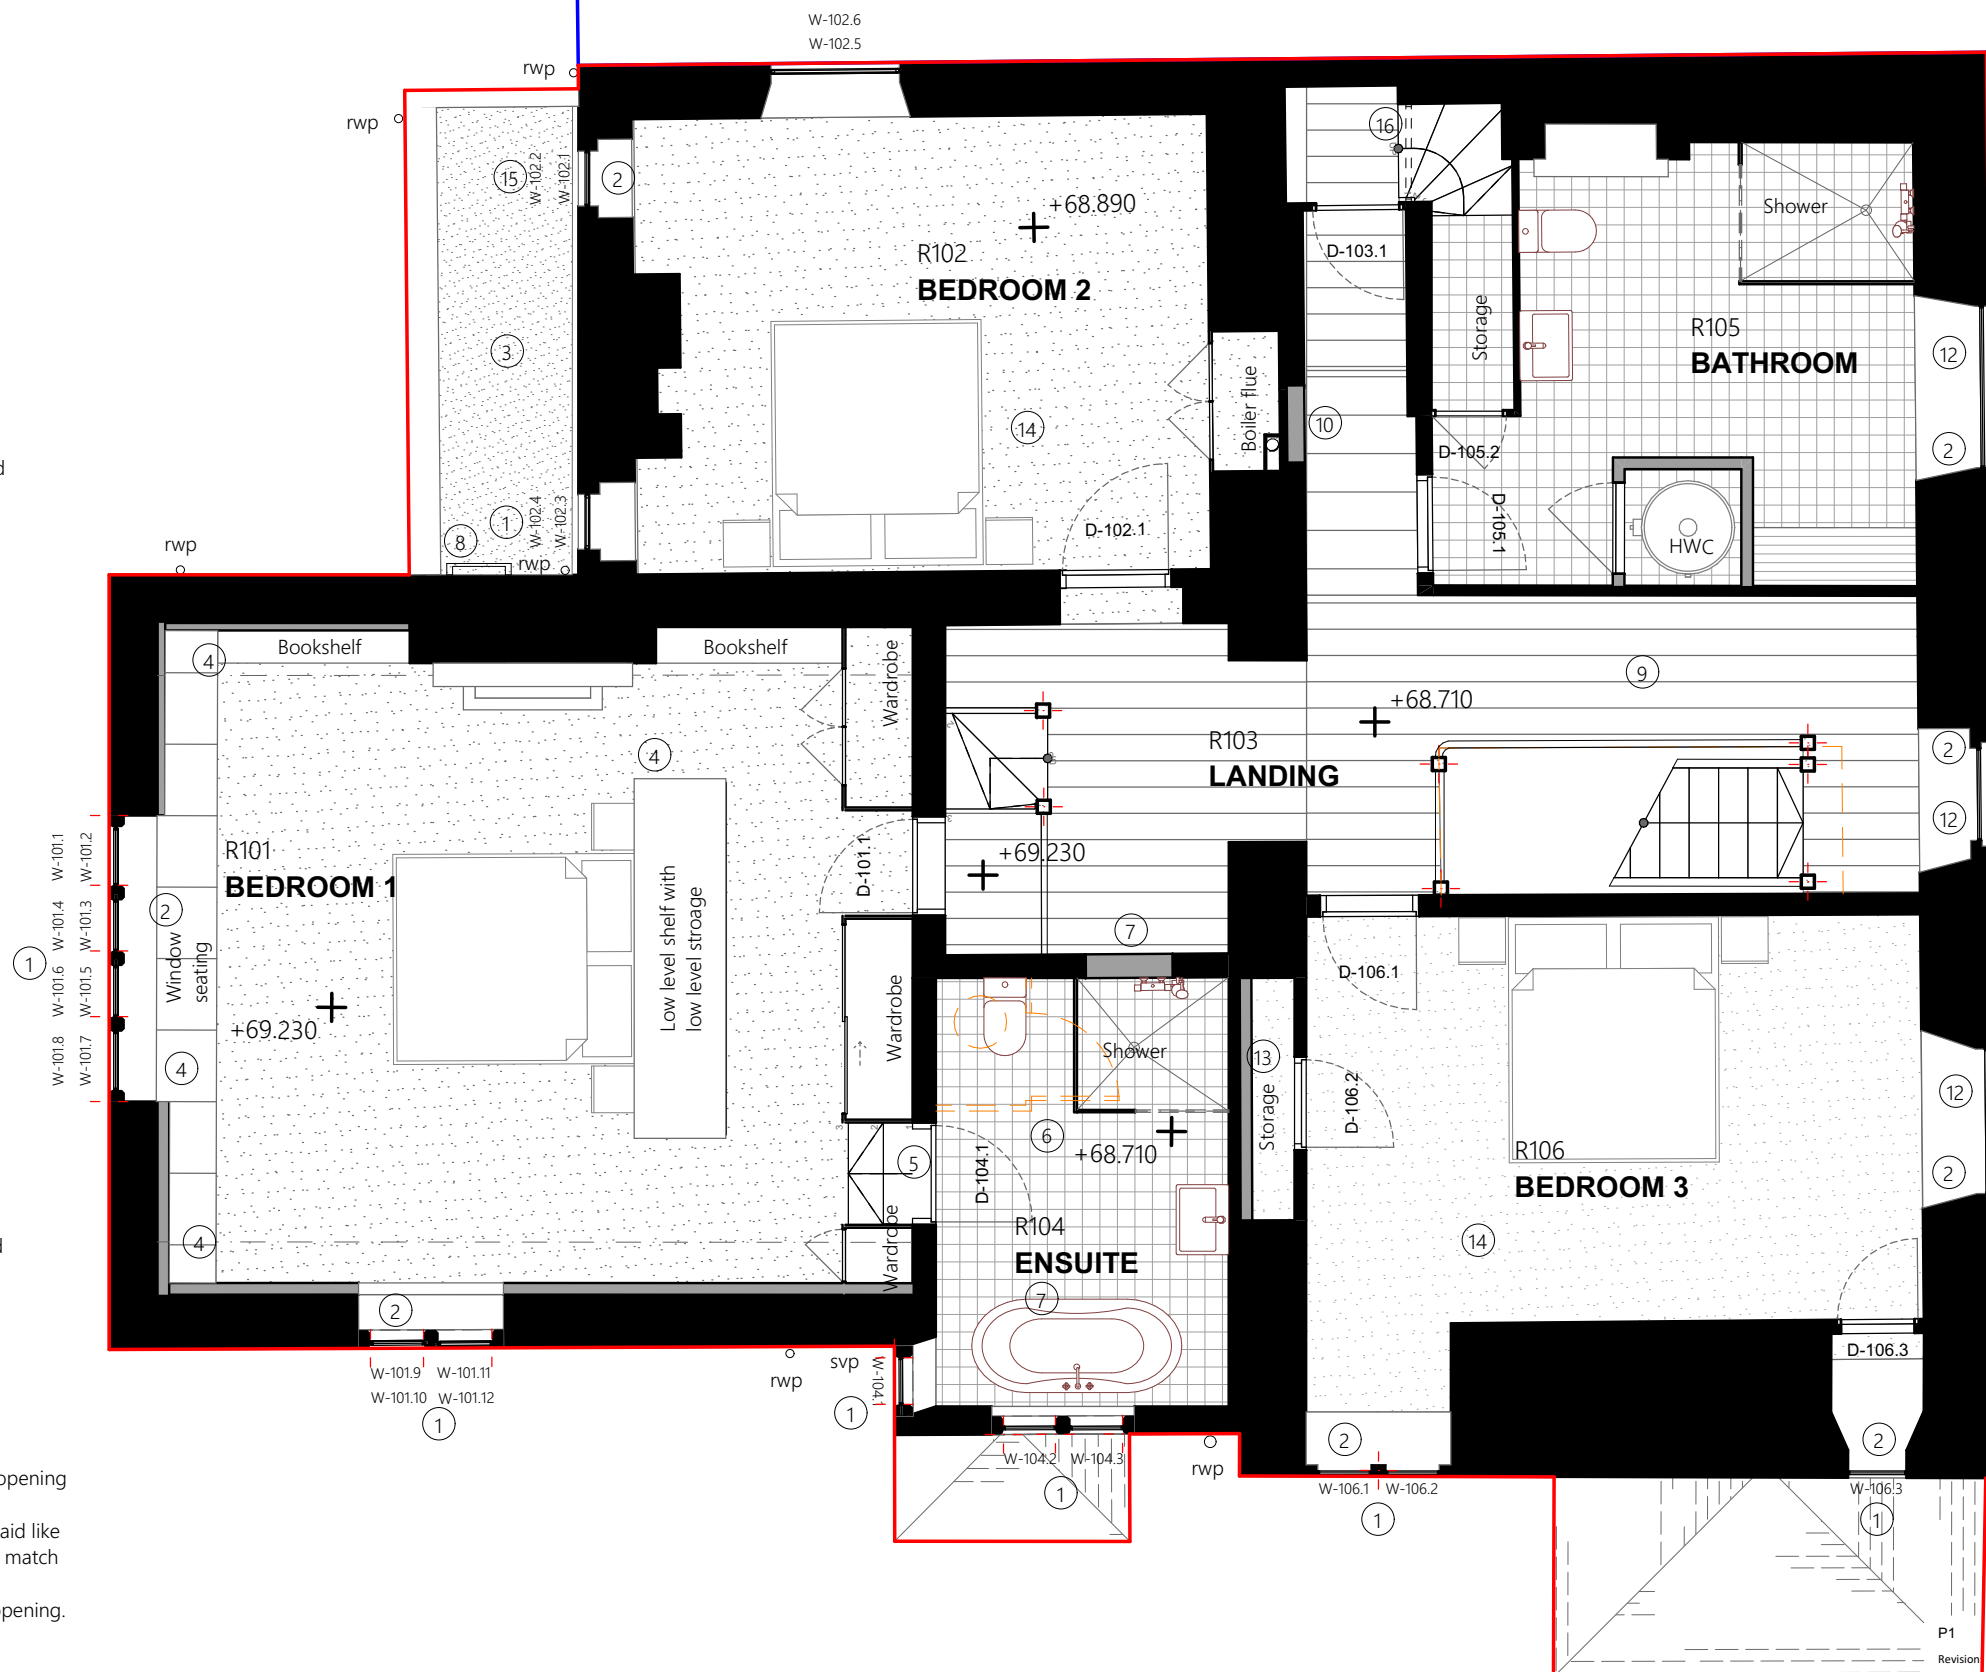
# 4 Proposals - OUTLINE PROPOSALS (First Floor )

- ① **Existing casement windows:**
  - Single glazed casement windows to be repaired like for like - Existing lead comes / steel frames renovated as required.

- Existing secondary glazing to be replaced with new secondary glazing installed between stone surrounds / mullions / transoms.
- ② **Stone window surrounds / mullions / transoms:**

- Existing profiled stone window surrounds / mullions / transoms to be repaired in situ. Extent of repairs to be confirmed by stonemason following inspection of window conditions.

- ⑨ **Staircase opening in landing:**
  - Existing landing opening to be adjusted to accomodate adjusted flight of stairs. (Existing opening denoted with orange dashed line).

- Timber plank floor finish on landing to be relaid like for like and any new timber planks required to match existing size and finish.
  - Balustrade/Stair posts adjusted around new opening.

- ⑩ **Doorway to be infilled:**
  - Existing doorway on landing to be infilled with stud walling - Doors to be removed.
- ⑪ **New bathroom:**
  - Existing bedroom to be converted to bathroom serving bedrooms 2 & 3. New drainage to connect to drainage from existing bathroom above on the second floor level. Contractor to investigate and confirm location of soil vent pipe from above. Floor as R104.

- ⑫ **Sash windows:**
  - Existing eight over eight / six over six sash windows on principal elevation to be renovated.
  - Renovate generally with new parting beads with brush seals.

- Existing secondary glazing to be replaced with new secondary glazing.
- ⑬ **Acoustic lining R106 :**
  - New acoustic insulation lining installed to back of storage cupboard in R106.

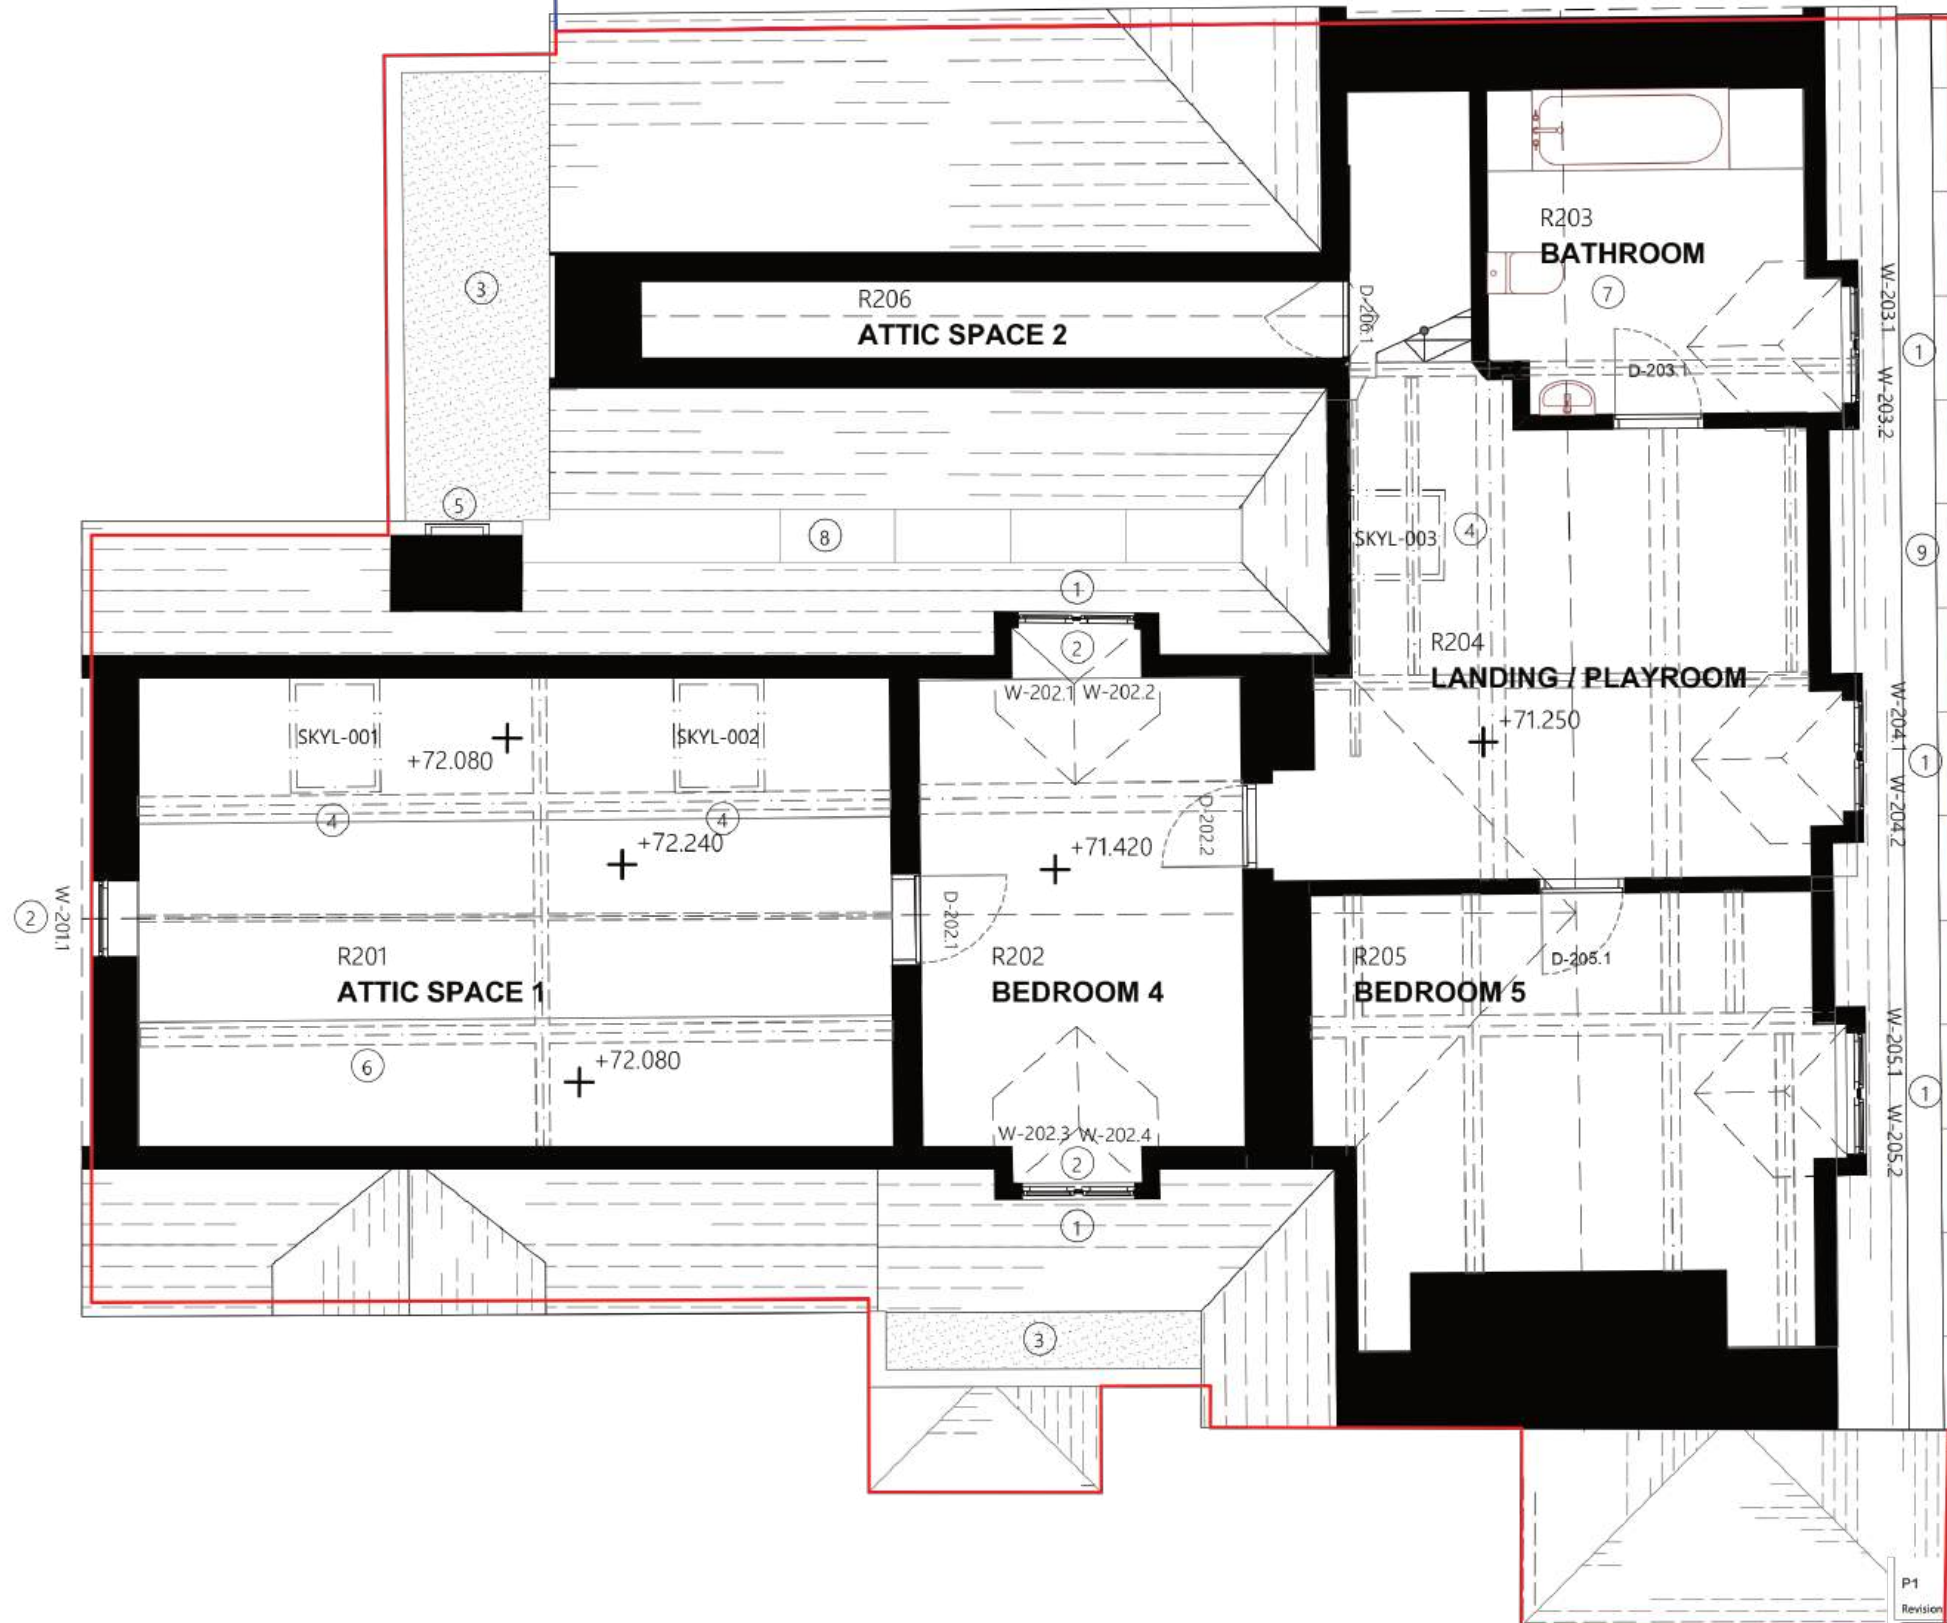
- ① **Existing casement windows:**
  - Single glazed timber / metal casement windows to be repaired like for like.
  - New secondary glazing installed to structural openings.

- ② **Stone window surrounds / mullions / transoms:**
  - Existing profiled stone window surrounds / mullions / transoms to be repaired in situ. Extent of repairs to be confirmed by stonemason following inspection of window conditions.

- ⑦ **Bathroom R203:**
  - Floor structure in R203 bathroom to be inspected and made good - Contractor to remove subfloor and inspect floor structure.
- ⑧ **Stepped valley Leadwork:**

- Leadwork forming stepped valley to be replaced - Contractor to assess valley structure upon removal of coverings
- ⑨ **Parapet gutter:**
  - Stepped leadwork gutter behind parapet wall to be removed and replaced on a like for like basis: Timber structure below to be replaced as required.

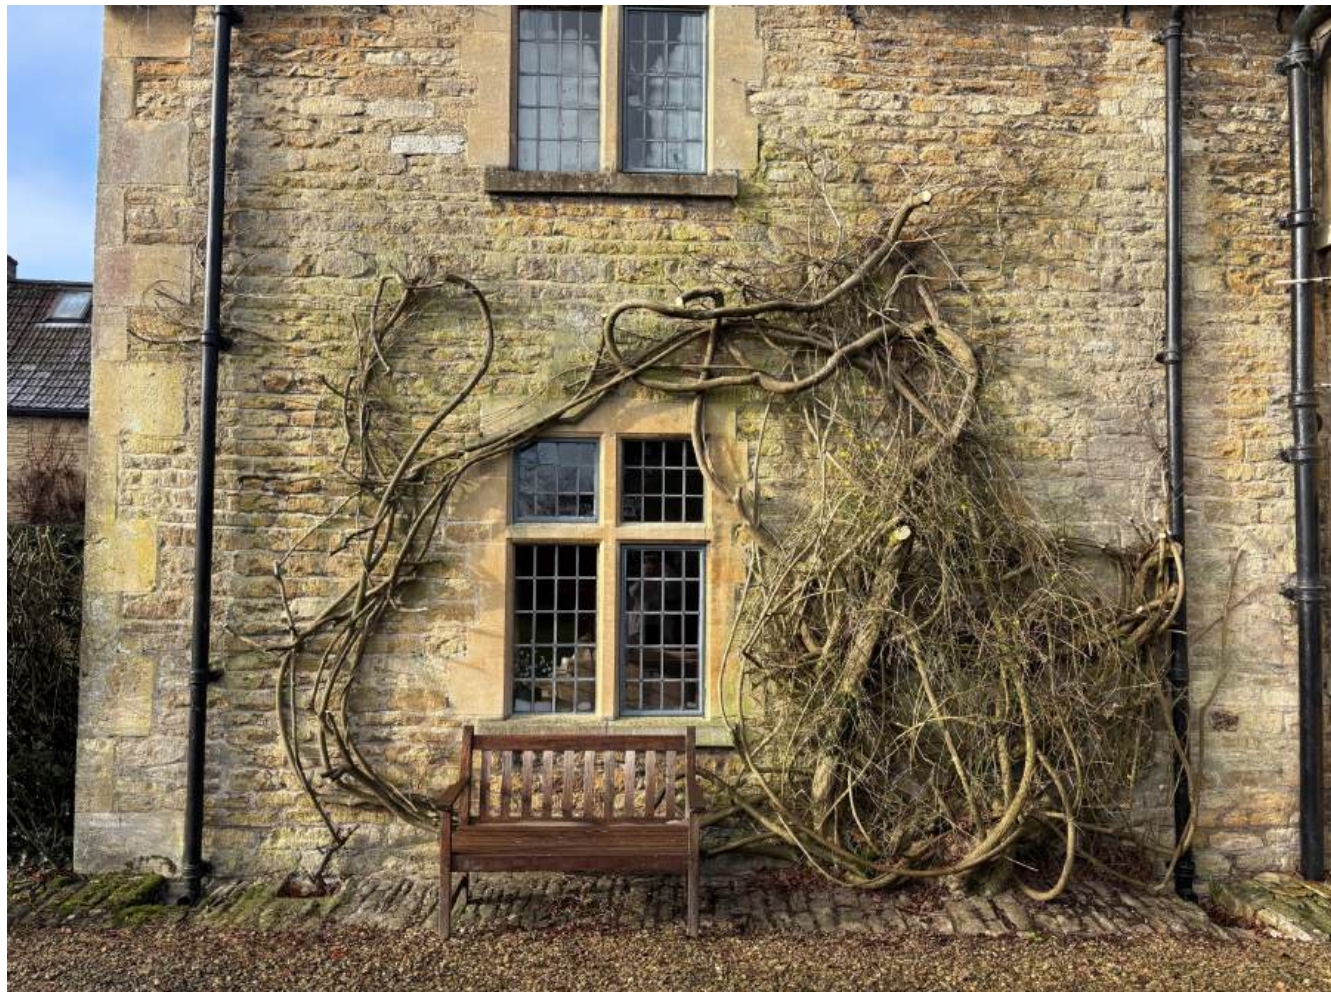
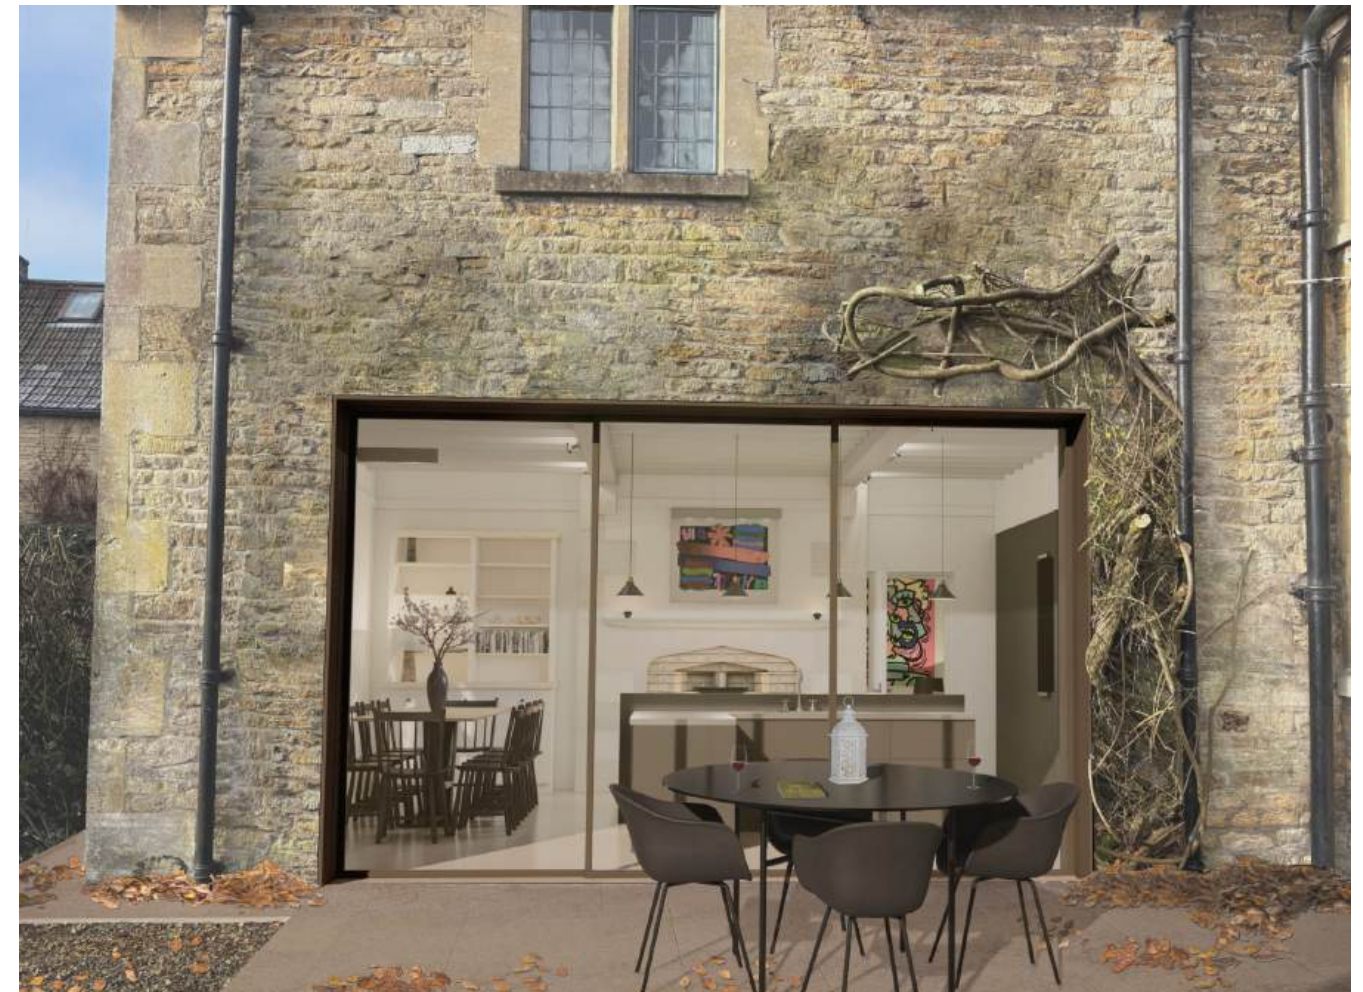
The proposal to replace an early C 20<sup>th</sup> mullioned window with an aluminium sliding glass doorset is linked with the intention to change the use of the room it serves. This will become a new Kitchen / Dining room - the most heavily used room in any modern household - and will link this room with the garden. The patio area outside this proposed window will provide greater privacy for the neighbours than the existing arrangement, and a more private outside sitting area for the residents of Lowden Manor House. Along with the other proposed alterations to the ground floor circulation - partly restoring an older plan form - is intended that this will also bring the walled garden closer to the kitchen and encourage its greater use.

The existing window will move to the North on the same elevation, in what was once probably an entrance door, currently blocked up with a tiny utility window. ( This was the intention of the 1919 scheme, but not implemented).
