# Lowden Manor House, Chippenham

## Heritage Statement and Design and Access Statement

Submission Document - Listed Building Application

Designscape Architects

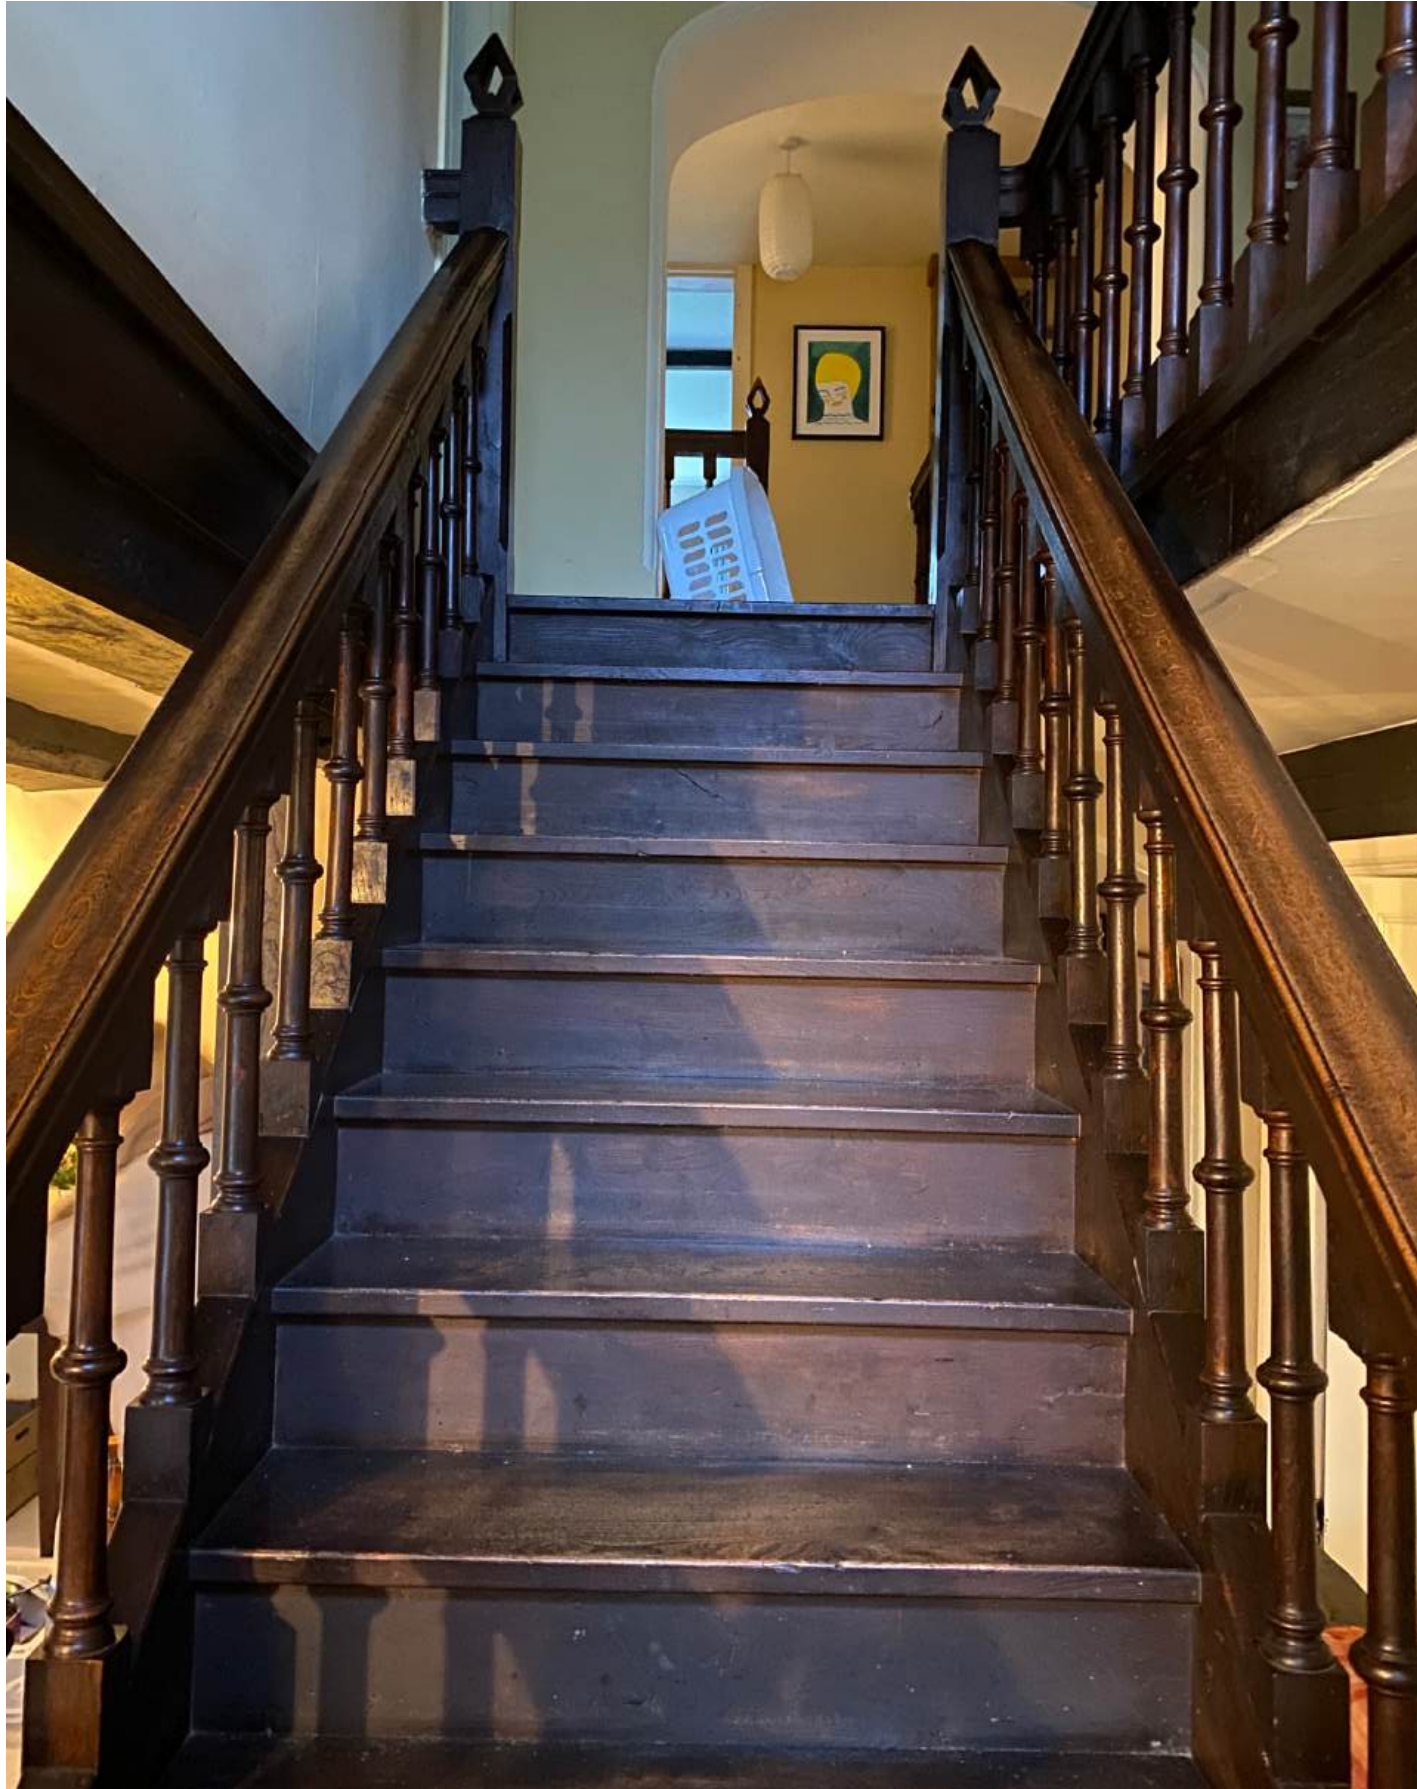
View 1 - Existing arts and craft staircase (1919) - For proposed renovation / repositioning

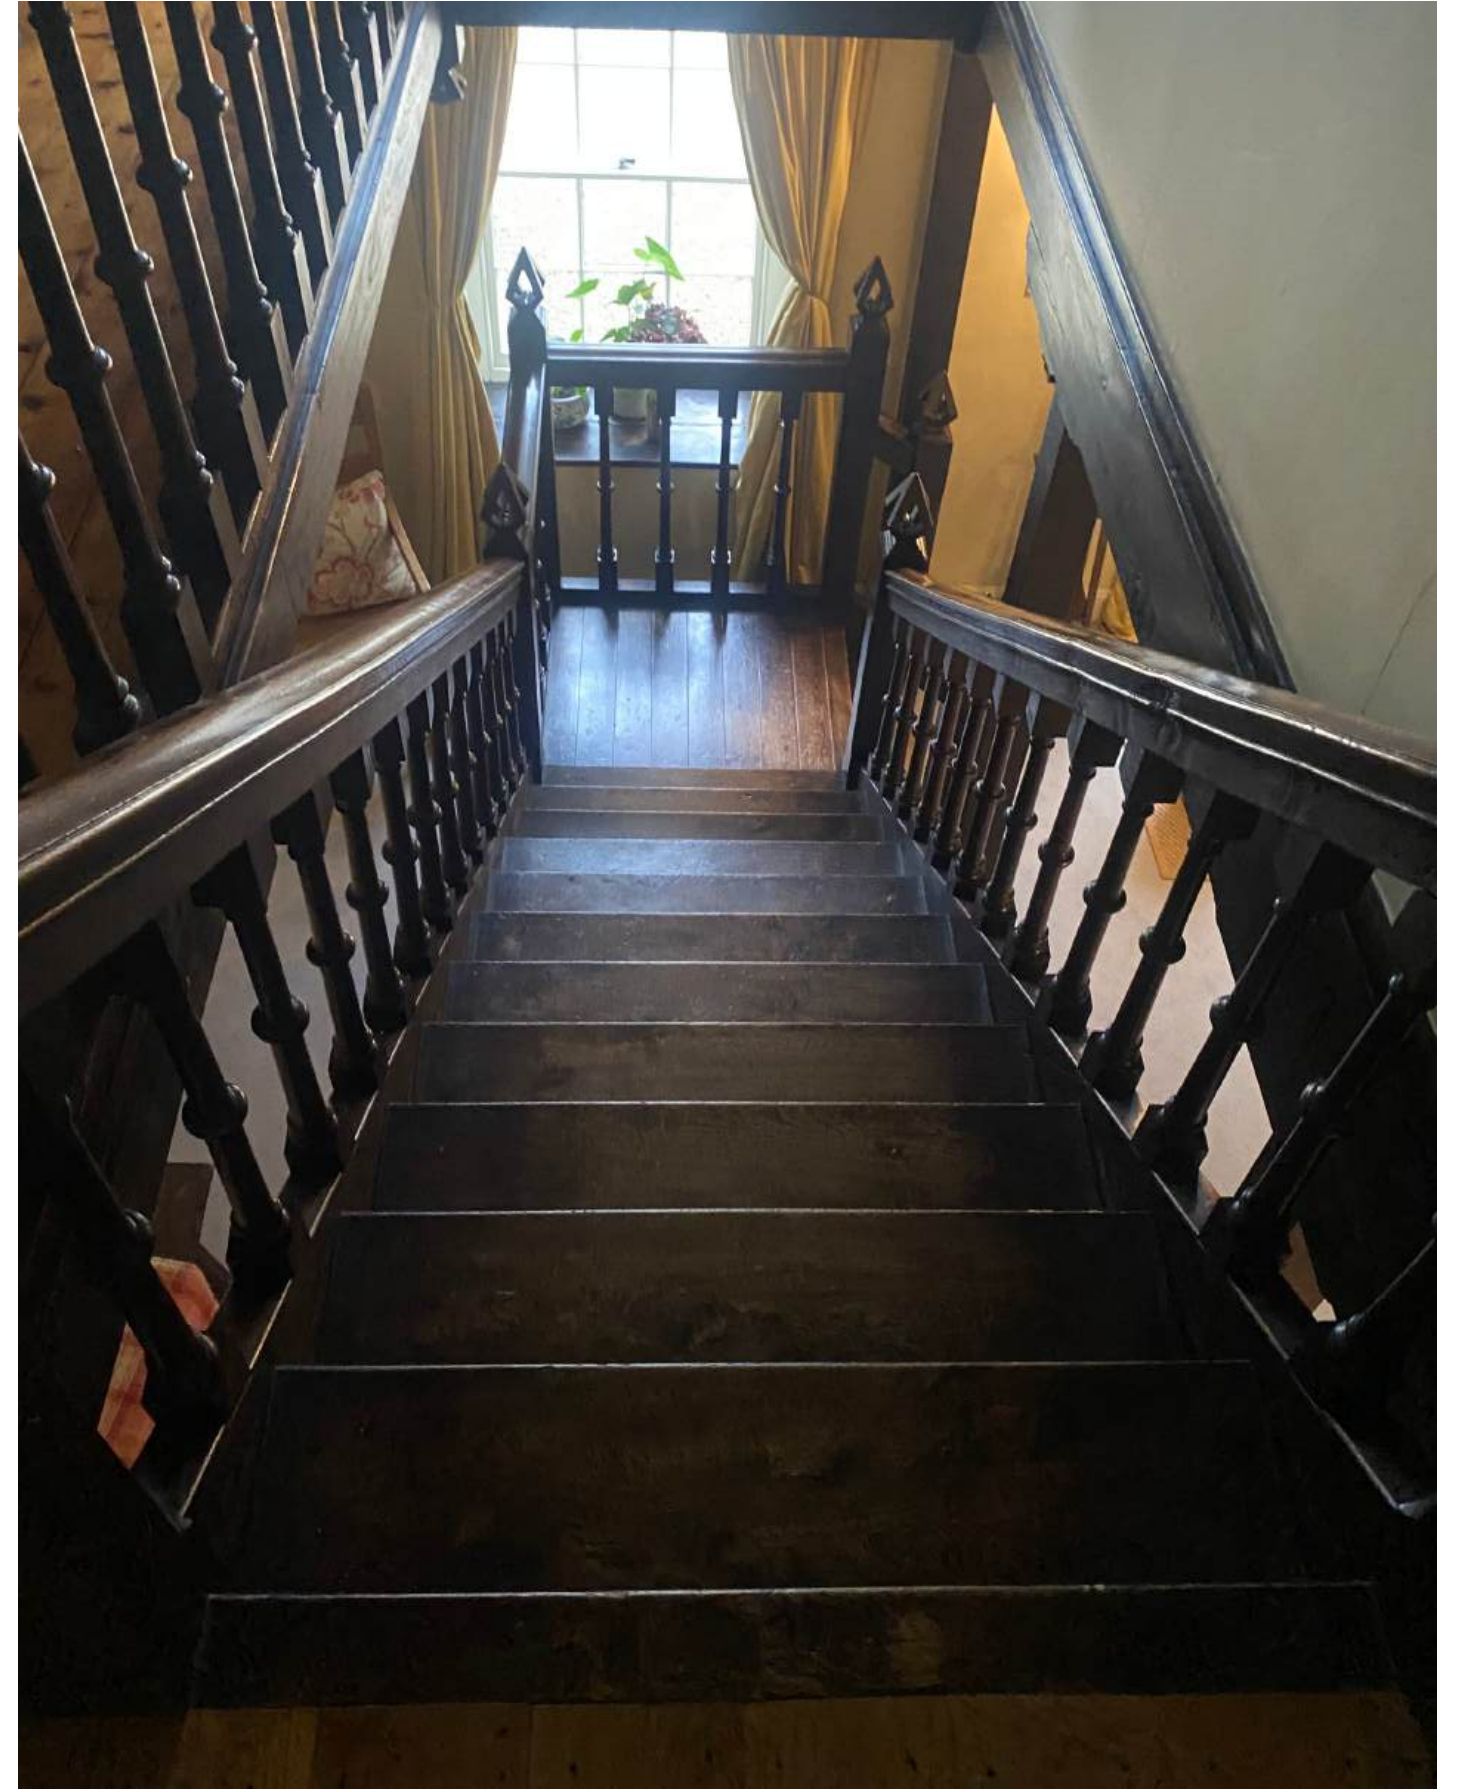
View 2 - Existing arts and craft staircase (1919) - For proposed renovation / repositioning

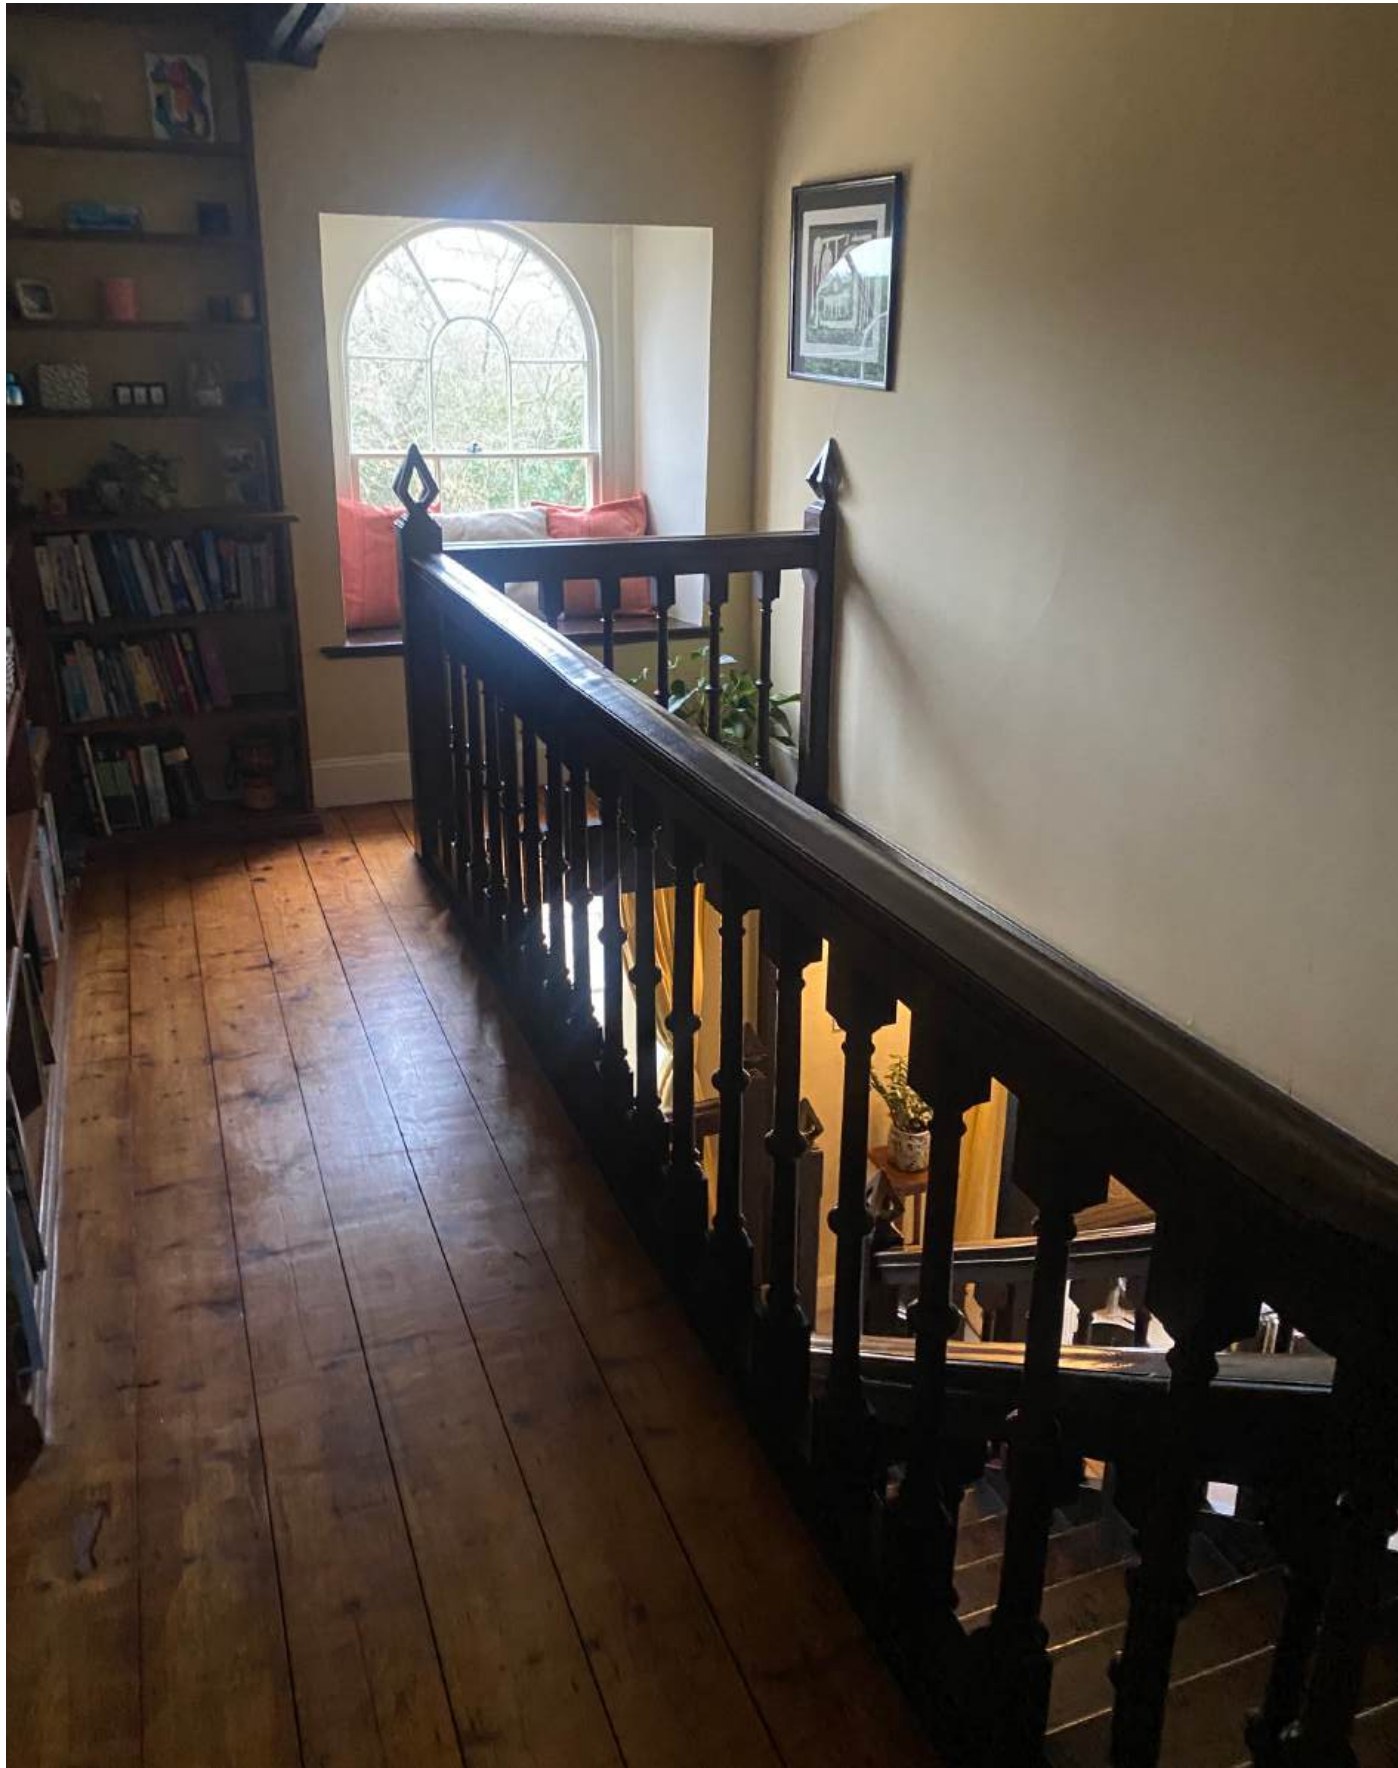
View 3 - Existing arts and craft staircase - For proposed renovation / repositioning

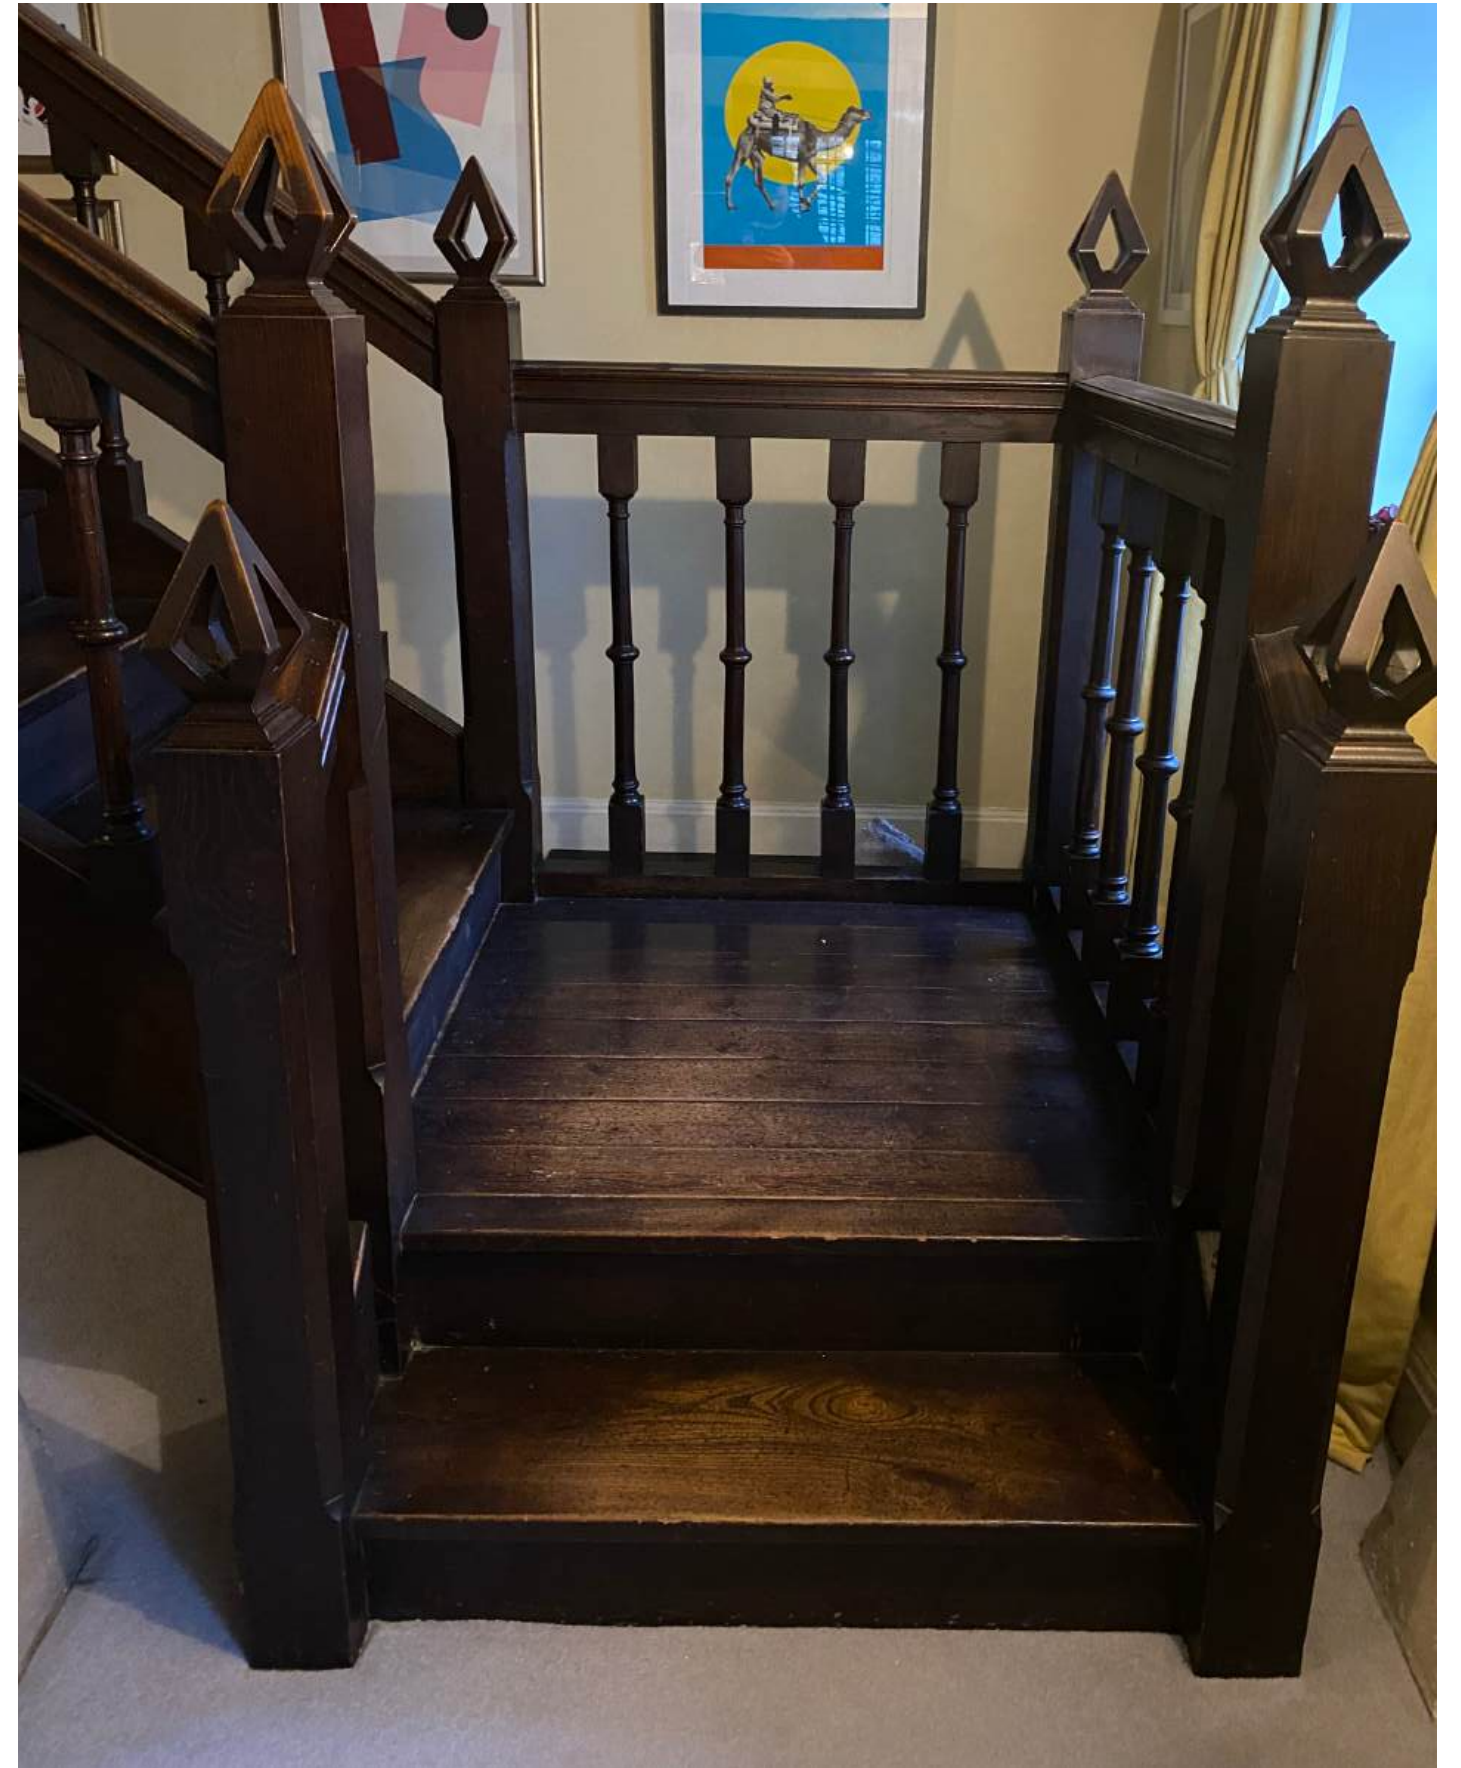
View 4 - Existing arts and craft staircase - For proposed renovation / repositioning

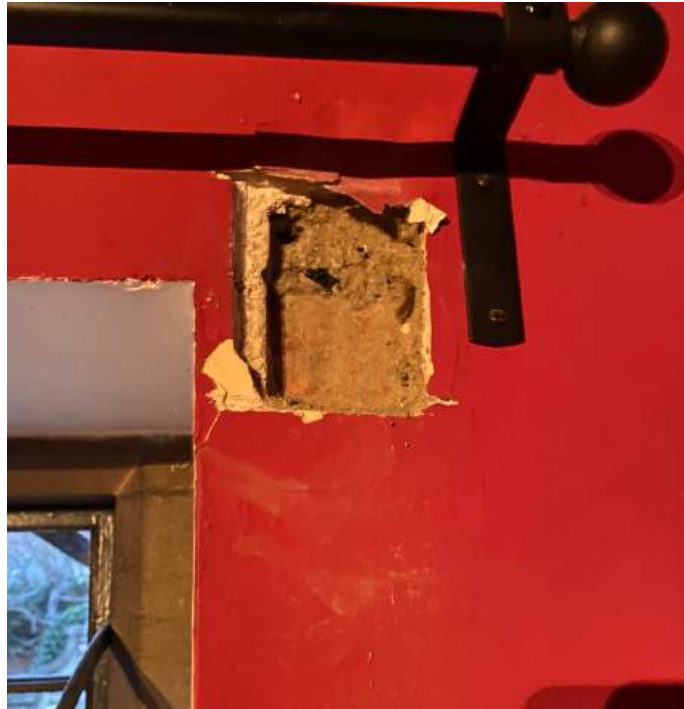
Confirmation of brick inner leaf with precast concrete lintel above proposed sliding doors

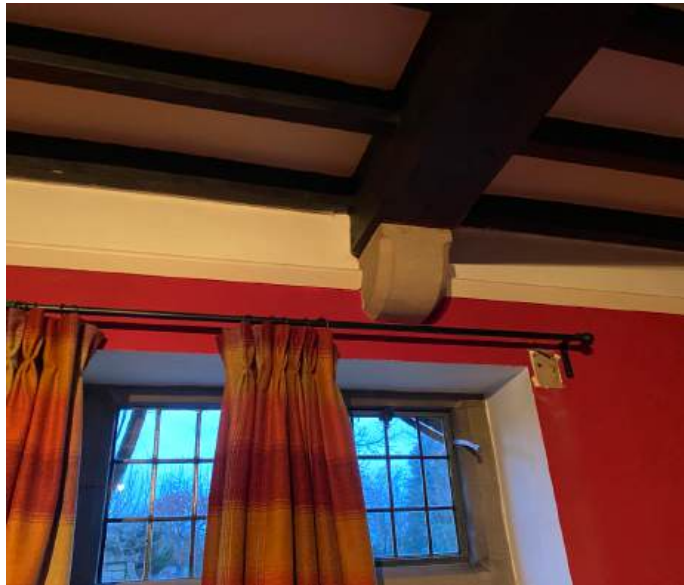
Image locating inspection hole adjacent to window for removal / sliding doors installation

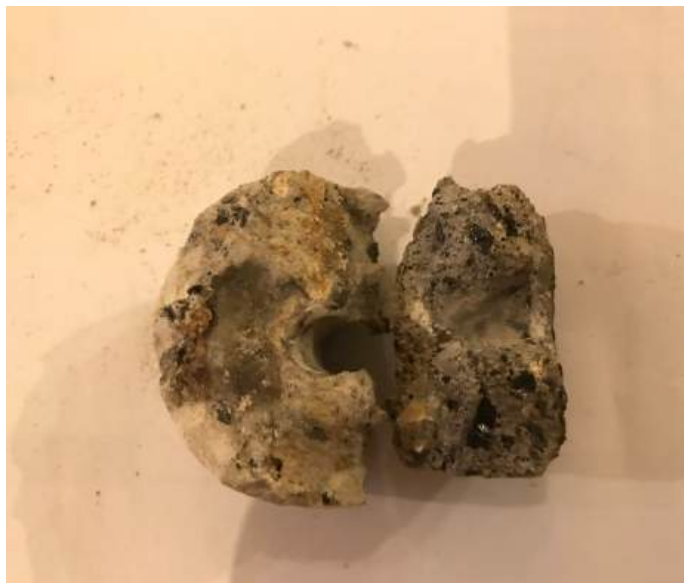
Core sample from R001 - Concrete slab in R001 to be removed and replaced with limecrete construction

Works will involve the replacement of the existing, more modern ground floor construction in R001 / R006 / R007. It is intended that the existing floor constructions be replaced with a breathable limecrete flooring solution as identified (Mike Wye system), that will improve the thermal performance of the dwelling but in a sensitive manner. The new floor areas will include low temperature Underfloor Heating which will be more comfortable and beneficial for the fabric of the house ( more stable temperature).

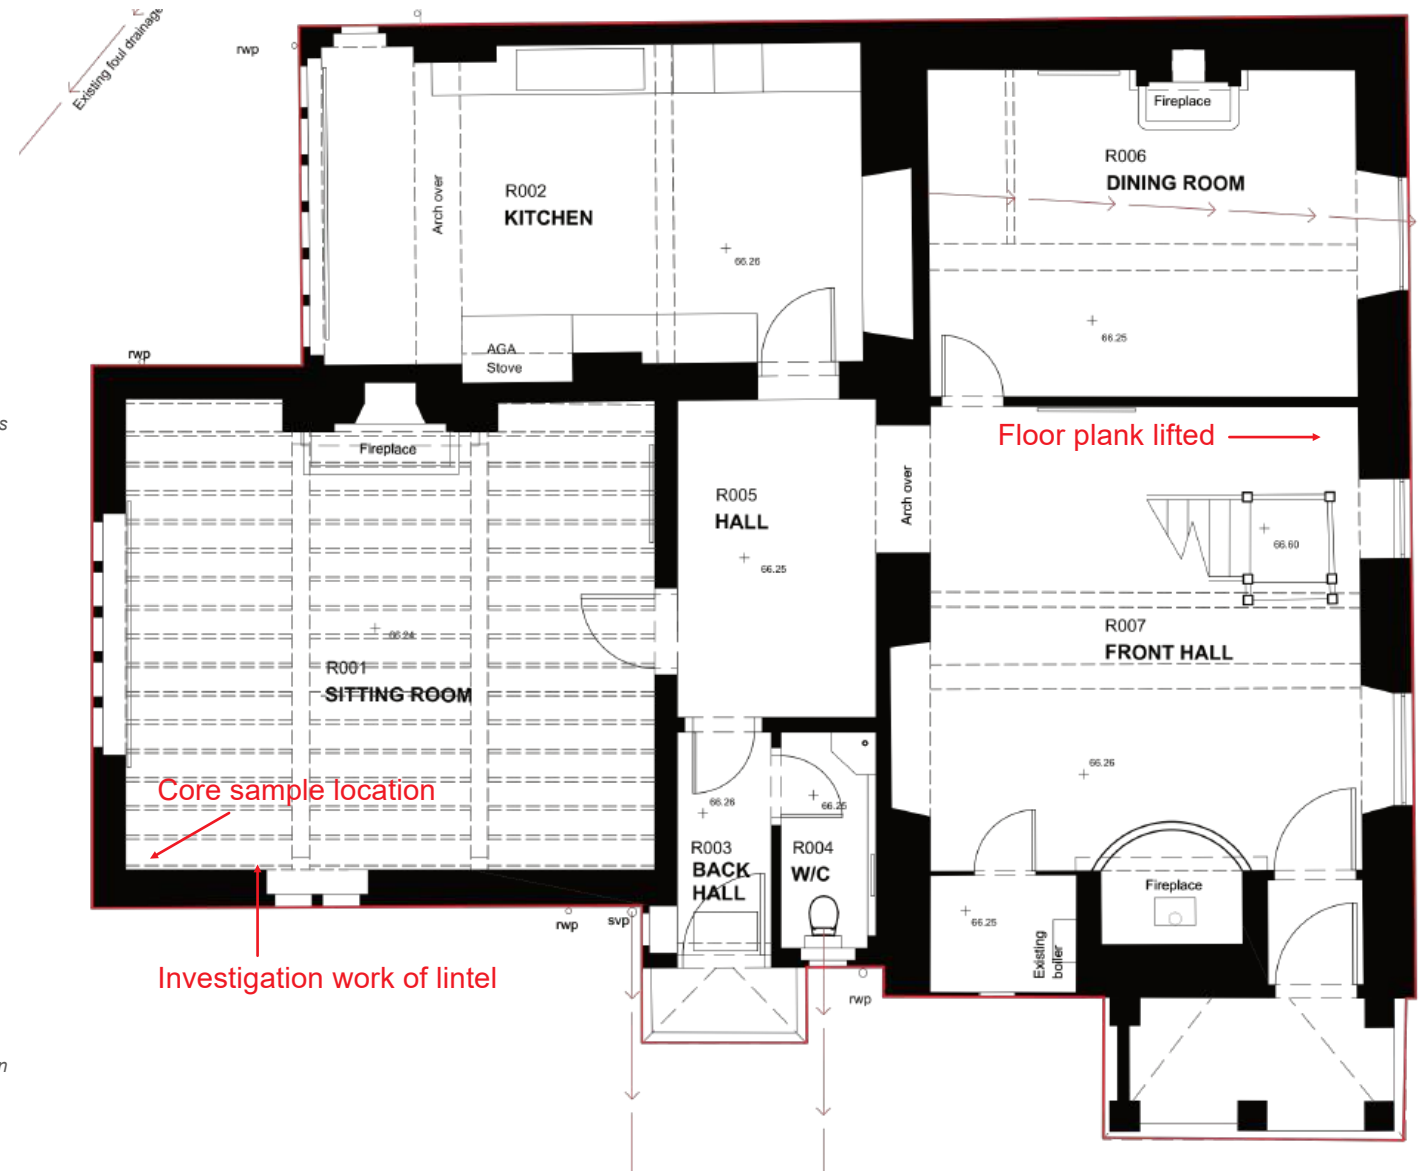
Existing ground floor survey - Indicating core holes / Investigations

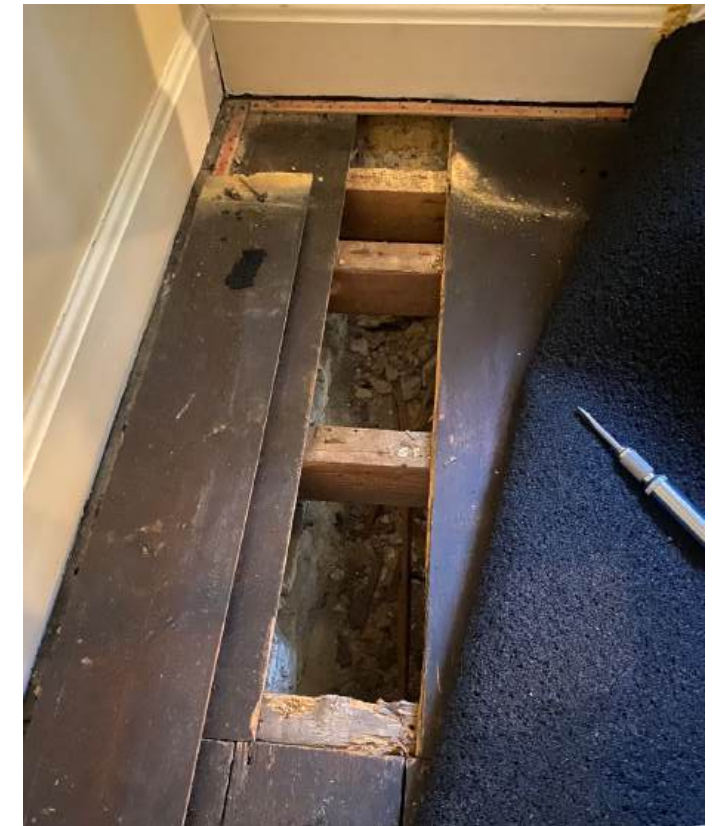
Floor planks lifted in R007 - Floor construction to be replaced with Limecrete construction.

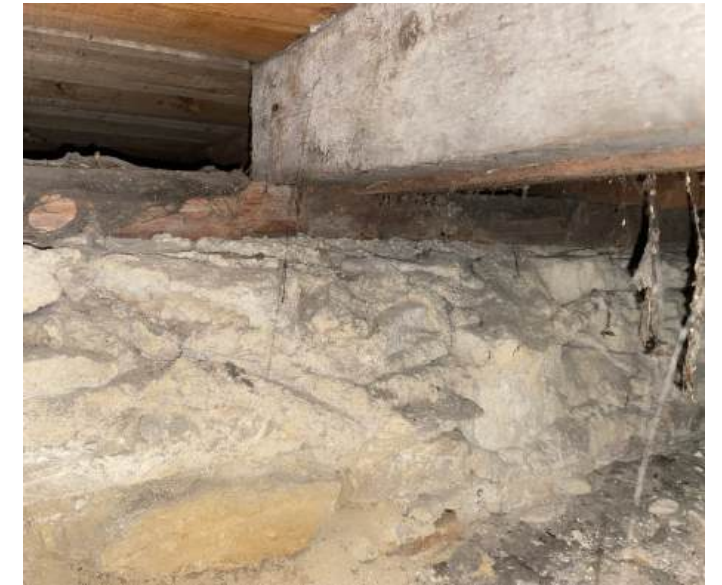
Soft wood floor joists supporting suspended floor in R006 / R007 supported on sleeper walls

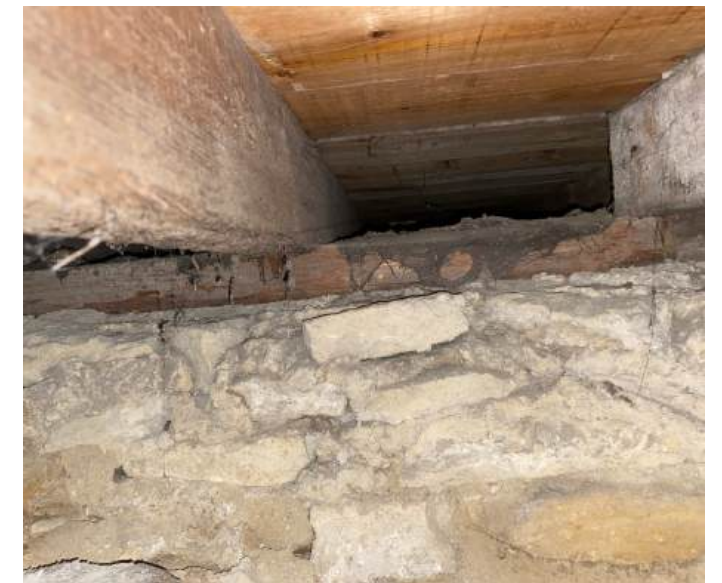
Sleeper wall for supporting floor joist spans R006 / R007
