# Arboricultural Impact Assessment

Uplands, West Ashton Road,  
Trowbridge

| Report Reference | 3183-AIA-MU |

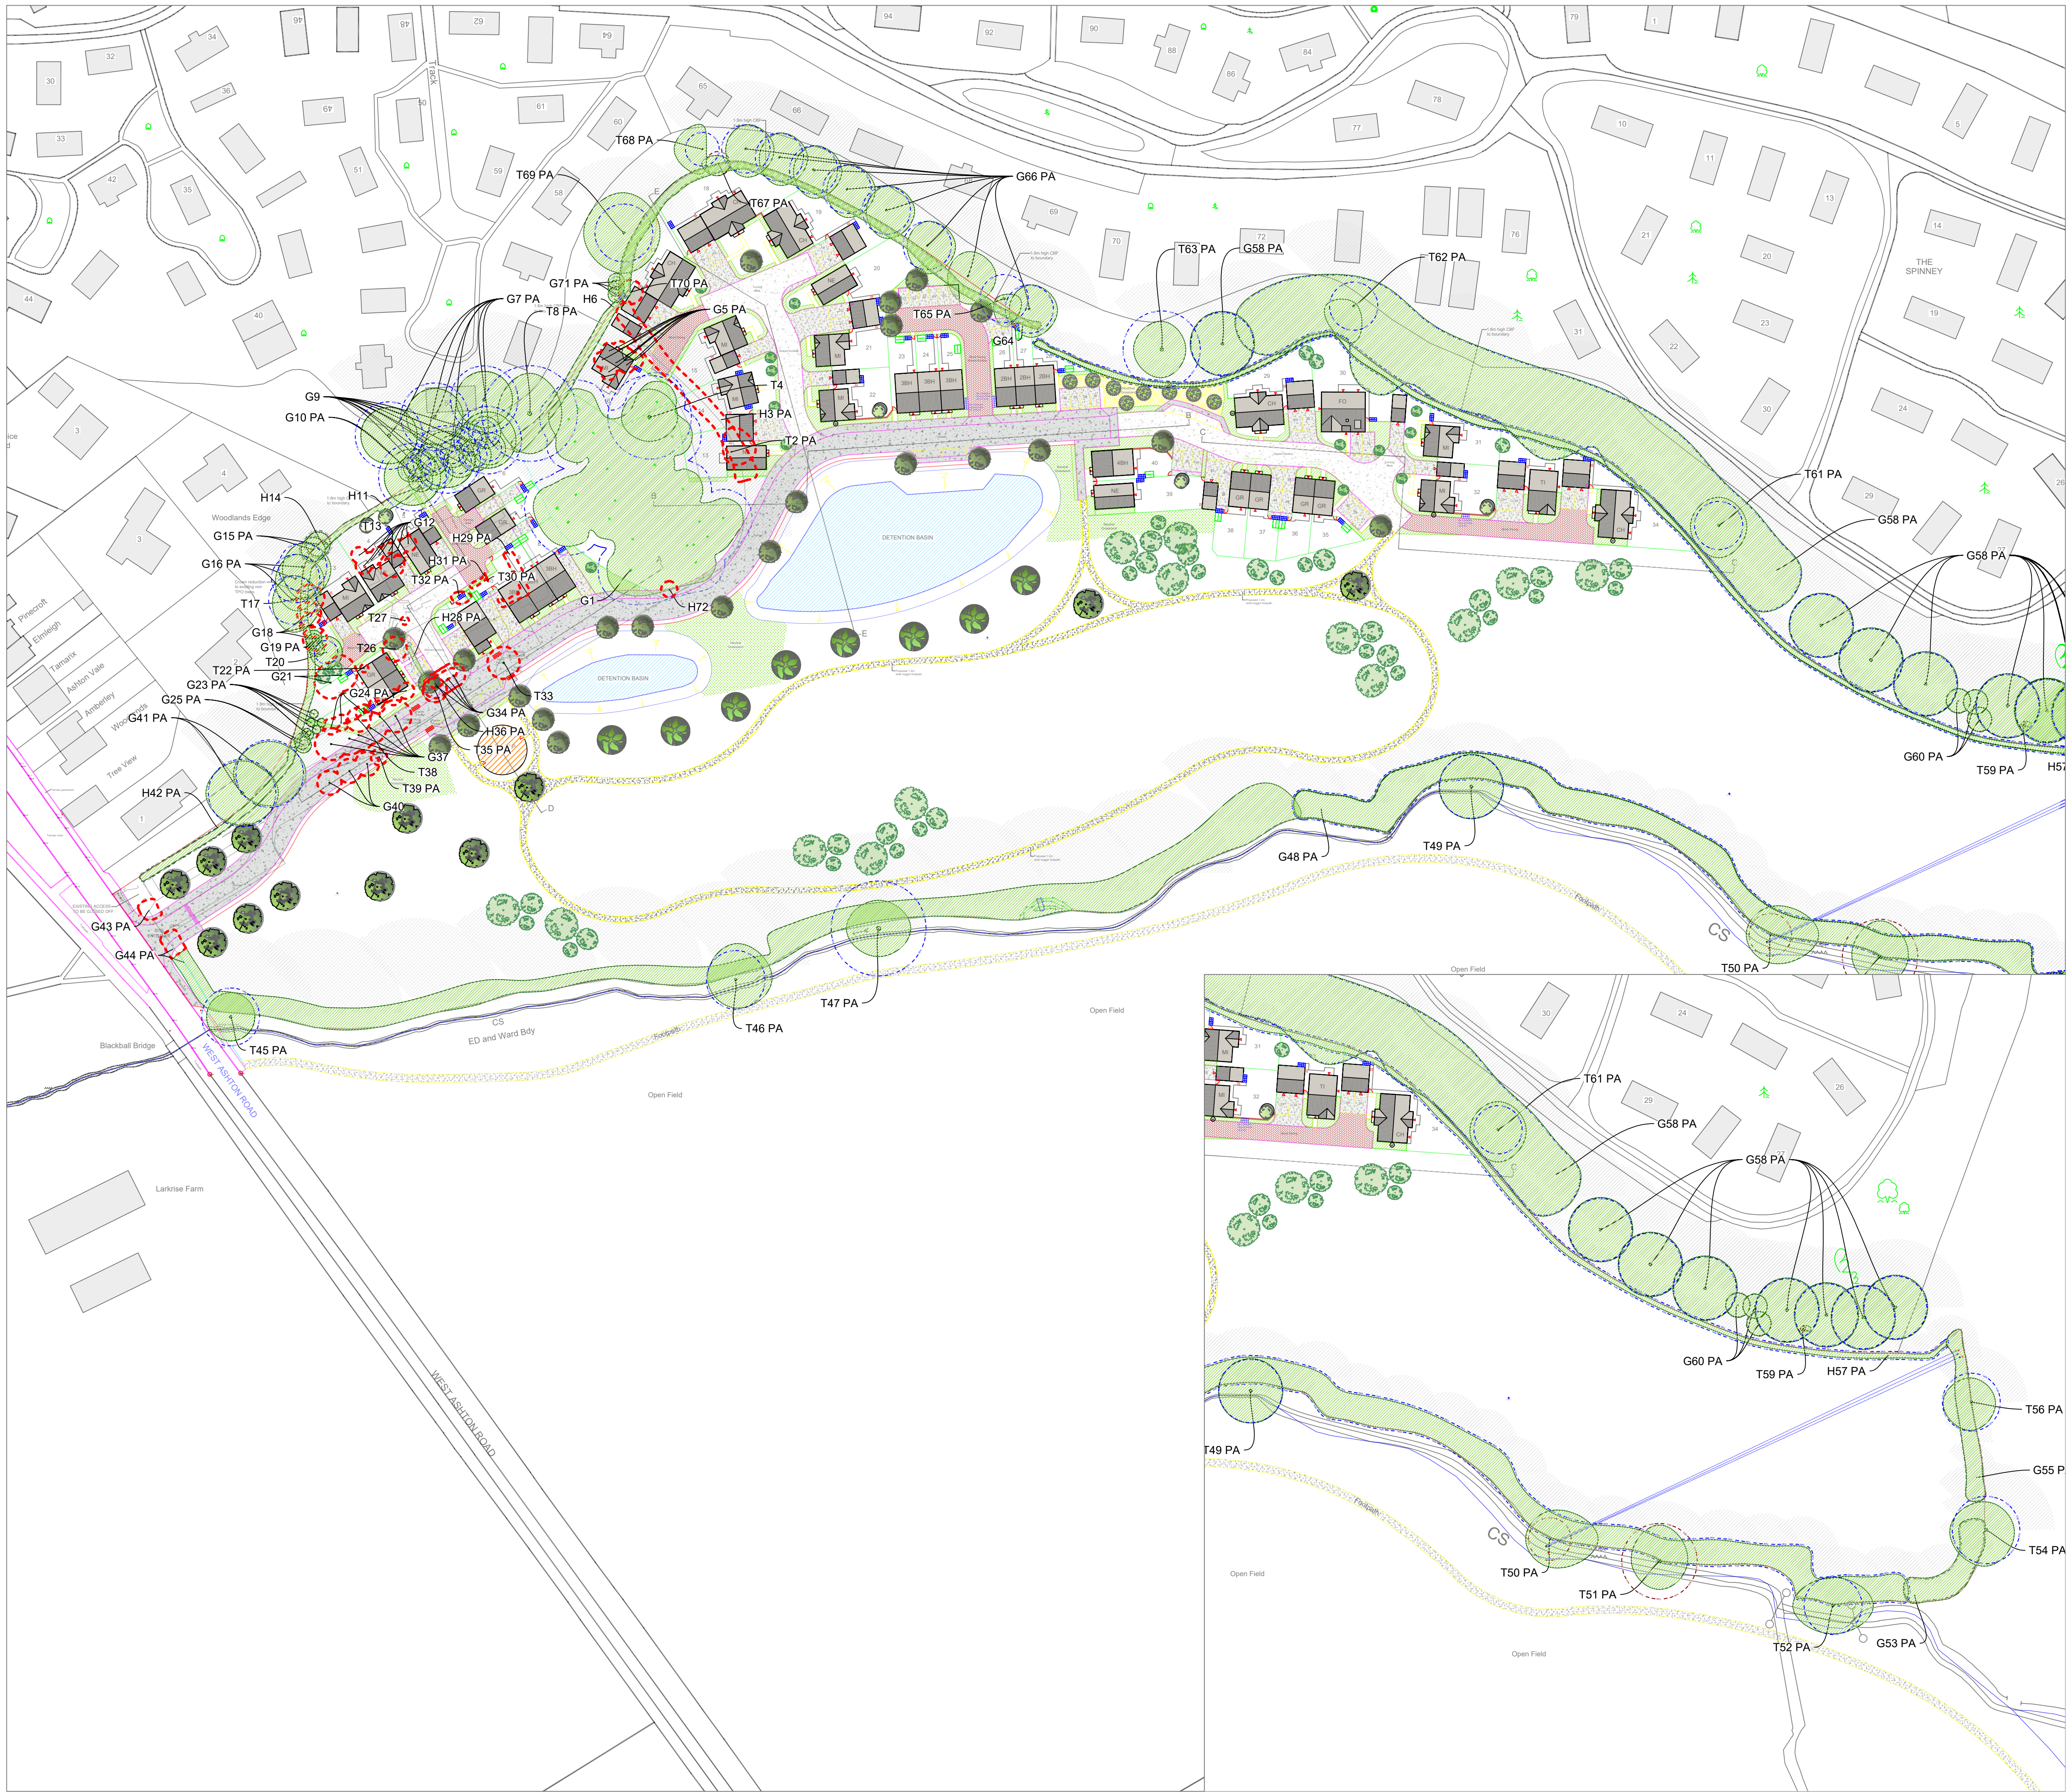
**Drawing Number:**  
3183-TRP-MU

Key:

Trees To Be Retained
