**Eastfield House, Plough Lane,  
Marston, Wiltshire, SN10 5SR**

**A Historic Buildings Statement**

**WBR No. B764**

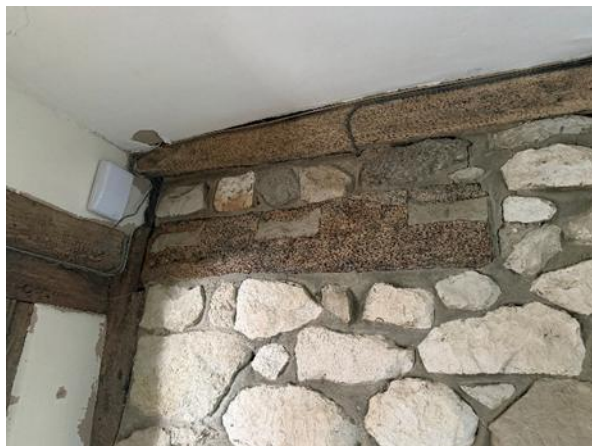
**Fig.10** Embedded beam with joist pockets

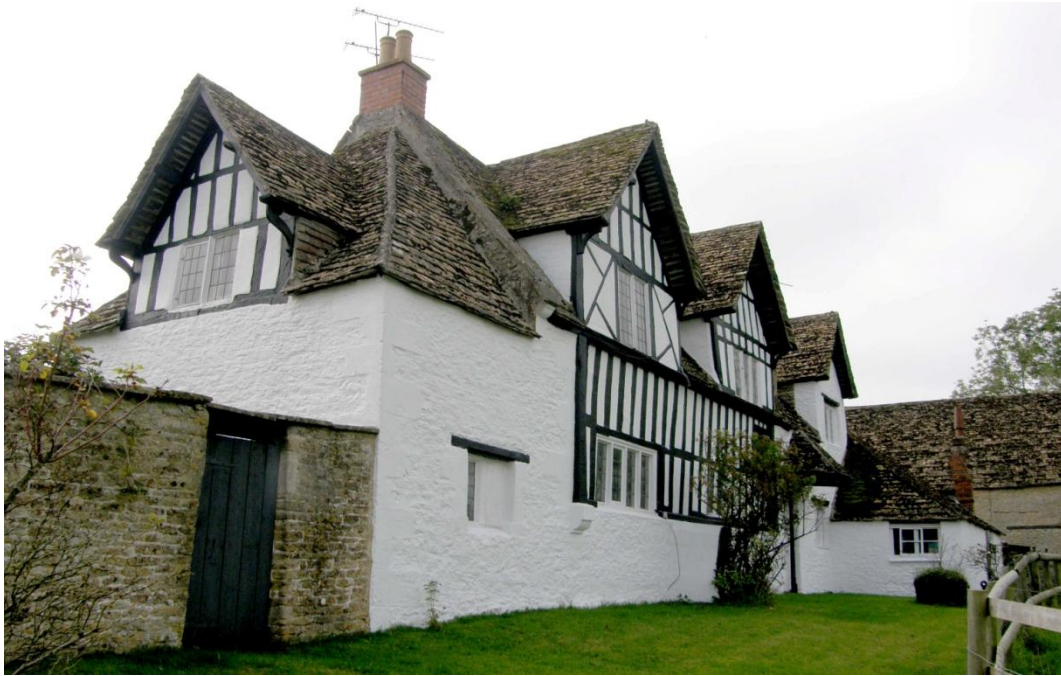
***Fig.11 Catridge Farm, Lacock; a later 16<sup>th</sup> century farmhouse and semi-basement dairy (in foreground). This yeoman farmhouse also has timber-framing built off a high plinth. Wiltshire Buildings Record has recorded numerous such examples, including farmhouses and cottages in the Devizes area***

The hall was remodelled at this time, and the distinctive timber-framed crosswing built, possibly at the start of John George's long lease in 1637. In the West Wilts and Kennet area there was a fashion in the 17<sup>th</sup> century for stone ground floors and timber-framing above, or even high stone plinths. Wiltshire Buildings Record has recorded numerous examples of this type of construction including at Catridge Farm, Lacock, dating to the later 16<sup>th</sup> century (**fig.11**), Kytes Cottage, Market Lavington, dating to the 17<sup>th</sup> century (**fig.12**), and Tudor House, Warminster, dated to 1651 (**fig.13**). Devizes has other examples of this construction including 20 Long Street, Devizes (**fig.14**). Some of these examples have been adapted to this construction.

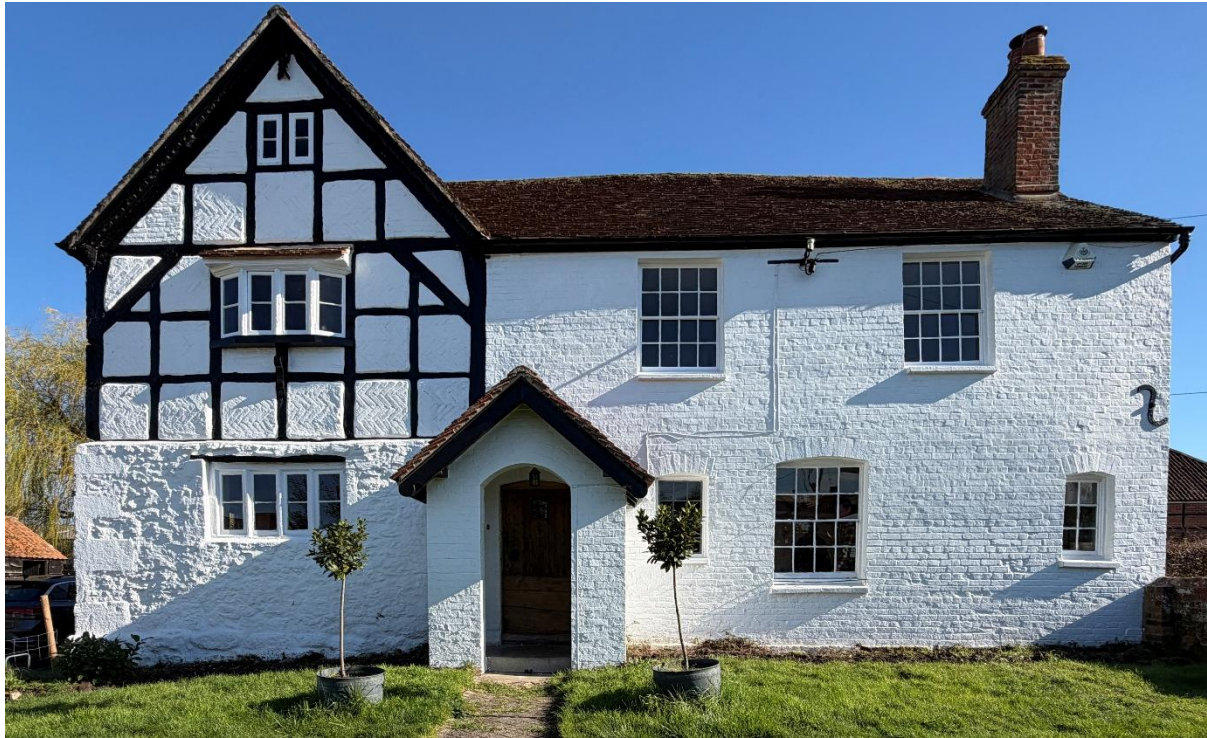
**Fig.18 Front (north-west) elevation**

The current appearance of the front elevation is the result of a range running forward on the right-hand side that was removed between 1839 and 1886<sup>17</sup> (**fig.18**). This range was less than half the width of the present front, so it is likely that the whole timber-framing of the hall range to the right of the timber-framed cross-wing was taken down and rebuilt in brick.

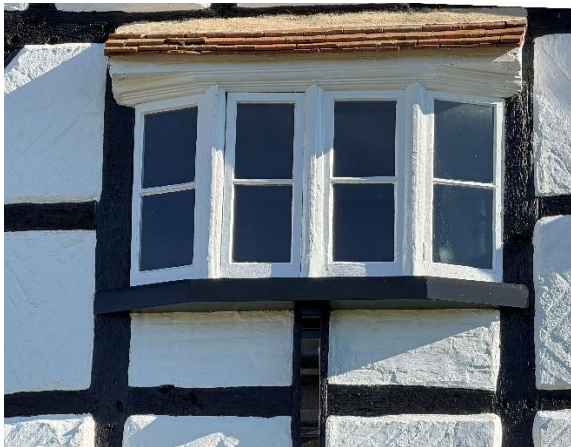
**Fig.19 First floor oriel window**

Above the plinth is timber-framing with panels less than 1 metre square – a typical size for the 17<sup>th</sup> century, as are the straight angle braces. The timber is probably oak. Panel infill is herringbone brick, replacing wattle and daub. The oriel window is likewise of 4 lights with a double ovolo cornice, typically noted as occurring between 1560 and the earlier 17<sup>th</sup> century. Over the window is a small pent roof with clay tiles (**fig.19**).

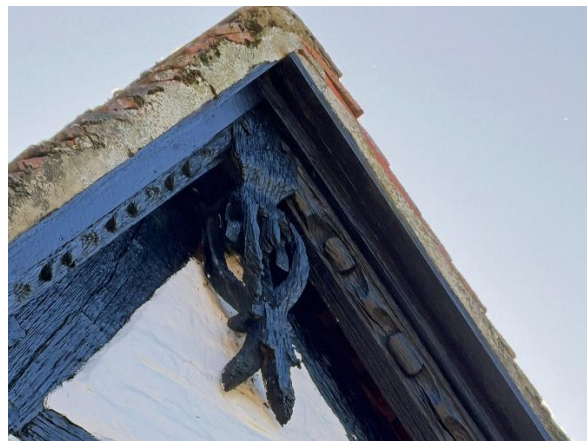
**Fig.20 Open pendant at apex of gable**

The cross-wing roof has good barge boards with a classically-inspired egg-and-dart bands of decoration, with an open pomegranate/heart pendant and leaf-shaped drop beneath – a high-quality detail (**fig.20**).

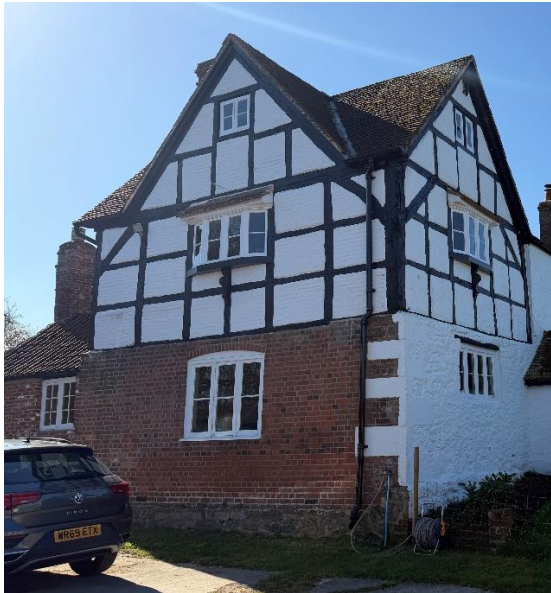
***Fig.21 North-east gable end***

The **north-east return** is in English bond brickwork rising from a low stone plinth, a replacement of the mid-19<sup>th</sup> century. The darker brickwork between the quoins is said to replace rotten stonework (**fig.21**). Segmental-arched ground floor window typical of the 19<sup>th</sup> century. This now contains replacement casements.

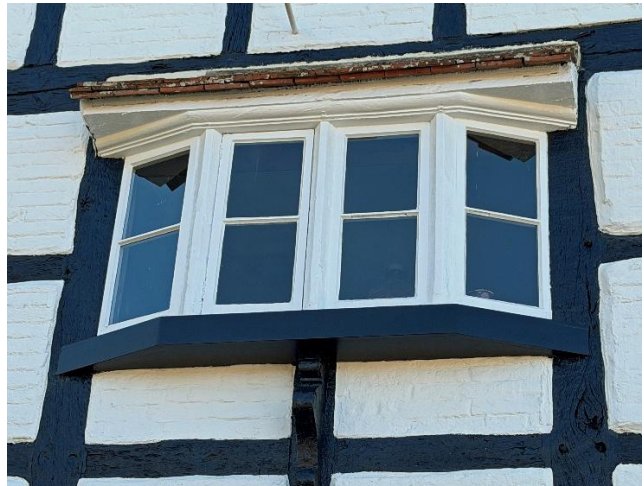
***Fig.22 Oriel window with decorative bracket***

At first floor the timber-framing is very similar to the front of the cross-wing with a similar oriel window that is simpler in design to the main north-west front. There is no decorative pendant here.

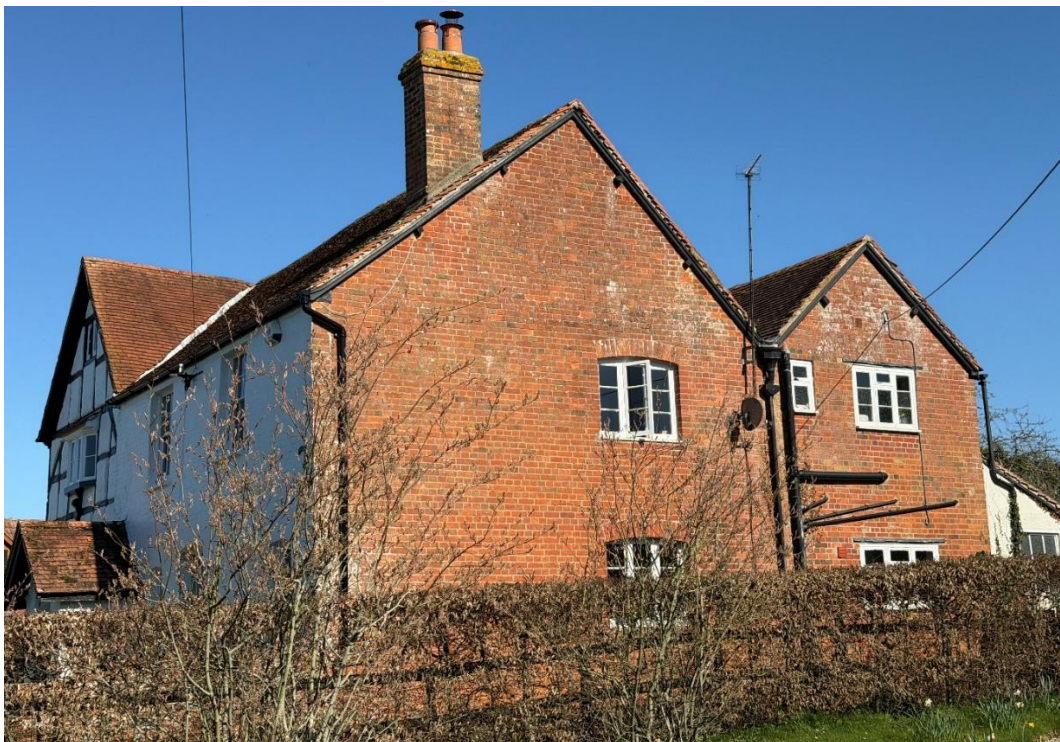
***Fig.23 South-west elevation***

The main south-west gable is of English bond brickwork with Edwardian verges to the roof and narrow purlin ends projecting through (**fig.23**). The 3-light windows at ground and first floor both have segmental arches over, as at the front, though the first floor window is shorter. The ground floor window is a modern replacement. Old metal hopper with plastic downpipe at valley.

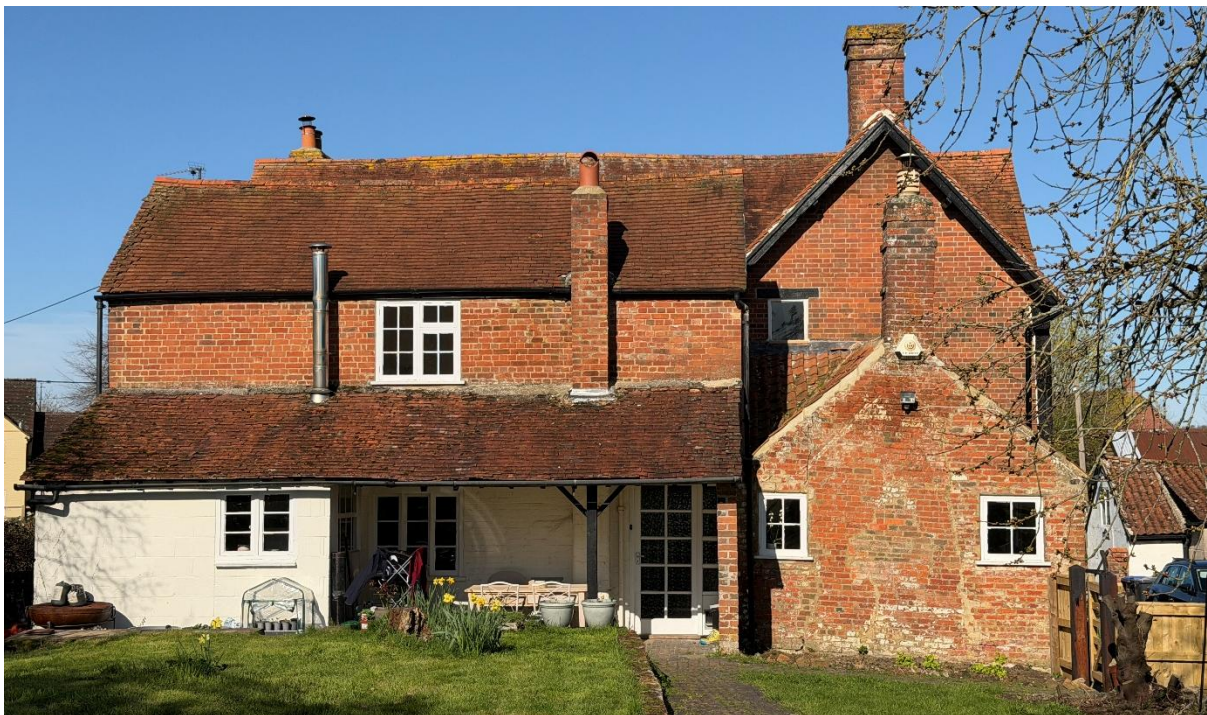
***Fig.24 Rear south-east elevations***

Constructed of English bond, with some Flemish garden wall bond brickwork, all likely dating from the mid-19<sup>th</sup> century remodelling of the house (**fig.24**). The parallel range comprising the present kitchen and linking passage to the brewhouse is of English bond brickwork, with a clay tiled roof.

Narrow exterior brick flue with access point for hearth in use when the kitchen was a dairy. 2-light window to the former cheese loft above. The open-fronted lean-to pentice roof was in specific dairying use where raw milk was left out of the sun to be processed in the dairy. The roof was supported on posts and padstones with up braces, of which only one post is left. The left-hand part is now built up in concrete block to form a WC off the kitchen in the earlier 20<sup>th</sup> century. It had an exterior access previously, now blocked.

To the right of the back entrance was a single-storey back kitchen used as a bake or brew house for the farm. This is constructed in English garden wall bond, the brickwork much cracked and patched. The two gable windows appear to be modern insertions with fixed timber casements. Rainwater goods and drain of c1900.

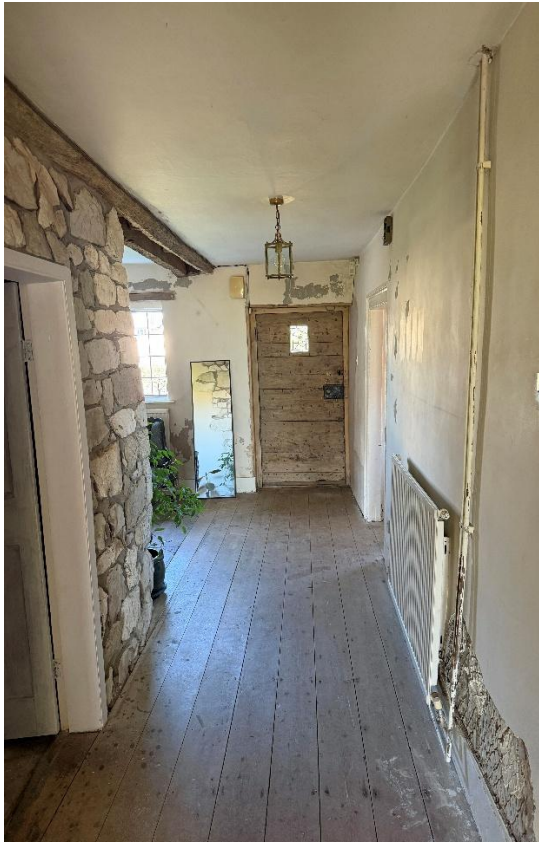
**Fig.25 Entrance hall looking north-west to front door**

Apart from the timber-framed rear wall containing a pegged doorframe using a mason's mitre between the lintel and jambs (**fig.30**), the **walls** are relatively featureless; a plastered stud partition to the dining room (G2). It is possible that this partition is based on the primary build. The entrance door is 4-panel with a moulded architrave surround. At the back of the hall the back of the chalkstone stack projects into the passage. It is unplastered with a modern opening into what was the rear wall of the fireplace. Of interest is an embedded timber near the ceiling at the back end of the stonework (**fig.29**). It is of some age and shows horizontal pockets for flat-laid joists. It appears to be morticed into a post partly embedded in the wall and so may be primary to the medieval phase. The level is lower than the smoke-bay beam above by about 30cm or so, and is likely to relate to a formerly lower ceiling over the passage, perhaps for a sleeping platform.

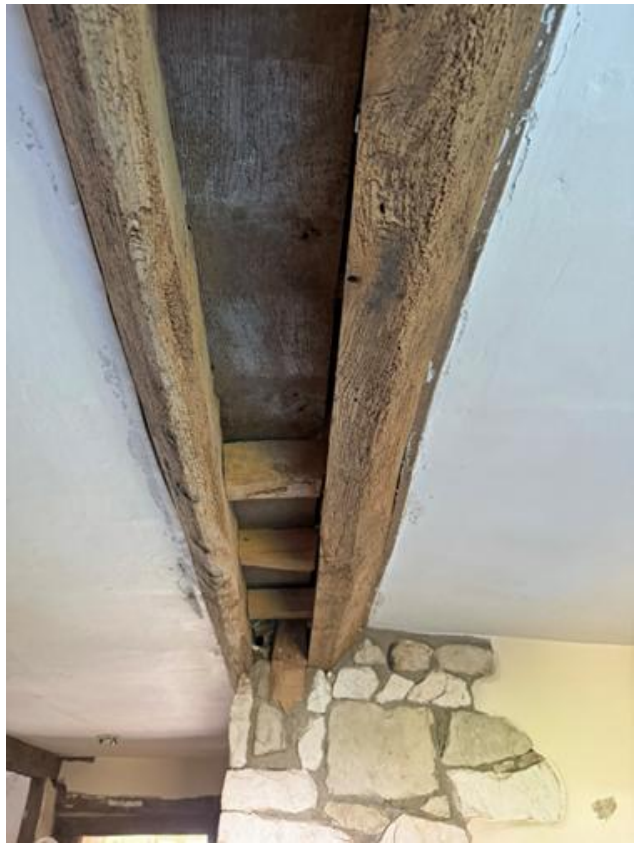
**Fig.26 Double half-beams on line of back of former smoke-bay**

This comprises the through passage and part of the probable smoke bay at the front. The transverse beam seen just inside the front door is made up of two spaced half-beams with wide chamfers which continue the whole width of the primary build encompassing and partly buried in the stone stack (**fig.26**). These are on a line of a former suggested smoke bay. The configuration is unusual but must relate to the smoke bay structure which spanned the width of the house. Chamfers on each side of the half-beams mean that they straddled a partition. It is possible that these were header beams to a timber-framed partition below, though there are no corresponding peg-holes visible to secure one. Differences in the floor on either side of the half-beams are visible which confirm that the partition continued in this position.

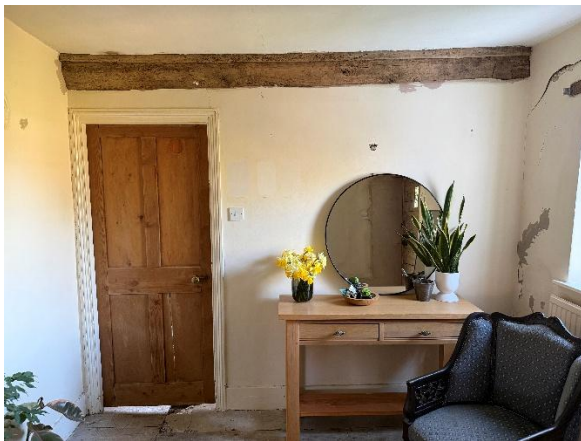
**Fig.27 Modern partition to living room (G9). The visible beam butted against the former suggested smoke bay**

To the right of the front door, a further beam is visible at the modern partition to the living room (G9). This is part of the compartmental ceiling of c1600 (**fig.27**).

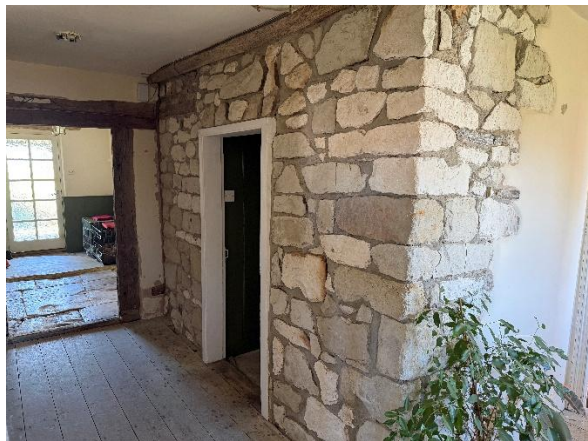
**Fig.28 Back of chalkstone stack now projecting into the through passage**

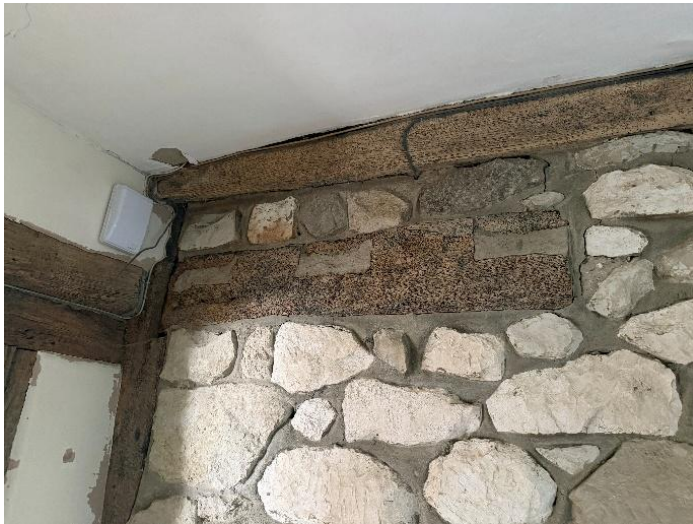
**Fig.29** Short length of beam with 3 joist pockets in situ, now embedded within the stonework of a later fireplace

The **floorboards** in the through passage are of narrow softwood boards, likely to be 19<sup>th</sup> century in date and are approximately 17cm in width (**fig.29**). There are older, wider elm boards in front of the stone stack, with softwood patches.

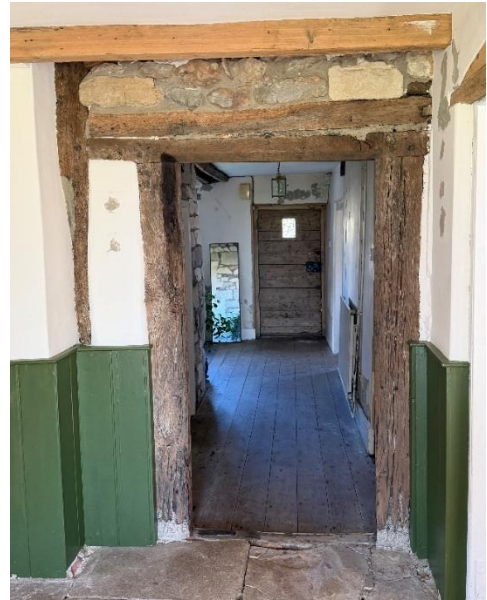
**Fig.30** Tenoned, pegged and chamfered frame to back doorway

The base of the jambs of the back doorway are much deteriorated, but would have had moulded stops to the chamfers (**fig.30**).

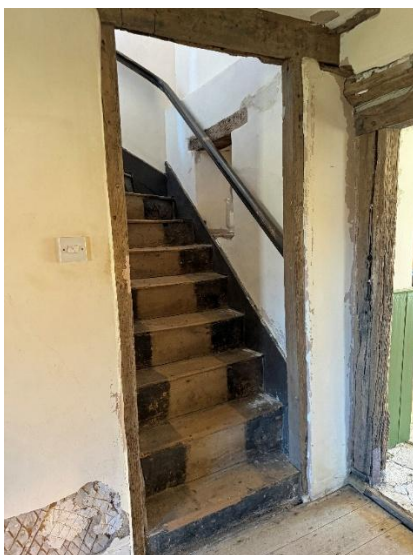
**Fig.31** 18<sup>th</sup> century stair

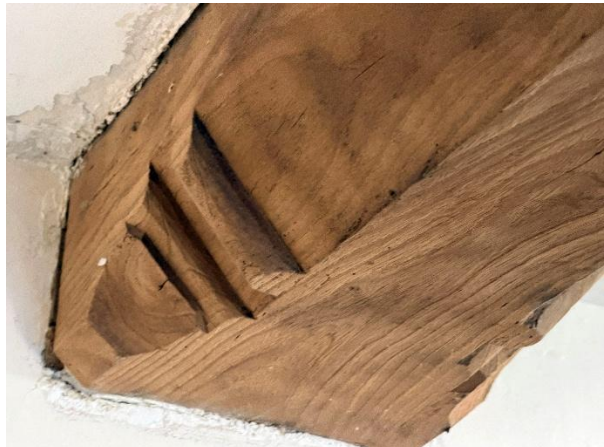
**Fig.34 Double roll and concave stop**

The room to the left of the front door. This has a substantial ceiling of two **chamfered beams** with double roll/3-sided geometric concave stops (**fig.34**). This clearly marks the room as a high status parlour. The **walls** are plastered, with a half-height dado of tongue and grooved boards, possibly of the early 20<sup>th</sup> century.

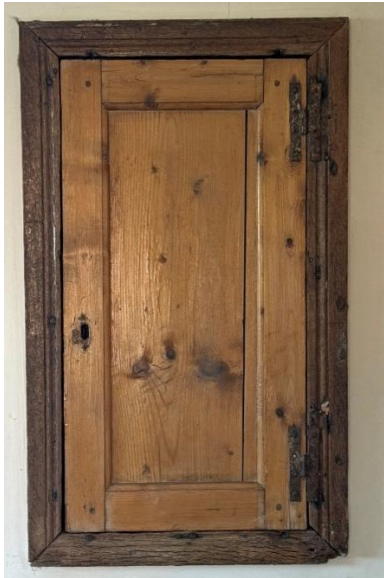
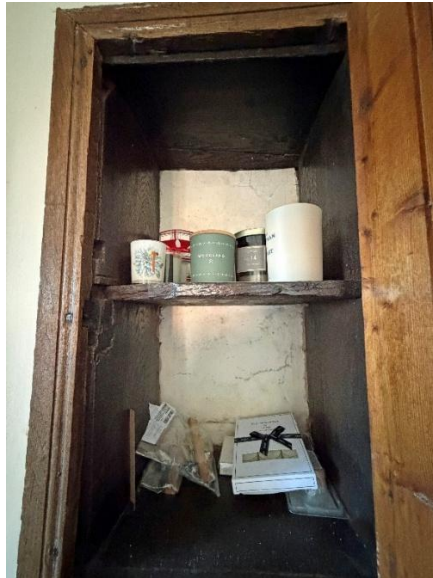
***Figs.35 & 36 Wall cupboard in north-east wall***

In the north-east wall between the window and the back of the room is a small **cupboard** in the thickness of the wall. The door is set on small H hinges, and lined with planks (**figs.35 & 36**) and dates to the mid-19<sup>th</sup> century refurbishment, with a door of that date.

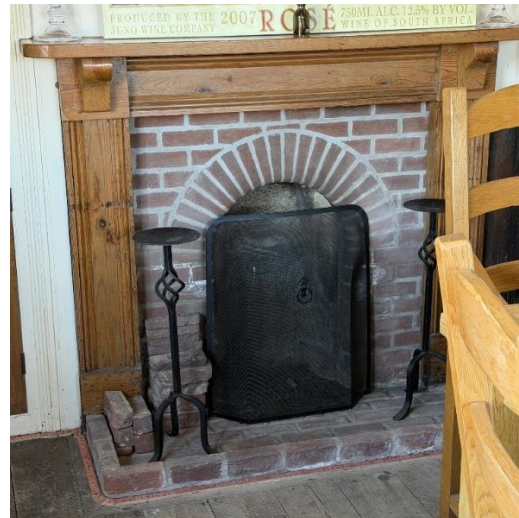
***Fig.38 Fireplace***

The **floor** is of 7" softwood boards, black-painted around the edges – a practice typical in the later 19<sup>th</sup> century and early 20<sup>th</sup> century. The room has 4-panel **doors**, also typical of the 19<sup>th</sup> century. One door opens into a cramped understair cupboard to the right of the fireplace (**fig.37**). The fireplace and fitted cupboards on either side appear to date to c1900. The fireplace is constructed of small bricks with a semi-circular arch, softwood chimneypiece with plain shelf on brackets and brick kerb (**fig.38**).

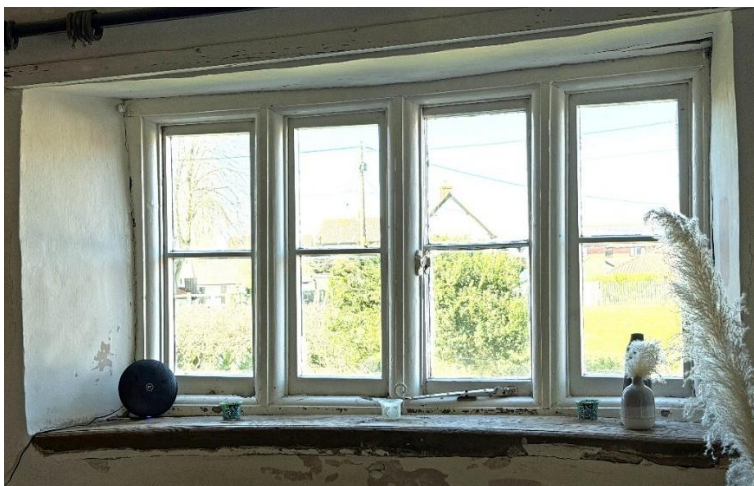
***Fig.39 4-light ovolo-moulded mullioned window***

The **window** to the front elevation has a tall ovolo-moulded frame with 20<sup>th</sup> century casements. Old sill with an ovolo-moulded edge. A well-preserved primary feature. The window to the gable end is a tall 3-light timber 20<sup>th</sup> century replacement.

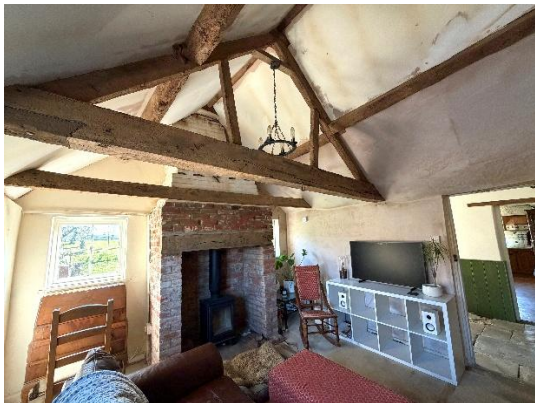
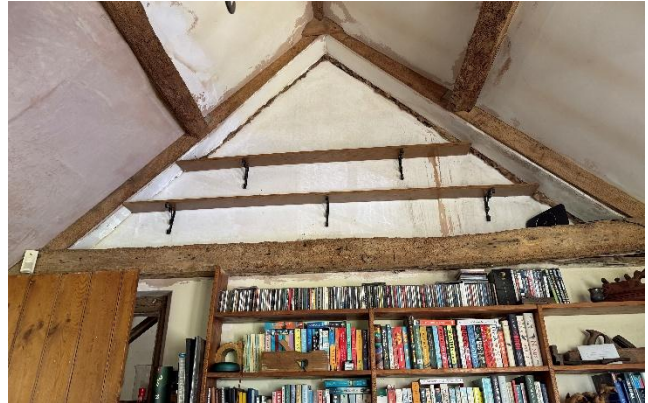
**Fig.40 Study (G3) looking towards the hearth** **Fig.41 North-west end truss**

Built as a 2-bay back kitchen onto the main range probably between 1835-1839. It was used as a brew- and bake-house serving the farm. The room is still open to the top of the **roof**, which is divided by a single elm truss with pegged joints and raking struts (**fig.40**). The apex is butt-jointed with a thick yoke plate and a diamond-set ridge purlin. There is one row of staggered butt purlins with tusk tenons (**fig.42**). There is a secondary tie behind the hearth to stabilise the patched brickwork as a brick corbel now supports the north-east end of the central truss, which has evidently moved over time (**fig.43**).

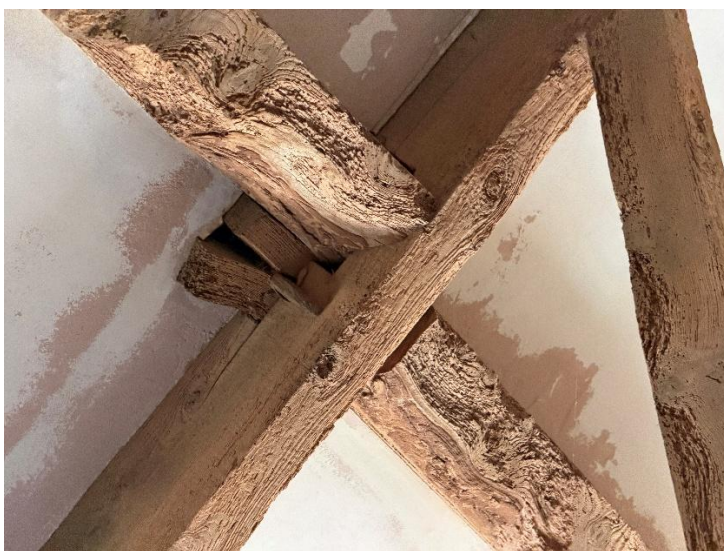
**Fig.42 Staggered butt purlins with tusk tenons**

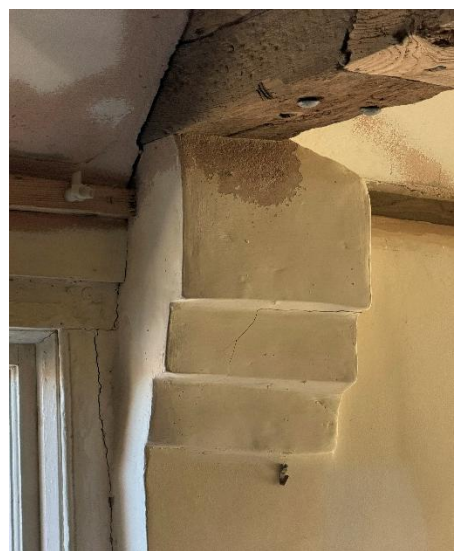
**Fig.43 Brick corbel**

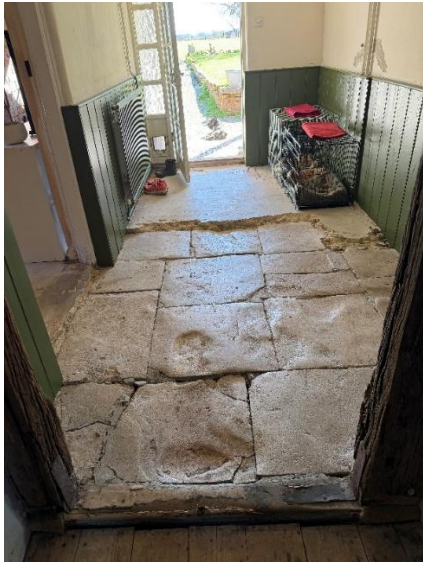
**Fig.44 Partially-uncovered flags**

Linking the Study (G3) with the present kitchen (G7). Flagstones were discovered under the concrete screed, still partially concealed (**fig.44**). The early c1900 planked dado continues here. Modern glazed back door and sidelight. The entrance to the back kitchen has a segmental brick head infilled with timber (**fig.45**).

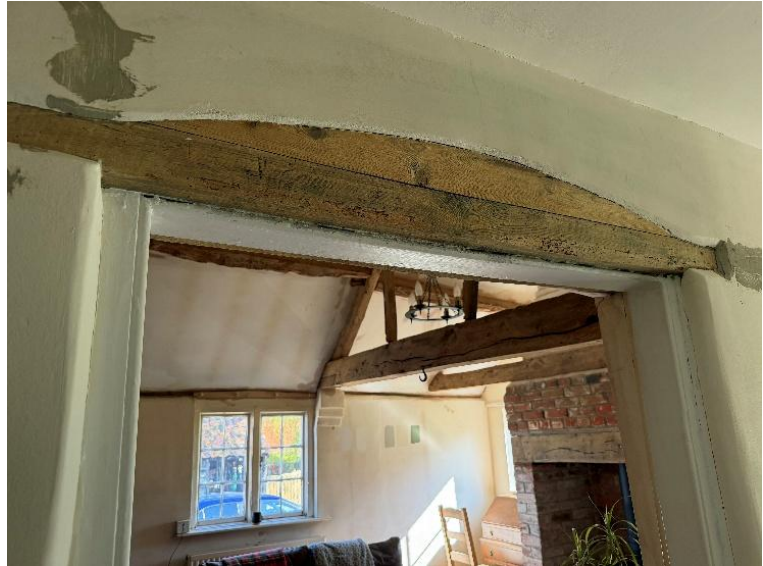
**Fig.45 Segmental head to back kitchen entrance**

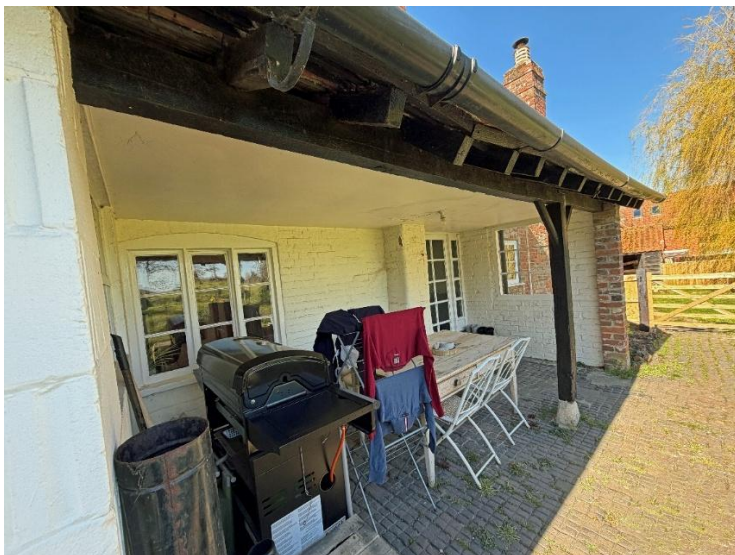
**Fig.46 Dairy pentice from the south**

This area was used to bring raw milk undercover from the sun before it was processed in the dairy. It was once open along its entire length, supported on timber posts resting on padstones. The underside is plastered in, though very likely was open to the top of the roof originally. Walls whitewashed for hygiene. The floor is of blue engineering brick (**fig.46**).

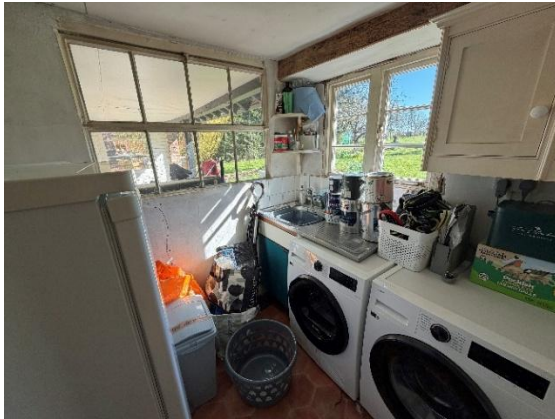
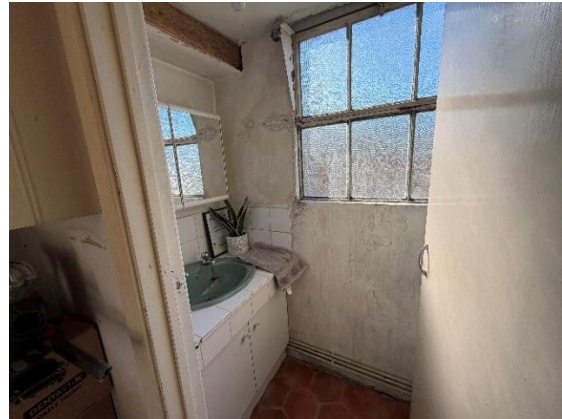
**Figs.47 & 48 Wall plate visible in Utility/WC**

Built in 1981 (absent in the sale particulars of that date). The wall-plate is visible through both rooms (**figs.47 & 48**).

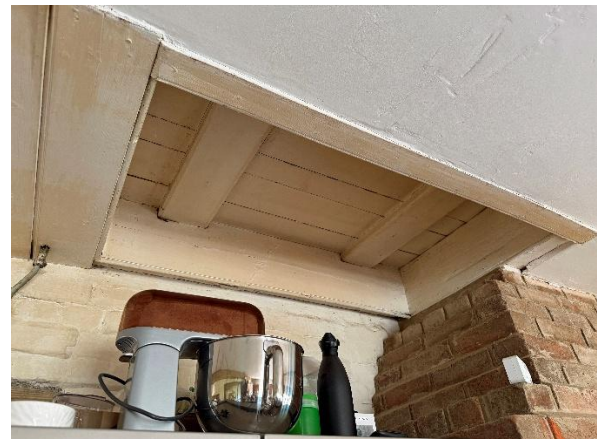
**Fig.50 Cheese loft hatch**

The kitchen was formerly a dairy, as identified by Pam Slocombe in her survey of 1981. Little remains of its former use, which would have contained wooden vats and troughs, excepting a tongue and groove boarded loft hatch in the ceiling specifically to lift cheese from the dairy into the loft (**fig.50**).

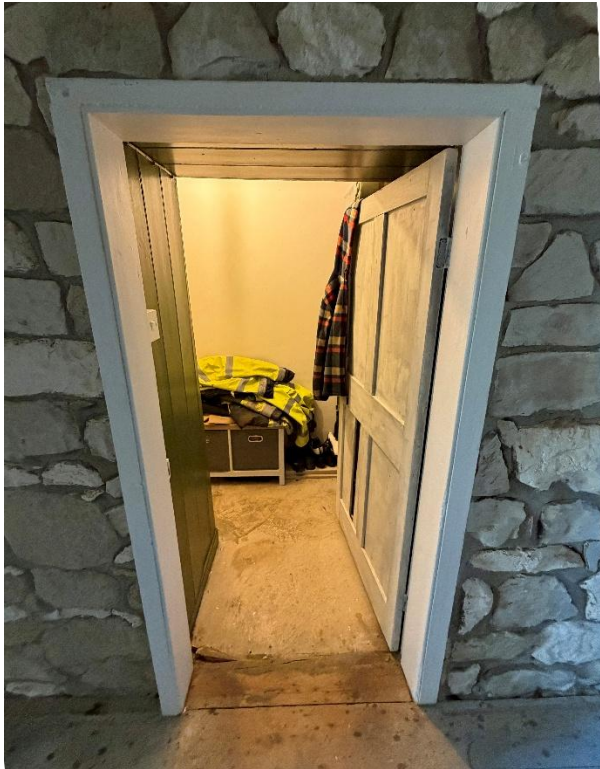
**Fig.51 Entrance to the Store from the through passage (G8)**

Subsequently the hearth was closed off when the division was removed. The back of the hearth was left open as a door into the enclosed space (**fig.51**). The interior is lined with a dado, perhaps of c1900 as in the Dining Room (G2). A timber post is seen in the south corner – possibly pertaining to the primary build, and the high-set lintel for the smoke bay (**fig.52**). Cement **floor**.

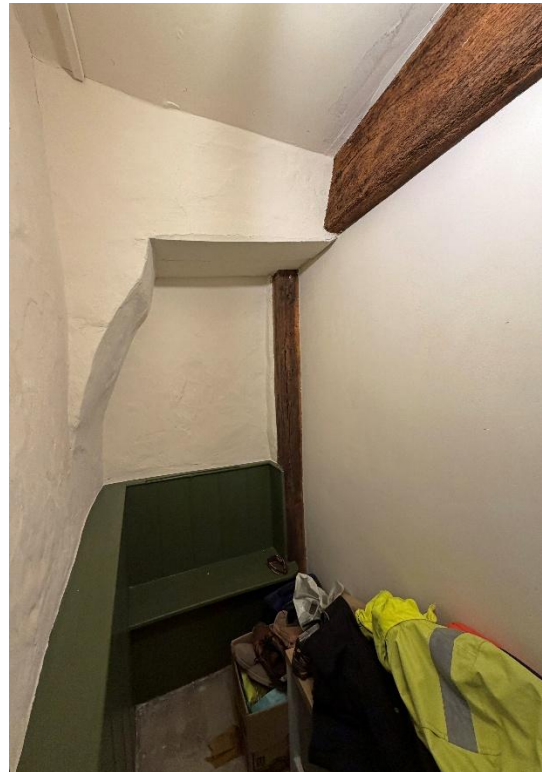
**Fig.52 Interior of the Store looking south-east**

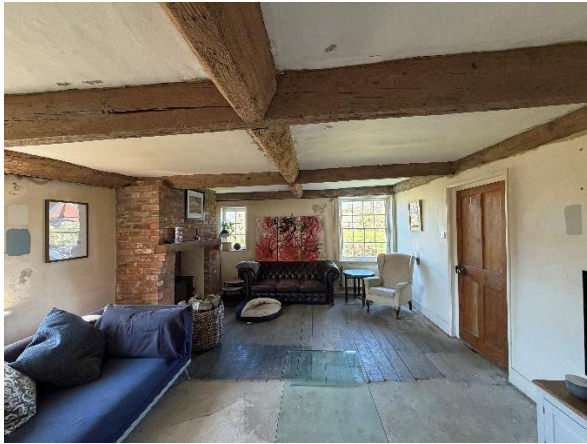
**Fig.53 Lounge looking to front elevation**

The former hall and largest room for the farmhouse, acting as living room/kitchen in the primary build. It has an impressive compartmental **ceiling** made up of two deeply chamfered transverse beams with an intersecting similarly chamfered beam, forming 6 compartments (**figs.53 & 56**). On all sides of the room are half-beams against the wall.

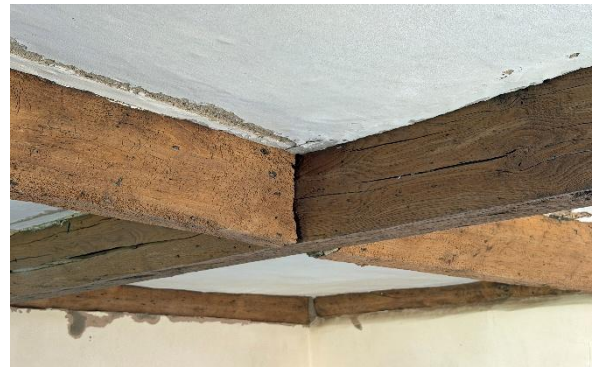
**Fig.54 Nailed junction of beams**

The junctions are plain, and there are no decorative stops as in the Parlour (G2). Some of the junctions are seen to be roughly nailed, rather than morticed and tenoned (**fig.54**)

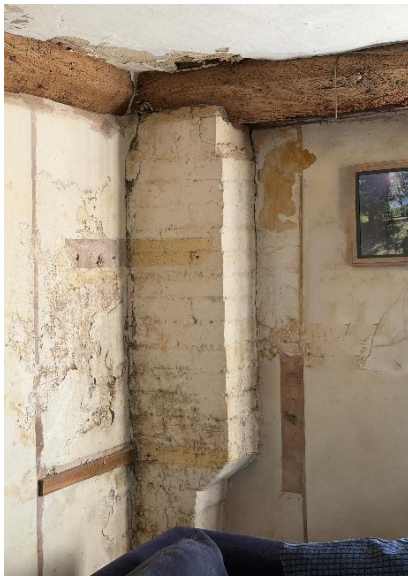
**Fig.55 Brick pier supporting ceiling timbers**

**Walls** are plainly plastered with plain skirtings, supposed to be no earlier than the 20<sup>th</sup> century. In the back west corner the ceiling timbers are supported on a corbelled brick pier, suggesting some movement in the walls subsequent to the alternate rebuildings over the years (**fig.55**). **Floor** of 6" softwood boards to the front half of this room, with black-painted margins. The rest of the floor is solid. **Windows** at the front are historic

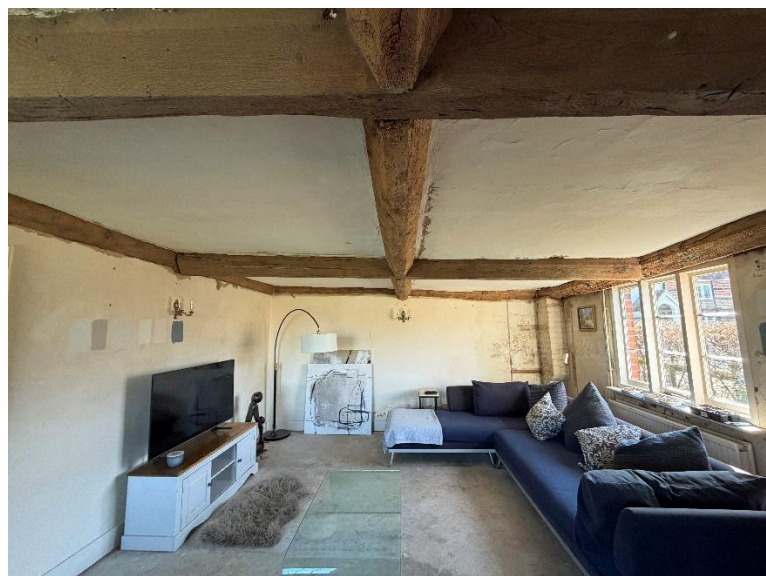
**Fig.56 View to rear of room**

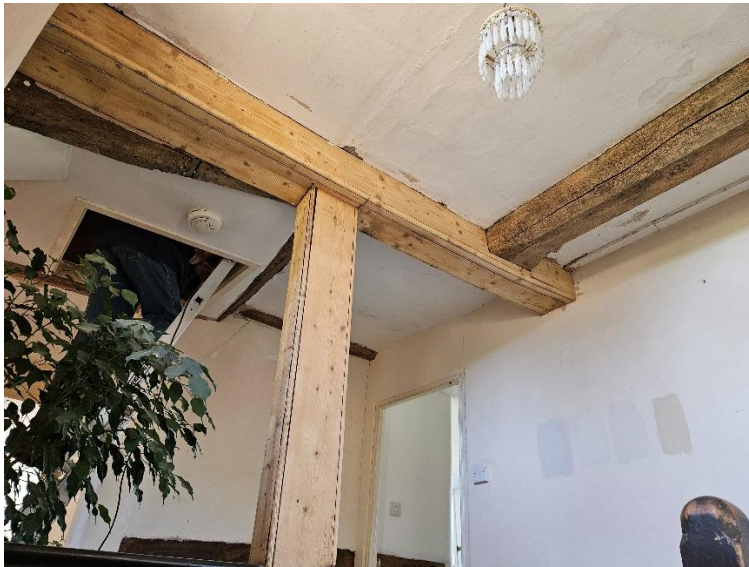
**Fig.57** Looking west; softwood beam at junction of two distinct areas

The landing can be considered two distinct areas, divided by a softwood planked boxed beam (spanning south-east and north-west walls) supported on a softwood planked boxed post (**fig.57**). A straight joint in the floorboards by the post (**fig.59**) could be from rearrangement of stairs and/or site of a former partition. The staining around the margins, typical of the 19<sup>th</sup> century, must have been made after removal of the partition, if it existed.

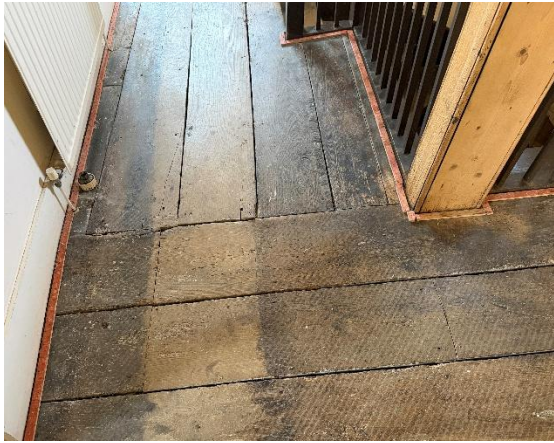
**Fig.59 Straight joint in floorboards** **Fig.60 Elm beam stop-chamfered on both faces**

The floor has wide elm boards in both areas of landing, varying widths, some measuring approx. 28cm (11 inches), likely reused during the mid-19<sup>th</sup> century refurbishment (**fig.59**).

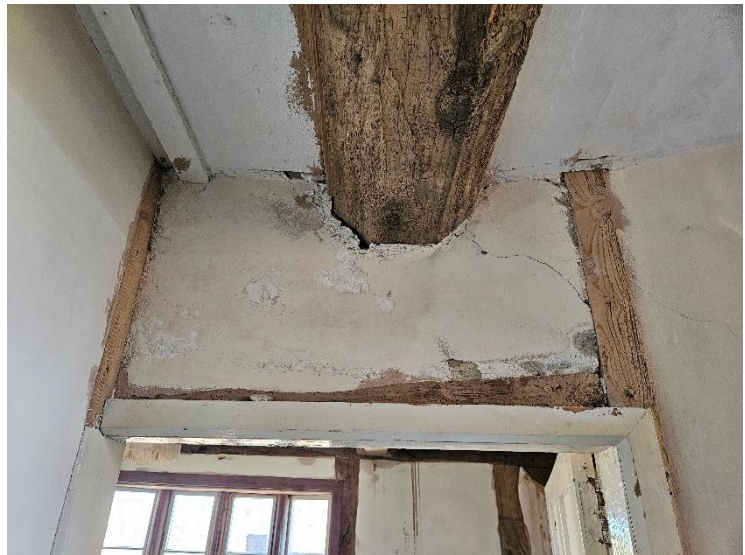
**Fig.61 Tenoned stud and rail, north-east partition**

Partially exposed around the door is an elm? stud and rail, tenoned, and apparently pegged (**fig.61**). This is perhaps part of a timber-framed partition. Visible timbers appear rather slender which might suggest a mid-19<sup>th</sup> century modification. Chamfered door architrave added later-20<sup>th</sup> century.

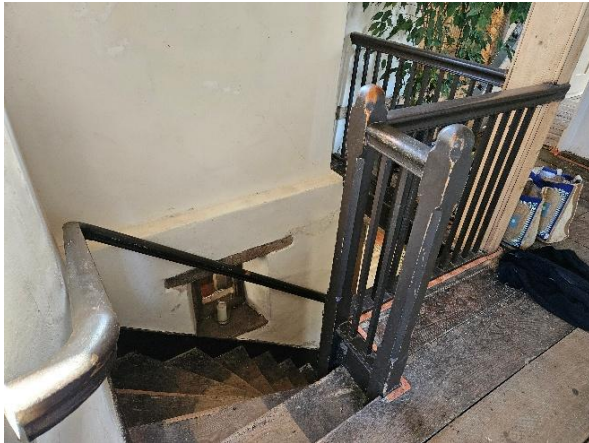
**Fig.62 Looking south-east. Stair balustrade, with stop-chamfered newel posts**

The plastered south-east (rear) stair wall is set back at the first floor (**fig.62**). The first-floor window, set high, has deeply spayed jambs and cill (**fig.63**). It contains modern glass in a plain wooden frame. Late-19<sup>th</sup> century or early-20<sup>th</sup> century balustrade guarding the stairs, with stick balusters, moulded handrail and stop-chamfered newel posts with domed caps (**fig.62**).

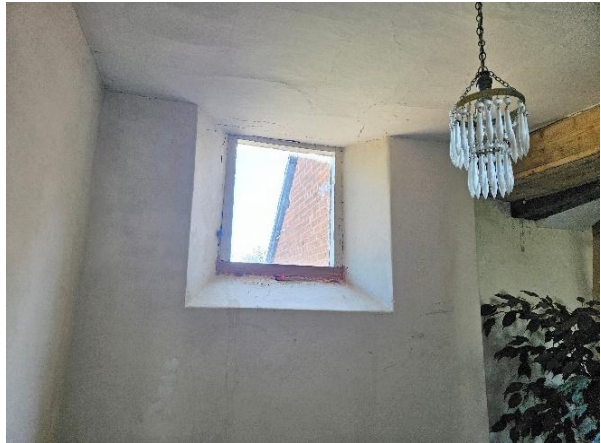
**Fig.63 Single-light window within deeply splayed opening, rear wall**

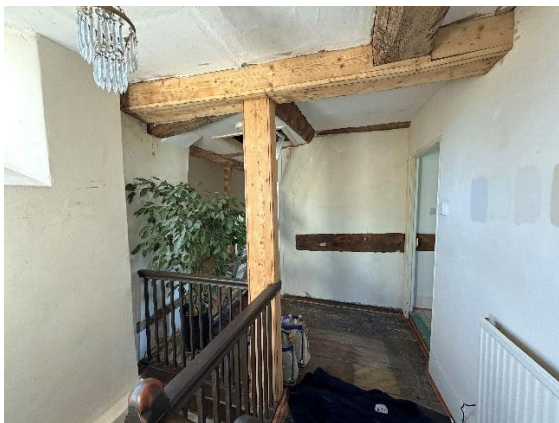
**Fig.64 Landing, looking south-west towards the inserted stack**

The south-west area in the main range (**fig.64**) has the later inserted main chimney stack largely forming the south-west wall. There are some possible primary phase features visible here, most likely associated with the surviving roof truss:

The south-east wall, set back here, is plastered to the entrance into the rear extension (**fig.67**). A rail from timber framing is exposed low down, but above floor level (**fig.64**).

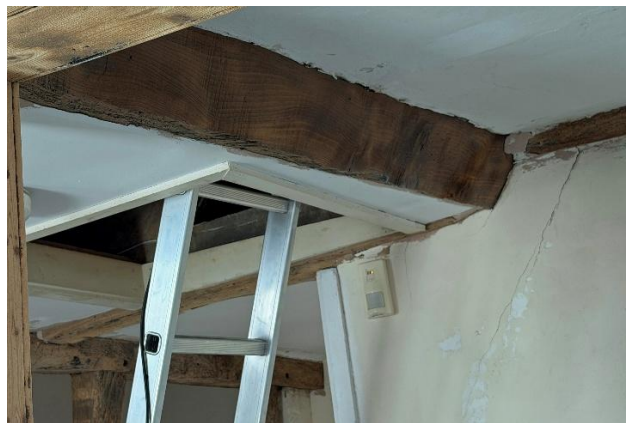
**Fig.65 Purlin, collar and possible witness mark of a principal rafter**

- (1) Purlin running between the stack and the softwood beam (**fig.65**), deeply chamfered on the north-west face, with diagonal conversion marks
- (2) Collar partially exposed in the stack wall at ceiling height (**fig.65**)
- (3) Principal rafter possibly indicated by a diagonal crack witness mark in the stack wall (**fig.65**).
- (4) Part of a tie-beam embedded lower down the stack wall (**fig.66**).

Ceiling is lath and plaster north-west of the purlin (**fig.65**). The south-east part of the ceiling surrounding the loft hatch is a later replacement (**fig.67**). There is a tentative suggestion this is a possible location of former attic stairs.

A ceiling beam, which runs into the stack and jointed to the possible wallplate (**fig.69**), is partly exposed in the stack wall (**fig.65**). Nail evidence on the soffit, and a straight joint in the floorboards (**fig.70**), suggest the landing and passage were once divided by a partition.

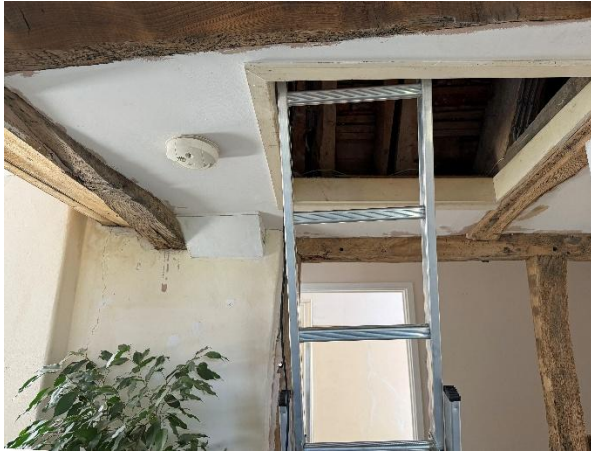
**Fig.67 Looking south-east**

- (1) Splint adjacent to the softwood beam (**fig.68**). It is attached to the underside of a feature above the ceiling
- (2) Boxed wedge feature (**fig.67**) adjacent to the splint, purpose unknown.

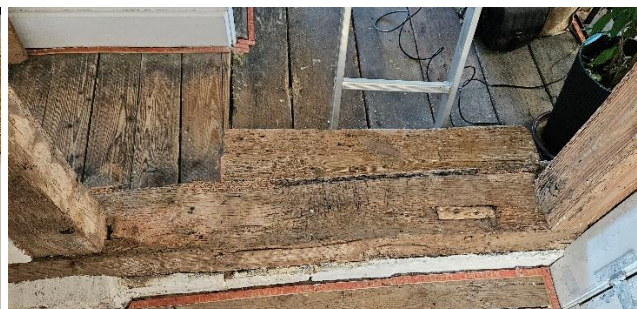
**Fig.70 Change in floorboards, viewed from rear extension. Redundant mortice for former stud in rail.**

Right of the plastered section, the south-east wall has exposed rail, possible wallplate and studs, tenoned and pegged (**figs.71 & 72**), all probably elm. One stud and infill has been removed, probably here to create the entrance to the rear extension. Redundant mortise and peg holes in the rail (**fig.70**) and wallplate (**fig.71**) indicate the former stud position. The timber at the north-east jamb is a later insertion.

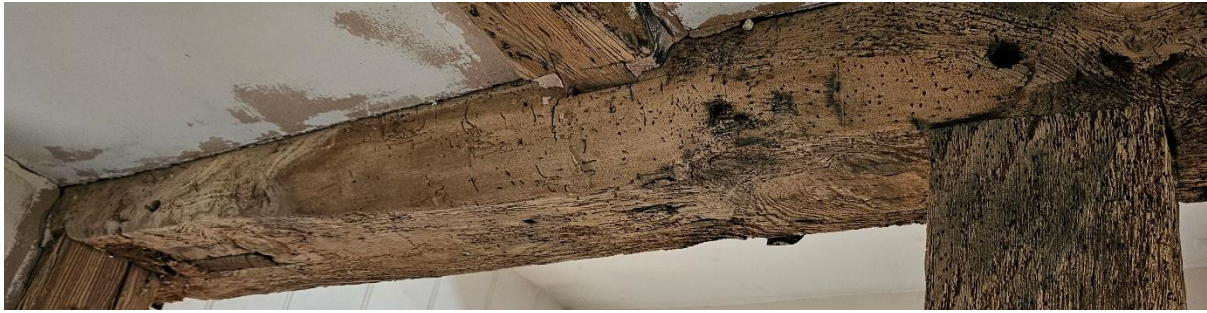
**Fig.71 Redundant mortise for former stud in wallplate soffit. Chamfer with runout stops could indicate a former opening.**

Over present opening, a section of wallplate has a broad chamfer with runout-stops, inner (landing) face only (**fig.71**).

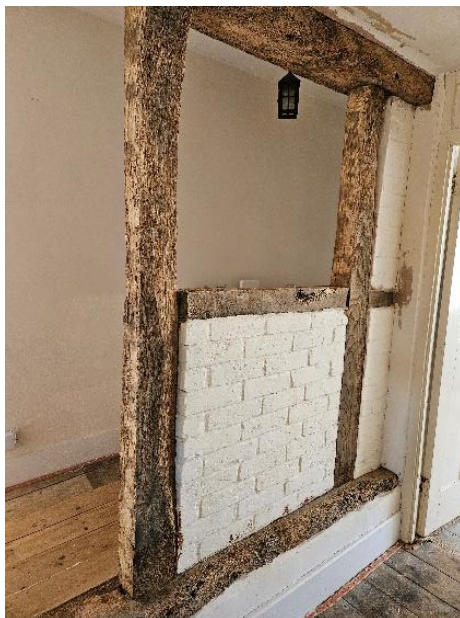
**Fig.72 Stud wall in passage**

The stud wall continues to the office doorway (**fig.72**). The nailed horizontal timbers forming panels are not pegged, perhaps a later alteration. No visible redundant mortises for pegged rail were seen on posts.

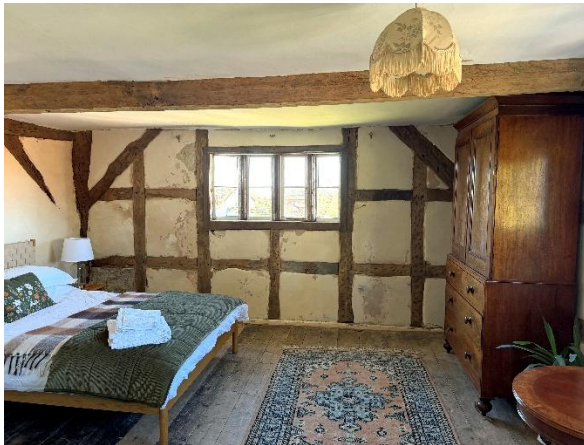
**Fig. 73 Bedroom F2, looking towards the north-west front**

The pegged timber-framing is exposed on both exterior walls. Two different types of framing are evident. Framing of the front wall has corner posts with jowelled heads, and long, straight corner braces, pegged twice, bisecting the adjacent stud and terminating in the adjacent panel (**figs.73 & 77**). The near-square panels are single pegged.

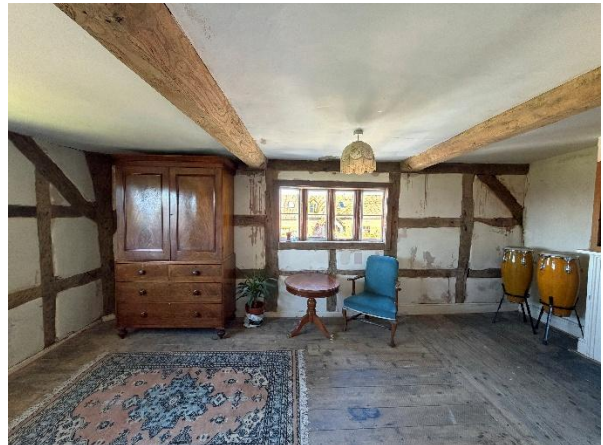
**Fig. 74 Looking towards the north-east side wall**

In contrast, the north-east (side) wall framing has larger rectangular landscape panels, single pegged. Corner braces are also pegged twice, but on this wall are more conventionally contained in the corner panel (**figs.74 & 78**). North-west brace is curved; north-east is virtually straight. The north-east wallplate was decorated with a narrow chamfer with runout stops terminating neatly at the beam; evident left of south-east beam (**fig.75**). Why there is a difference is not known, perhaps the framing was set out by different carpenters.

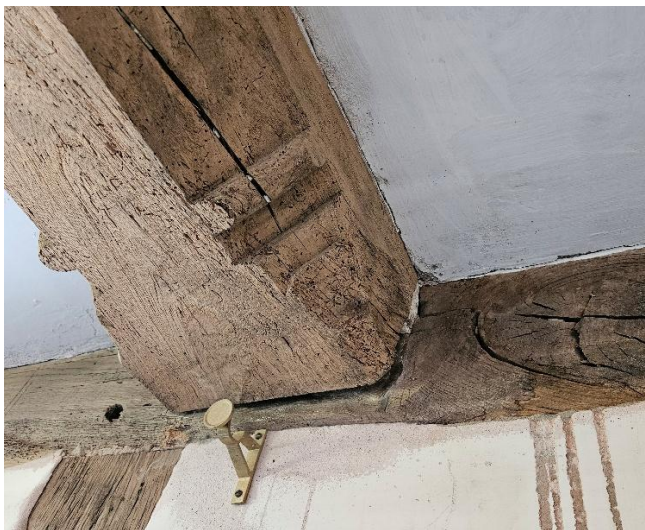
**Fig. 75 South-east beam joint; north-east wallplate chamfer respects the beam**

The solar, the principal first floor chamber, was always a ceiled room, and the two transverse ceiling beams have chamfer stops as the dining room below (G2). At the joint with the north-east wallplate where carpenter's setting out marks are visible (**fig.75**). The north-west beam is jointed to the girding beam at the south-west partition. The south-east beam shows evidence of a former partition. Much of the carpentry is good quality and, it is lit by two oriel windows.
