**Eastfield House, Plough Lane,  
Marston, Wiltshire, SN10 5SR**

**A Historic Buildings Statement**

**WBR No. B764**

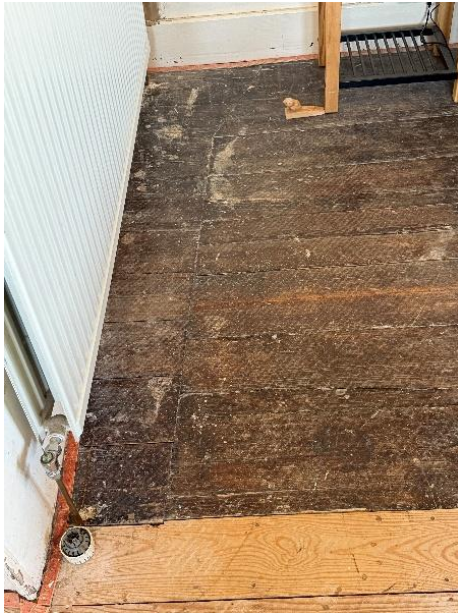
**Fig.79 Former alignment of landing partition reflected in floorboards**

The south-west partition (with bedroom F7) contains some historic fabric. The wall is plastered below the girding beam. Jointed to the girding beam is an exposed long straight brace with features matching front wall (**figs.78 & 88**). The other end of the brace is obscured but presumably pegged to corner post. The landing end of the partition appears to have been reconstructed. Adjacent to landing partition is a modern stud. Visible skirting here is modern. Floor evidence indicates the south-east partition with the landing used to have a different alignment, the extent reflected by a straight, then diagonal joint where it meets the partition (**fig.79**).

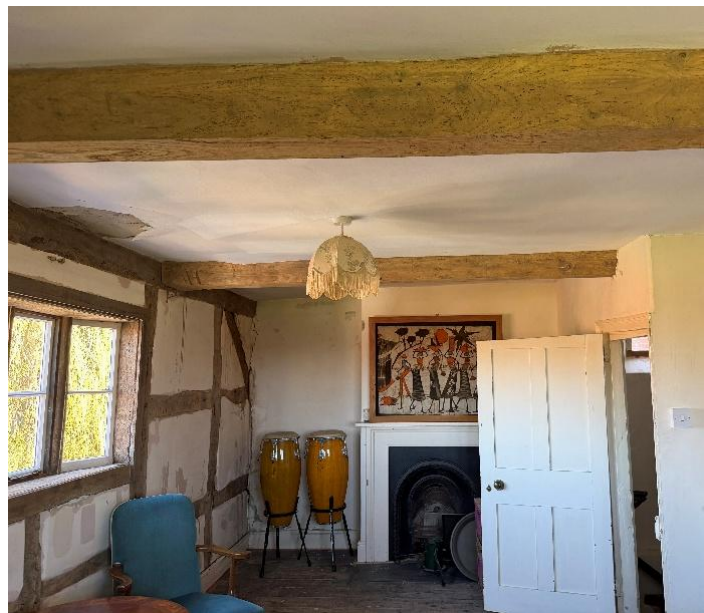
**Fig.80 Looking towards the south-east (rear) wall**

The solid south-east rear wall is plastered, and overlaps the end of the timber-framed north-east side wall (**figs.78 & 80**). The projecting chimney breast is not central to the room, offset right.

The south-west partition with the landing is plastered (**figs.80, 81 & 82**). The 4-panel door hung on butt hinges is typical 19<sup>th</sup> century. It has plain recessed panels, metal rim lock, brass knob and circular escutcheon. Door might be reused, the top shaved to fit. The double fascia architrave is also typical 19<sup>th</sup> century (**fig.82**). Evidence in the south-

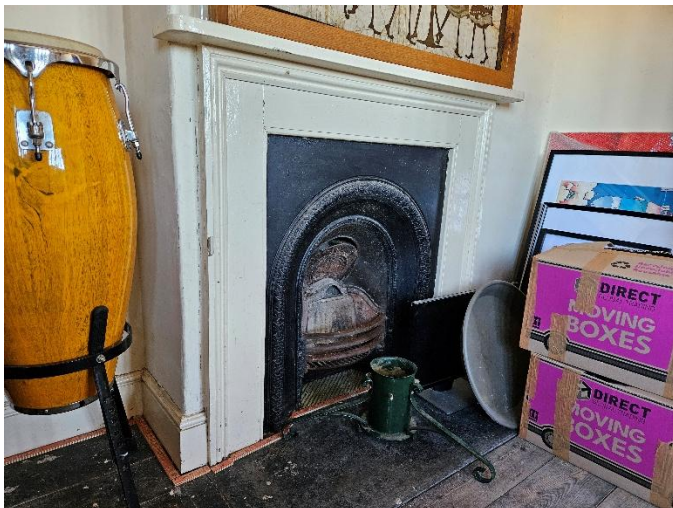
**Fig.81 Cast iron arched register grate**

The fireplace contains a mid-19<sup>th</sup> century cast iron register grate (**fig.81**). The plain mantelshelf with curved ends is characteristic of 19<sup>th</sup> century. The mouldings on the wooden surround are also typical of the period.

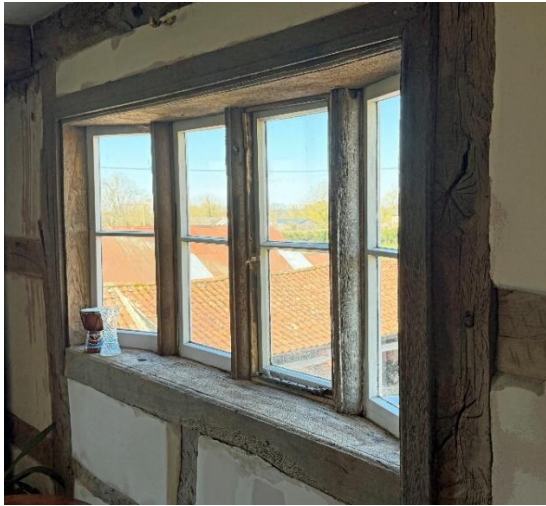
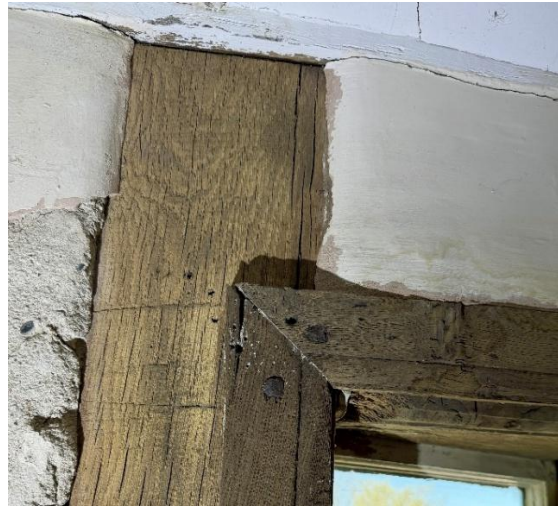
**Fig.83 Timber 4-light oriel window, with ovolo-moulded mullions, ledge and soffit**  
**Fig.84 Original setting-out marks on stud; architrave added later, nailed**

Both timber 4-light oriel windows have ovolo-moulded mullions (**fig.83**), a feature characteristic of 17<sup>th</sup> century. In both, the ledge and soffit are decorated with a narrow ovolo-moulding. On the stud adjacent to front window are carpenter's setting-out marks (**fig.84**), which likely indicate an original window position. Both have a plain later-added architrave, nailed with iron nails (**fig.84**).

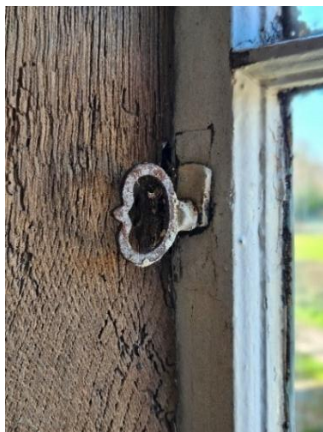
**Fig.85 Turnbuckle catch**

Probably replacement 2-pane timber casements throughout, except left casement north-east window with turnbuckle catch, likely late-19<sup>th</sup> or early-20<sup>th</sup> century (**fig.85**). Reset stay fixed to another light, same window, could date from same period. Front window has similar turnbuckle catch, reset. Fixed to another light is an earlier-mid 20<sup>th</sup> century handle with matching stay.

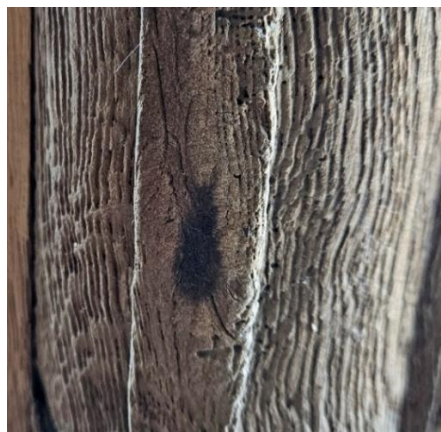
**Fig.86 Flame burn mark, thought to be deliberately made for ritual protection**

Front window has a flame burn mark present on a mullion (**fig.86**). Burn marks like these are relatively common on timber in historic buildings, and even furniture. Recent practical research by archaeologists has shown they were made deliberately and with care. It is thought they were ritual protection from fire damage. Though we often see these in 17<sup>th</sup> and early 18<sup>th</sup> century settings, it could have been made on construction or any time up to the early-19<sup>th</sup> century.

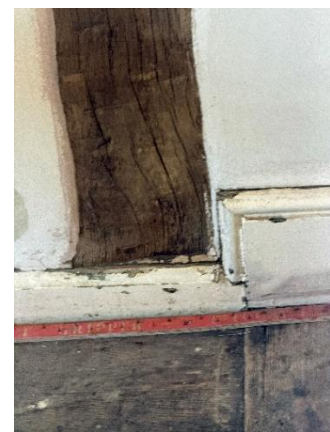
**Fig.87 Change of skirting at location of former partition; torus-skirting to right**

Changes in floor height, floorboards, floor staining and skirting boards, indicate the room has been divided into smaller spaces during its history. At least three former partitions existed. A room at the south-east (rear) end extending to south-east beam, contains 19<sup>th</sup> century features, including fireplace, 16.5cm (6½-inch) softwood floorboards and torus-moulded skirting (**fig.87**). No visible evidence to indicate location of entrance or window.

North-west of south-east beam, the exterior walls mostly have low skirting (moulding indistinct) (**figs.87 & 89**), perhaps predating torus-skirting. This former room would have been well-lit by both windows, but was originally unheated. Mixed floorboards measuring approx. 17-23cm (6¾ - 9 inches).

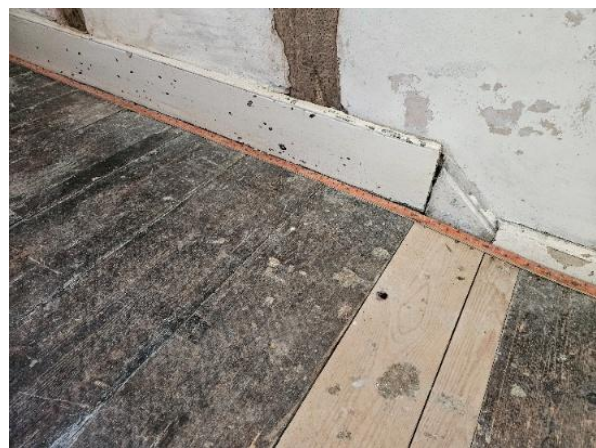
**Fig.89 Changes in floor and skirting at location of former partition; bead skirting to left**

A change in the height and type of flooring, staining, and a change in skirting from low to taller bead-skirting (retained at front wall) (**fig.89**), marks the site of another former partition parallel with the south-west wall. Stained floorboards here vary in width but measure approx. 22cm (8½ inches).

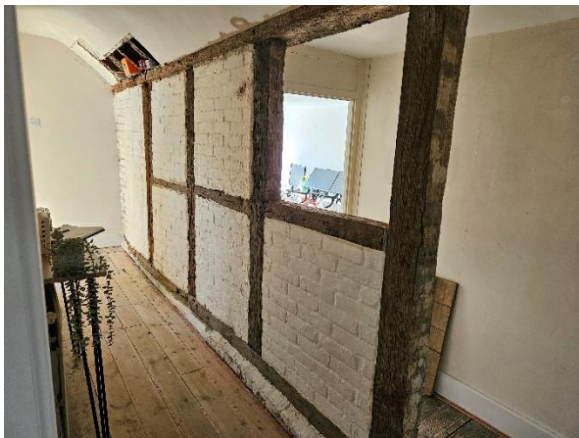
***Fig.95 Rear corridor, looking south-west***

This corridor is contained in the rear extension. The outer face of the stud partition (also seen from the landing of main range) forms the north-west wall (**fig.95**), but here an additional three panels with two studs are exposed at the south-west end. The pegged north-easterly stud (to the right) has Roman numeral carpenter's mark 'VI', bottom rail joint (**fig.96**). The wallplate is scarf-jointed above one stud (**fig.97**). Iron straps seen in two places on wallplate; above a stud (**fig.98**) and over the entrance.

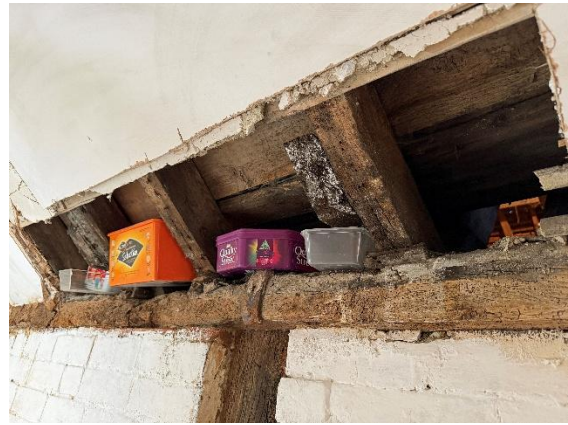
**Fig.98 Extension has machine-sawn rafters, supported on the old wallplate**

A section of lath and plaster has been removed from the ceiling to expose machine-sawn softwood rafters of the extension roof, supported on the old wallplate (**fig.98**).

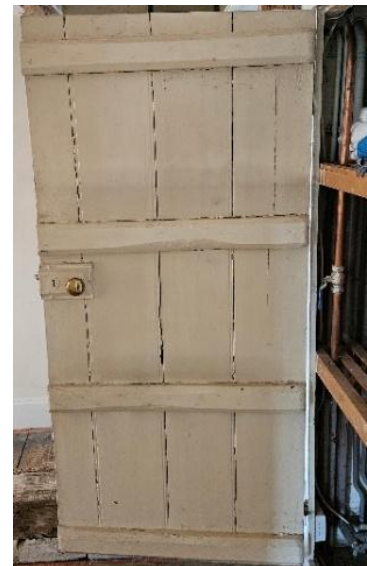
**Fig.99 Plank & batten door**

At the north-east end of the passage is an airing cupboard. It opens with a good 4-plank and 4-batten door (**fig.99**) with wide unequal width planks, primary to the mid-19<sup>th</sup> century build. Strap hinges with rounded ends. Door reused; the later-added rimlock with brass knob is fitted to the interior face. The partition surrounding the door is matchboarded. Inside, the wallplate also visible in the passage is exposed. Rear and north-west walls of brick. 20<sup>th</sup> century shelves.

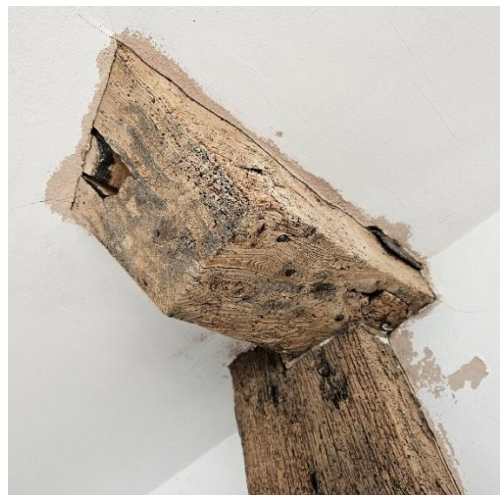
**Fig.101 Post and stub-tie**

The entrance is via the passage along the stack, shallow step down into the room. Embedded in the plastered south-east wall is a post and stub-tie (**fig.101**), with an iron strap partially visible.

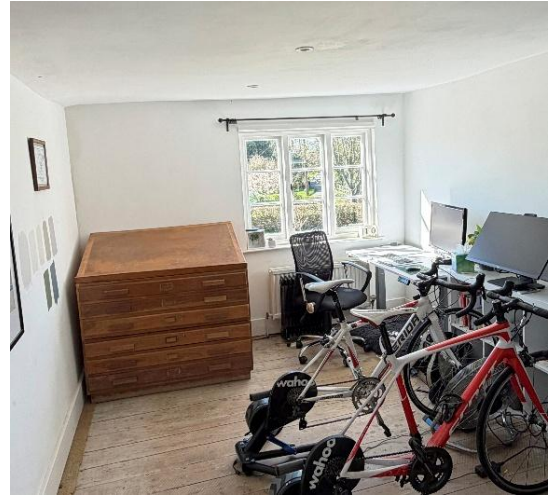
**Fig.102 Looking south-west; window offset**

There is a likelihood that the plastered north-west partition with bedroom 7 might be an a mid-19<sup>th</sup> century addition. The 3-light window, containing a modern replacement casement, is in an offset location, very close to the partition (**fig.102**).

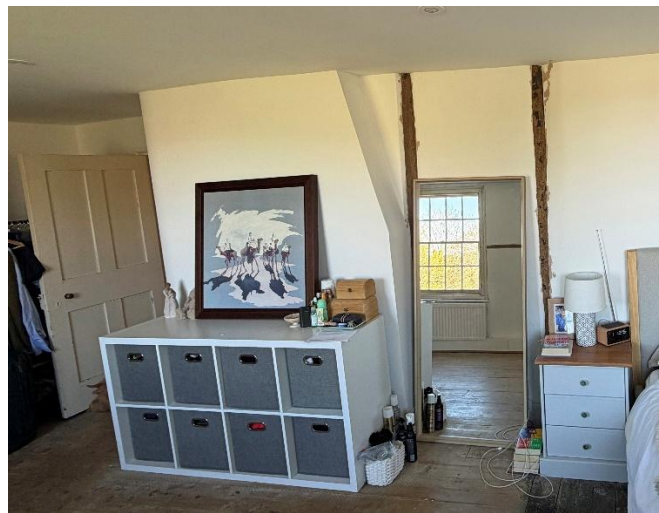
**Fig.104 Two studs, south-east partition**

The main stack projects out from the end of the south-east partition (with office F6). The partition is plastered, with two slender, full-height timber studs exposed adjacent to

the stack (**fig.104**). The accessible south-west stud has a series of iron nails, some possibly hand-wrought, clenched (**fig.105**). The nails might have been for a former partition marked in the floorboards by a vertical joint (**fig.109**). A joint in the skirting (**fig.106**) could be associated with the former partition and/or might indicate a former opening.

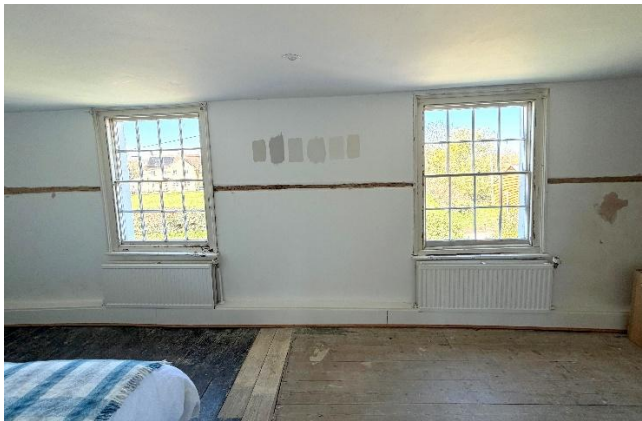
**Fig.107** North-west (front) wall

A course of three slender horizontal timbers run the full length front wall (**fig.107**). They might be levelling timbers relating to the rebuilding of the front wall in the mid-19<sup>th</sup> century. The surface of the north-easterly (right-hand) timber appears weathered date (**fig.108**), though any of them could be reused.

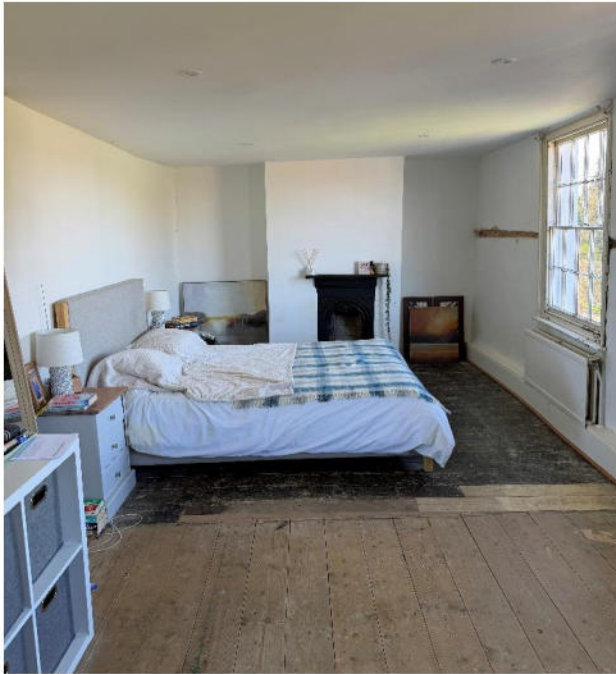
The inserted chimney breast projects into the room from the south-west wall (**fig.109**). This end of the room, evidently once a separated from the rest of the room, has stained floorboards. The fireplace has a cast iron register grate and moulded mantel, all one piece (**fig.110**). There is no chimney stack below, so it appears that the stack always started at first floor level.

**Fig.109 Looking south-west**

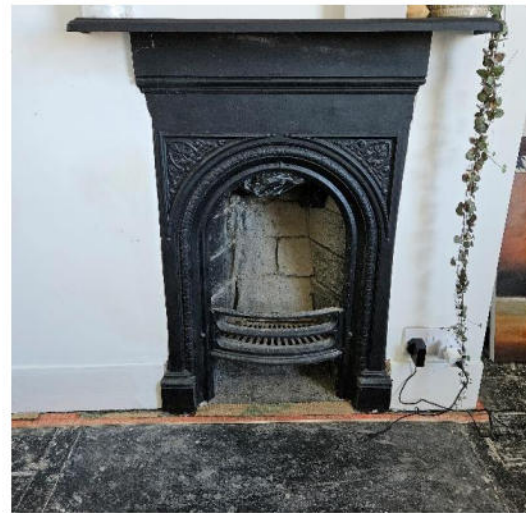
**Fig.110 Arched register grate**

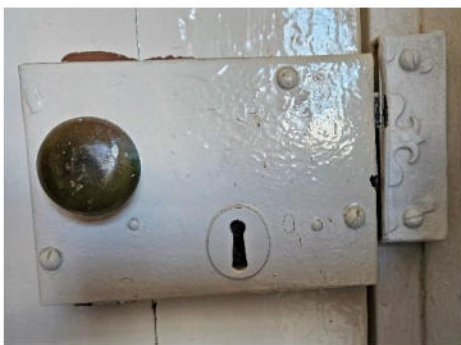
The 4-sunk-panel door is perhaps reused; fixed to the frame is a different type of rimlock (**fig.111**). The plain chamfered architrave surround was added later-20<sup>th</sup> century. The architrave on the outer (landing) face has bead and torus mouldings (**fig.112**).

**Fig.111 Two phases of rimlock**

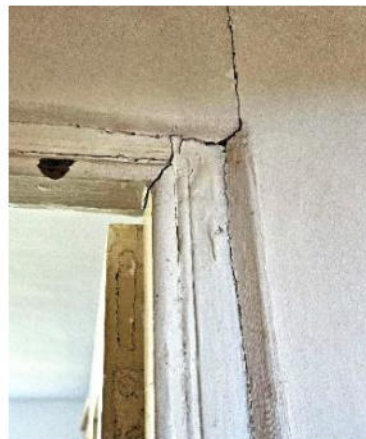
**Fig.112 Bead & torus-moulded door architrave, landing face**

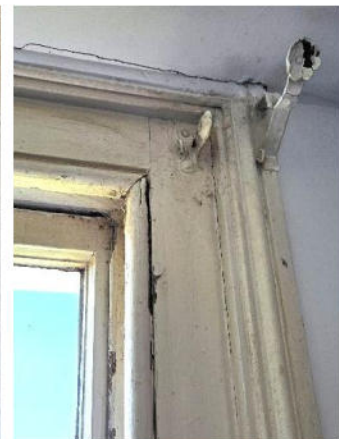
**Fig.113 Bead & torus double fascia window architrave. Stylised flower curtain bracket**

The double fascia window architraves also have bead and torus mouldings, contemporary with door architrave (landing face) (**fig.113**). Fixed to lefthand window architrave is a pair of stylised flower curtain brackets.

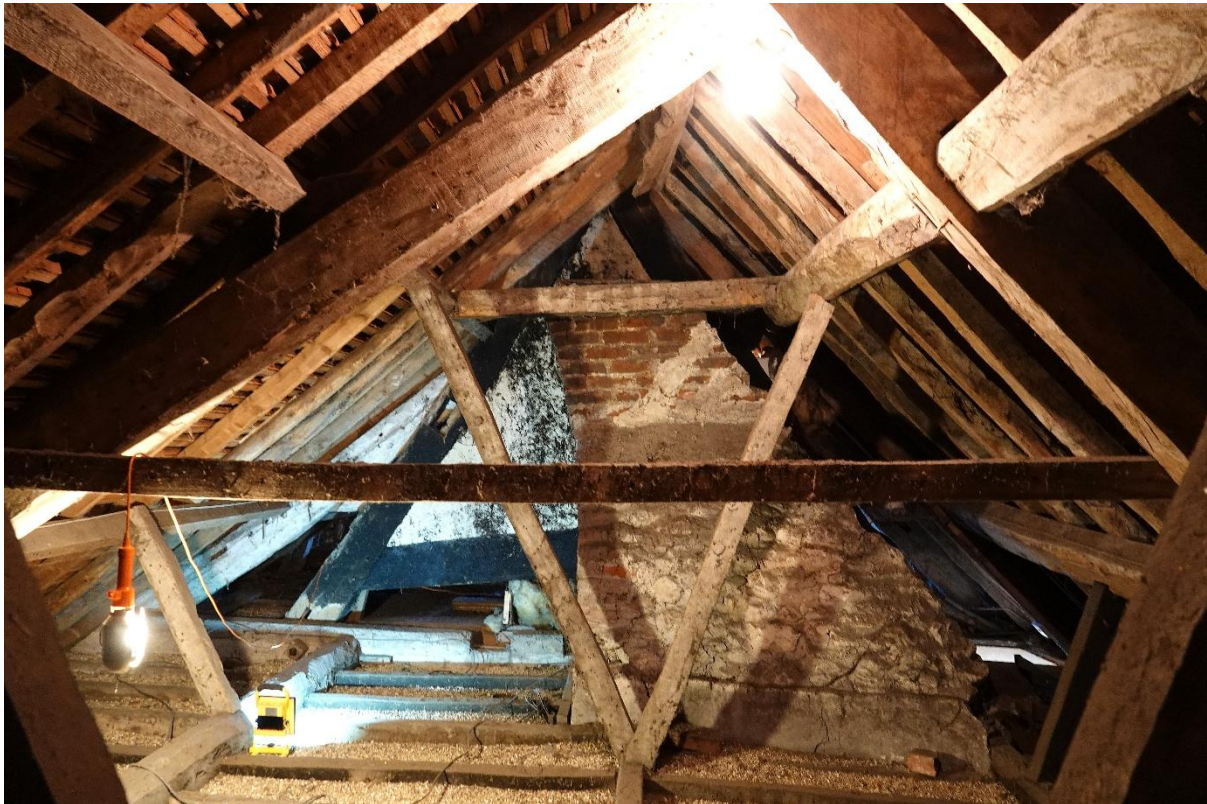
**Fig.115** A general view of T2 from the SW. In this view the smoke-blackened truss T2 is seen behind the stack; the NW principal of T2A can be seen to its left. Immediately in front of the camera is T1

The only surviving truss from this first phase is **truss T2**, a heavy collar-and-tiebeam truss, smoke-blackened both sides (**Figs.115-117**). The blackening is a heavy stain but is not soot encrusted, possibly because of later cleaning. The timbers are well crafted but without any decoration or chamfer. The truss is sited adjacent to the stone stack which has been inserted abutting its SW side (i.e. on the hall side). Both the principal rafters survive and measure 140 x 280mm; they are straight not curved. On the front (NW) side the foot of the principal is lost in the rebuilt front wall, but on the rear (SE) side the principal can be seen descending steeply by the chimney void. It has been sawn off, vertically, some 800mm below the first-floor ceiling level. The foot of the principal has therefore been lost but it is estimated that it aligns with a horizontal timber

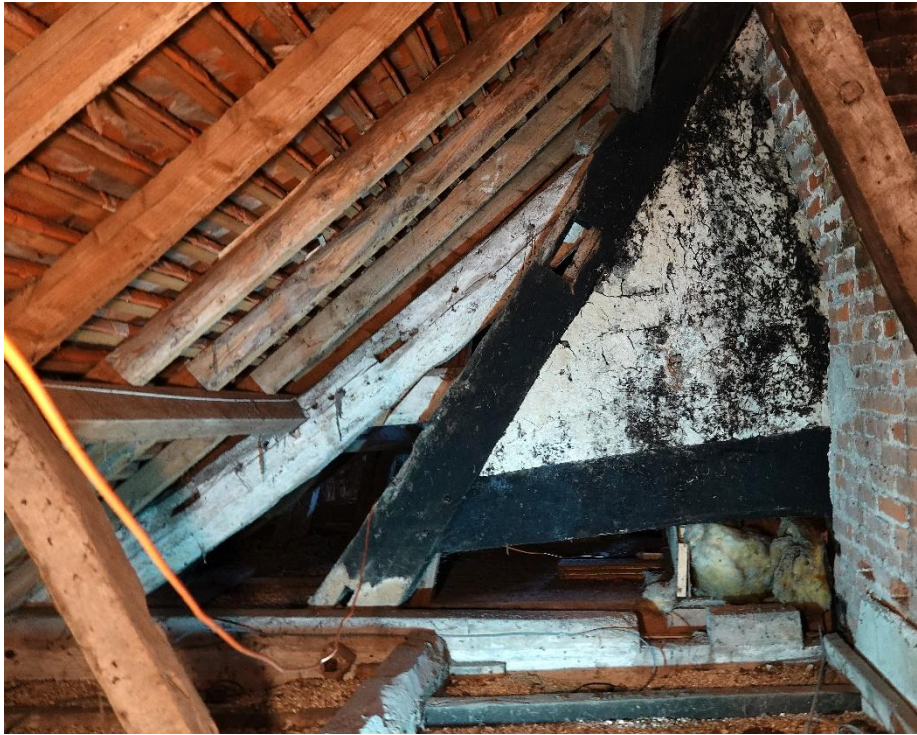
***Fig.116 Truss T2 from the SW, showing the cranking of its collar; and the principal and tiebeam of T2A***

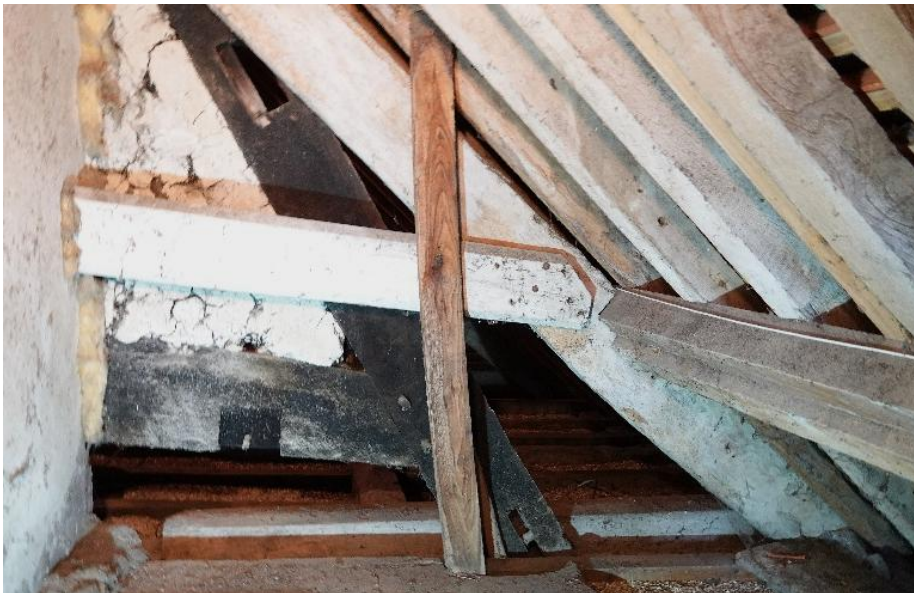
***Fig.117 Truss T2 from the NE. This view shows T2A with its nailed-on collar***

The rebuilding operations retained the medieval truss T2 but in order to achieve the rasing of the eaves new principal rafters were afixed to the outside of the principals of T2, with their feet some 1150mm further out, and the new principal sloping back to meet the medieval one in a long taper, for some reason notably at a lower level on the front slope than on the rear slope where it tapers almost right up to the apex (**Figs.116 & 117**). These new principals added to T2 will be termed **Truss T2A**. A low collar has been nailed across from the new principals of T2A back to the stack (**Figs.117 & 131**); this may possibly be contemporary with the truss but is probably a later addition.

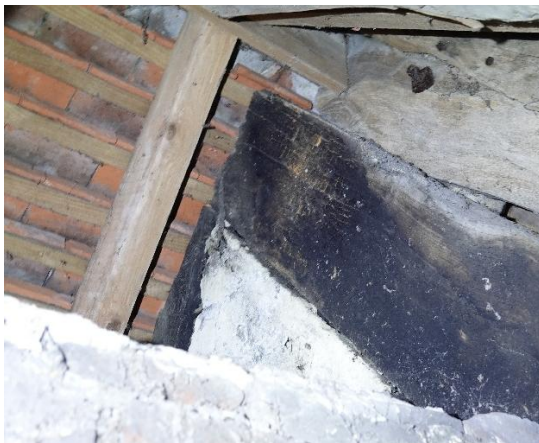
The apex of T2 has been mutilated by the cutting back of the NW principal but the apex would appear to have been a simple bridle (**Fig.119**)<sup>20</sup>; no evidence for a yoke is present.

**(left) Fig.119 Apex detail of T2 from the SW side; the far principal has been cut back by the later replacement tiled rafters. (right) Fig.120 Detail showing the staining of the principal and the sooting of the infill on the SW side**

chamfer to its soffit, on both sides. The truss is closed above the collar with (presumably) wattle-and-daub infill which has been given either a limewash or a white chalky plaster on both sides. While the principals and collar are heavily smoke-stained, the infill is not significantly stained at all, but does have a number of soot particles, more on the SW side than on the NE side (**Figs.120 & 121**) – these particles are not present on the principals and collar and may perhaps have resulted from a leaky flue? Notwithstanding the soot particles, the absence of smoke-staining on the infill shows it is not primary.

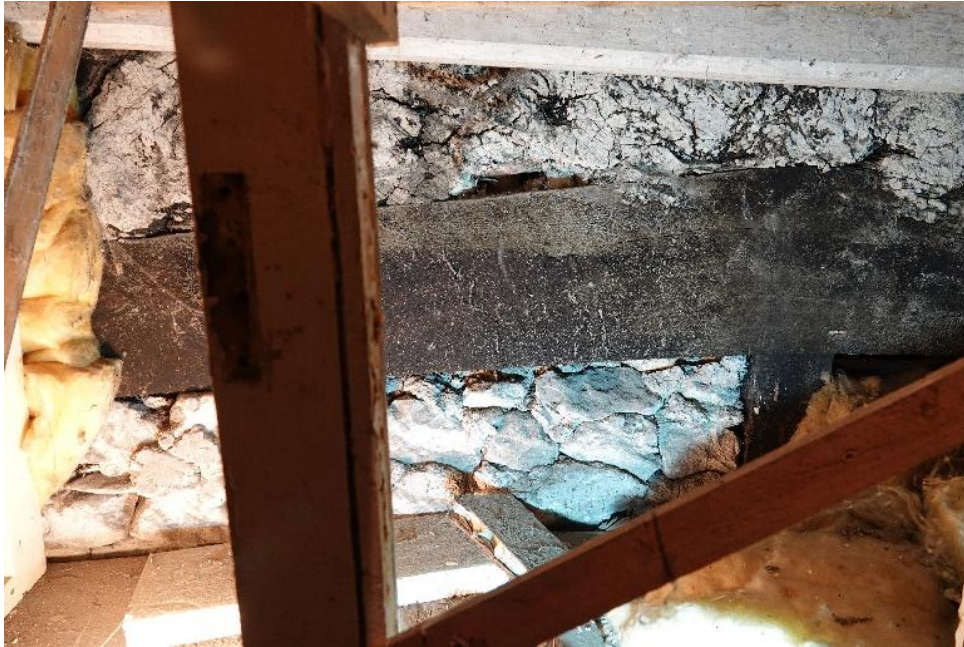
***Fig.121 The collar of T2 seen from the NE, with a pronounced crank to its upper face, and central stud. Above the collar is limewashed infill with some soot particles; the stone stack has been underbuilt beneath***

The soffit of the collar could be inspected NW of the stack and has a line of stave holes. There is also a central stud running up to the collar, and NW of this a raking open mortise for a further stud (**Fig.121**). The open mortise still contains an iron nail, apparently to secure the stud. An interesting feature here is the extent of smoke-staining - both sides of the collar, including its soffit, and the stave holes, and the open mortise and even the nail, are deeply stained. This suggests that the truss below the collar was closed (hence the stave holes) but that this was removed within the period the hall was open, allowing the smoke to stain the soffit and stave holes also. This may possibly relate to a lost smoke bay sited where the stack now rises, but no direct evidence for any such bay was noted.

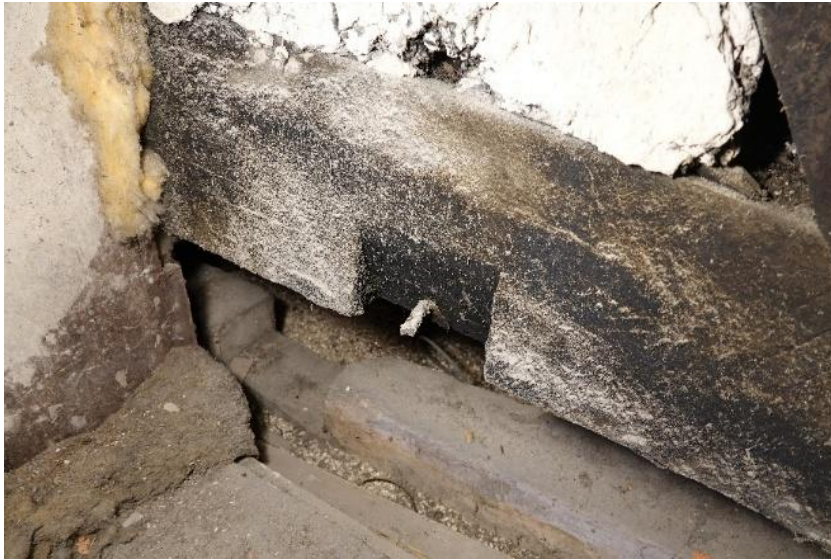
**Fig.122** *The collar of T2, showing the vacant open mortise with its iron nail*

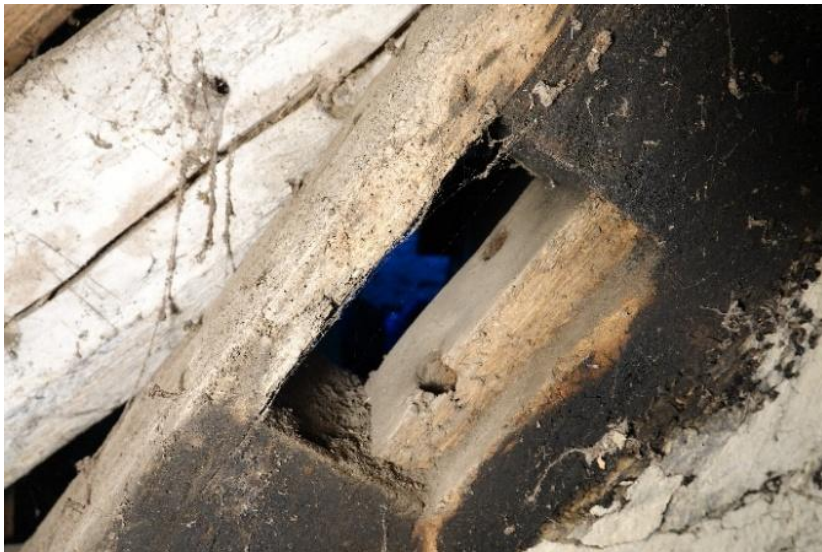
**Fig.123** *T2, the vacant mortise for the butt purlins, upper tier, each single-pegged*

Truss T2 carried two tiers of purlins, none of which now remain, except for a possible purlins seen on the Landing (F2). Examination of the vacant mortises and pegging shows these were butt purlins, each timber single-pegged to the principal (**Fig.123**).

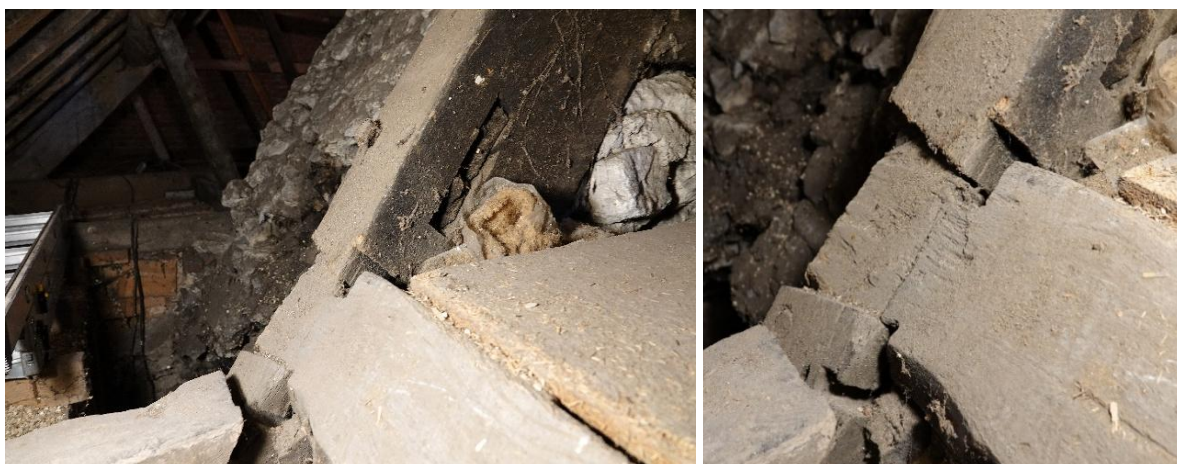
A feature noted is a short length of horizontal timber (annotated 'DT' on the roof diagram) and shown in **Figs.124 & 125**. This timber is set only 300mm above the first-floor ceiling. It is smoke-stained and is therefore from the open hearth phase, but unusually is *dovetailed* to the outer face of the principal, and therefore probably built in the primary build. It is sited only slightly below the mortise for the lower purlin so probaly did not duplicate this function. Its purpose is unclear.

**Figs.124 & 125** A short purlin-like timber set immediately below the lower purlin of T2. Note the dovetail joint

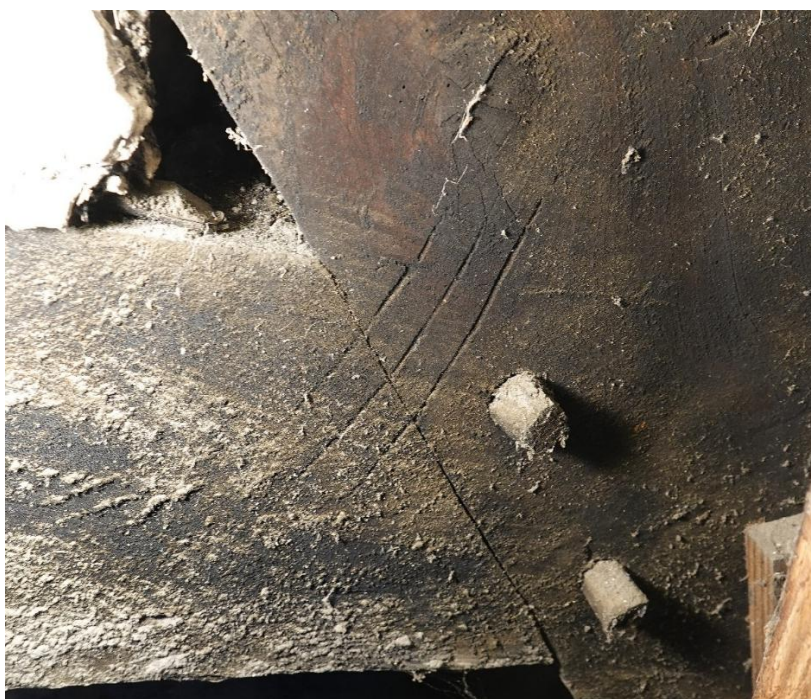
Only one carpenters' mark was noted on truss T2, although this may be due largely to difficulties of inspection. The mark (**Fig.126**) is on the collar/principal of T2, NE side. It comprises three parallel long curved race knife marks.<sup>21</sup> In this position the numbering suggests T2 a hall of two bays to the SW, with the central and SW end trusses now lost.

**Fig.126** Carpenters' mark on T2

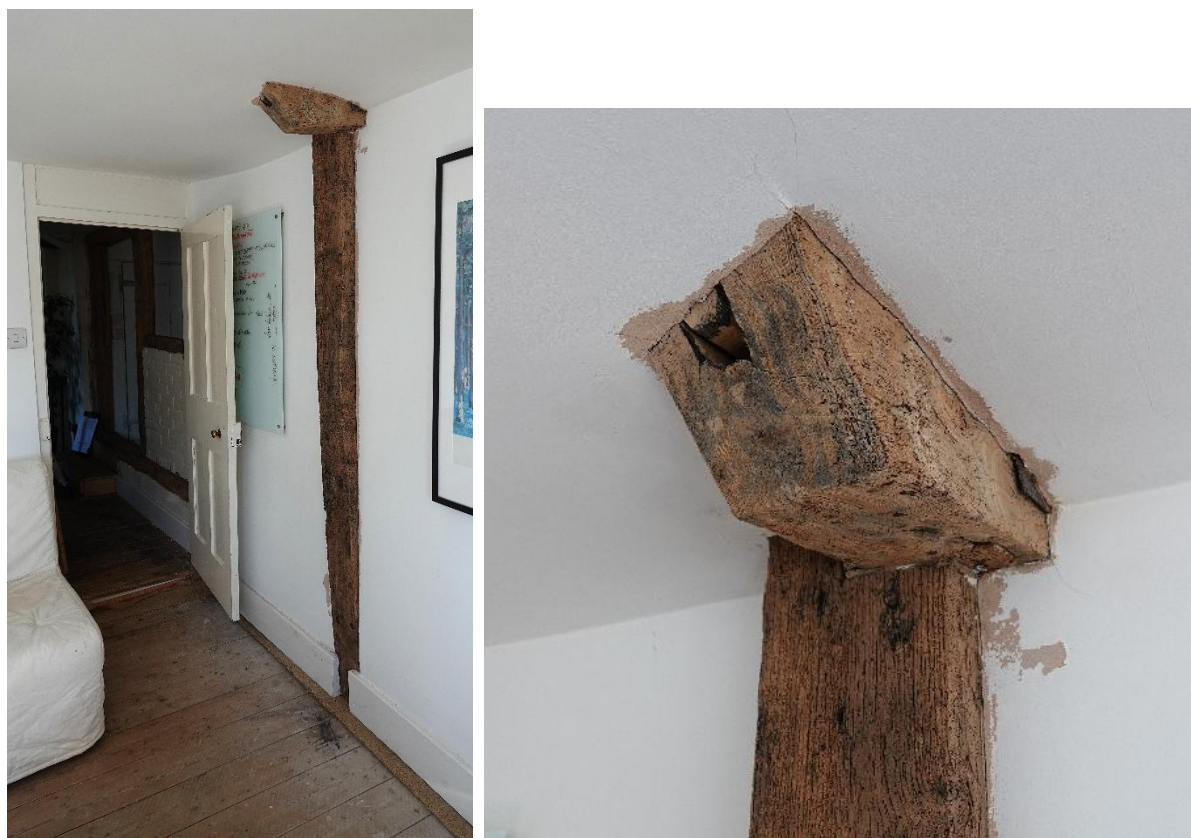
The new roof was supported by a central truss (termed **Truss T1**), in approximately the same position as its medieval predecessor. This truss survives although its tiebeam, at the new eaves level, was later sawn through, for reasons which are not apparent (**Figs. 127 & 128**).<sup>22</sup>

**Figs. 127 & 128** The post and sawn-through tiebeam of T1 at first-floor level

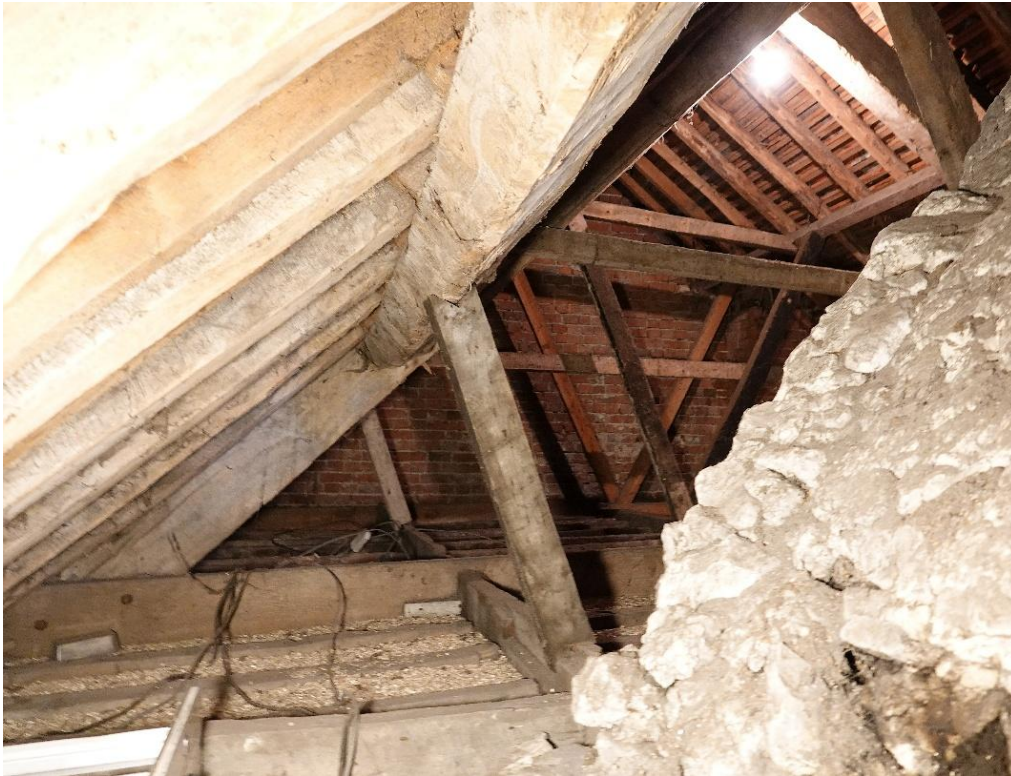
In the roof space, the principal rafters of T1 are substantial elm timbers (130 x 250mm) but of poor quality, with some waney edges. It can be seen here that the sawn-through tiebeam has been replaced by a later machine-sawn timber to which the feet of the

principals are bolted (**Fig.129**). The principals have vacant mortises for two tiers of single-pegged butt purlins, but the purlins themselves survive only on the rear (SE) slope; again they are substantial waney elm timbers. There is no collar to T1 but in a later strengthening a simple high collar has been bolted across T1.

**Fig.129** Truss T1, looking SW. One principal rafter can be seen, bolted to a replacement tiebeam, with a lower purlin running into it, now propped

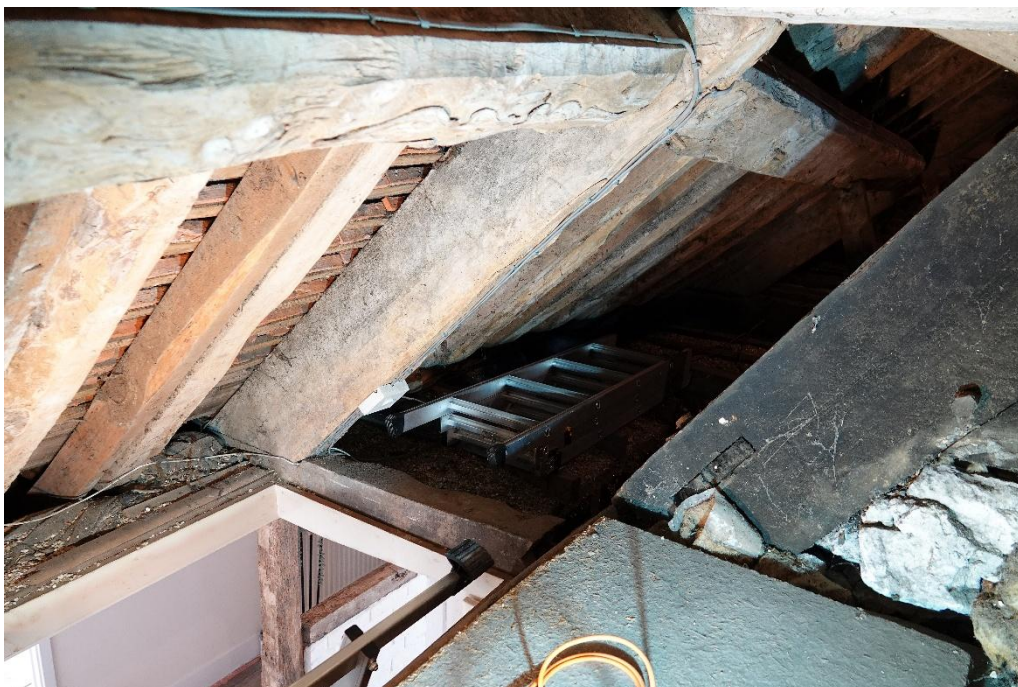
**Fig.130** This view shows to the SE of the stack shows the blackened principal of T2 to the right, and the unblackened principal of T2A, with its lower purlin tier

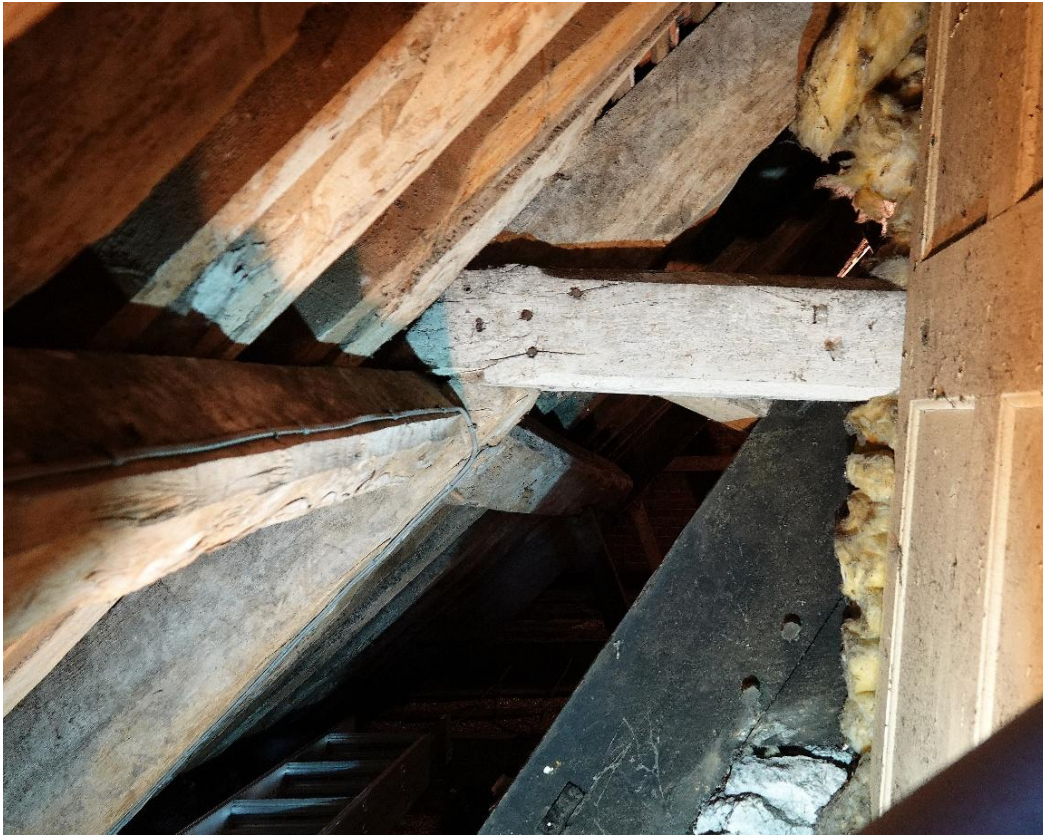
**Fig.131** This view shows the nailed collar on T2A

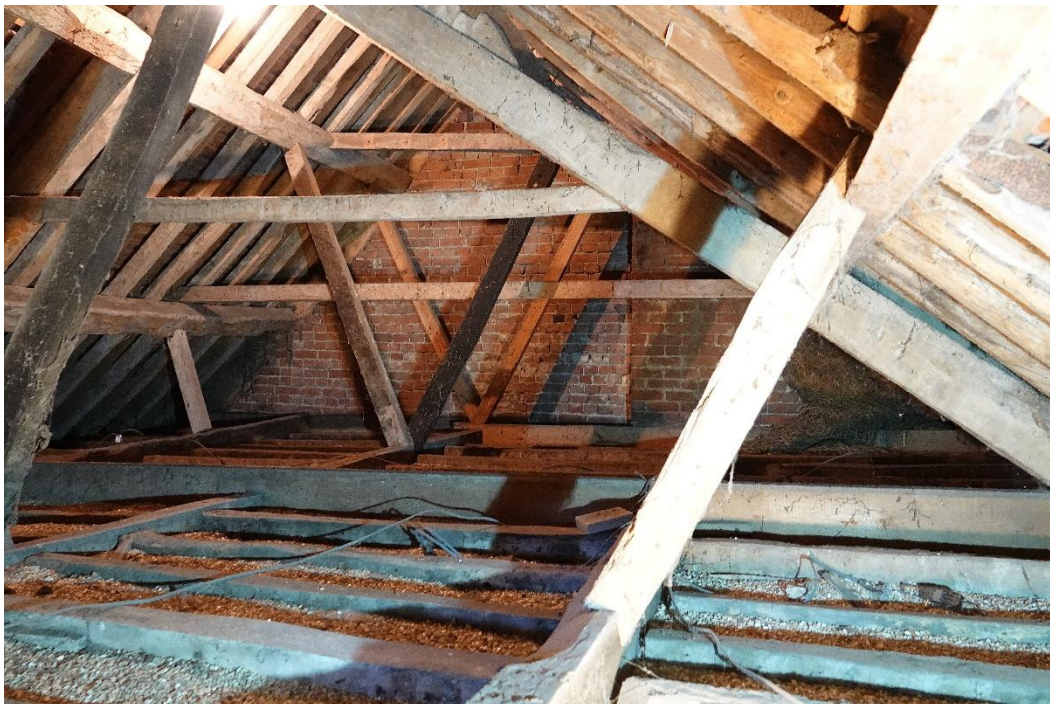
The **far SW end wall** contains no truss from this rebuilding phase, or indeed from any subsequent period. The wall is now of brick, probably C19<sup>th</sup> or later. At this end of the roof, the common rafters and numerous props and struts also date from later work (**Fig.132**), and the change in roof covering to clay pantiles in 1900.<sup>23</sup>

**Fig.132** The SW end of the hall roof. To the left the principal and purlins of T1 can just be glimpsed, but the rafters, struts and props are all later; note the blackened common rafter re-used as a prop

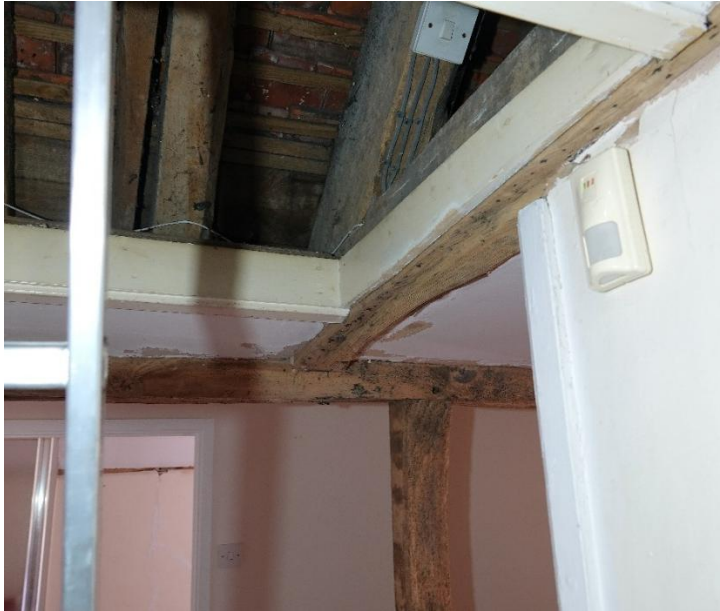
Unlike Truss T1, where the tiebeam has been sawn away and replaced only a later bolted addition T2A does possess a tiebeam, albeit only a thin timber, which runs back to the stack (**Fig.133**). However, whereas T1 does rise from a post, T2A does not - the post of the adjacent timber-framed wall (room F5) is misaligned from the truss as can be seen in **Fig.133**. Since the original medieval post is missing here, having been lost when the foot of the principal and the end of its tiebeam were removed, the result is a structural weakness (although probably not serious because of the nearby stack).

**Fig.133** *The foot of T2A showing how it is misaligned in relation to the adjacent post, but does have a thin tiebeam running back to the stack*

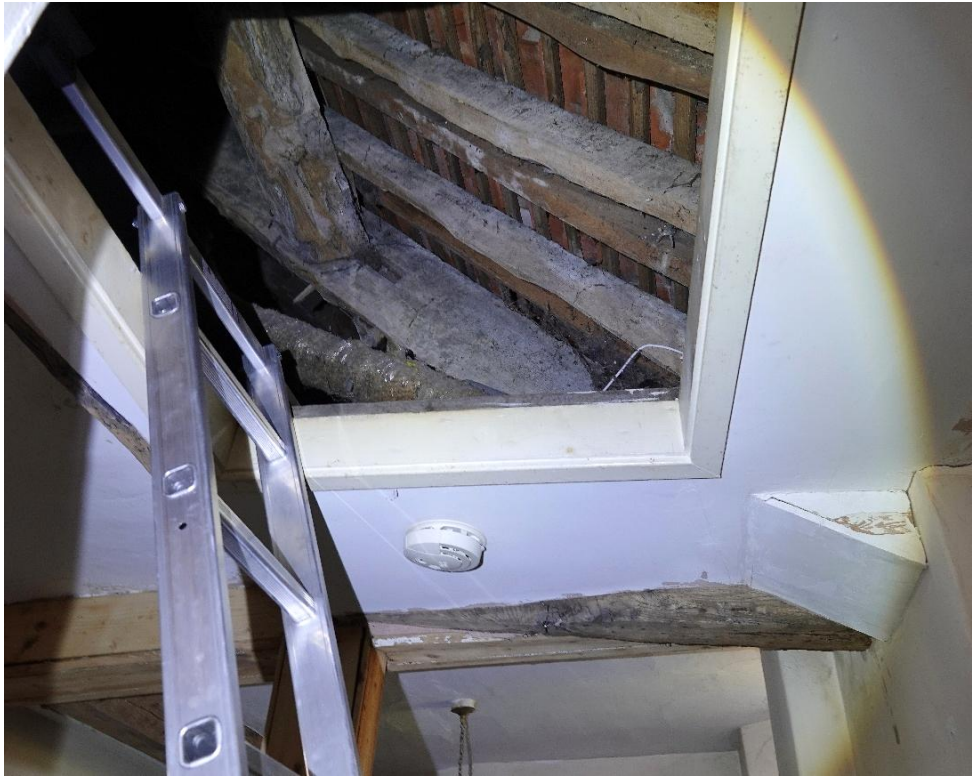
***Fig.135 Truss T3, looking up through the loft hatch. The principal and its tiebeam, and a purlin, can be seen***

On the rear (SE) slope, T3 is largely intact, albeit with a truncated purlin, but on the front (NW) slope the principal of T3 is little more than a heavy common rafter. An upper purlin from T2A now runs through uninterrupted to the crosswing, where it ends in a tenon but is now wedged between valley timbers. The lower purlin on this slope is a replacement.

On the NE side of T2A is an area of confused carpentry. There is a **truss, T3**, sited only some 1.7m NE of T2A, but clearly part of the same rebuilding phase of the hall roof (here it is over the cross-passage)(**Figs.134 & 135**), The carpentry is the same as that of T2A and T1 but is complicated by the crosswing structure which in part is dependant on it – for example the valley board of the crosswing appears to load onto the tiebeam of T3, buried beneath the floor (**Figs.134 & 135**). (These valley boards are anoted ‘VB’ on the roof diagram). The lower purlin NE from T3 has been truncated by the crosswing and is now vestigial only (**Fig.134**), again confused carpentry.

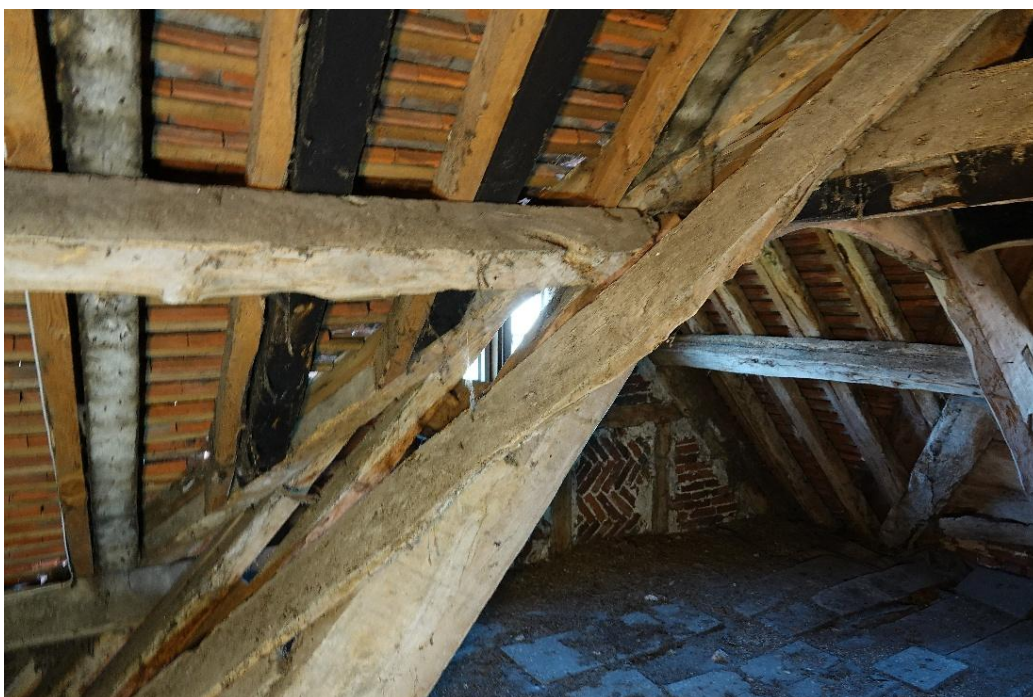
***Fig.136 The purlin from T2A running onto the outer face of T5***

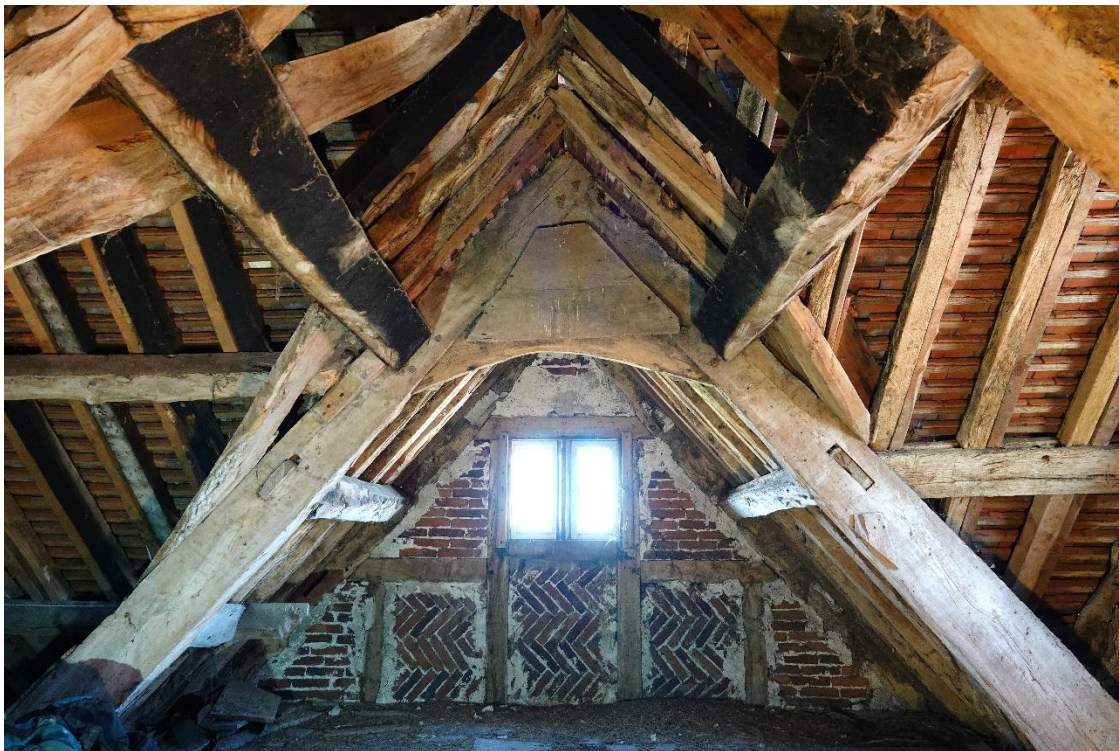
The crosswing truss apices have a double-pegged bridle joint, strengthened on T5 by a modern nailed yoke (plywood?) (**Fig.138**). Each truss has a collar (100 x 200mm) set at a high level, so high as to almost be a yoke. This timber is finely crafted in a steep camber (almost to proper a segmental arch) with an open spandrel above; it is clearly designed to be decorative as well as structural (**Fig.141**). It double-pegged to the principal. At the collar/principal joint T5 has a semi-circular carpenter's mark (**Fig.140**), probably from a gouge.<sup>24</sup>

***Fig.138 Truss T5 looking NW to the front wall***

The two trusses are shown in **Figs.137 & 138**. Each truss has principal rafters (130 x 270mm) and a single tier of butt purlins. All the timbers are elm, many with waney edges although the main elements are of better quality than elsewhere in the roofs. There is much re-use of timber, presumably from the medieval hall roof. **Fig.137** shows four such purlins from re-used timbers, all heavily smoke-stained. The re-used timbers include common rafter pairs (**Fig.139**), and in particular two floor beams with steeply-diminished tenon haunches for floor joists, re-used as the two purlins in the central bay (**Fig.144**). Assuming they came from the medieval roof of the primary house, this suggests that the primary house had at least one floored bay, perhaps a low-end sleeping platform. Interestingly, these beams were carefully chamfered for re-use as purlins – the blackening has been planed off in the chamfering – which indicates the status being afforded to this attic chamber of the crosswing.
