**Eastfield House, Plough Lane,  
Marston, Wiltshire, SN10 5SR**

**A Historic Buildings Statement**

**WBR No. B764**

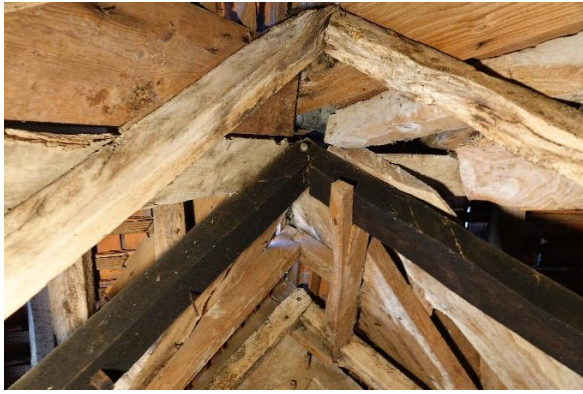
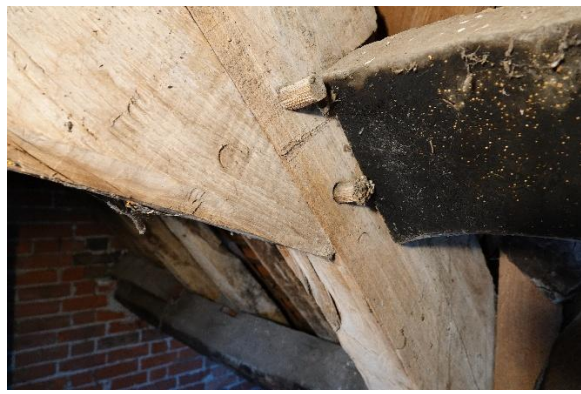
**(left) Fig. 139** A re-used rafter pair in the crosswing roof. **(Right) Fig. 140** Gouge marks on T5

The crosswing truss apices have a double-pegged bridle joint, strengthened on T5 by a modern nailed yoke (plywood?) (**Fig.138**). Each truss has a collar (100 x 200mm) set at a high level, so high as to almost be a yoke. This timber is finely crafted in a steep camber (almost to proper a segmental arch) with an open spandrel above; it is clearly designed to be decorative as well as structural (**Fig.141**). It double-pegged to the principal. At the collar/principal joint T5 has a semi-circular carpenter's mark (**Fig.140**), probably from a gouge.<sup>24</sup>

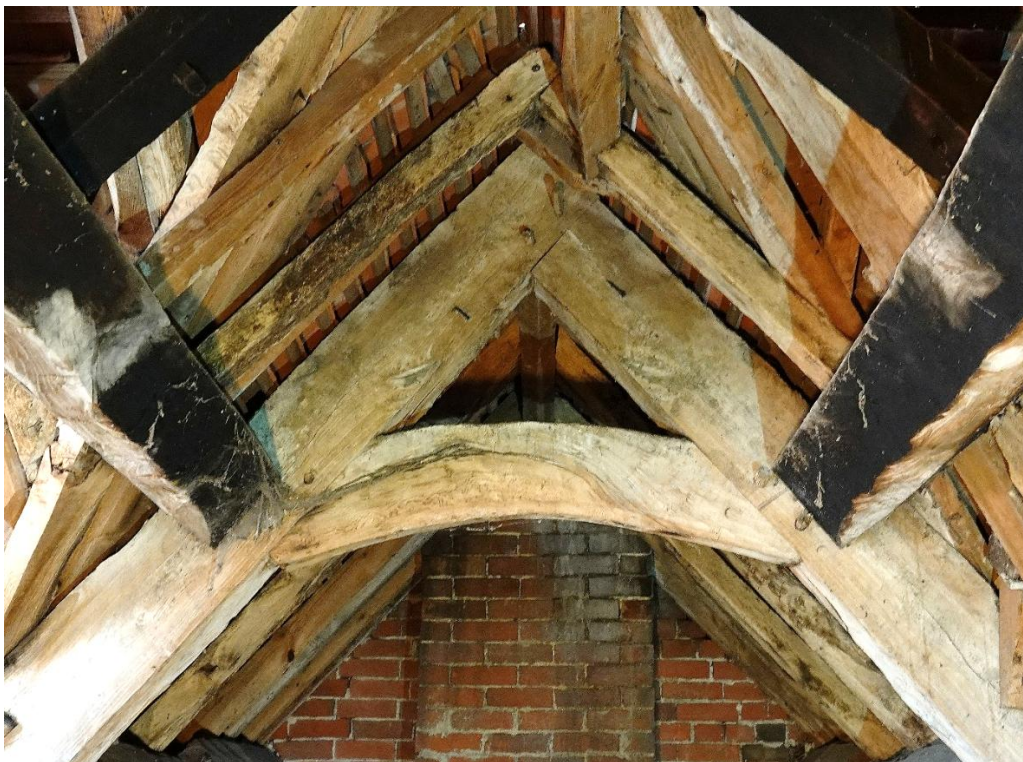
**Fig. 141** The decorative collar of T4

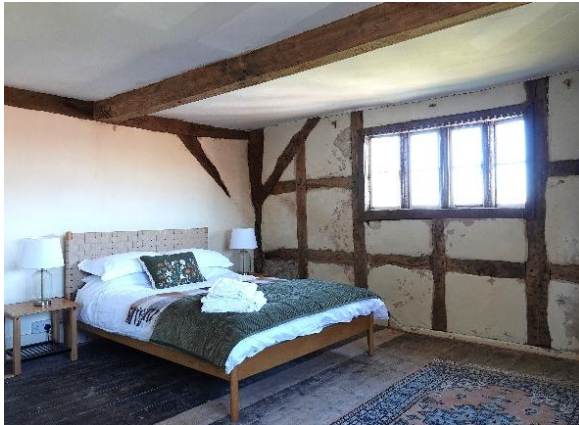
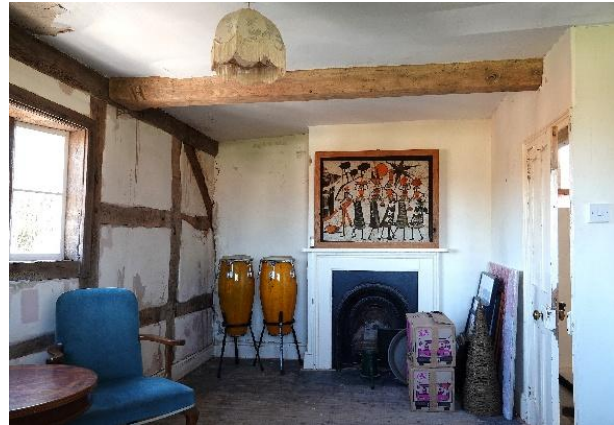
The tiebeams of the trusses are not apparent in the roof space but project down into the first-floor chamber below, room F2 (now ending in the stair landing area, room F1) (**Figs. 142 & 143**). The tiebeams in the chamber have the same decorative stops with two rolls as the ground-floor parlour room below (room G2). The use of these decorative, matching beams demonstrates that the roof space of the crosswing was purpose designed as an attic room, rather than being a decorative feature to an unceiled first-floor chamber below. At the date the crosswing was probably erected this use of a *ceiled* first-floor chamber would have been innovative.

***Figs.142 & 143 The tiebeams of (left) T5, and (right) T4, visible in the chamber below***

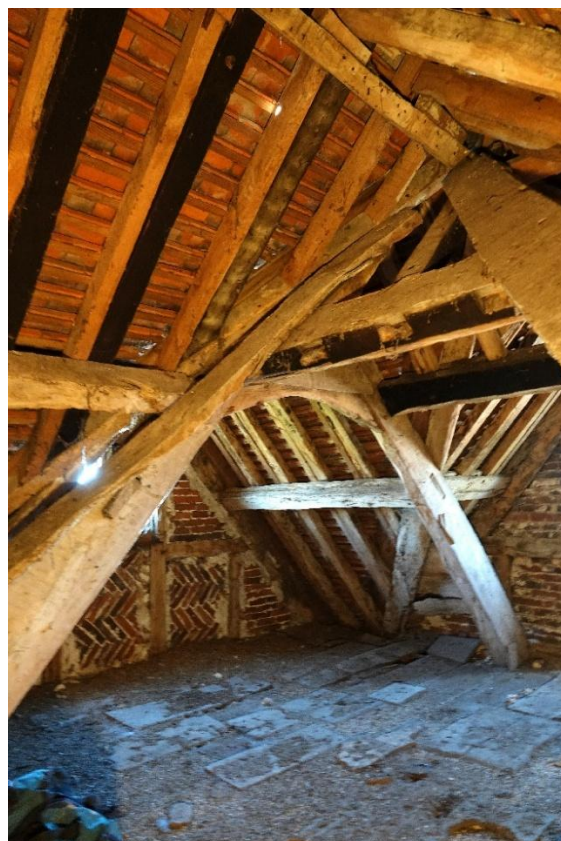
Trusses T4 and T5 have one tier of butt purlins, but those in the central bay are raised to allow headroom into the flank gable on the NE side, and on the SE side into the roof space of the cross-passage bay T3-T2. The purlins are single-pegged to the principals and the raising of those in the central bay allows all the purlins to project a few cm through the principals. The head height resulting from the raising is generous, as can be seen in **Figs.144 & 146**, and this attic room would clearly have been used for an important function. Unfortunately, the floor is now much decayed and it is not possible to ascertain whether it was boarded and with what.

***Figs.144 & 145 The crosswing attic space showing the generous head height available. (left) Looking south to T4, (right) looking north to T5***

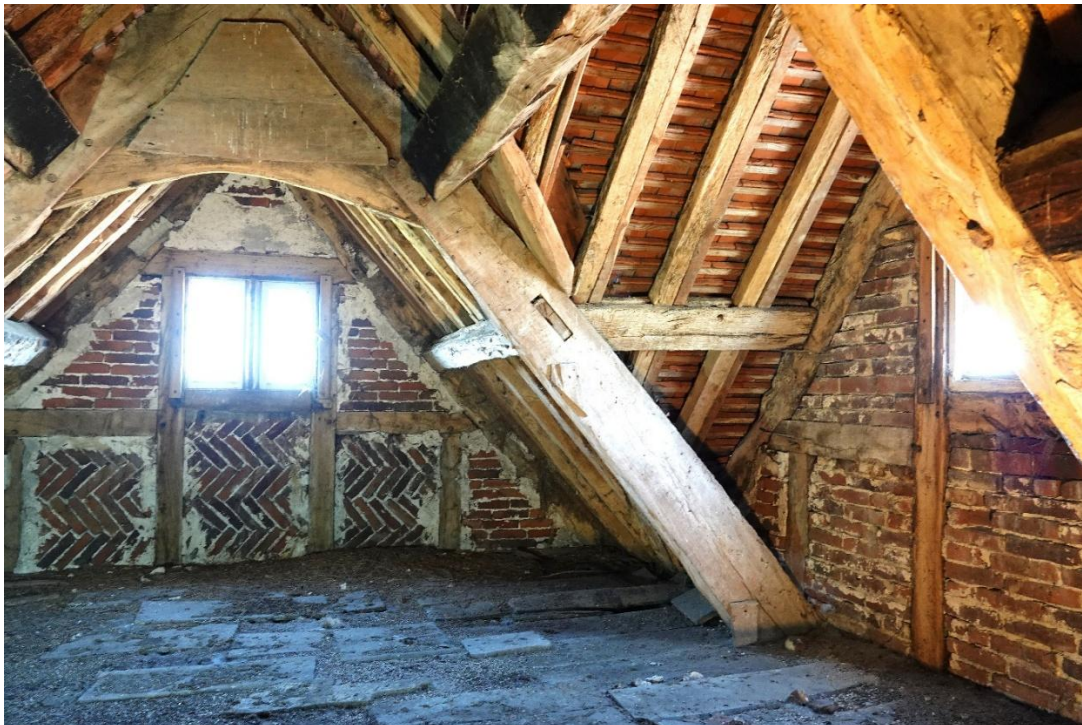
**Fig.146** A general view to the north corner, showing the two gables

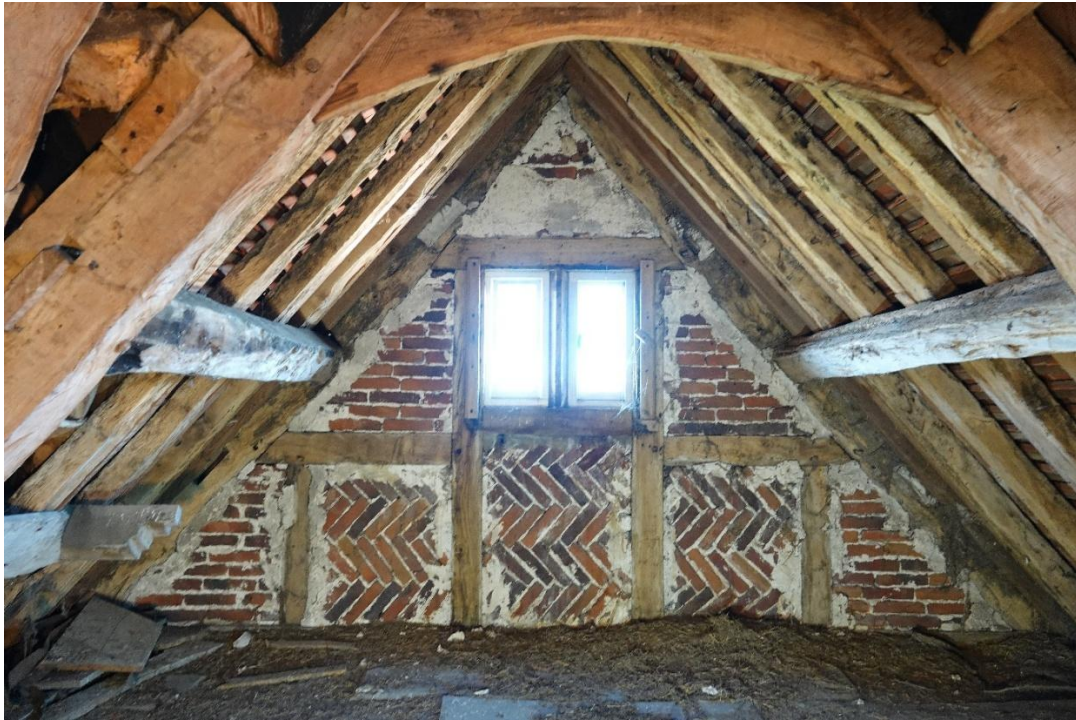
**Fig.147** *The timber-framing of the front (NW) gable, set in truss T6*

The timber-framing on the two gables is exposed to the room (**Fig.147**) and comprises rectangular panels, single-pegged. There is a high-level collar in oak, which acts also as the window head. The window itself is a replacement. The window jambs are heavy studs running down uninterrupted to the tiebeam below. Either side of these is a rail and secondary studs below. The infill can be seen in **Fig.147** and has three panels of herringbone brickwork, with the other panels in header brickwork. The bricks are laid in white lime mortar and for the herringbone at least, may possibly be original (**Fig.148**).

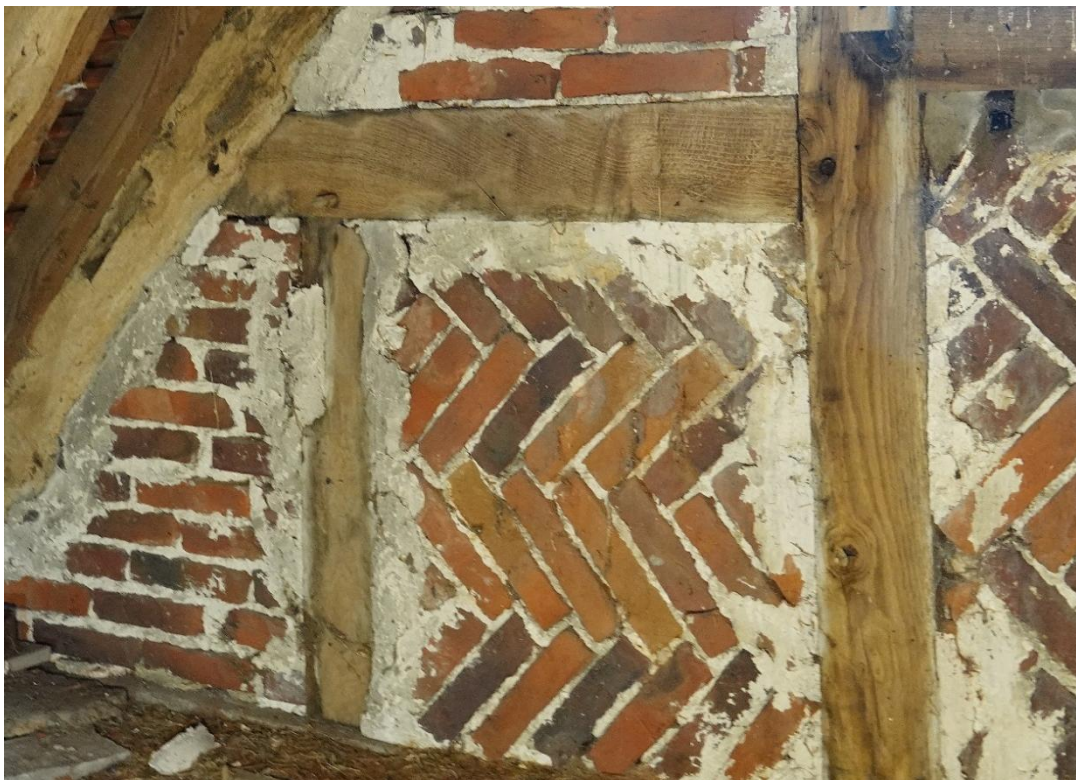
**Fig.148** *Detail of the timber-framing of the front (NW) gable*

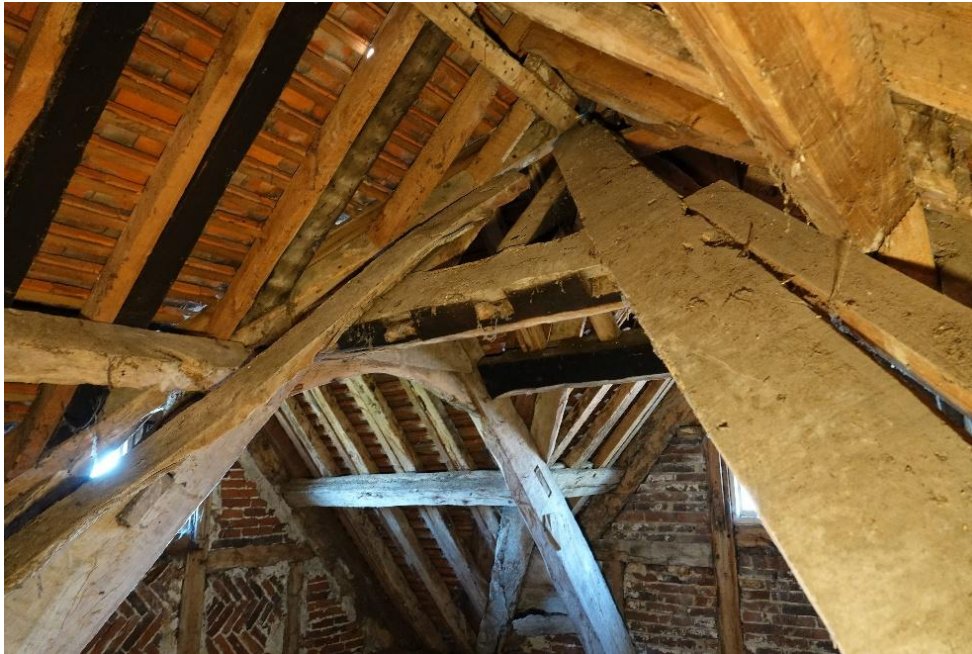
**Fig. 149** *The valley boards from the hall side (SW)*

On the SW side of the crosswing are heavy valley boards (**Figs.149 & 151**). These boards are steeply pitched and of heavy scantling but do not define the present valley and appear structurally redundant.

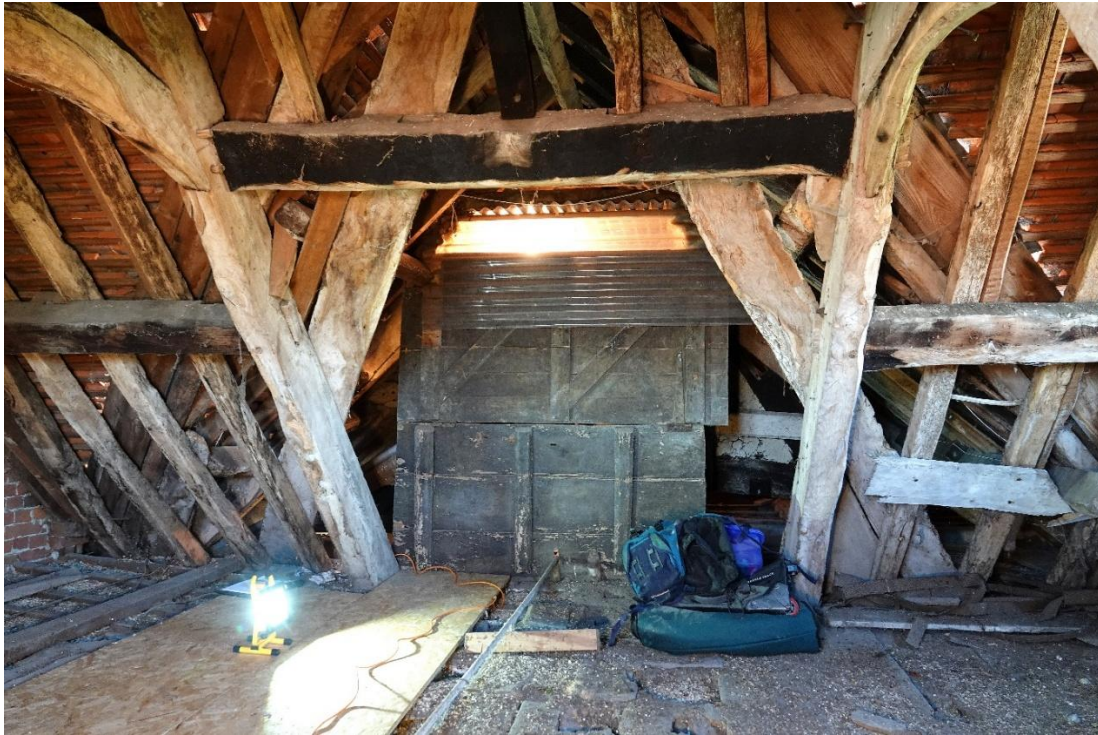
***Fig.151 The crosswing looking SW into the hall and cross-passage roof. The principal rafters of T4 and T5 are seen central in this photograph, with the valley boards immediately behind them***

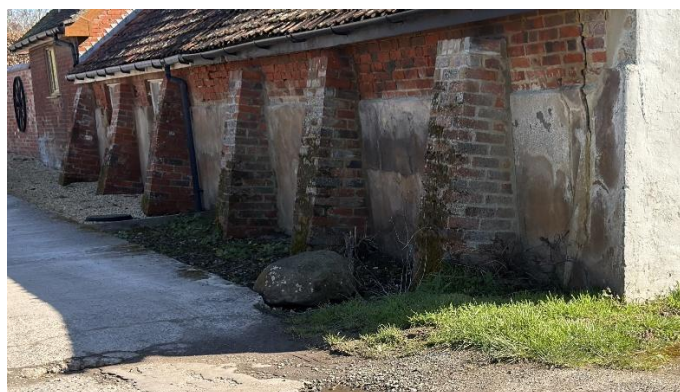
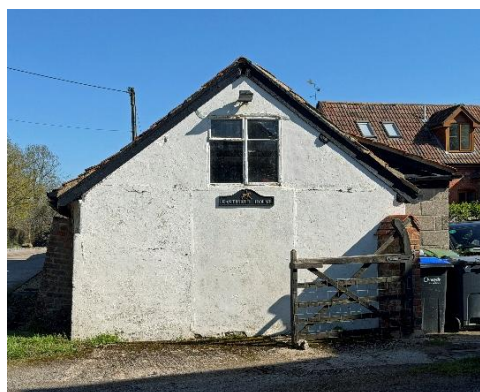
***Figs.152 & 153 Milking Parlour from south-west***

The construction is of Flemish garden wall bond (also known as Sussex bond) brickwork<sup>29</sup> on the rear elevation, with a pantile roof. When the building was extended at the front, the rear wall became outward-leaning, so brick buttresses and a concrete render were added to this (**fig.152**), and to the south-west gable, which has a Crittal-type window. The gable end of the building forms the north-east side of the entrance to the farmyard, and an Arts and Crafts-type gatepost is attached to the stub of a wall against the gable (**fig.153**).

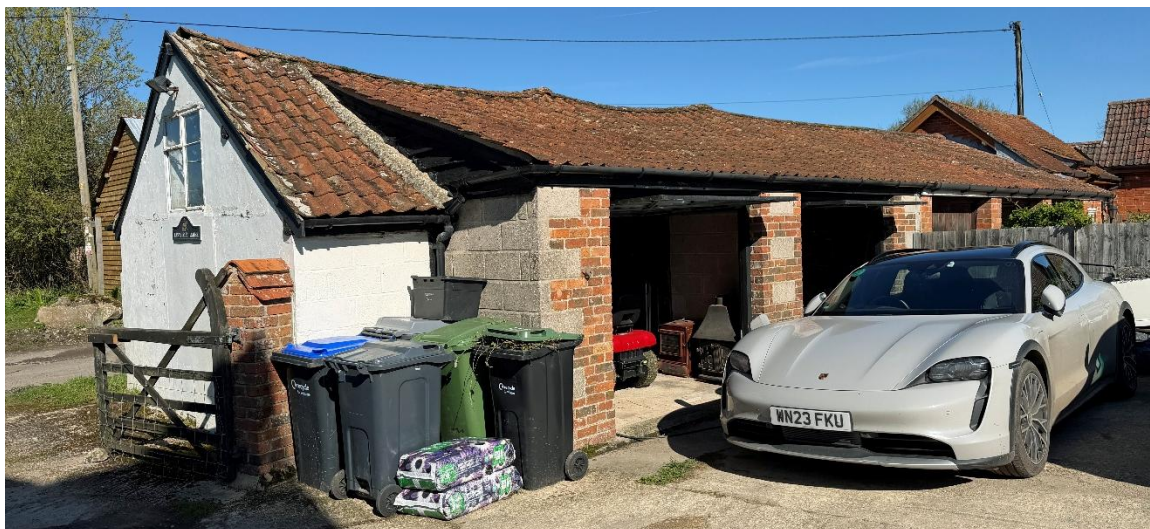
***Fig.154 South east open front***

The open side has been extended into the yard by about 1.5 metres after 1924, formed in concrete block and old brick, with a concrete floor (**fig.154**).

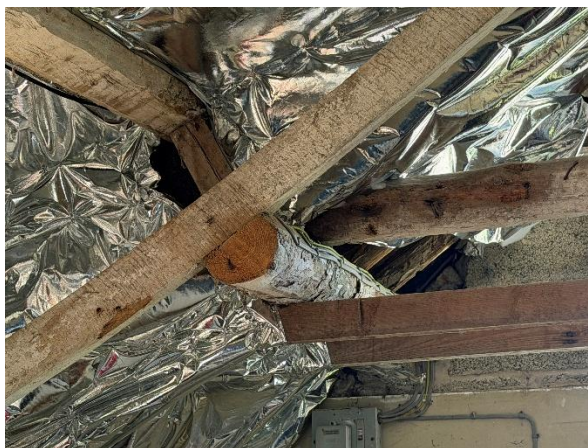
***Fig.156 Strutted purlins to raise the roofline***

The **interior** of the roof has been lined, but the sawn softwood of the main truss is still visible, and light pole purlins, some of which are simply scarfed and nailed together (**figs.155 & 156**). This remaining truss has a tie to the top of the wall and the wall-plate of the open side, once with raking struts on either side of a strainer timber (**fig.155**). A partition wall with End Farm is in concrete block clad in vertical planking.

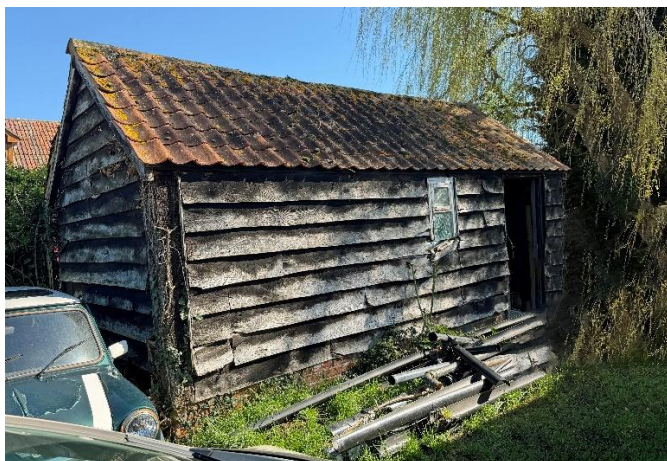
***Fig.157 South-west elevation***

Small weather-boarded, timber-frame shed on a concrete-mortared brick plinth set on a concrete raft foundation (**figs.157 & 158**). Pitched pantile truss-less roof. Frame of sawn softwood with a plank ridge. The king post and raking struts directly support the purlins. The rear is clad in corrugated iron. Concrete floor. Multi plank door on heavy cast iron strap hinges. The single visible jowled post suggests that this is a 19<sup>th</sup> century structure that was relocated to the present position after c1970<sup>30</sup>.

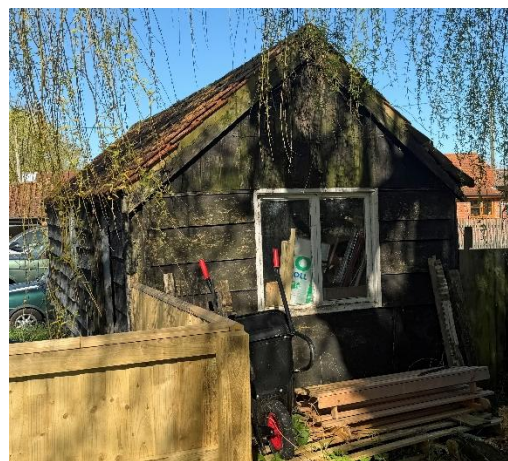
***Fig.158 South-east gable***
