Littlecott Mill, Enford, SN9 6AW  
Design & Access Statement

1.01 INTRODUCTION

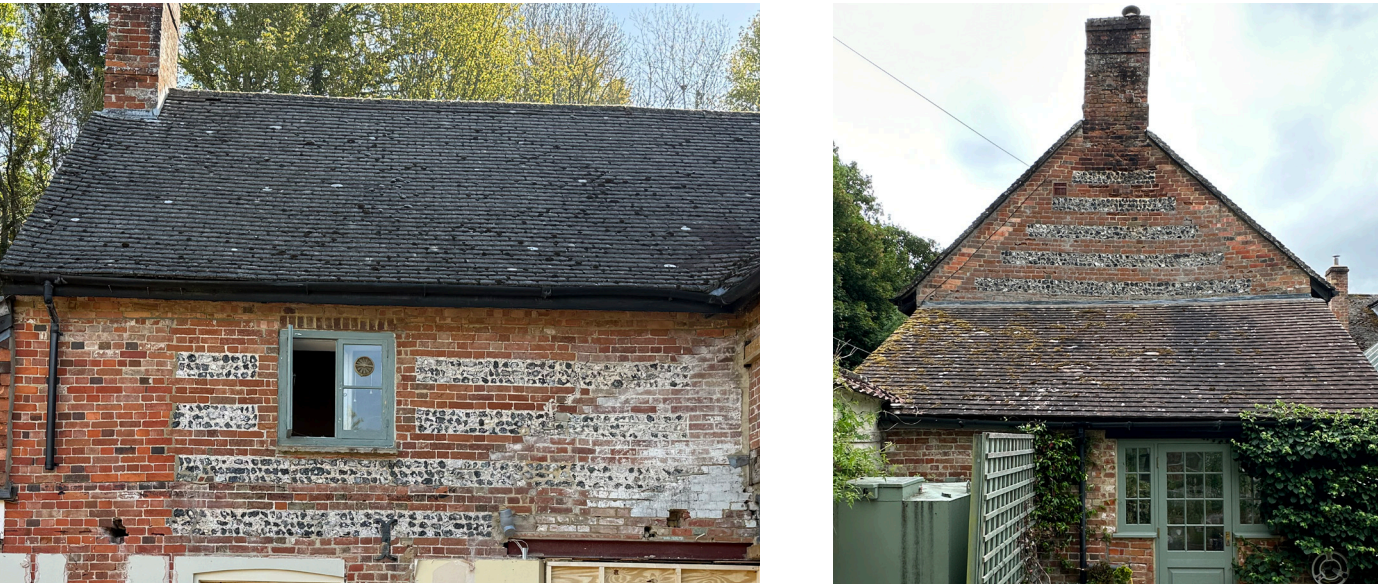
Images: Evidence of extra brick coursing below the eaves and on the gable end verges to mask the subsidence.

Site renovations have unveiled previous remedial interventions, including additional brick coursing at the gable end and eaves, which appear to have been introduced to mask the effects of differential movement rather than address the underlying cause. Internally, timber furrings ranging from 5 mm to 300 mm in depth were installed to level floors within the east wing, further evidencing long-standing and unrectified subsidence.

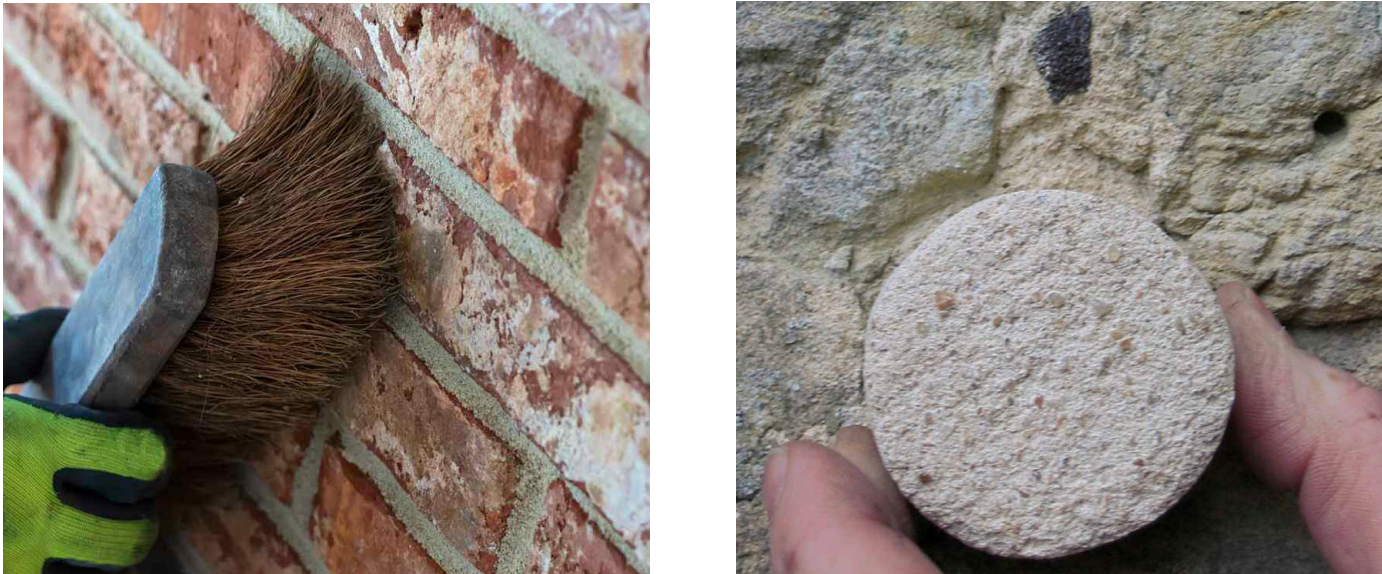
Image left: Brickwork to be reinstated and traditional lime pointing to be used extend the life of the brick.  
Image right: A lime mortar 'biscuit' to help colour match to existing pointing on site.

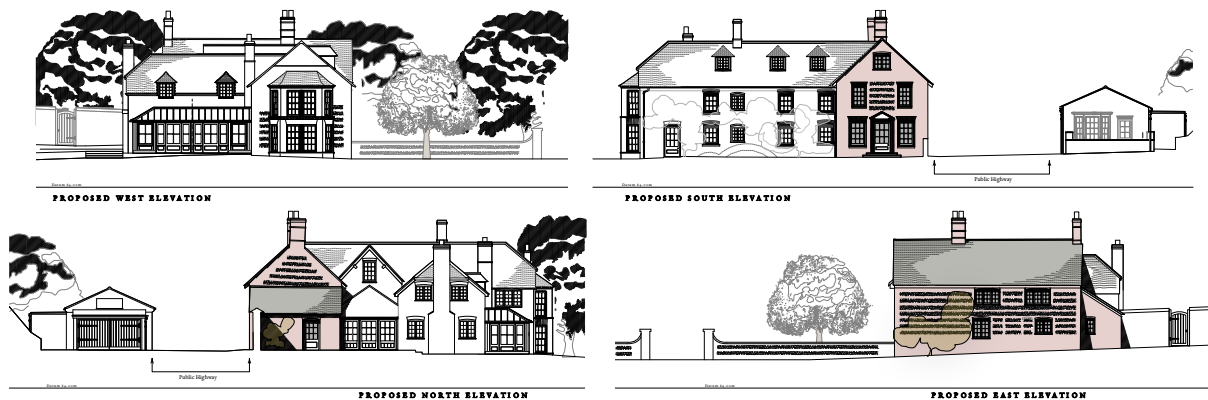
Above: Elevations highlighted to be carefully dismantled and reconstructed with the help of PER and cataloging materials.

A photographic evidence report (PER) of the elevations will be undertaken, including detailed recording of the flint banding, to support accurate architectural details and straightforward reconstruction. Historic features that illustrate the organic development of the building, such as the remnants of previously blocked openings, will also be reinstated where appropriate so as not to diminish the character of the building.
