# Tottenham House and Estate

## Design and Heritage Statement

Approval of Details Application to partially discharge  
Condition 11 Ref 18/00195/LBC Walled Garden Repairs  
and Openings and Condition B Ref PL/2024/09243

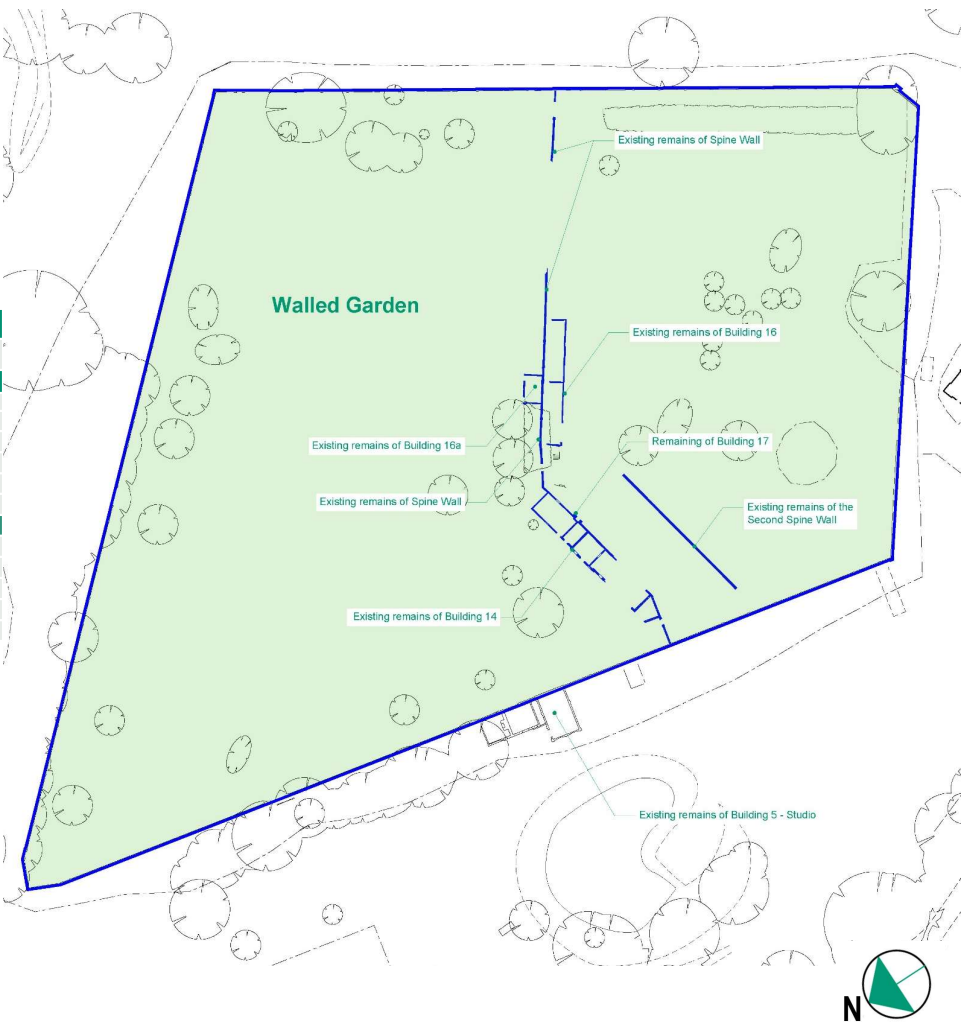
Figure 1 - Existing Spine Wall within Walled Garden Landscape – Not to Scale

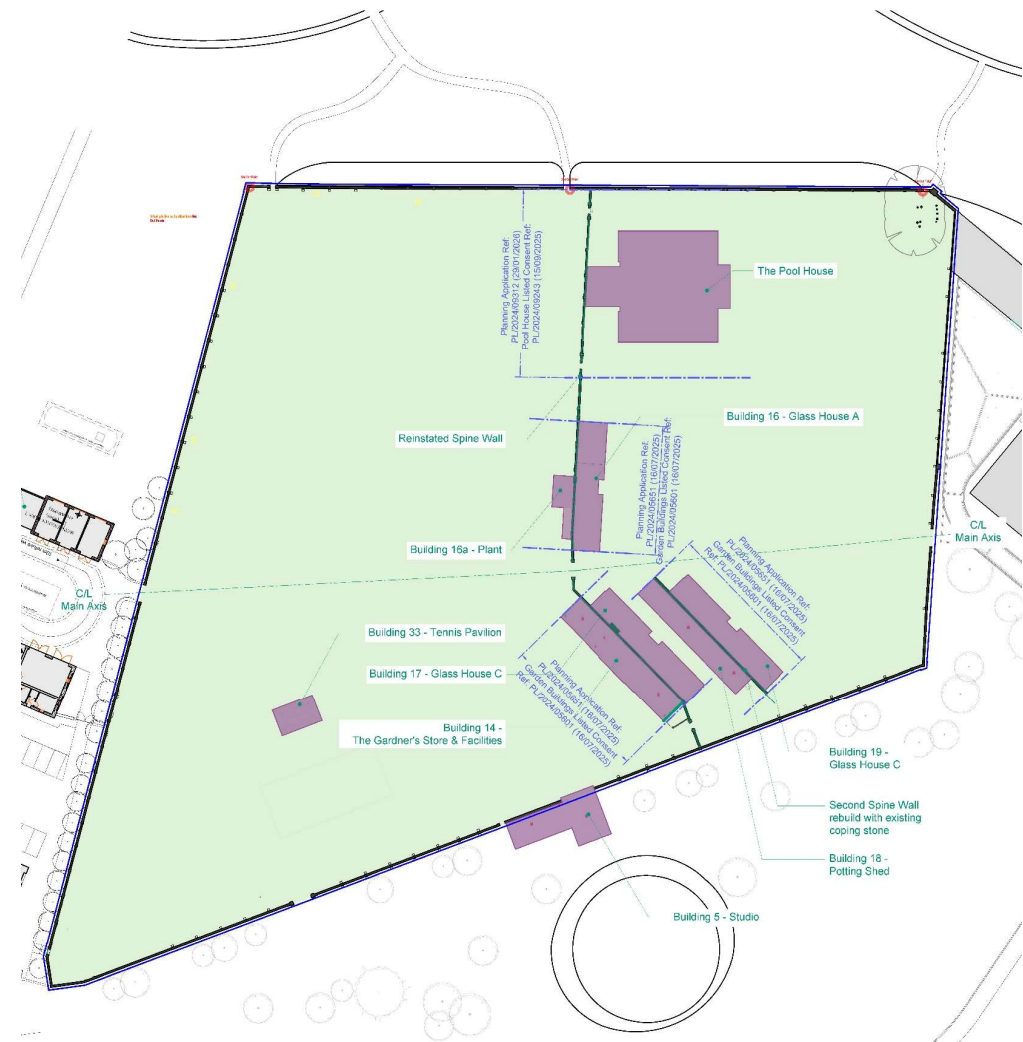
**Figure 2 -** Proposed Spine wall within Walled Garden Landscape (Not to scale) identifying buildings

- 2.8 In summary- this statement is to cover the sections of Spine Wall where it is not part of the buildings listed above and therefore covered under those consents. (See BLDA Drawing No 3122 202 A and the Elevations 3122 220;220.1;221;222 for demarcation of already consented sections.)

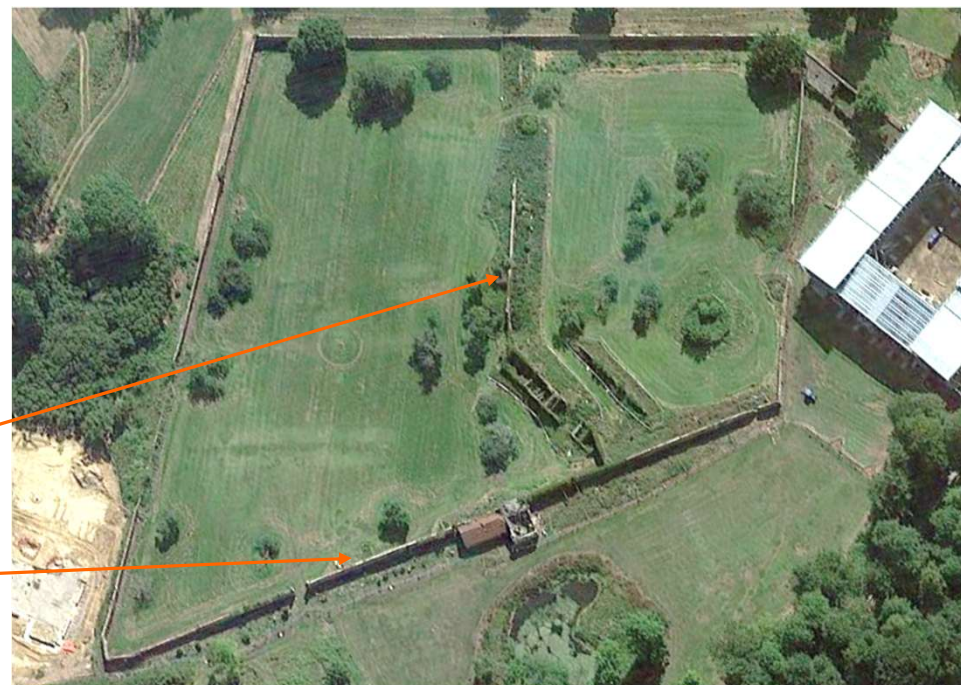
Spine Wall

Walled Garden Boundary

Figure 4 - Aerial photograph of the historic walled garden

- 3.2 The walled garden covers approximately 5 acres and is divided into two sections by a spine wall running from east to west- which is primarily the subject of this Statement.

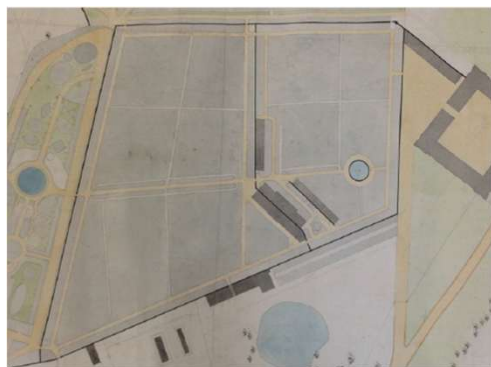
Figure 5 - Historic Walled Garden 1830 Plan

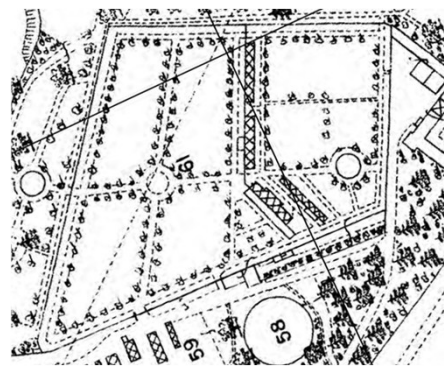
Figure 6 - Historic Walled Garden 1880 OS Plan

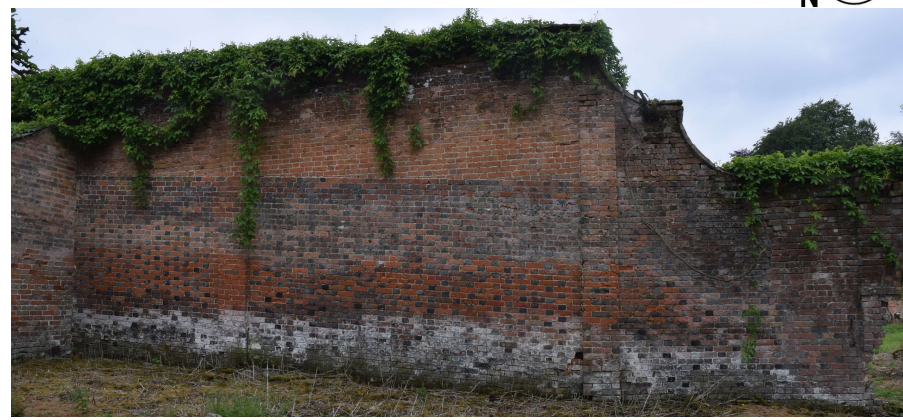
Figure 7 - Historic Walled Garden (Historic Photograph)

- 3.3 The photographic evidence from the recently surviving sections of the wall show that it was built with a similar Flemish bond red brick with black header pattern to that in the surviving external walls. There is strong evidence to suggest that the pattern was originally a full regular black header pattern. This can be seen where the original construction has been enclosed within Building 16 as an example. The original thickness was generally about 380mm thick or 1 1/2 bricks, (with regular piers approximately 440mm thick) all laid in lime mortar.

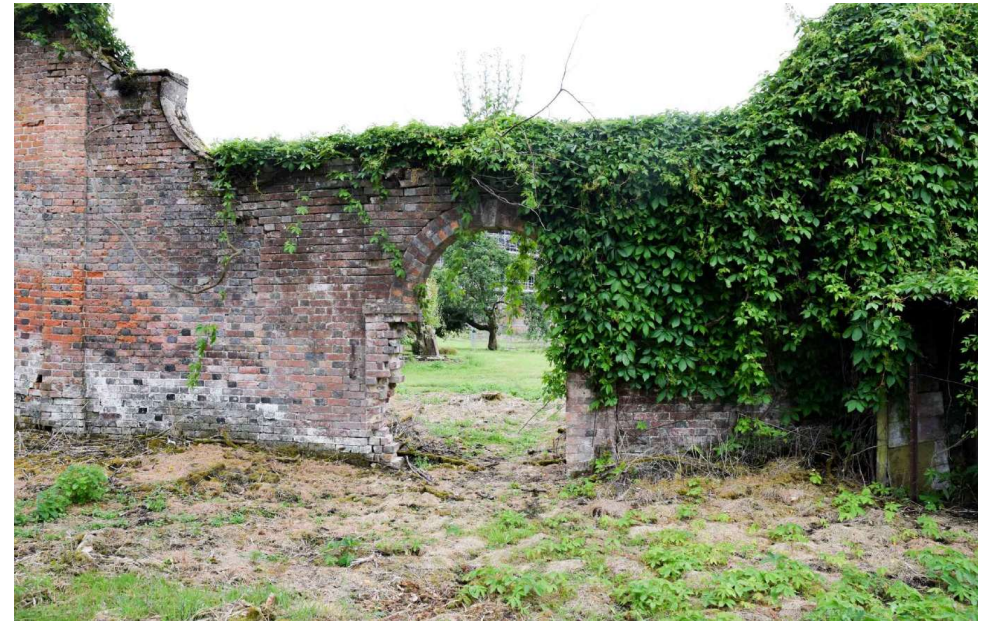
Figure 8 - Historic photograph of opening 2

- 3.6 There was also a larger arched opening in the center section of the wall on the line of the historic pathway axis running north south between the historic fountain pond in the south section and the feature plinth in the North section . The available photographs, taken in 2021, show this opening to be in very poor condition. We can also see that the arch and the brick work around it have been rebuilt at some time in a different brick to that in the adjacent wall- with a distinct jagged vertical construction joint and mismatched brick coursing due to the different size of the bricks used. It is also notable that it is a common arch, not gauged as the original opening near the west end of the spine wall. All evidence suggests that this central arch and this section of the wall have been rebuilt at some stage and the work is not of the quality of the rest of the original wall. Please see the photographs on Drawing Number 3122 220.1

- 3.10 During 2022 there was a severe storm which caused further damage to the weakened wall- some sections collapsed- it is at this time the central arched Opening 2 appears to have fallen down - such that by the time of the current existing survey it had disappeared altogether.

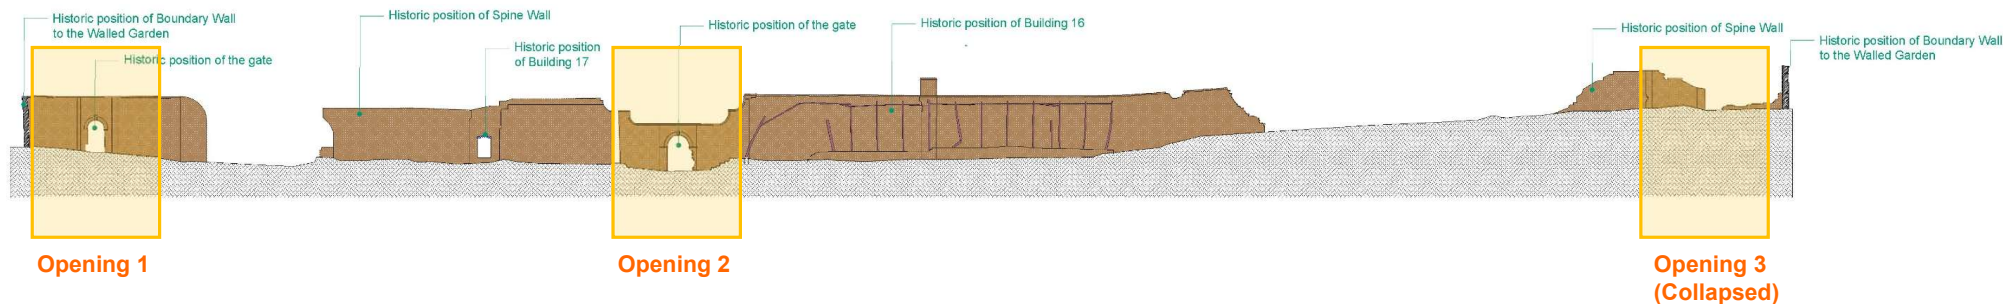
Figure 9 - Existing Spine Wall Elevation to South (Not To Scale)

- 3.4 The principal spine wall was originally built with 3 openings. For clarity these are labelled as openings 1, 2 and 3 on the existing elevations.

- 3.7 It can also be seen that the spine wall was extended up wards at some time possibly to enclose the north side of building 16 . This added brickwork does not have the regular black header pattern.

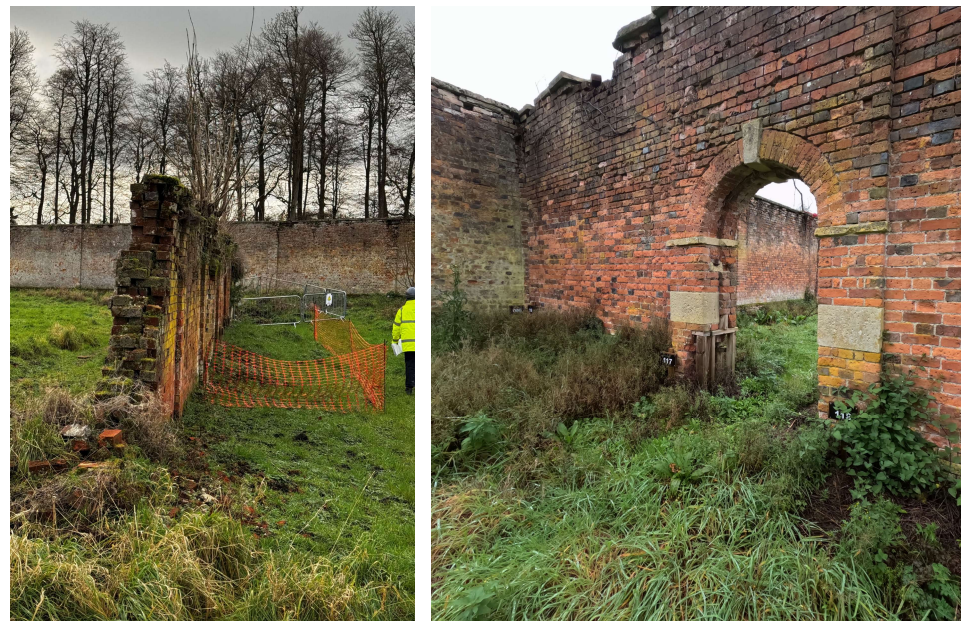
Figure 10 - Historic photographs of Spine Wall, Opening 3 on RHS

- 3.8 Located near the east wall, there was only evidence of the edge of the opening extant in the existing survey - and this now covered under the consented Pool House North and South elevations. See Drawing Ref No:3122 021 A

- 3.9 By the time of the current ownership of the site, the spine wall was in a very poor condition with large sections of the wall missing. The remaining sections had missing coping stones and the brick work had suffered extensive damage caused by water saturation of the top third of the wall- washing out the joints and darkening the brickwork. The bricks can be seen to be coming loose at the top of the wall- early photographs show extensive creeping plants rooted at the top of the wall, which will have caused much of this damage.

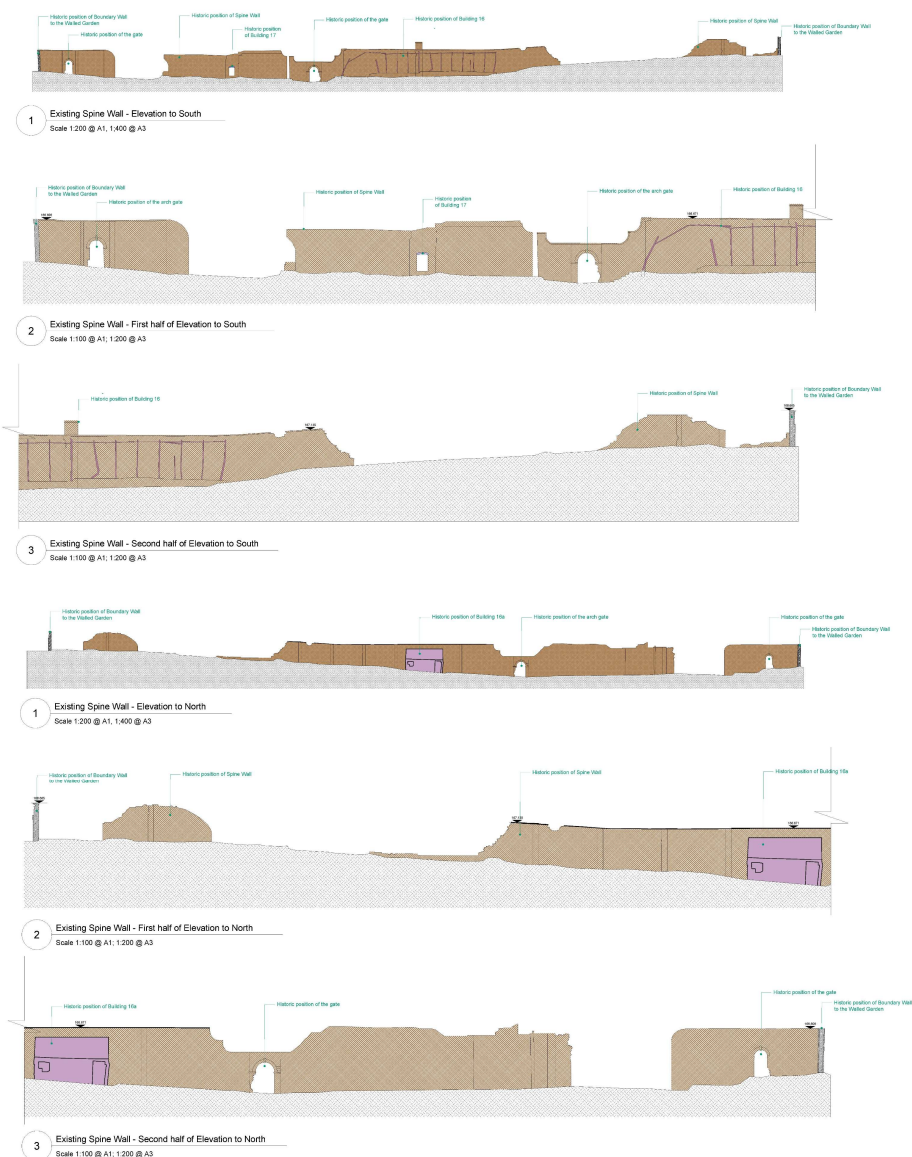
**Figure 11** - Existing spine wall

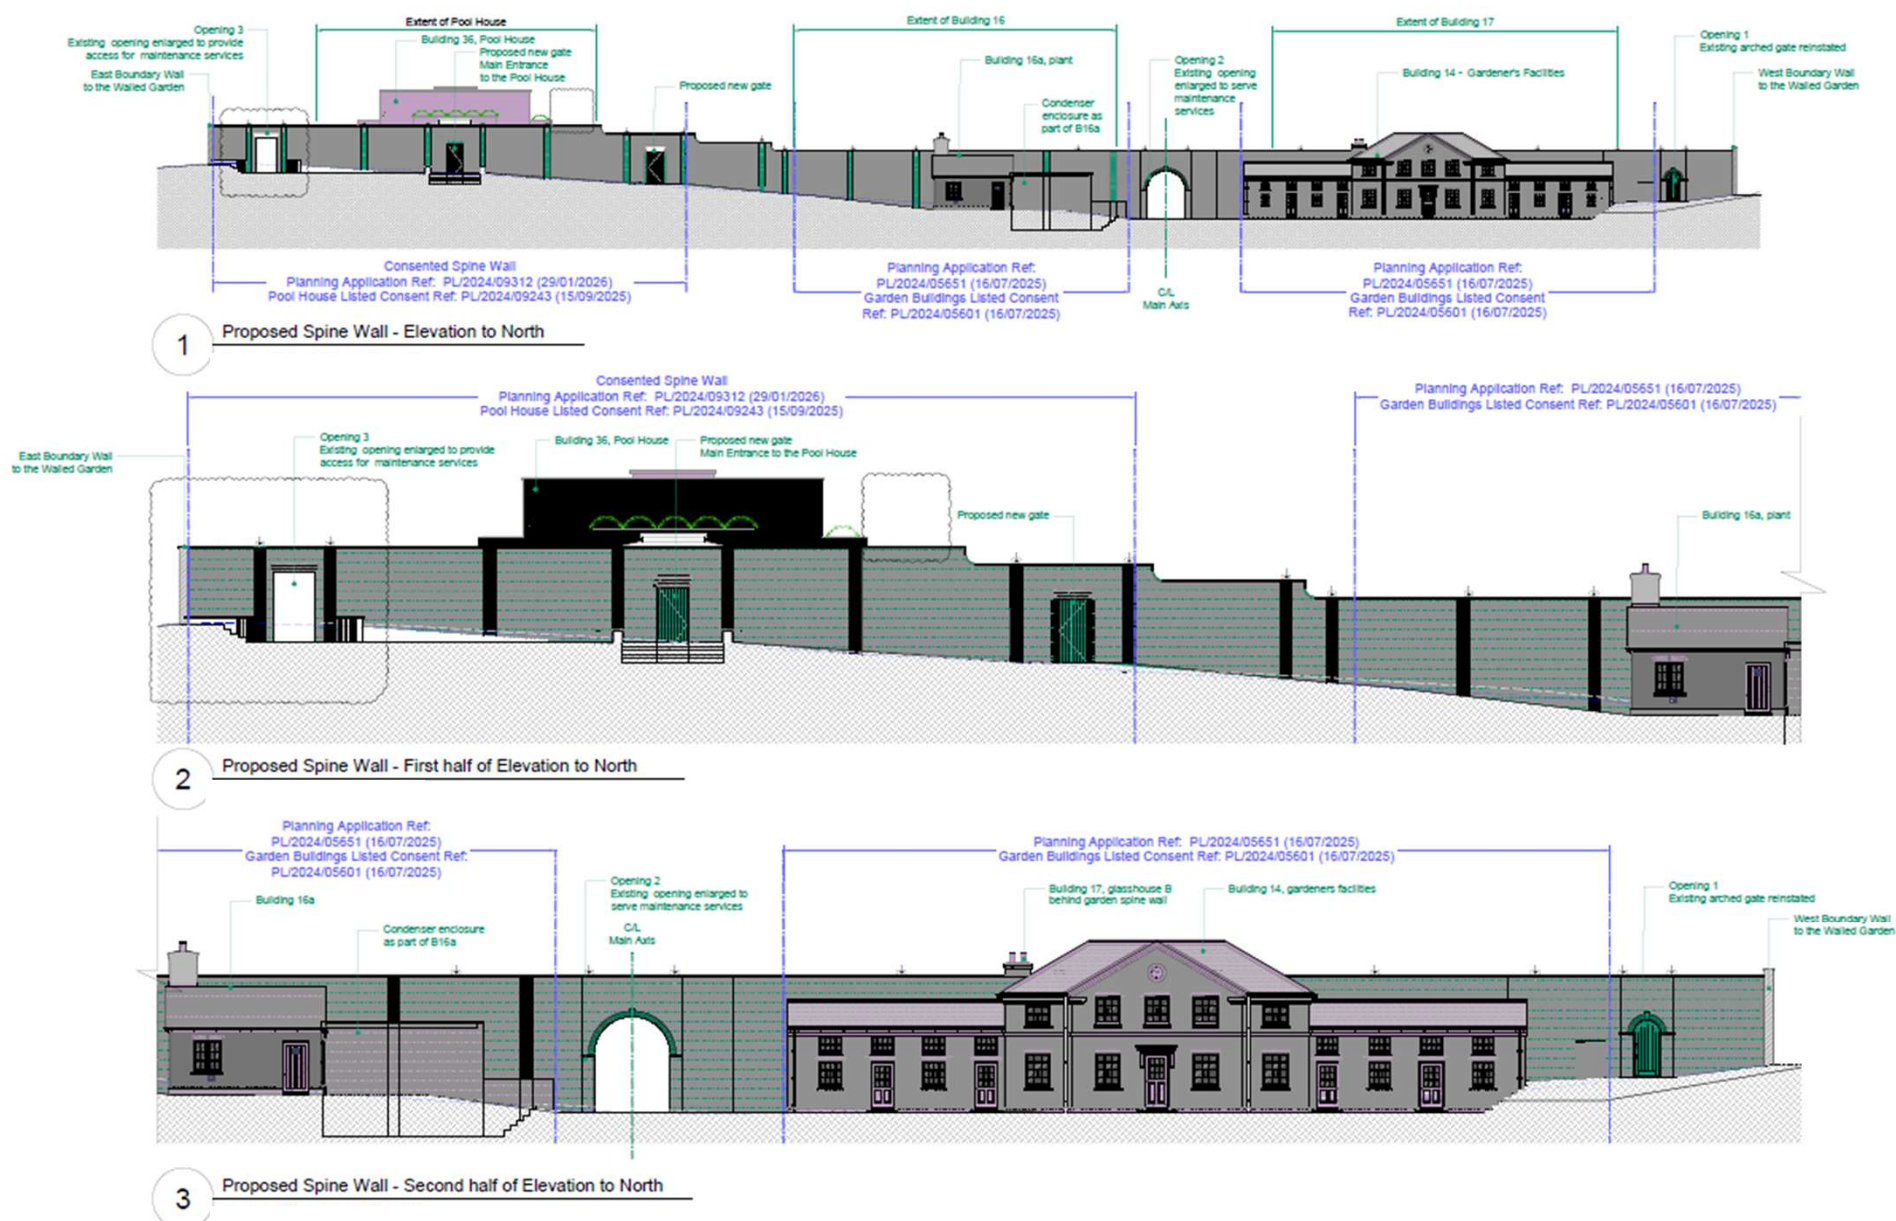
**Figure 12** - Proposed Spine Wall Elevation to North (Not to scale)

- 4.1 The scope of the proposed work is to reconstruct the spine wall in a like for like manner, using new bricks closely matching the original bricks and header pattern in accordance with an approved sample. Many of the existing bricks recovered from the dismantling of the spine wall are in very poor condition and not fit for reuse. The small quantity of useable bricks will therefore be used in the repair of the adjacent east and west garden walls.

- 4.2 In the reconstruction, the original piers and wall thickening around the openings will be faithfully reconstructed to the original plan and section following the survey information.

- 4.4 It has now also been found necessary to incorporate slender reinforced concrete columns within the piers in selected places to reinforce the slender wall sections to resist wind loadings. This is shown in the elevation, typical details and wall sections prepared by the Structural Engineer (MBP). Please also see their Structural Statement.

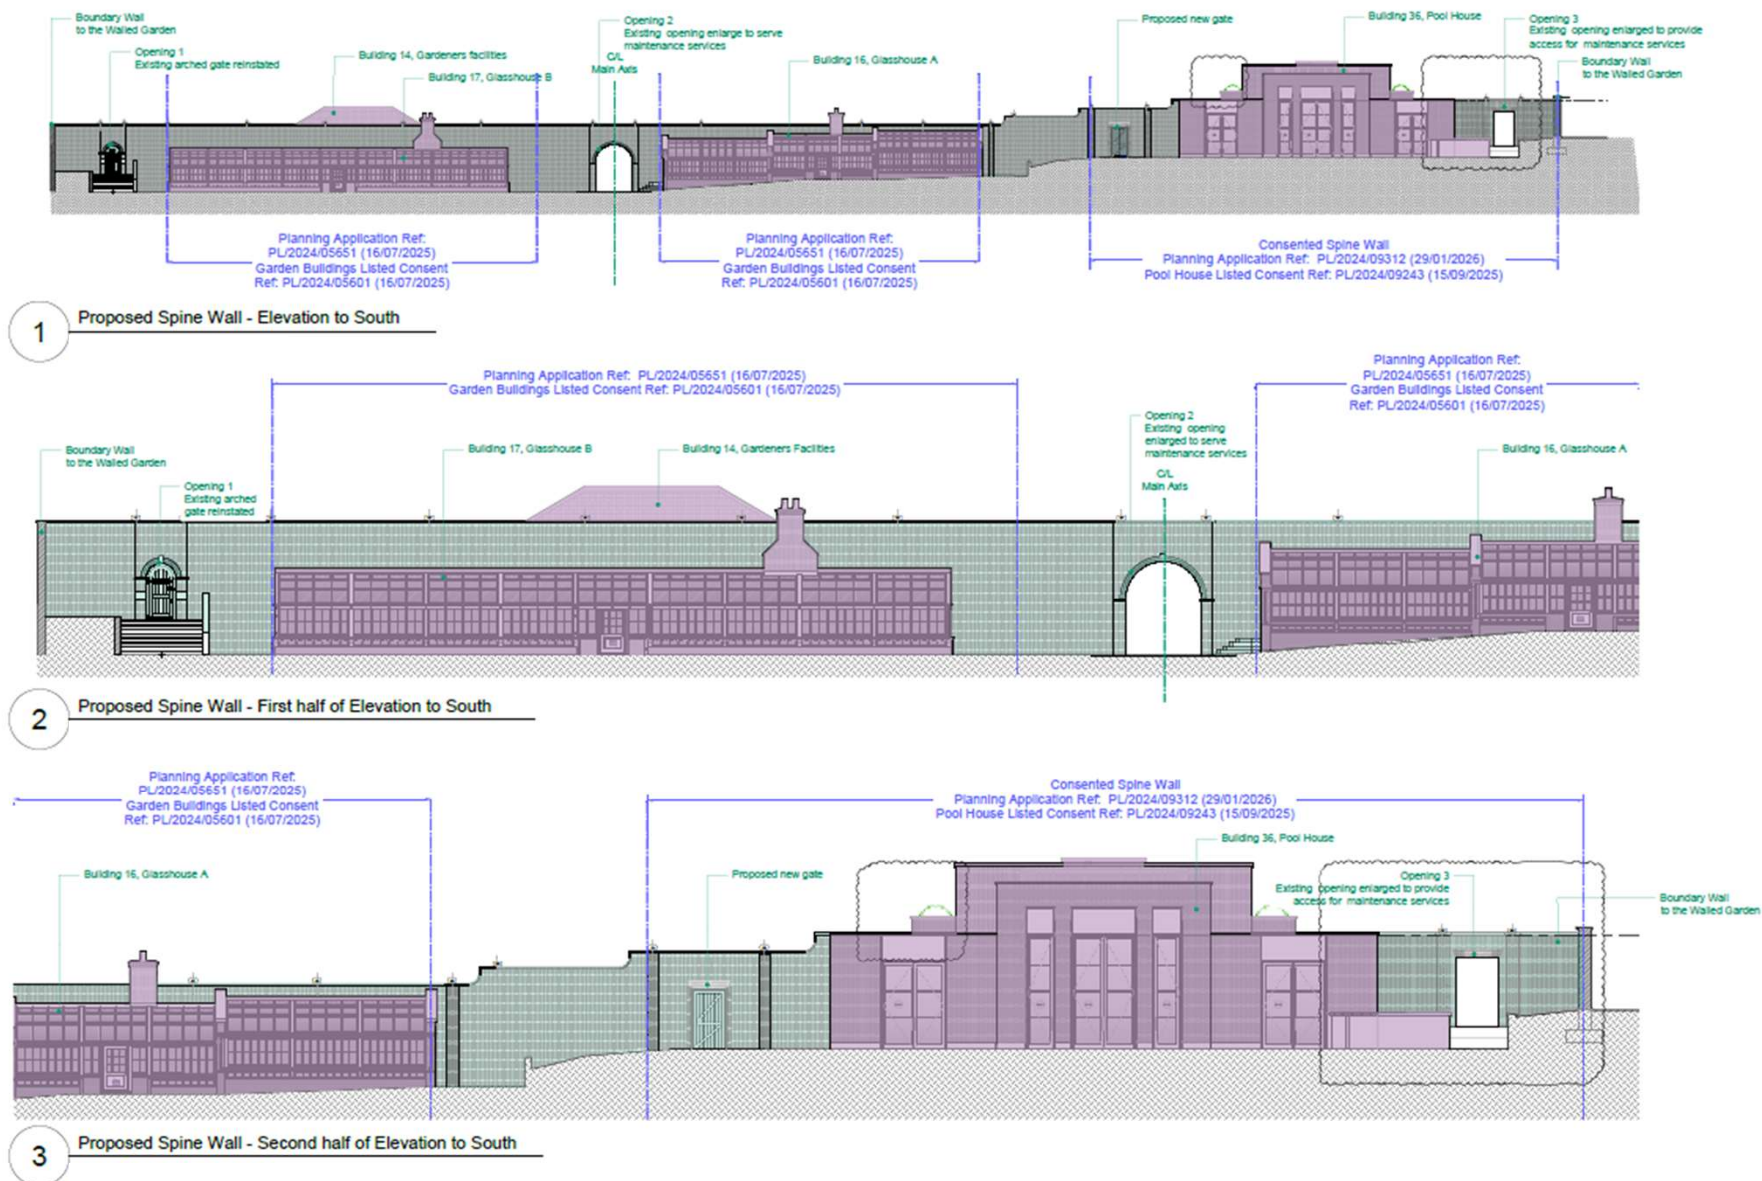
**Figure 13** - Proposed Spine Wall Elevation to North (Not to scale)

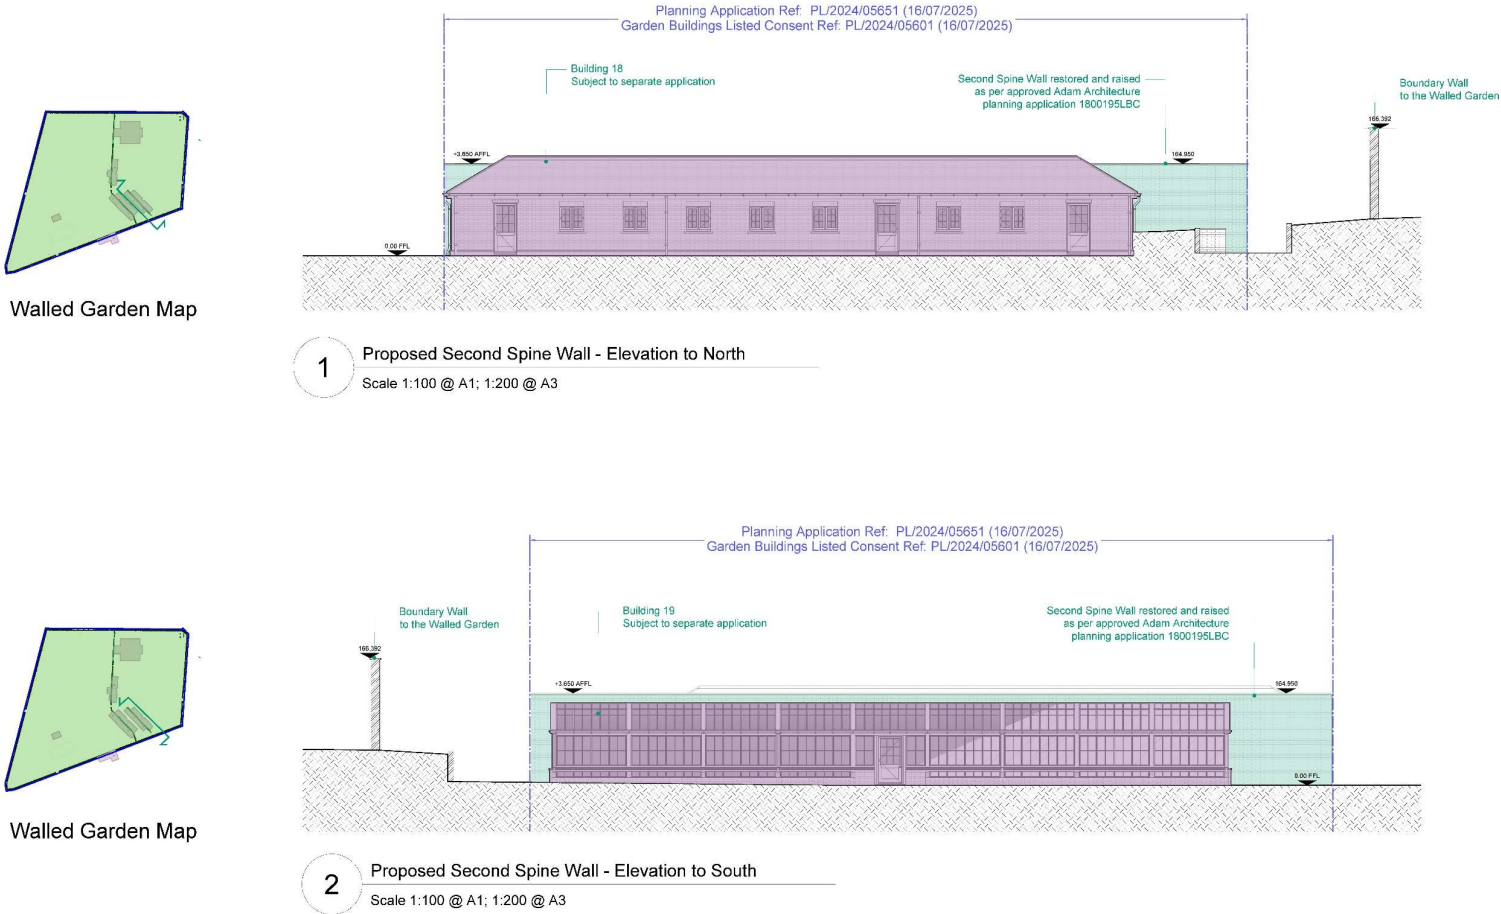
Figure 14 - Proposed Second Spine Wall Elevations (Not to scale)

- 2.7 We also include here the section of wall standing between and incorporated into the reconstruction of Building 18 and 19. This is built in the same manner as the central spine wall but stands separately. Although included already within the consents for those buildings- it is intended to incorporate existing coping stones recovered from the external walls that have been cleaned and are deemed fit for reuse into the reconstruction of this wall between Buildings 18 and 19.

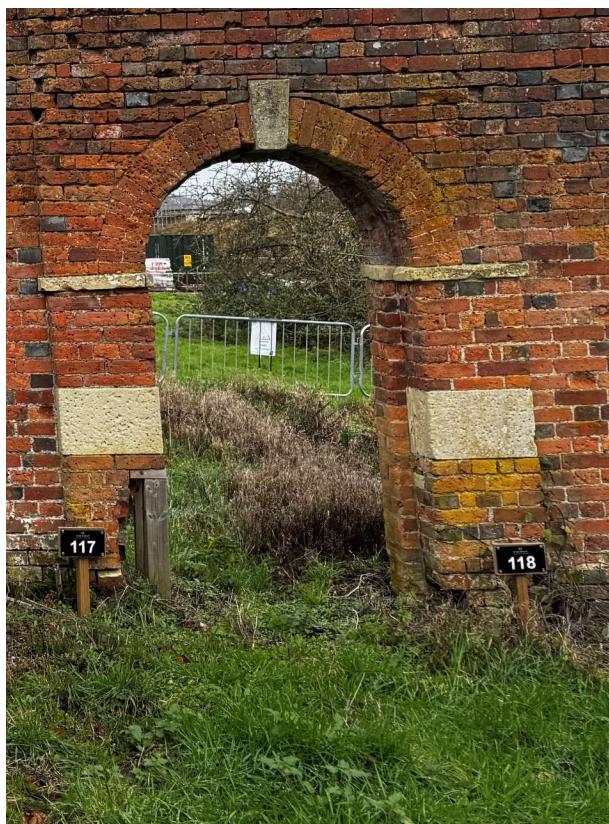
**Figure 15** - Existing Opening 1

- 3.5 A round topped arched opening built within a thickened section of the spine wall near the west perimeter garden wall. We can see this in recent photographs taken in 2024- with original gauged red brick voussoirs, stone string course, key stone and stone hinge pintle support blocks. The opening is rebated with the remains of wrought iron hinge pintles which would have supported a gate within the opening. (See Photos XXXXX )

- 3.15 Key elements of the west arched opening 1 were retained e.g. stone elements for reuse in the reconstruction of this opening.
- 3.16 Bricks, where not decayed, have been carefully cleaned and sorted for reuse in the reconstruction and repair works to the garden walls.

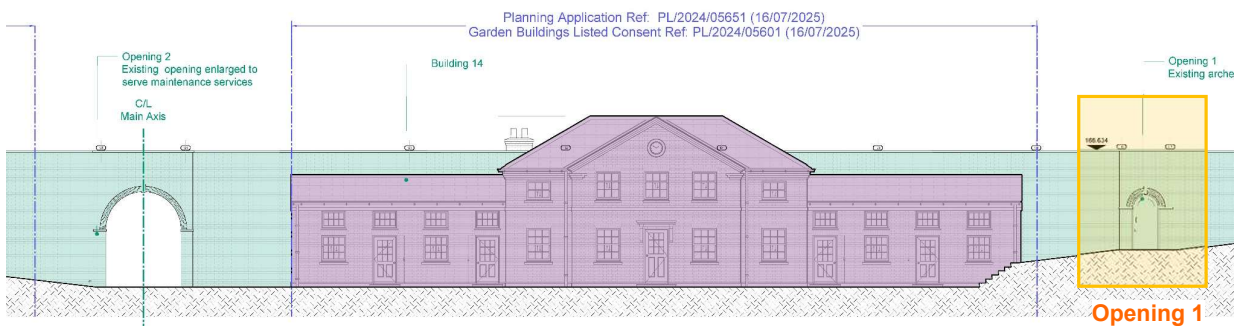
**Figure 16** - Opening 1: North Elevation

- 4.6 Opening 1 will be carefully reconstructed incorporating the original stone hinge support blocks arch springing point stones and keystones- with new gauged voussoirs to match the originals which were decayed.
- 4.7 A new gate will be manufactured for this opening using the principles established with the wooden gates in the external walls with similar ledges and stiles and L shaped hinge straps.

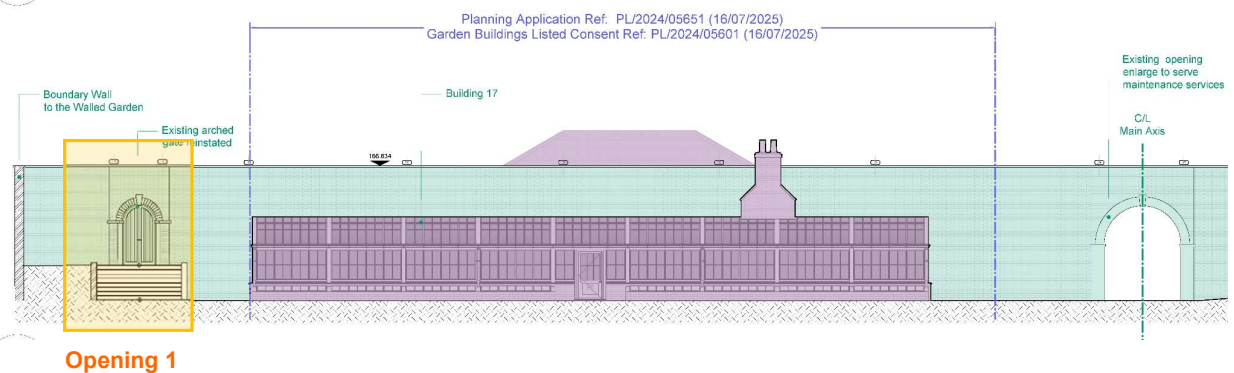
**Figure 17** - Opening 1: South Elevation

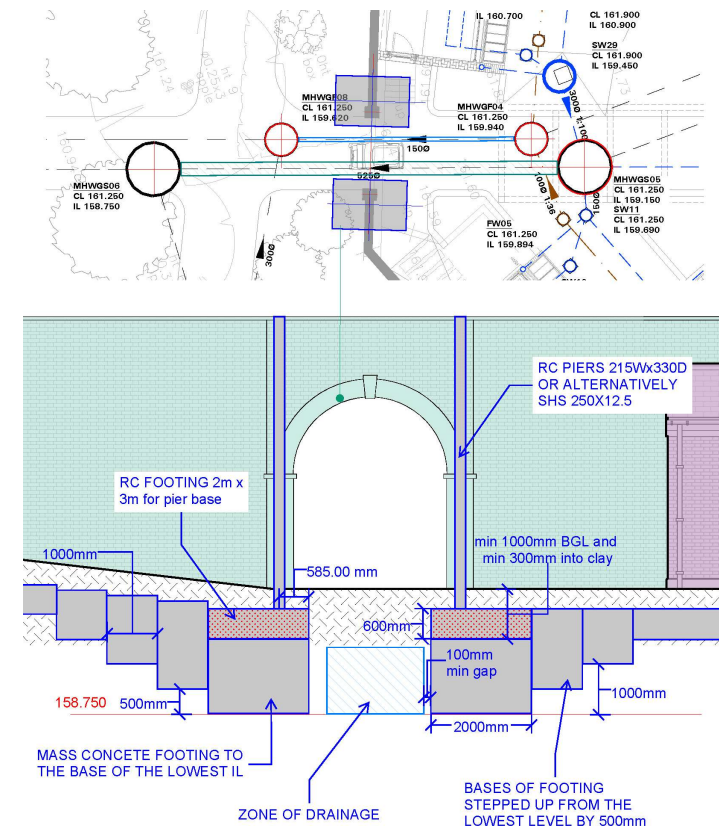
Figure 19 - Proposed Spine Wall: Elevation to North – not to scale

- 4.10 The larger arch would replicate the appearance of the original opening, as typified by the original west arched **Opening 1**. The top of the wall would be increased in height to maintain the scale and appearance of the original opening. It should be noted that the original section of wall above the original arch was reduced at this point and the new raised height above the arch would thus be level with the main section of the spine wall.

- 4.11 The arch that did exist recently had patently been crudely rebuilt with common brick voussoirs. We propose that the original example set by **Opening 1**-the West arch is followed to set the proportions and style for the reconstructed opening. New keystones and arch springing stones will be built into the work- as the originals have been lost. In the original survey data for both the old central arch 2 and West arch Opening 1 the section of wall was thickened by one brick thickness either side of the wall. During the reconstruction of the archway slender reinforced concrete columns will be incorporated into the greater wall thickness and it is intended to incorporate a concrete core to the brick arch as has been consented for the openings in the main garden walls to ensure stability and long life.

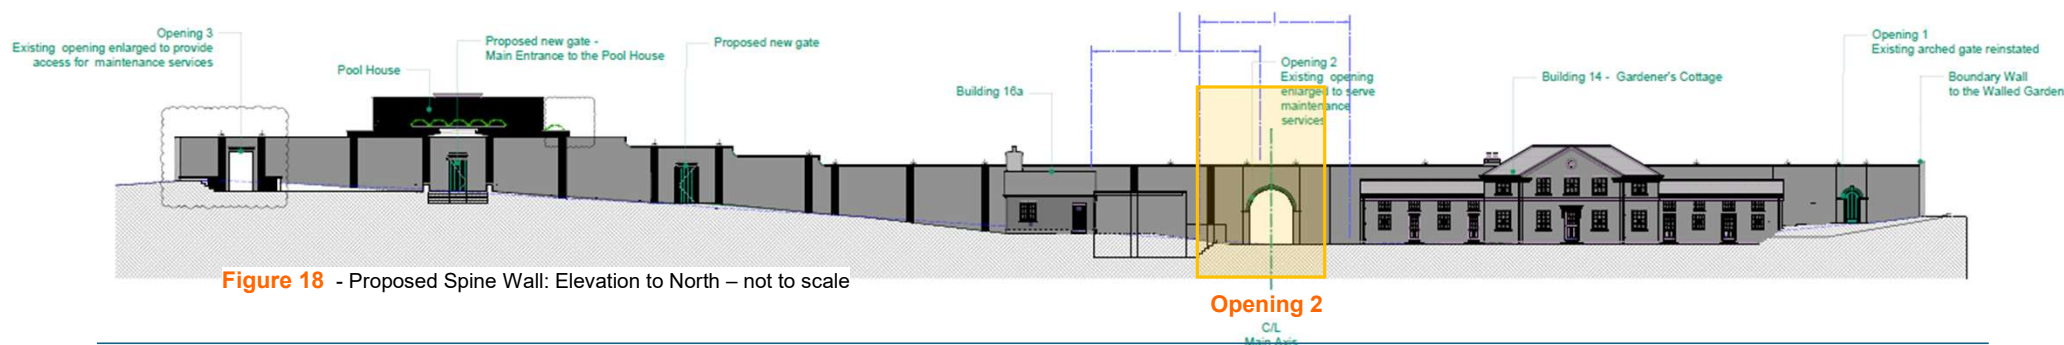
Figure 18 - Proposed Spine Wall: Elevation to North – not to scale

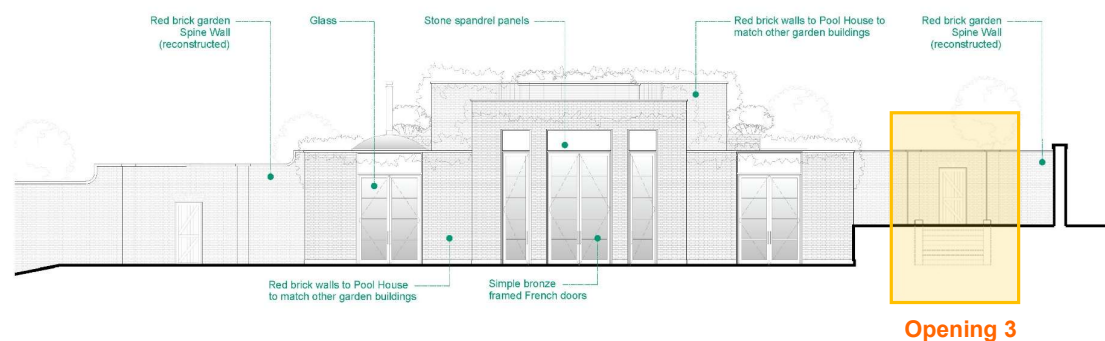
**Figure 20** - Extract from approved drawing 3121/220/E

- 4.12 The opening near the East external wall must have been a flat gauged arch opening - as the known height of the adjacent coping stones would mean that an arched top opening would not fit within the wall height. This had previously been shown as a flat arched opening in the consented elevations for The Pool House. (see Drawing Number 3121/220/E)
- 4.13 To provide improved step-free access for deliveries to the East Elevation of the Pool House Building, the proposed Opening 3 that had previously been approved has been slightly widened.

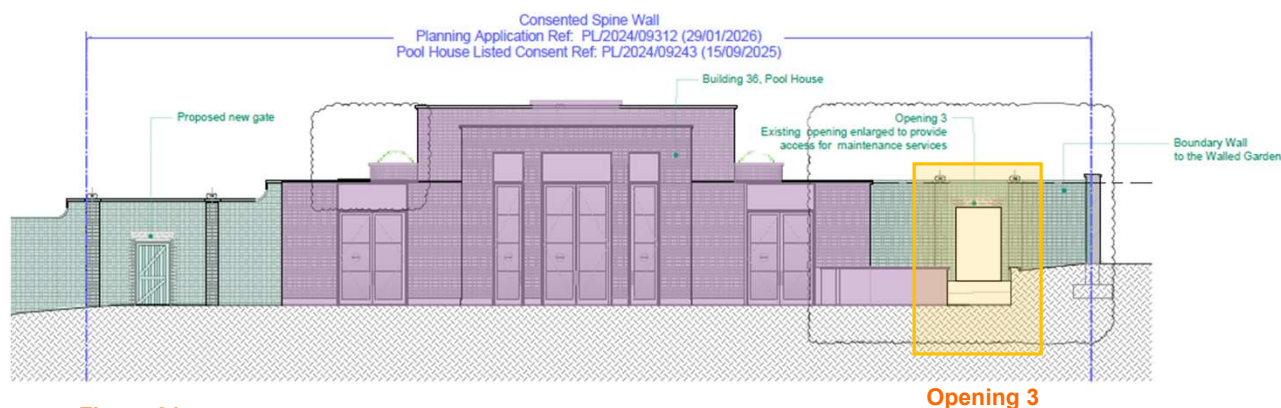
**Figure 21** - Proposed enlarged Opening 3

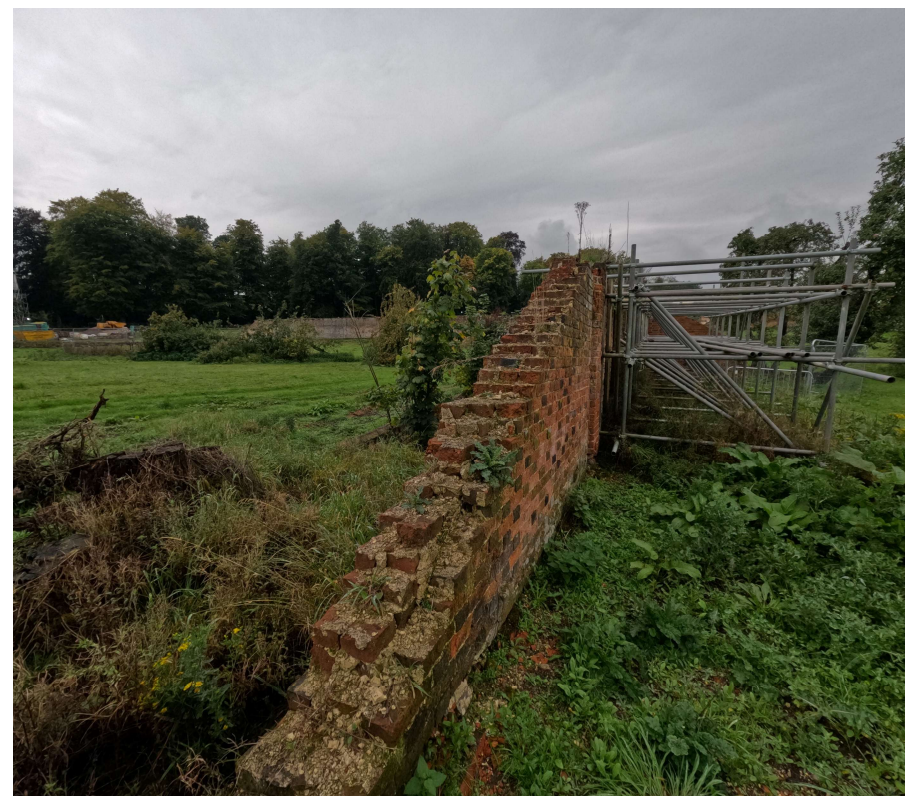
**Figure 22** - Existing spine wall brickwork

- 4.14 Many of the existing bricks recovered from the dismantling of the spine wall are in very poor condition and not fit for reuse. It is intended that reuseable bricks recovered will therefore be used in the repair of the adjacent east and west garden walls- and possibly during the reconstruction of the secondary spine wall between Buildings 18 and 19 to match the reused coping stones as set out in the section below.

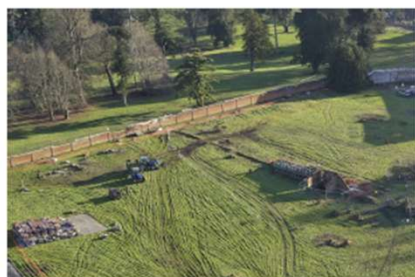
Spine Wall – Existing condition

The spine wall is of masonry construction and situated within the confines of The Walled Garden within The Tottenham House Estate and runs across the full width in an East-West direction. The wall was originally built in the late 18<sup>th</sup> Century, laid out by Lancelot 'Capability' Brown'. Surviving sections of the wall show that the original construction was generally 380mm thick brickwork, with regular projecting piers that are approximately 440mm thick, all laid with lime mortar. There is evidence that the wall has been adapted over its lifetime observable by construction joints and mismatching brick coursing, with vertical extensions also visible to the north side of Building 16.

The wall was in a poor and unstable condition as a result of water saturation, vegetation growth and possibly ground movement (foundations were shown to have varying depths). During 2022 the structure suffered storm damage and some sections collapsed. In 2024 it was decided by others that the wall was in an unsafe condition and represented a safety hazard to site personnel working on the external boundary wall repairs. The wall was therefore carefully dismantled in stages from January 2025.
