## **SOUTH WRAXALL** **South Wraxall Manor** Pilates Studio

### Design and Access Statement

Project No 1084

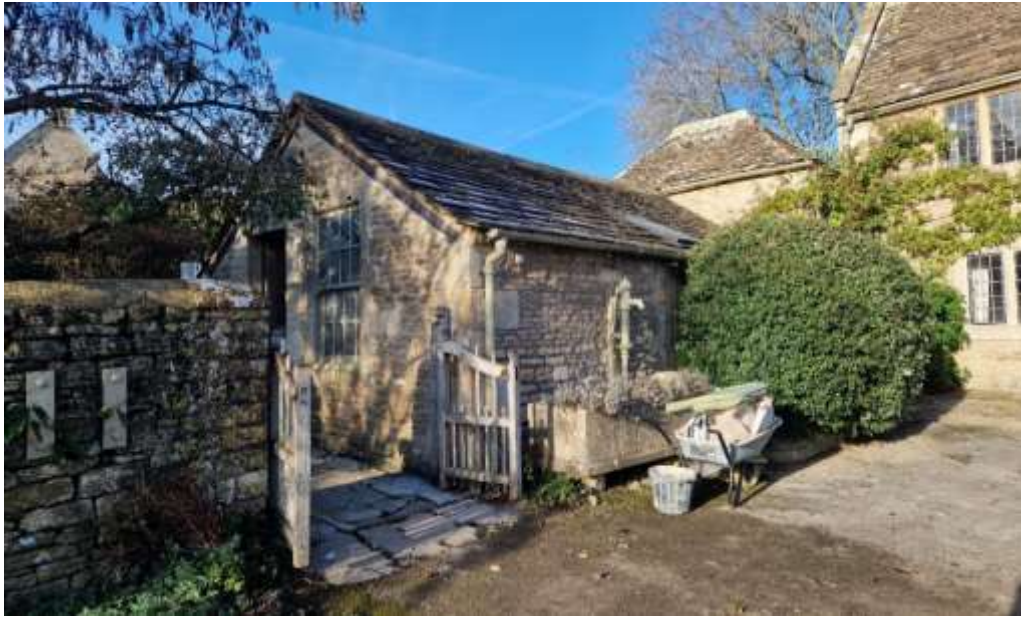
Workshop from the stable yard, re-used elements of dressed stone set within rubble masonry. Pavilion can be seen behind to the right.

The east and south walls of the workshop are of 1970s construction and its quoins and window are re-used from elsewhere. The relocation of openings and replacement units in timber with traditional detailing would be of overall neutral impact to its aesthetic value.

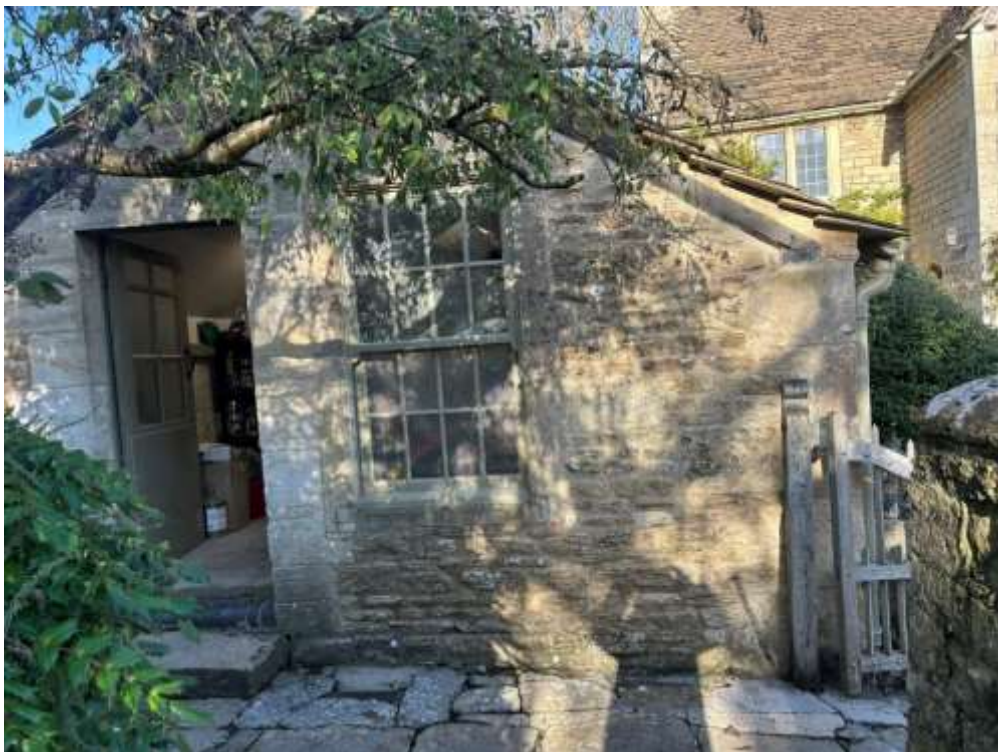
Workshop from the south, re-used sash window, concrete slab introduced to raise floor level can be clearly seen at the door threshold.

- 8.4. Other alterations will include introduction of external land drainage, repairs to the roof and repointing of masonry to reduce water ingress.
- 8.5. Internal alterations include the removal of a modern, concrete slab to the workshop and lowering of floor level here to provide increased headroom. Other alterations include the introduction of internal finishes of high quality.

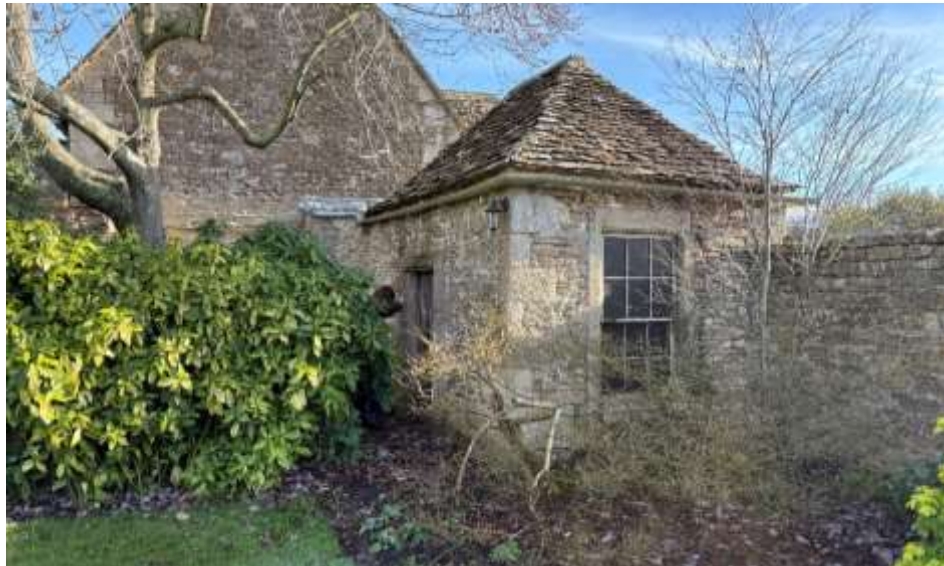
Pavilion from the garden - false window is actually painted board.

- ii. Workshop & pavilion: The pavilion is currently unused and its dilapidated door and false boarded window are currently negatively impacting its overall value and condition. Replacing with traditionally detailed units in timber would be an overall improvement. Internally, the sauna is to be a standalone unit which leaves the interior ceiling unaltered. Lowering the later inserted floor and blockwork will be beneficial with careful structural consideration. The stopped access will face north to the gardens and will be detailed in high quality materials; its impact is neutral. Overall, utilising the structure will safeguard its condition.

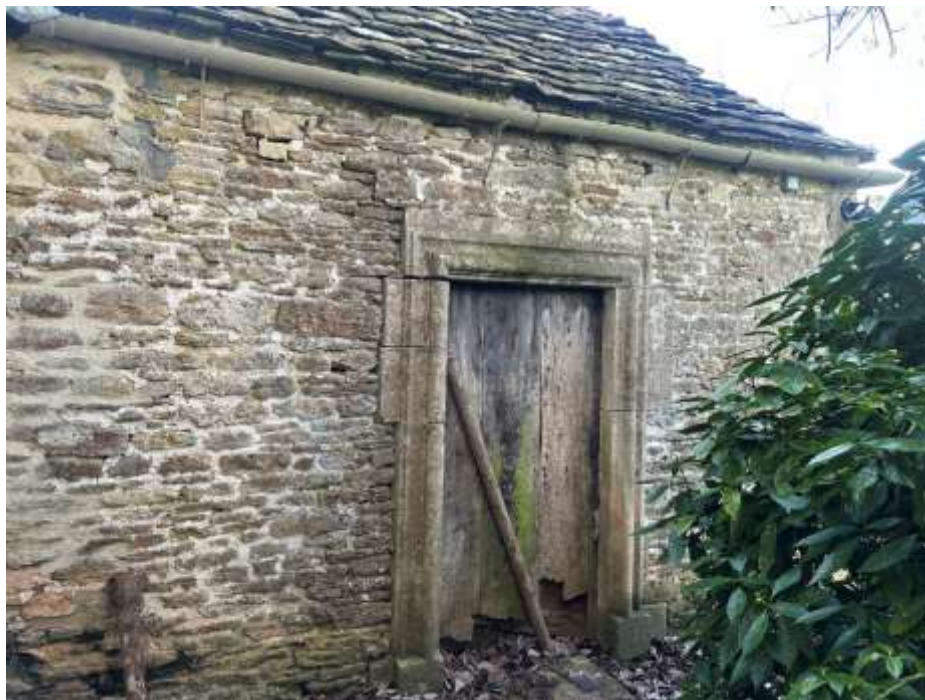
Pavilion, boarded opening which internally has a threshold considerably higher than floor level, is to be replaced by to be replaced by an additional window, cement pointing removed and masonry re-pointed with lime work. **Threshold to doorway to be lowered to allow use as door, plinth to be re-set at lower level, dressed stone surround to be extended.**

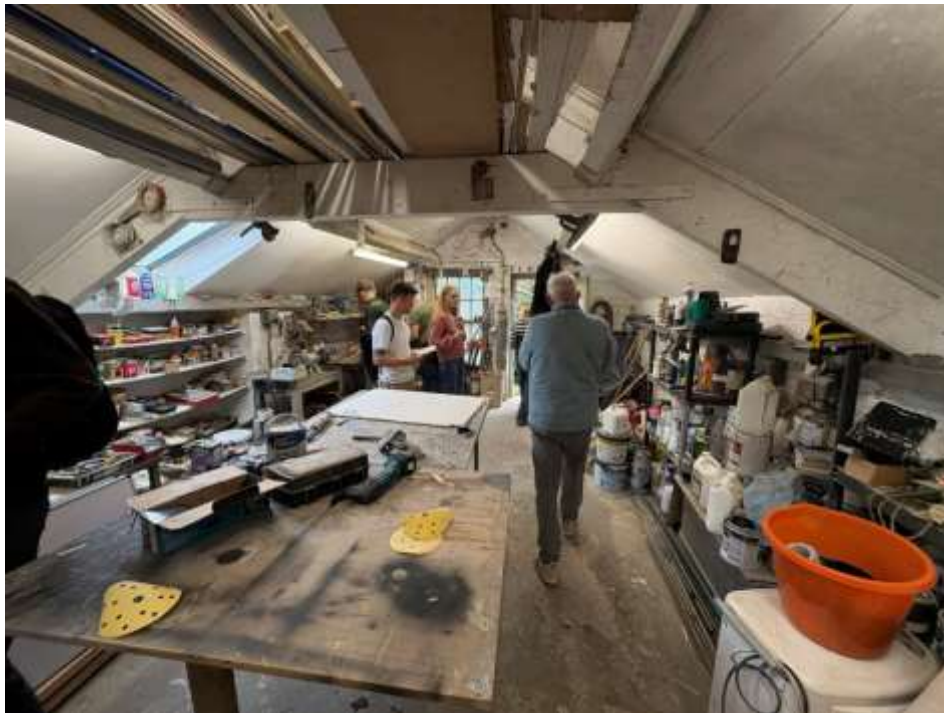
Workshop interior, modern construction, concrete floor slab to be removed to increase headroom.

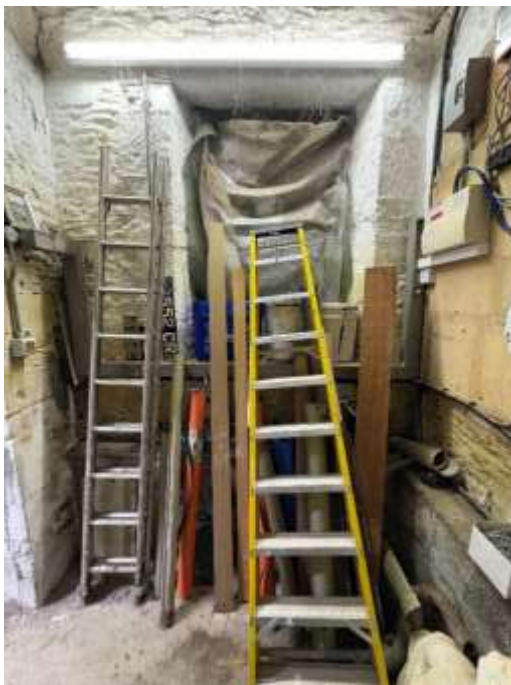
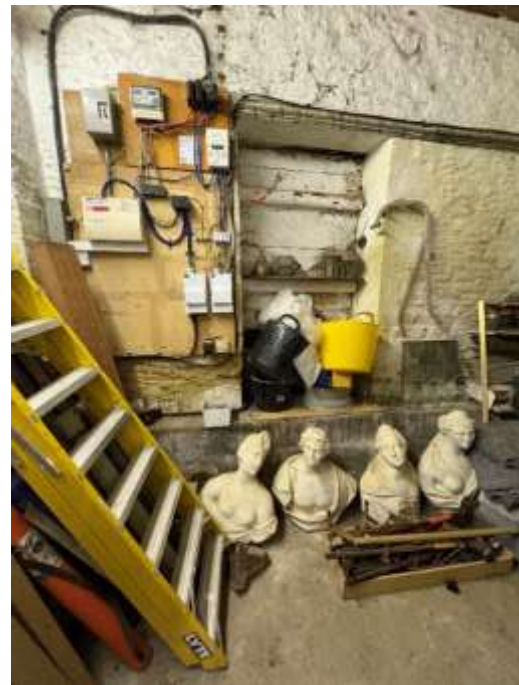
Pavilion interior, window open (left) door opening (right) to be reinstated to include new joinery.

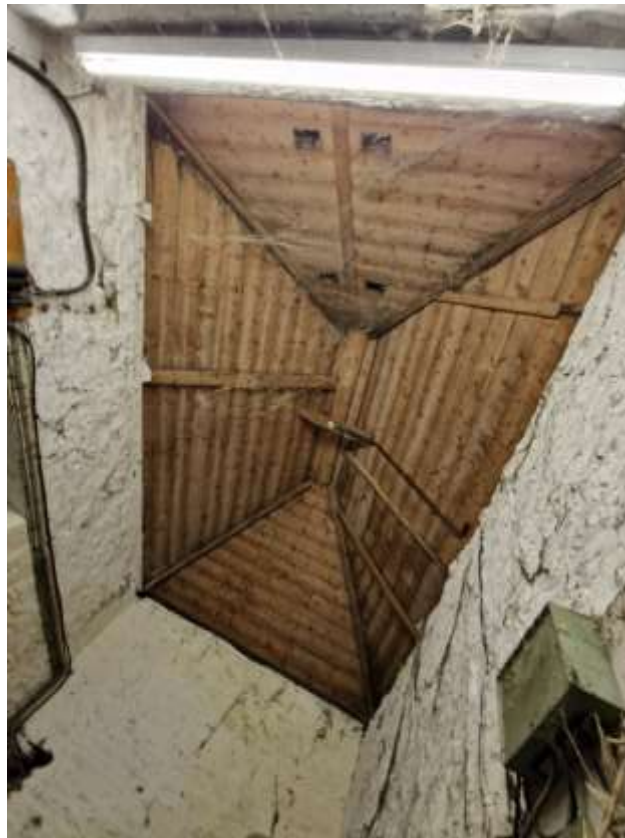
Pavilion: sauna insertion to be self-contained. The existing boarded ceiling to remain unaltered.
