MANOR HOUSE, HIGH STREET,  
WINTERBOURNE STOKE,  
SALISBURY, SP3 4SZ.

### **HERITAGE STATEMENT**

- A report to inform proposed internal alterations to a Grade II\* listed building.
- September 2026
- James Webb  
BSc(hons) MSc Hist Con. PG Dip UD IHBC

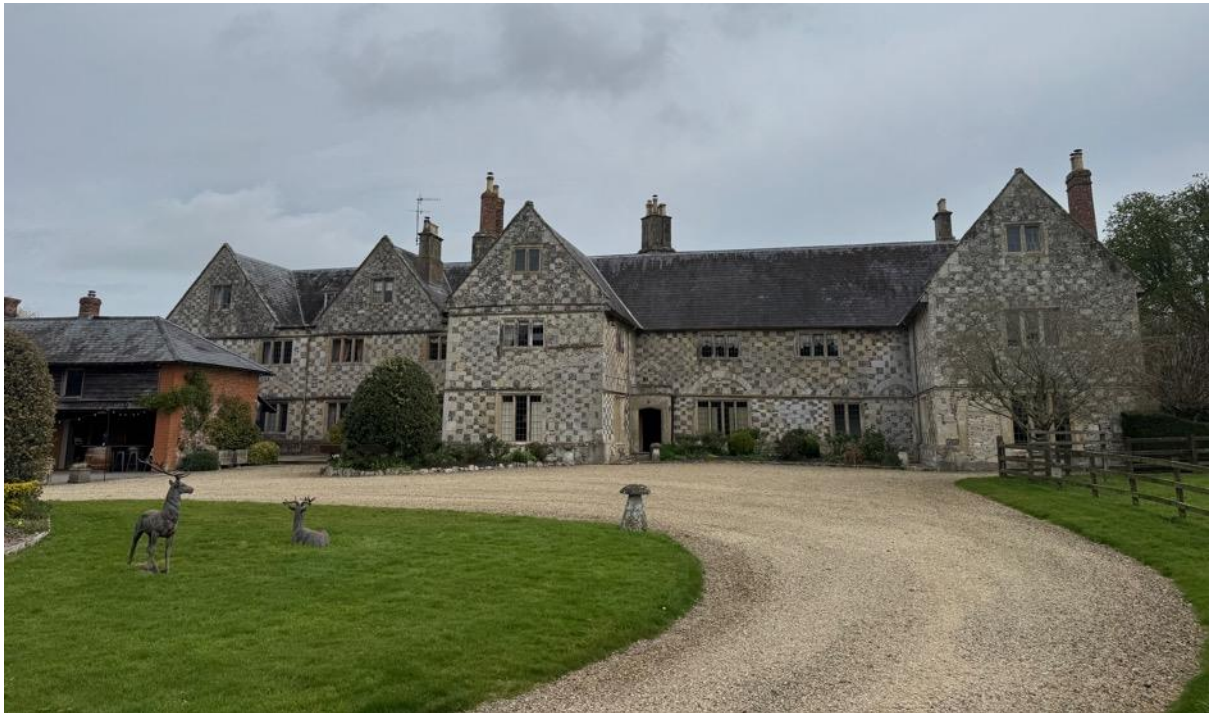
**Figure 1:** The Manor House, Winterbourne Stoke – west elevation

- 4.1 There is a list description (**Appendix E**) which describes the west elevation (**Figure 1 Appendix D**) only, is produced here for information:

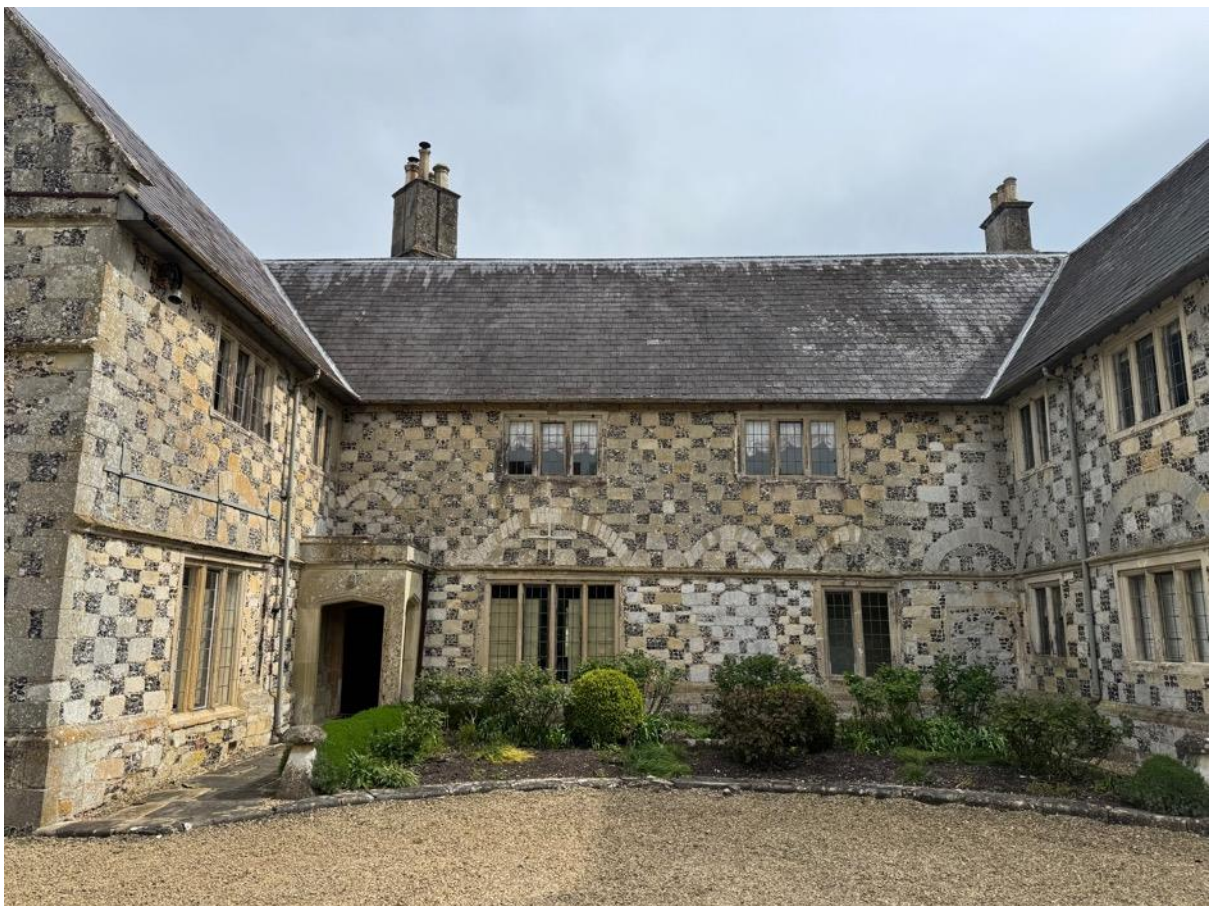
**Figure 2:** West elevation - series of blocked openings with relieving arches above

- 4.2 There are a series of blocked openings to the west elevation to ground floor (expressed by both changes in stone and retaining arches above). This is particularly to the area towards the south-west projecting wing (the Billiard Room) (**Figure 2 Appendix D**). The Billiard Room also has a blocked doorway to its west elevation (**Figure 3 Appendix D**). The stonework to the first floor in the re-entrant angle of the main range and the south-west projecting wing appears to show some evidence of rebuilding. The stone work is a different tone and this extends diagonally across a bay of the main range at first floor (**Figure 4 Appendix D**). It is clear that much alteration and remodelling has taken place to this part of the building.

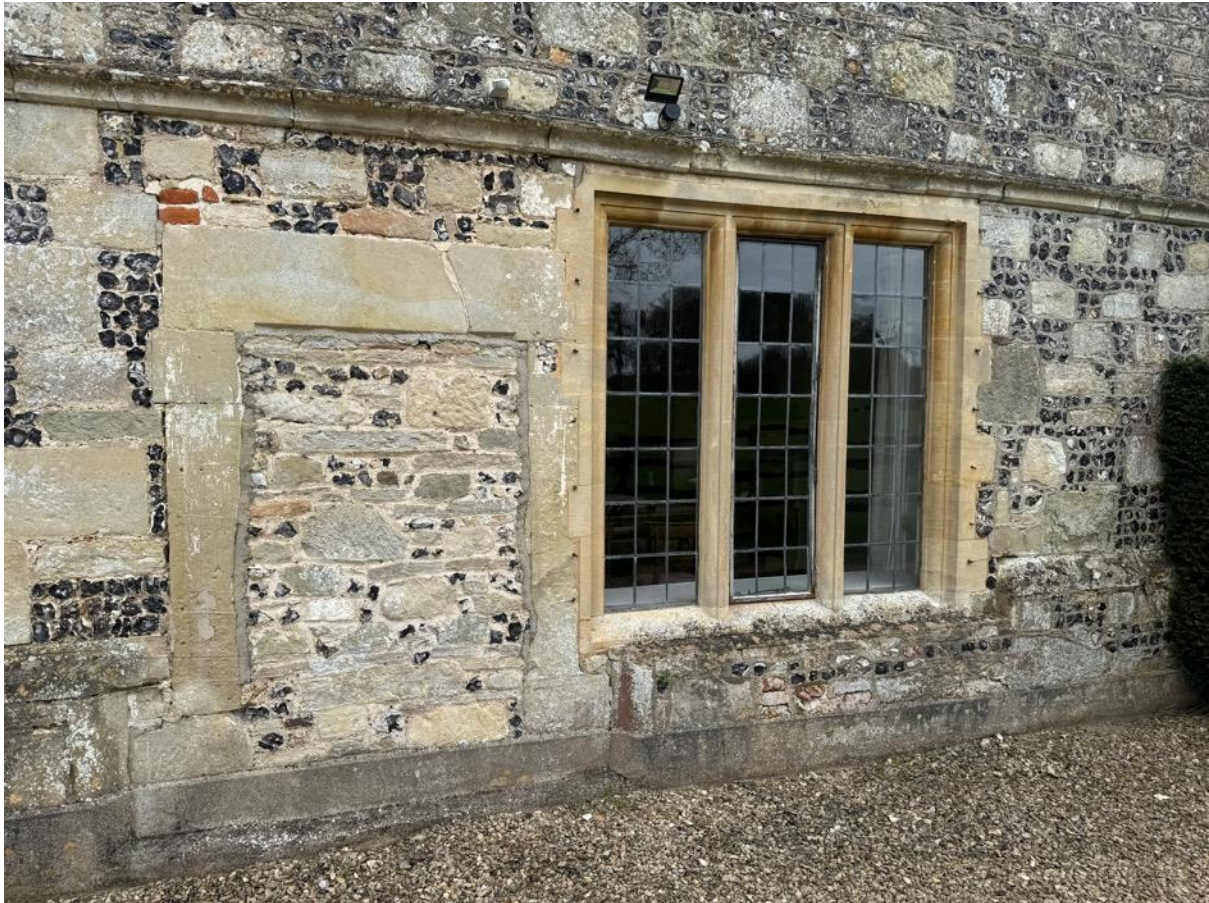
Figure 3: Blocked doorway to billiard room

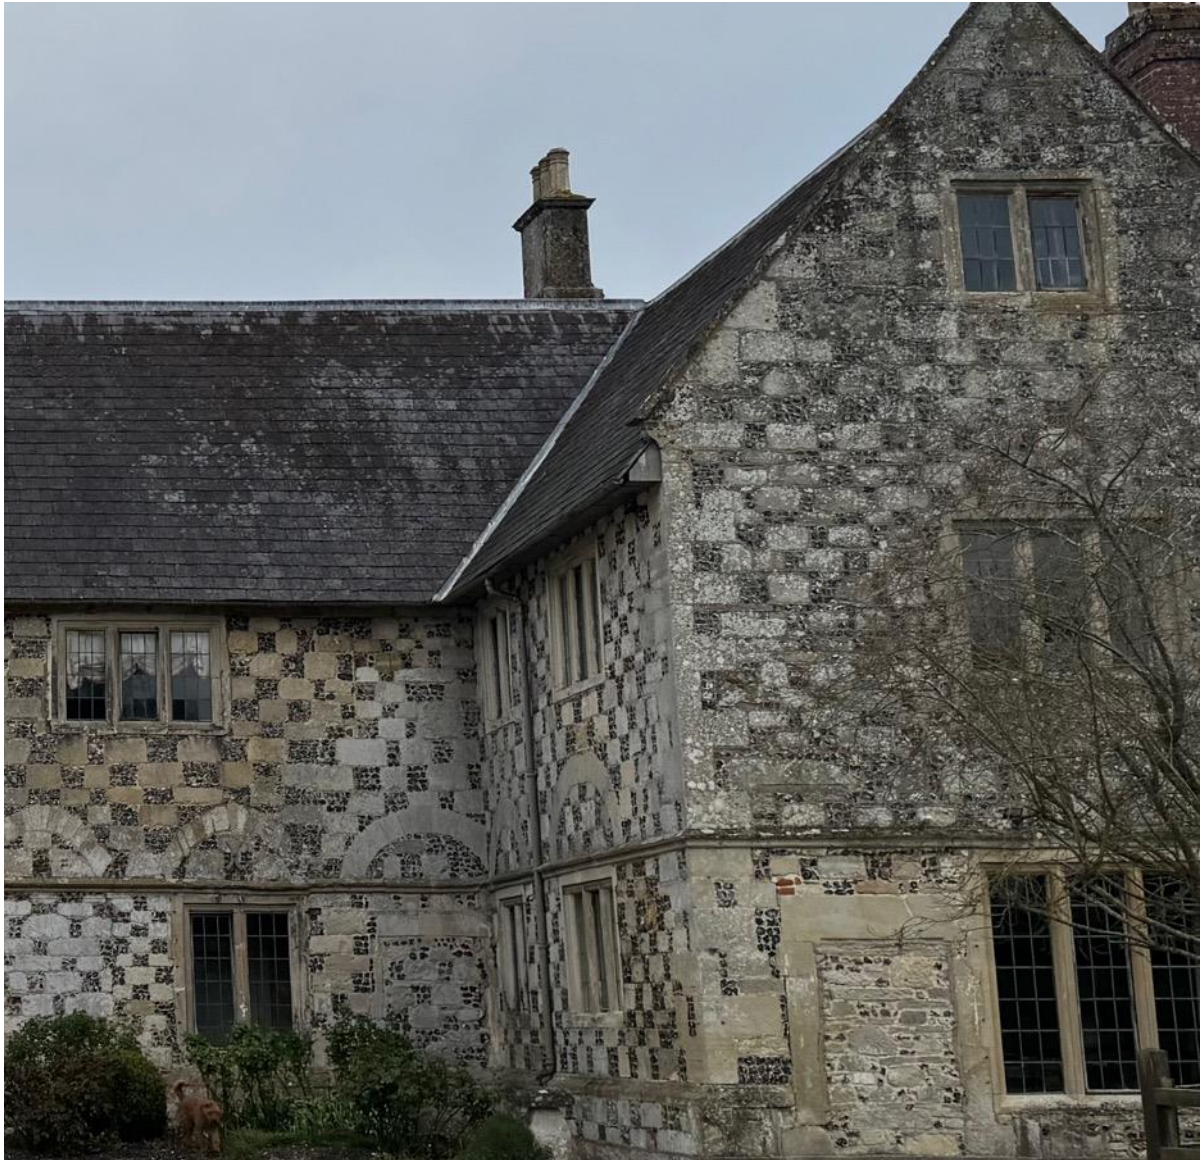
**Figure 4:** Change in stone work between west elevation and south-west wing

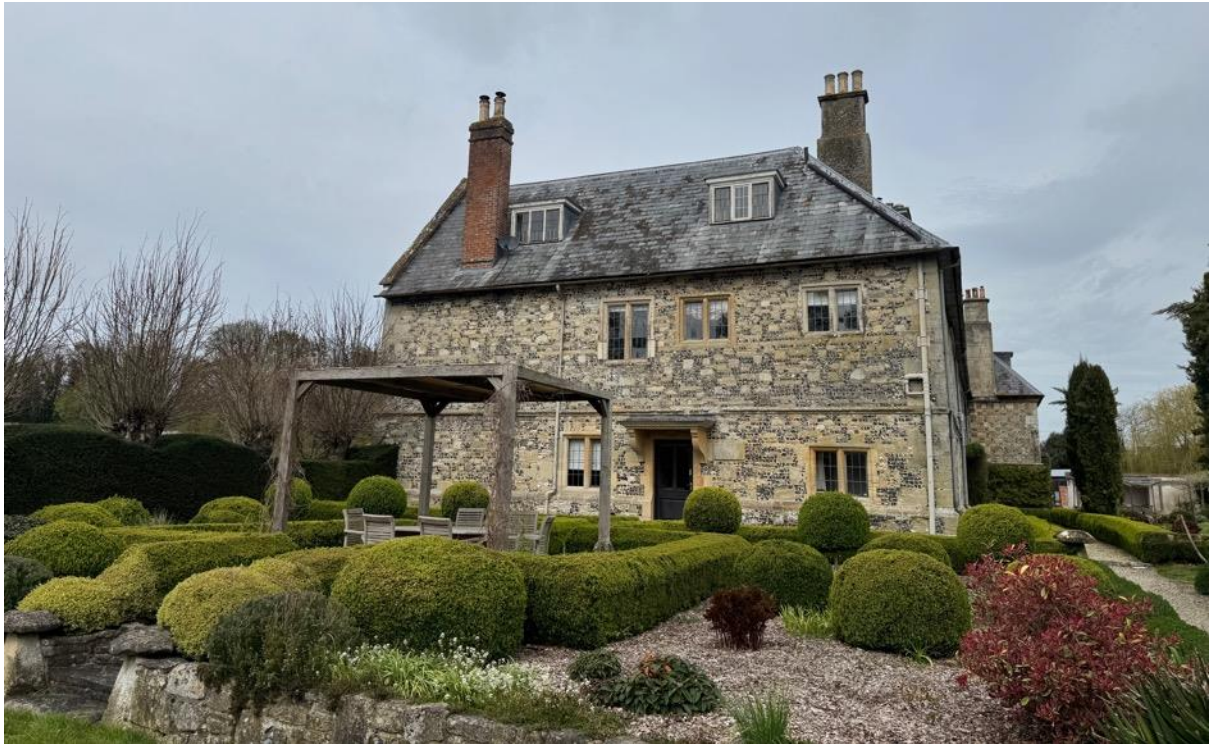
**Figure 5:** South elevation

- 4.3 The south elevation (**Figure 5 Appendix D**) has seen much change. Between 1923 and 1939 a series of extensions to the southern elevation were removed. It is suspected that this resulted in the substantial if not full rebuilding of this elevation with associated re-setting and introduction of new windows and a new porched garden entrance. It has irregular fenestration (all stone mullion windows – some reset and some 19<sup>th</sup> or 20<sup>th</sup> century, with metal-framed square leaded lights). It is stone and flint but in a far more irregular pattern than seen elsewhere. There is a moulded stone string course between ground and first floor. There is an off-centre door with bracketed stone hood with a flat (lead-covered) hood with cornice. The door is panelled with a single panel to the lower section and glazing to upper panels (probably 19<sup>th</sup> century or reproduction). There is a brick chimney stack with two flues to the south-west corner of the plan and projecting from the natural slate (hipped and gabled) roof.

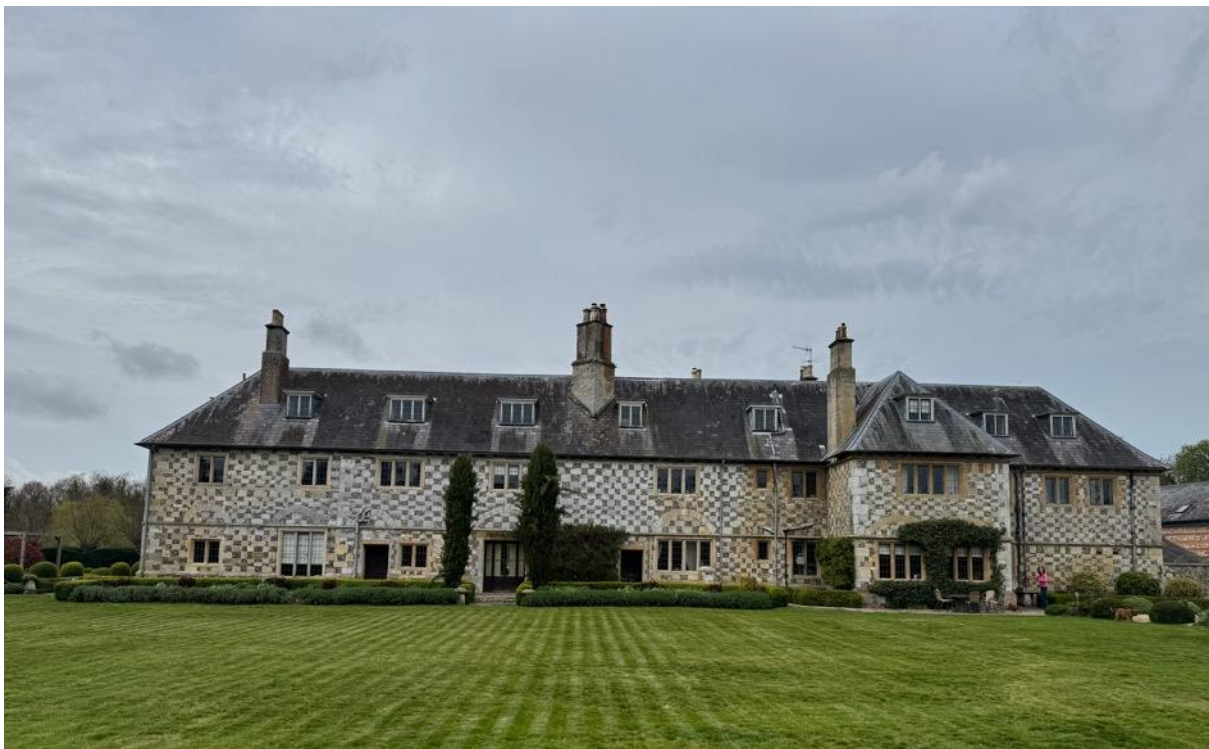
**Figure 6:** East (garden) elevation

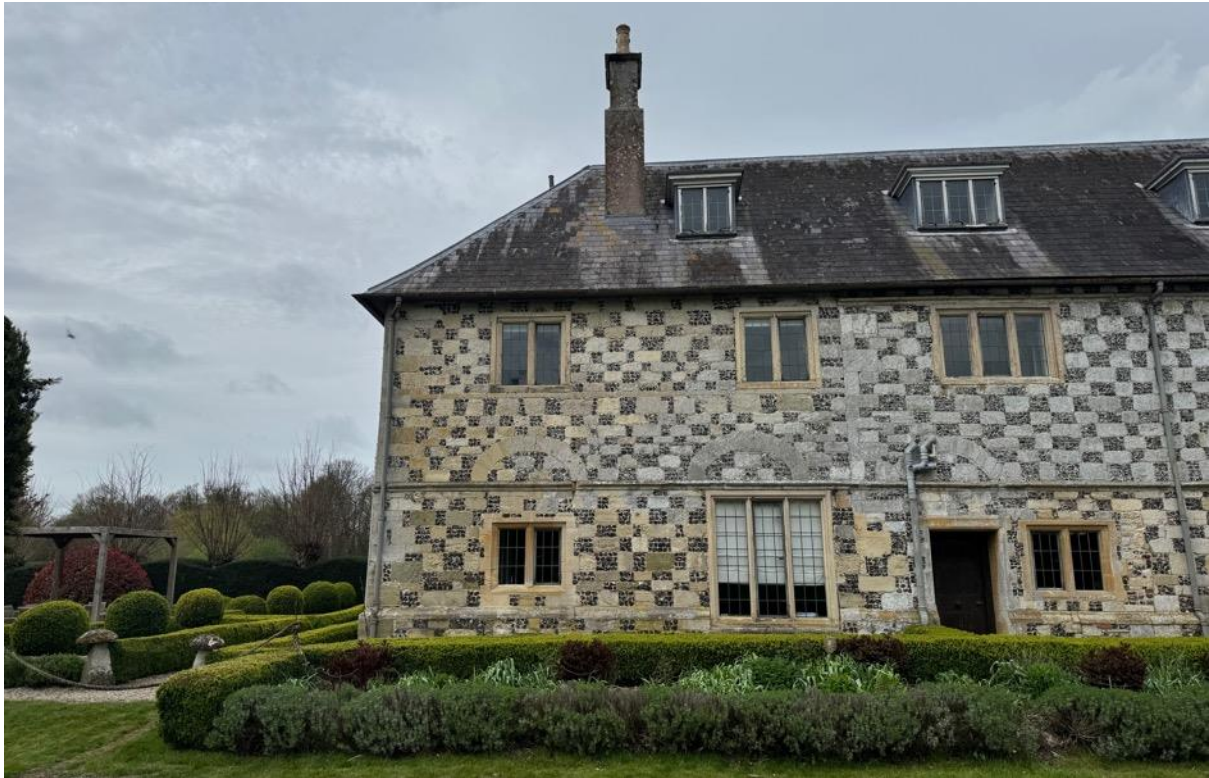
**Figure 7:** Straight joint to stonework between bays 2 and 3

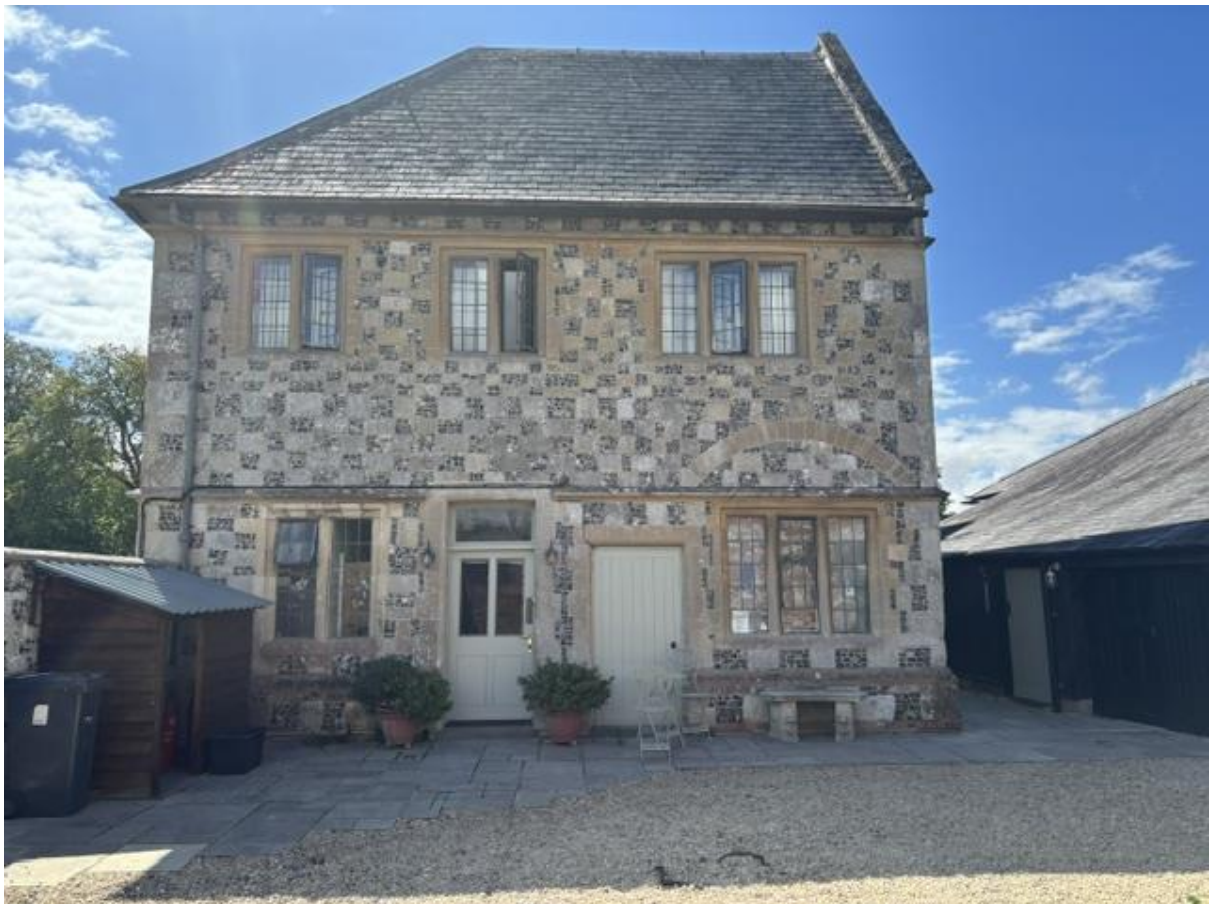
**Figure 8:** North elevation

- 4.5 The north elevation of c1920 (**Figure 8 Appendix D**) continues the stone and flint chequerwork and the moulded stone string and comprises a series of two-light stone mullion windows to ground and first floor and a door with fanlight. The roof is hipped natural slate.

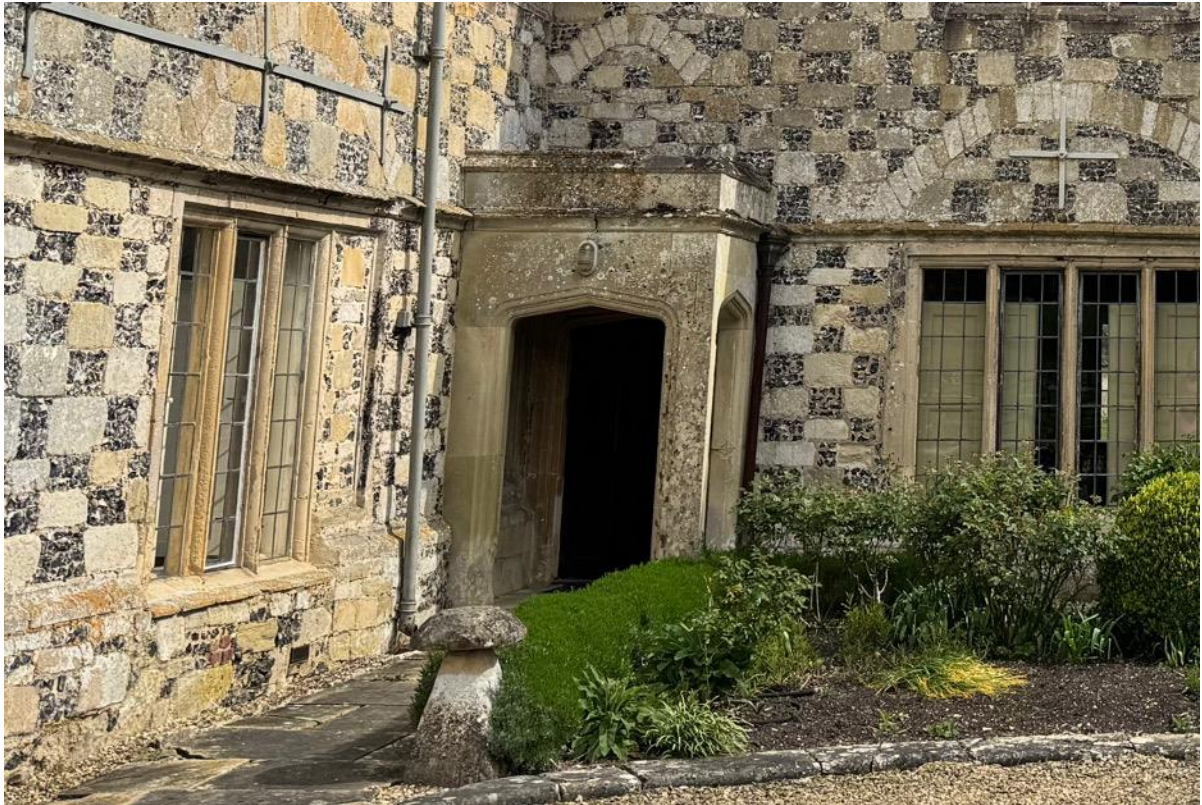
Figure 9: Stone porch entrance (west elevation)

- 4.6 The principal entrance (**Figure 9 Appendix D**) on the west elevation is enclosed with a stone porch with depressed moulded stone arches expressing doorways. The entrance leads to a hall space which has the principal stair (**Figure 10 Appendix D**) and a late 16<sup>th</sup>/ early 17<sup>th</sup> century stone fireplace with vase stops to the moulded ovolo and hollow surround (**Figure 11 Appendix D**). A cloakroom has been added probably in the c1920 building phase.

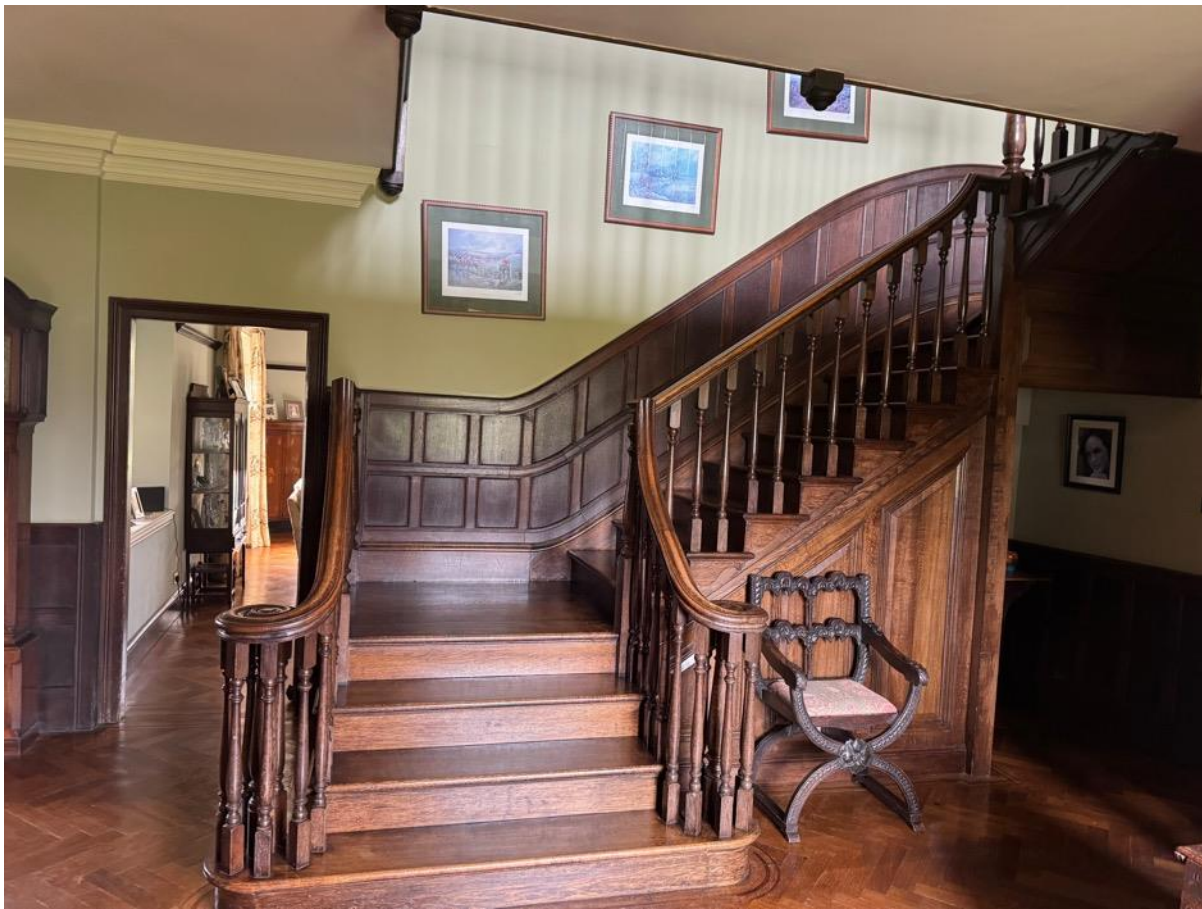
Figure 10: Principal stair c1920s

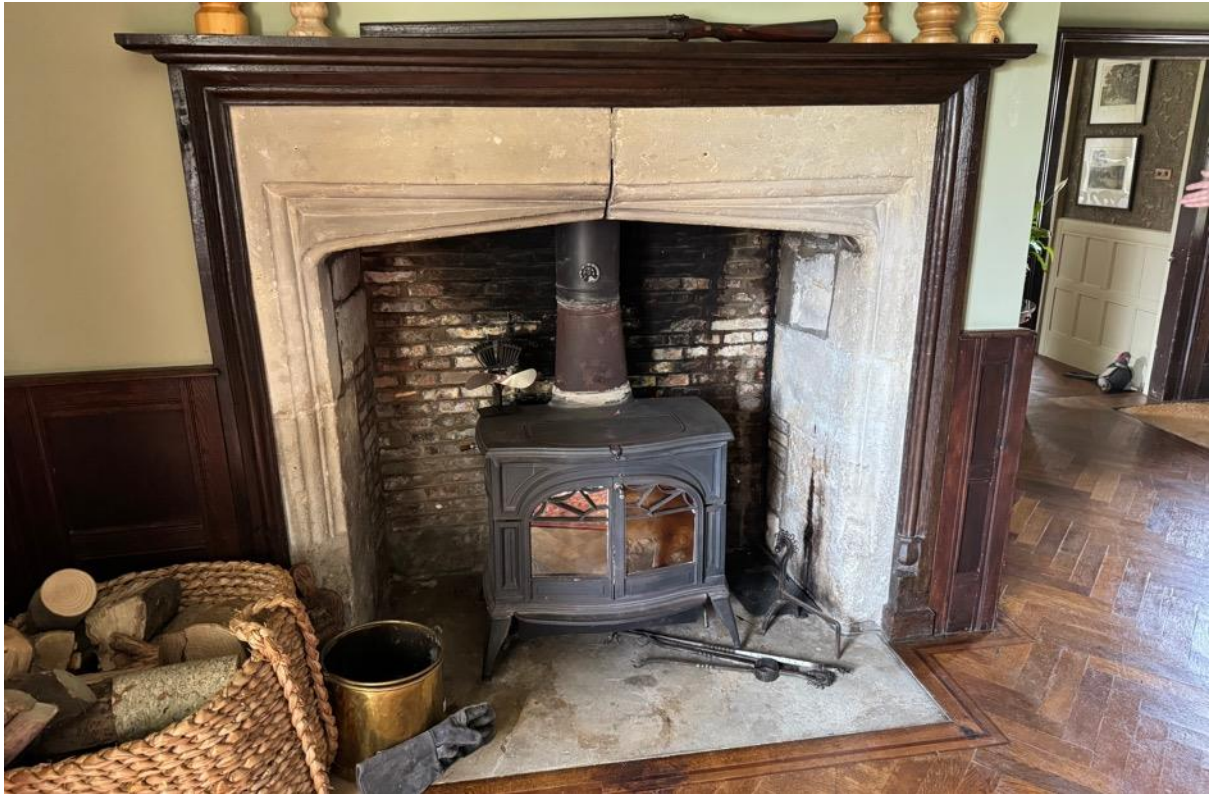
**Figure 11:** Late 16<sup>th</sup>/ early 17<sup>th</sup> century fire surround to hall – vase stops and ovolo and hollow moulding

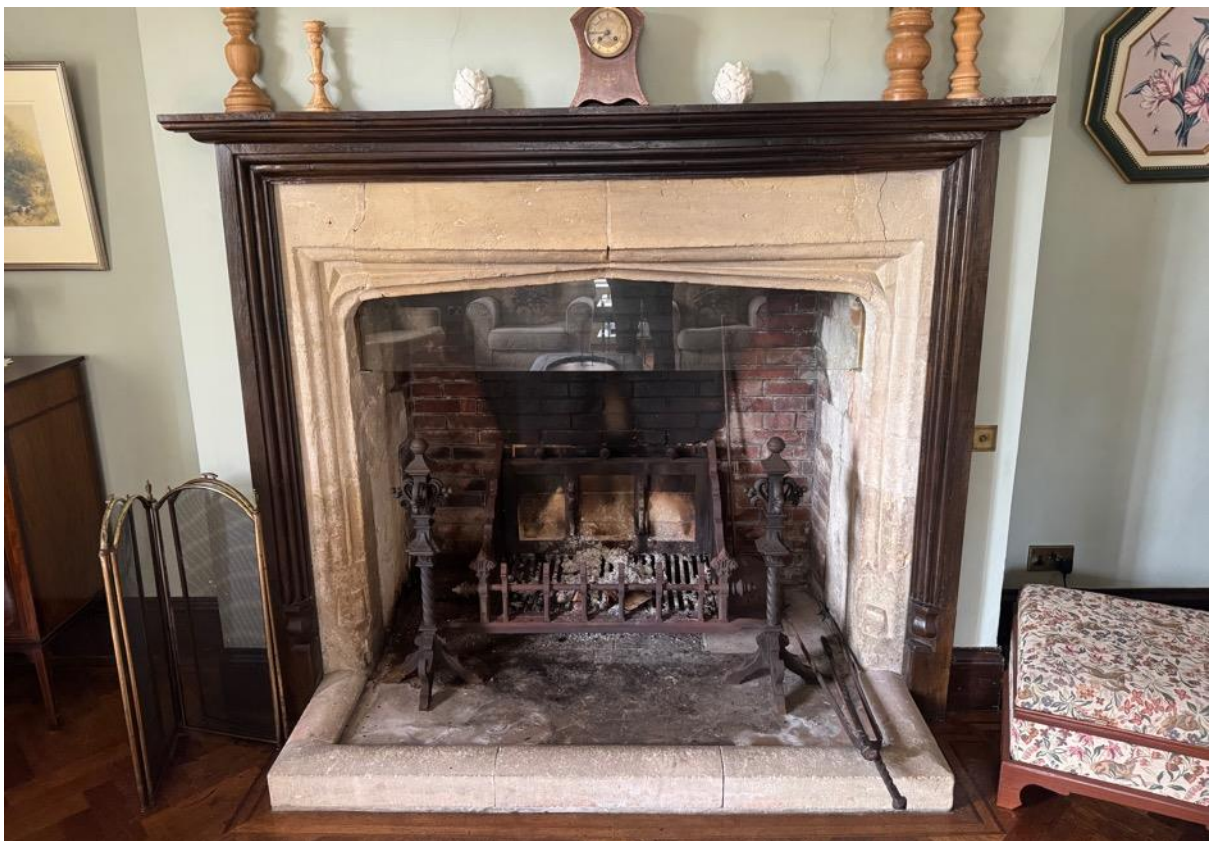
**Figure 12:** Drawing Room: Late 16<sup>th</sup>/ early 17<sup>th</sup> century fire surround – vase stops and ovolo and hollow moulding

- 4.7 The drawing room to the west of the hall has a late 16<sup>th</sup>/early 17<sup>th</sup> century depressed moulded stone-arched fireplace with vase stops (**Figure 12 Appendix D**). The dining room has a c1920 reproduction fireplace of similar form to its older neighbours (**Figure 13 Appendix D**).

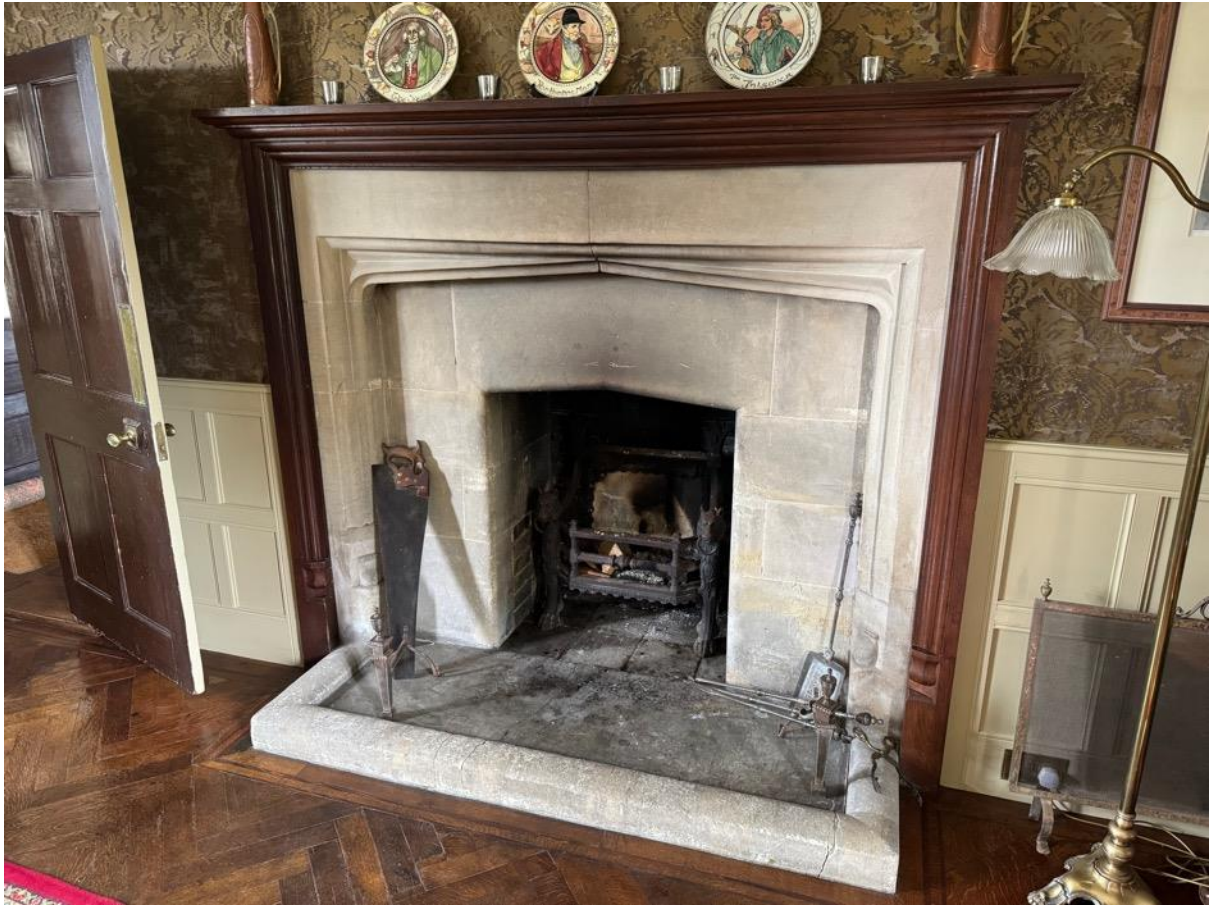
**Figure 13:** Dining Room – replica Tudor fireplace c1920s

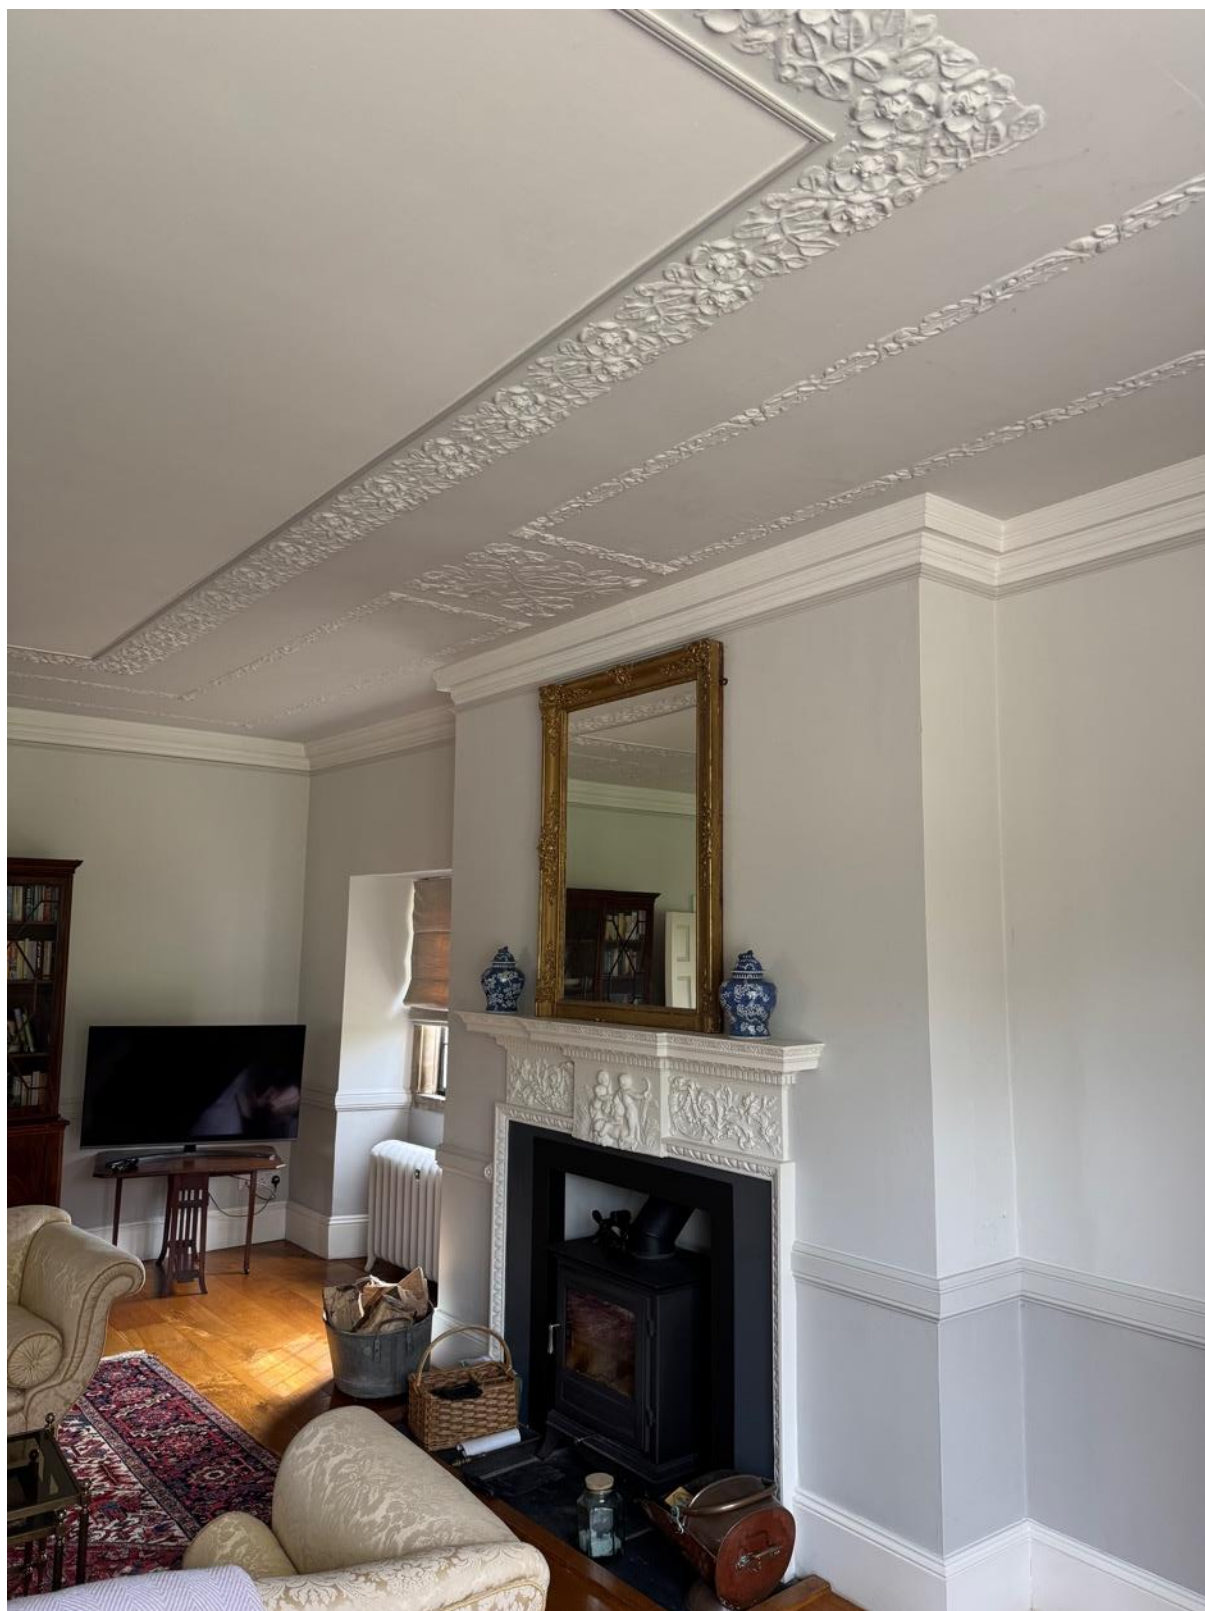
**Figure 14:** Replica (probably c1920s) Adam style fireplace in (former) Billiard Room

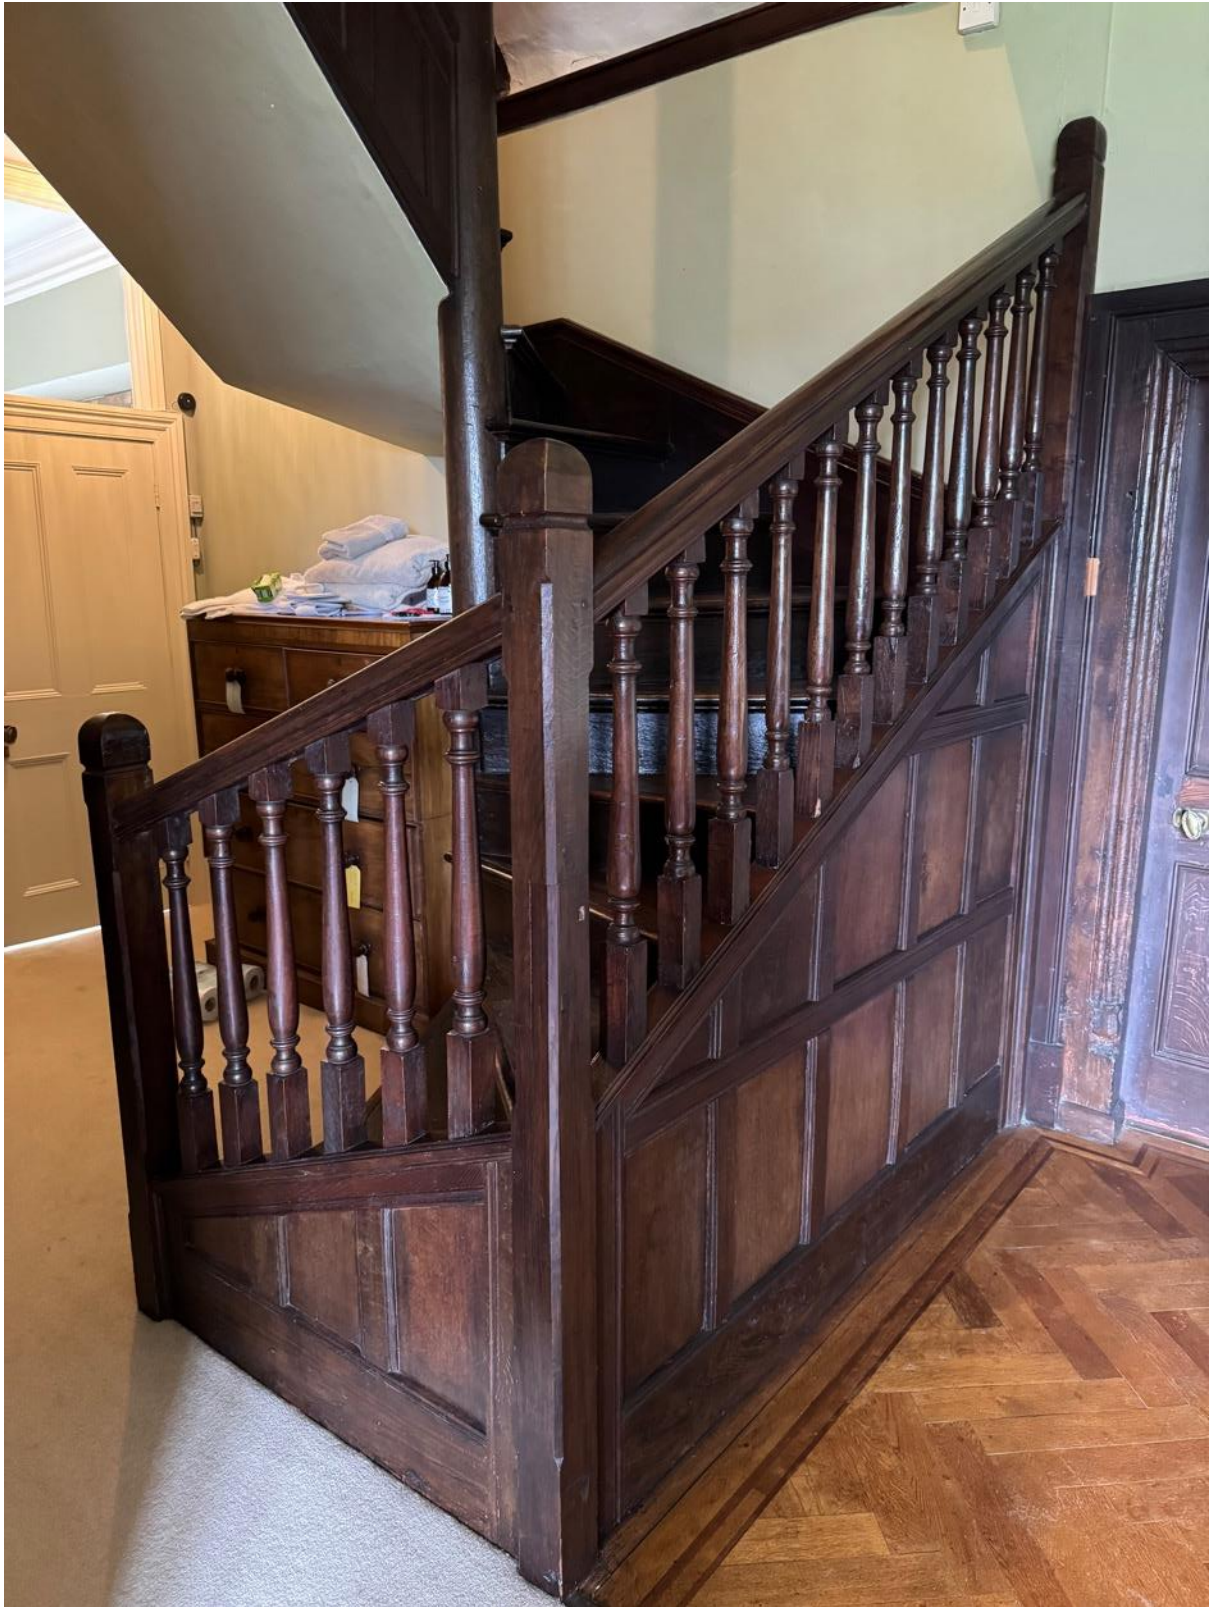
**Figure 15:** Probably 17<sup>th</sup> century winder stair from first to second floor

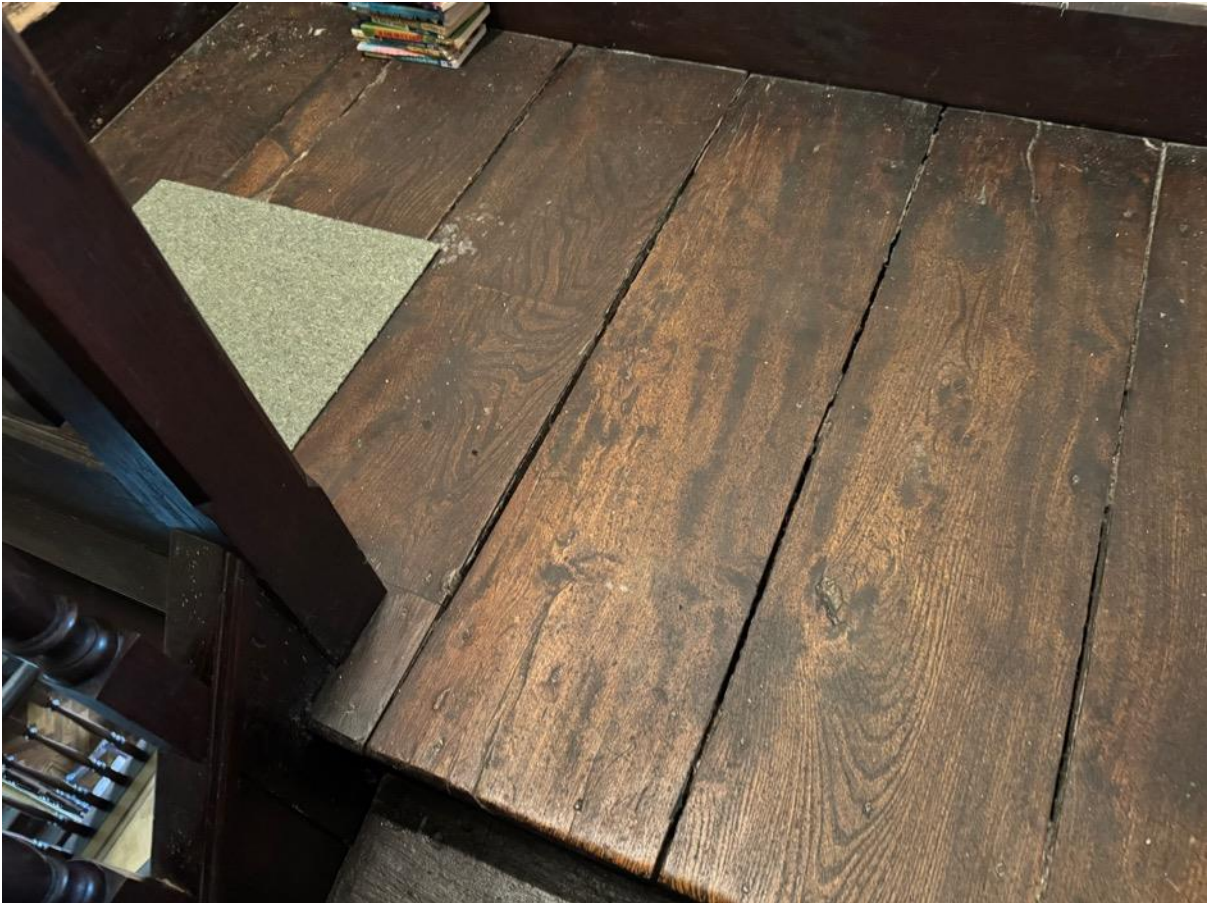
**Figure 16:** Oak boards to landing of winder stair

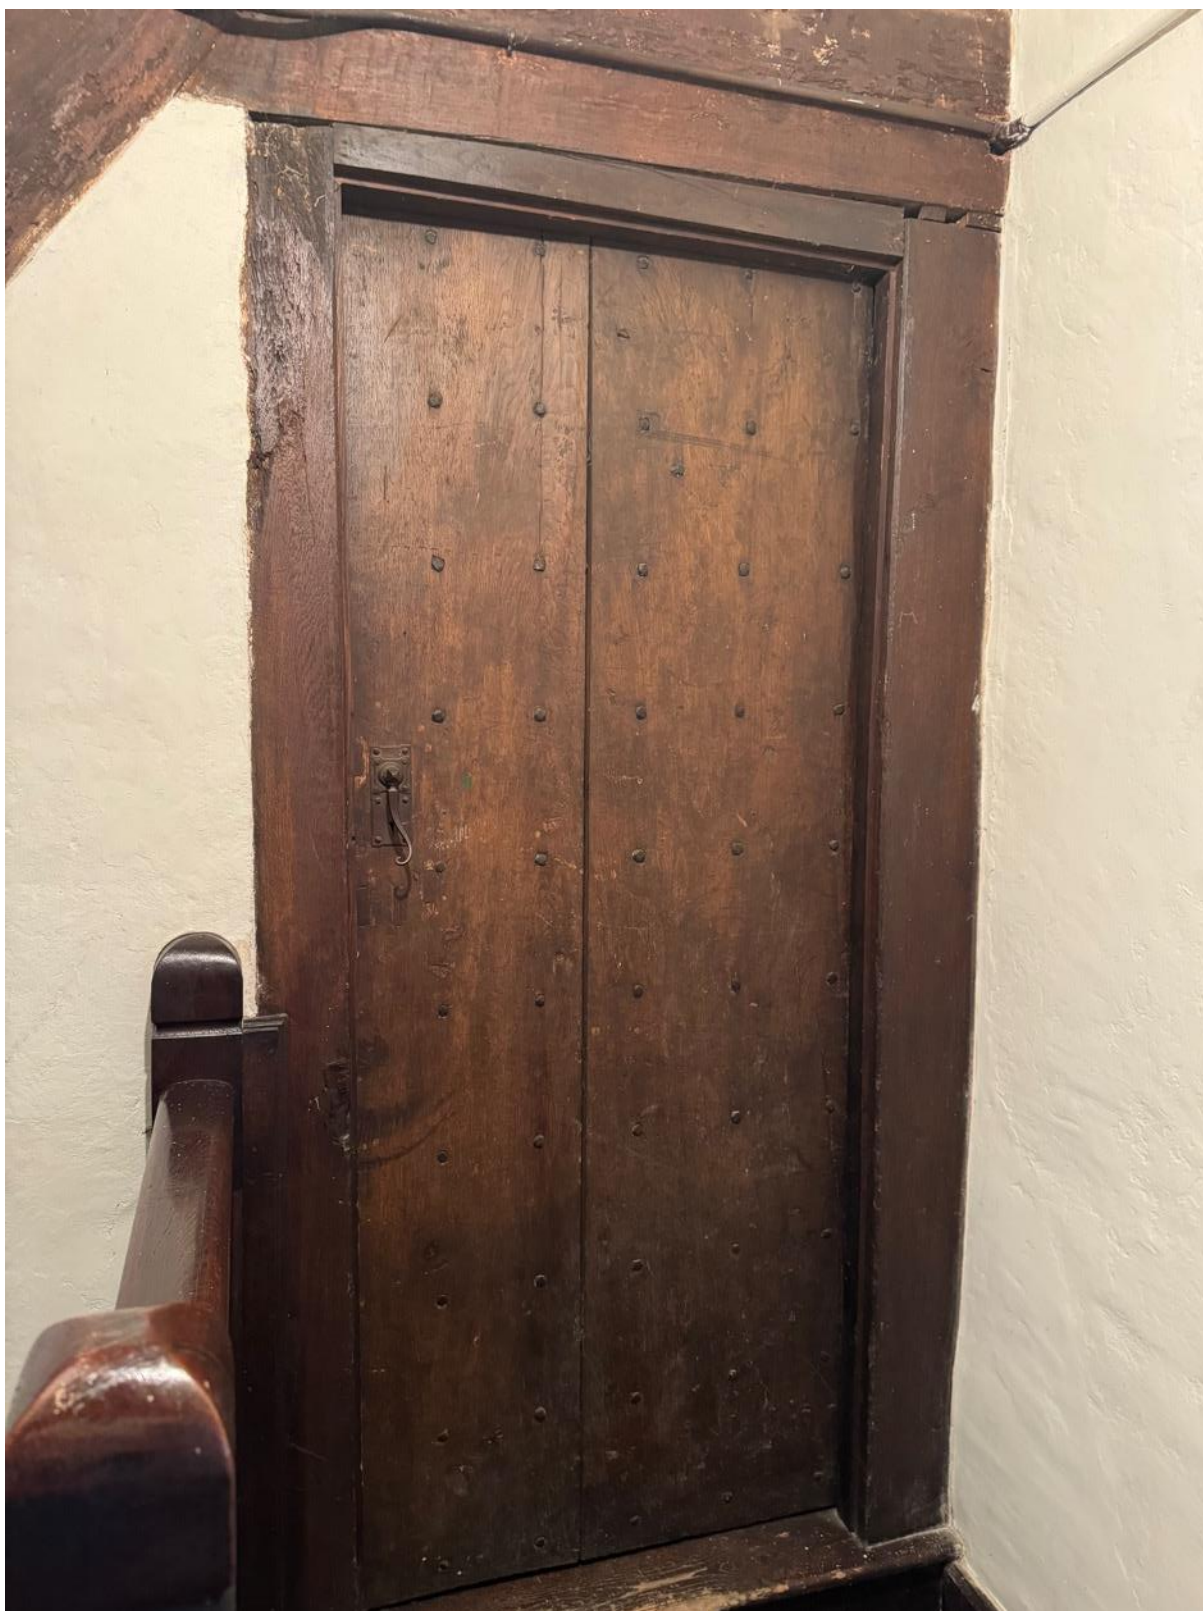
Figure 17: 17<sup>th</sup> century door at north side of winder stair lobby

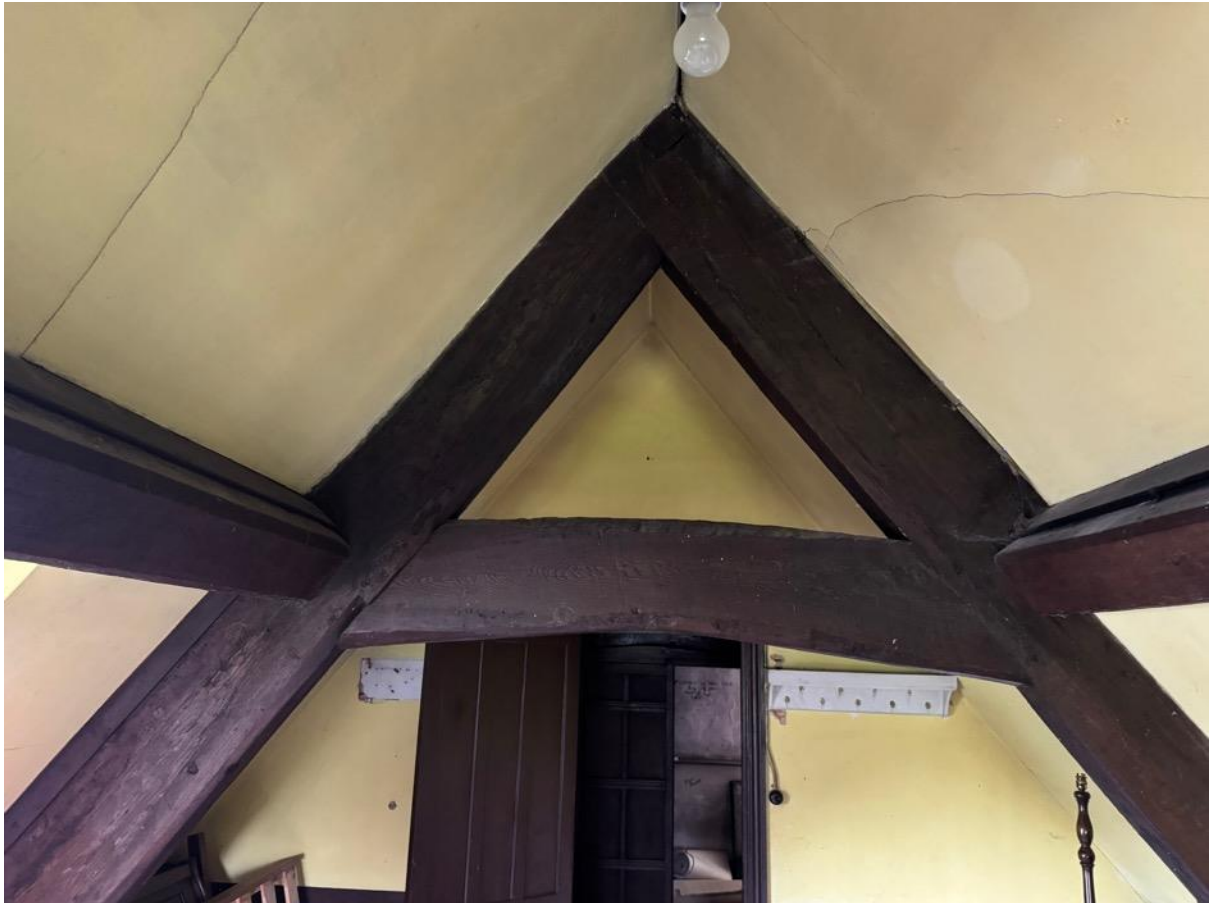
**Figure 18:** Roof structure of two bay of north-west wing – possibly early 16<sup>th</sup> century?
