MANOR HOUSE, HIGH STREET,  
WINTERBOURNE STOKE,  
SALISBURY, SP3 4SZ.

### **HERITAGE STATEMENT**

- A report to inform proposed internal alterations to a Grade II\* listed building.
- September 2026
- James Webb  
BSc(hons) MSc Hist Con. PG Dip UD IHBC

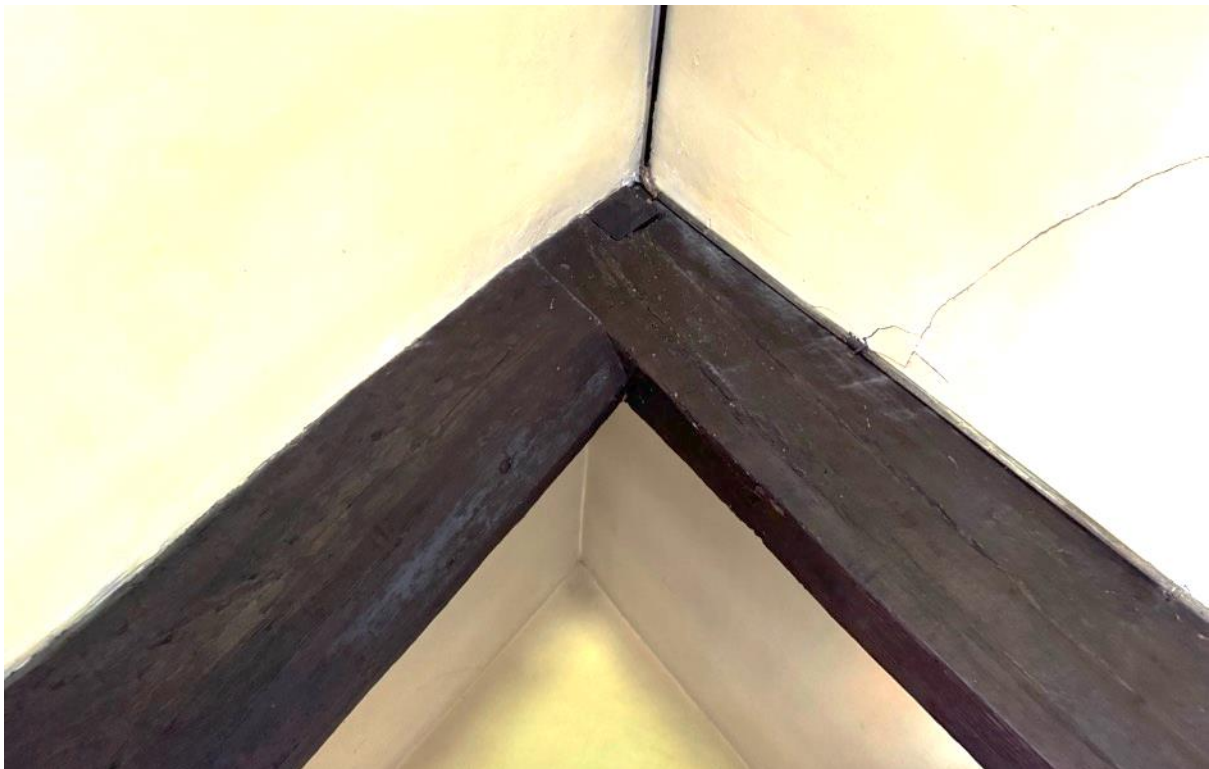
**Figure 19:** Evidence for a ridge purlin – suggesting early date for this truss (and its neighbour)

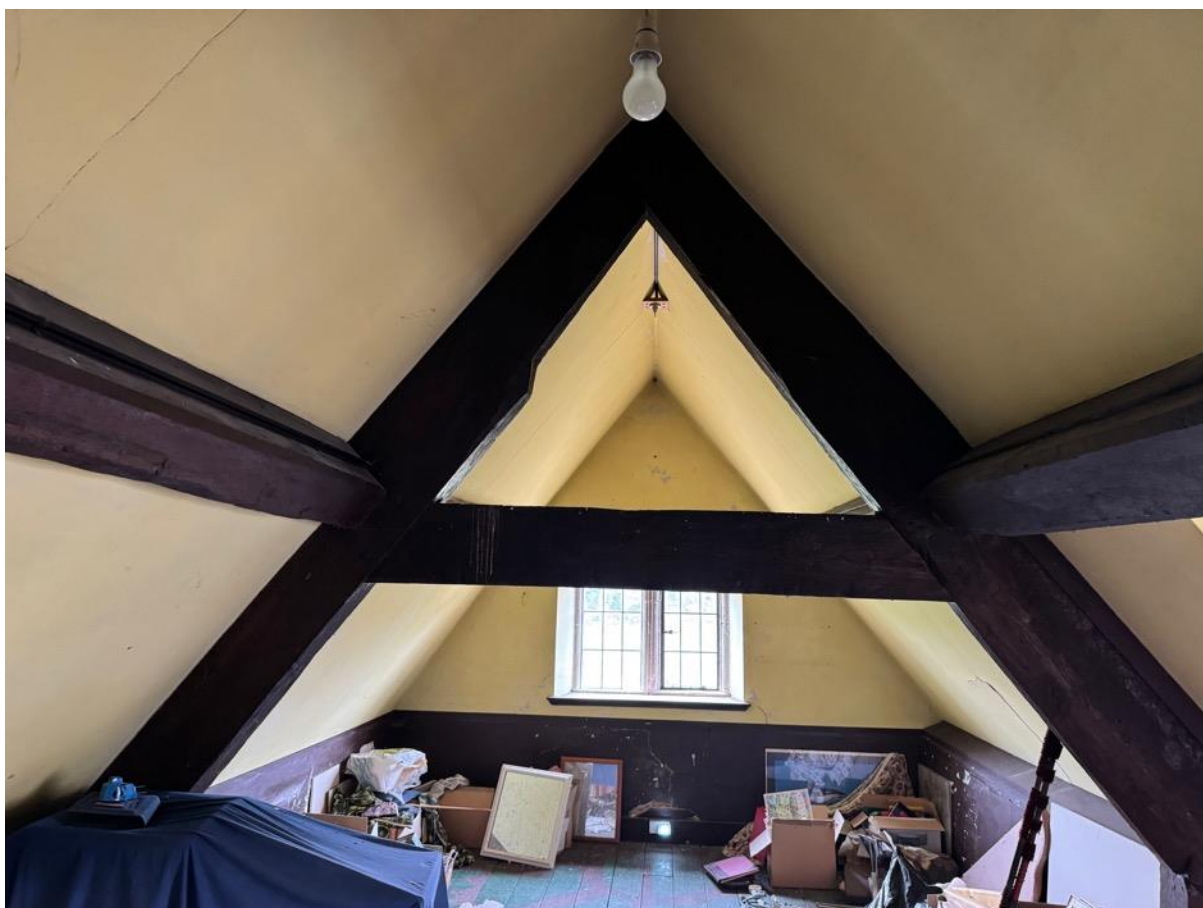
**Figure 20:** Straight collar to remaining truss to north-west wing

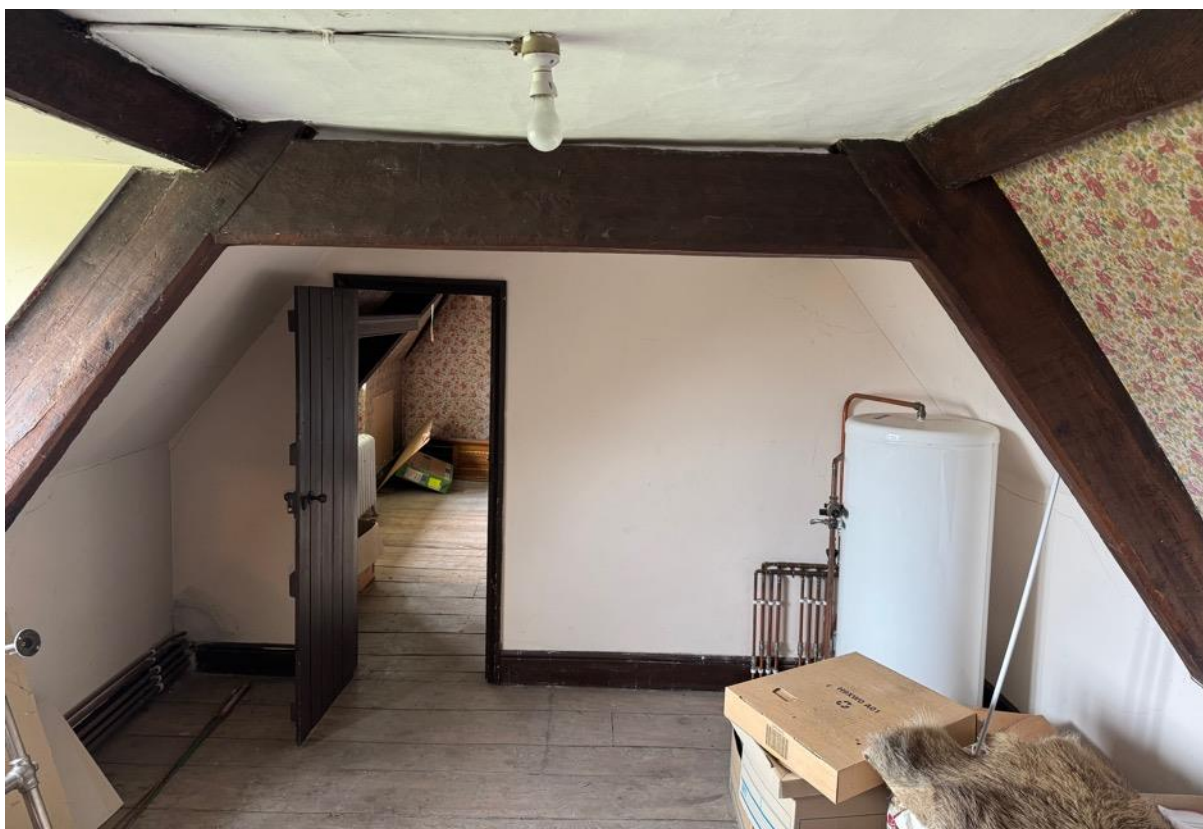
**Figure 21:** Typical truss of main range with straight collar and chamfering to the principal rafter

Butt purlins and chamfered principal rafters with straight collars (**Figure 21 Appendix D**) continue to the main range.

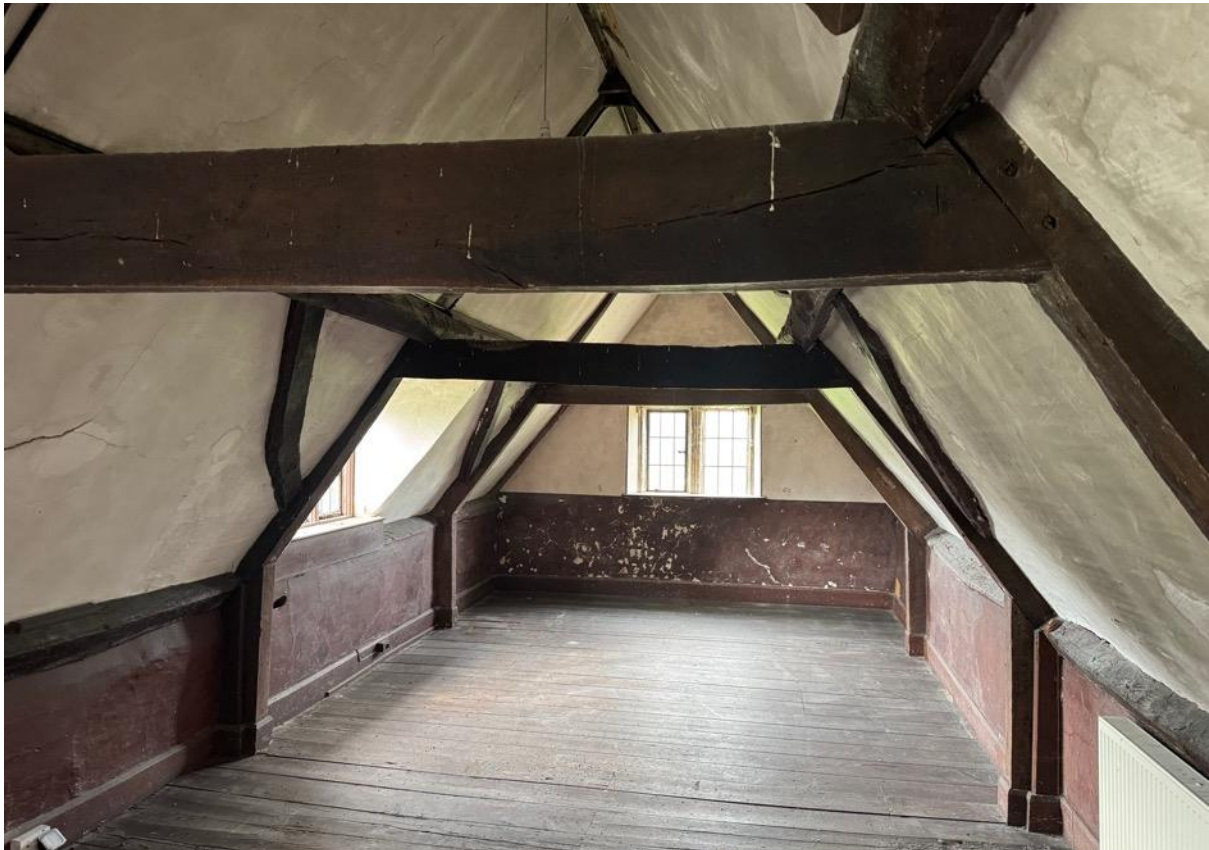
**Figure 22:** Roof structure to south-west wing- clapsed purlins and straight collars, but with straight wind braces

- 4.12 The south-west wing has a different configuration of roof to the rest of the house. It has pegged ashlar posts (which are now built into the wall), straight wind braces and straight collars (**Figure 22 Appendix D**). There is a clearly defined ridge purlin (with yolk to a number of the trusses) (**Figure 23 Appendix D**). There are clasped purlins, but the purlins have been replaced as the principal rafters are cut for a larger purlin (**Figure 24 Appendix D**). The roof would in theory date from an earlier period than the butt purlin roof to the north. However, this roof has been remodelled and may well have come from another part of the house or another house and been adapted to this space. It is not as resolved or complete as the roof to the north-west wing.

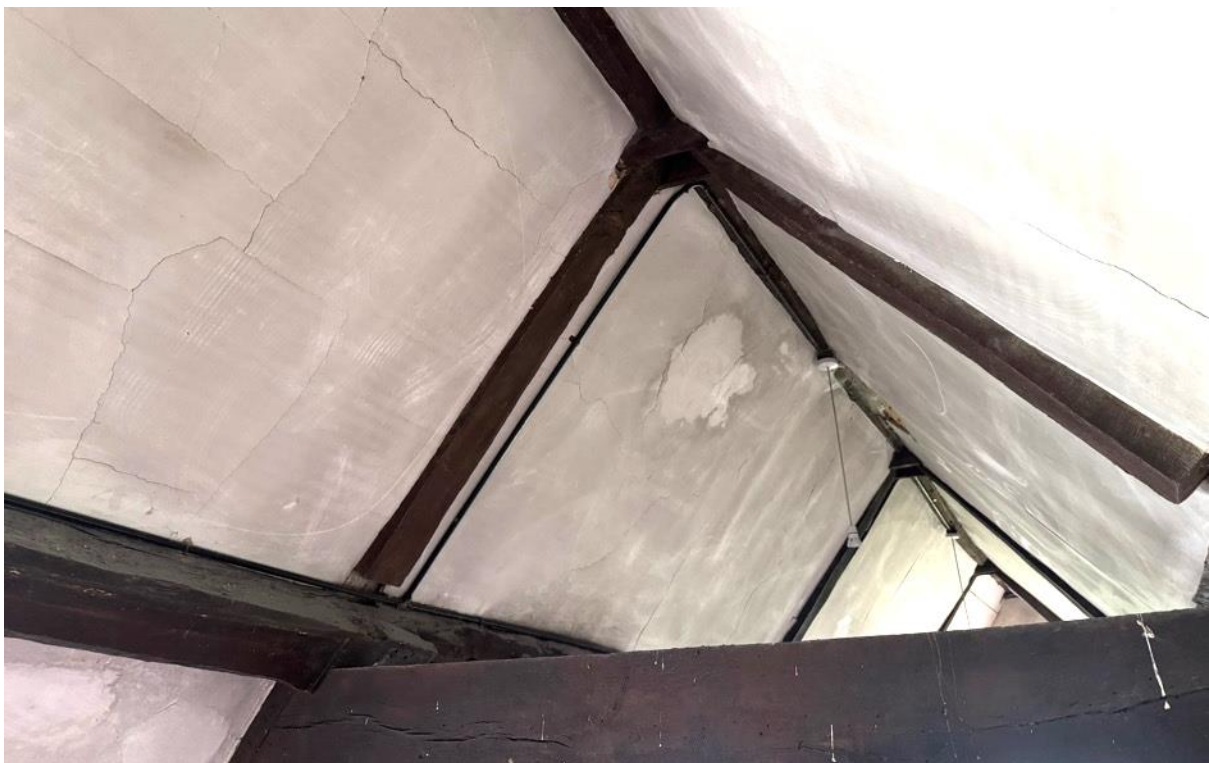
**Figure 23:** Yolk to ridge-piece (often an 18<sup>th</sup> century feature)

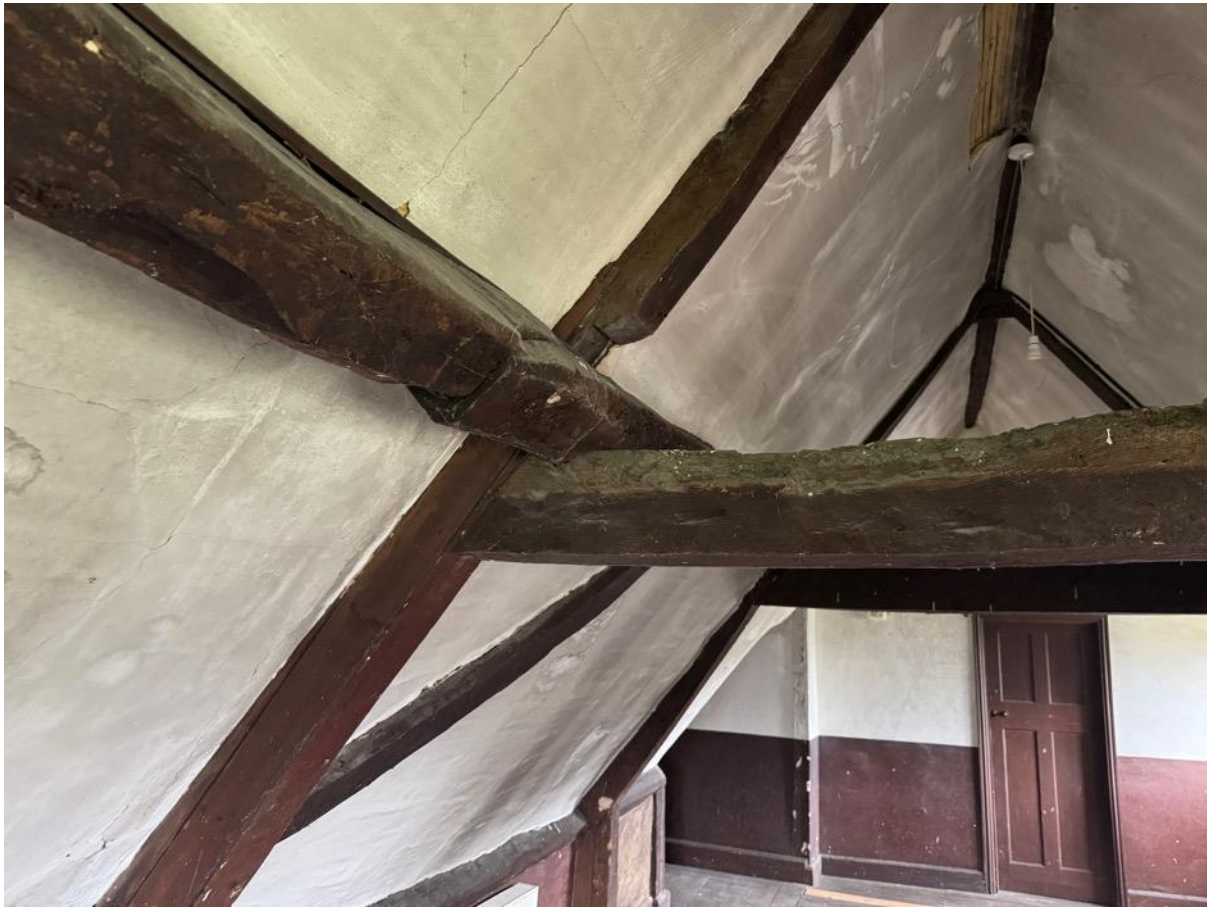
**Figure 24:** Purlins are re-set (the cut out to the principal rafter is much larger (consistently) than the present purlins

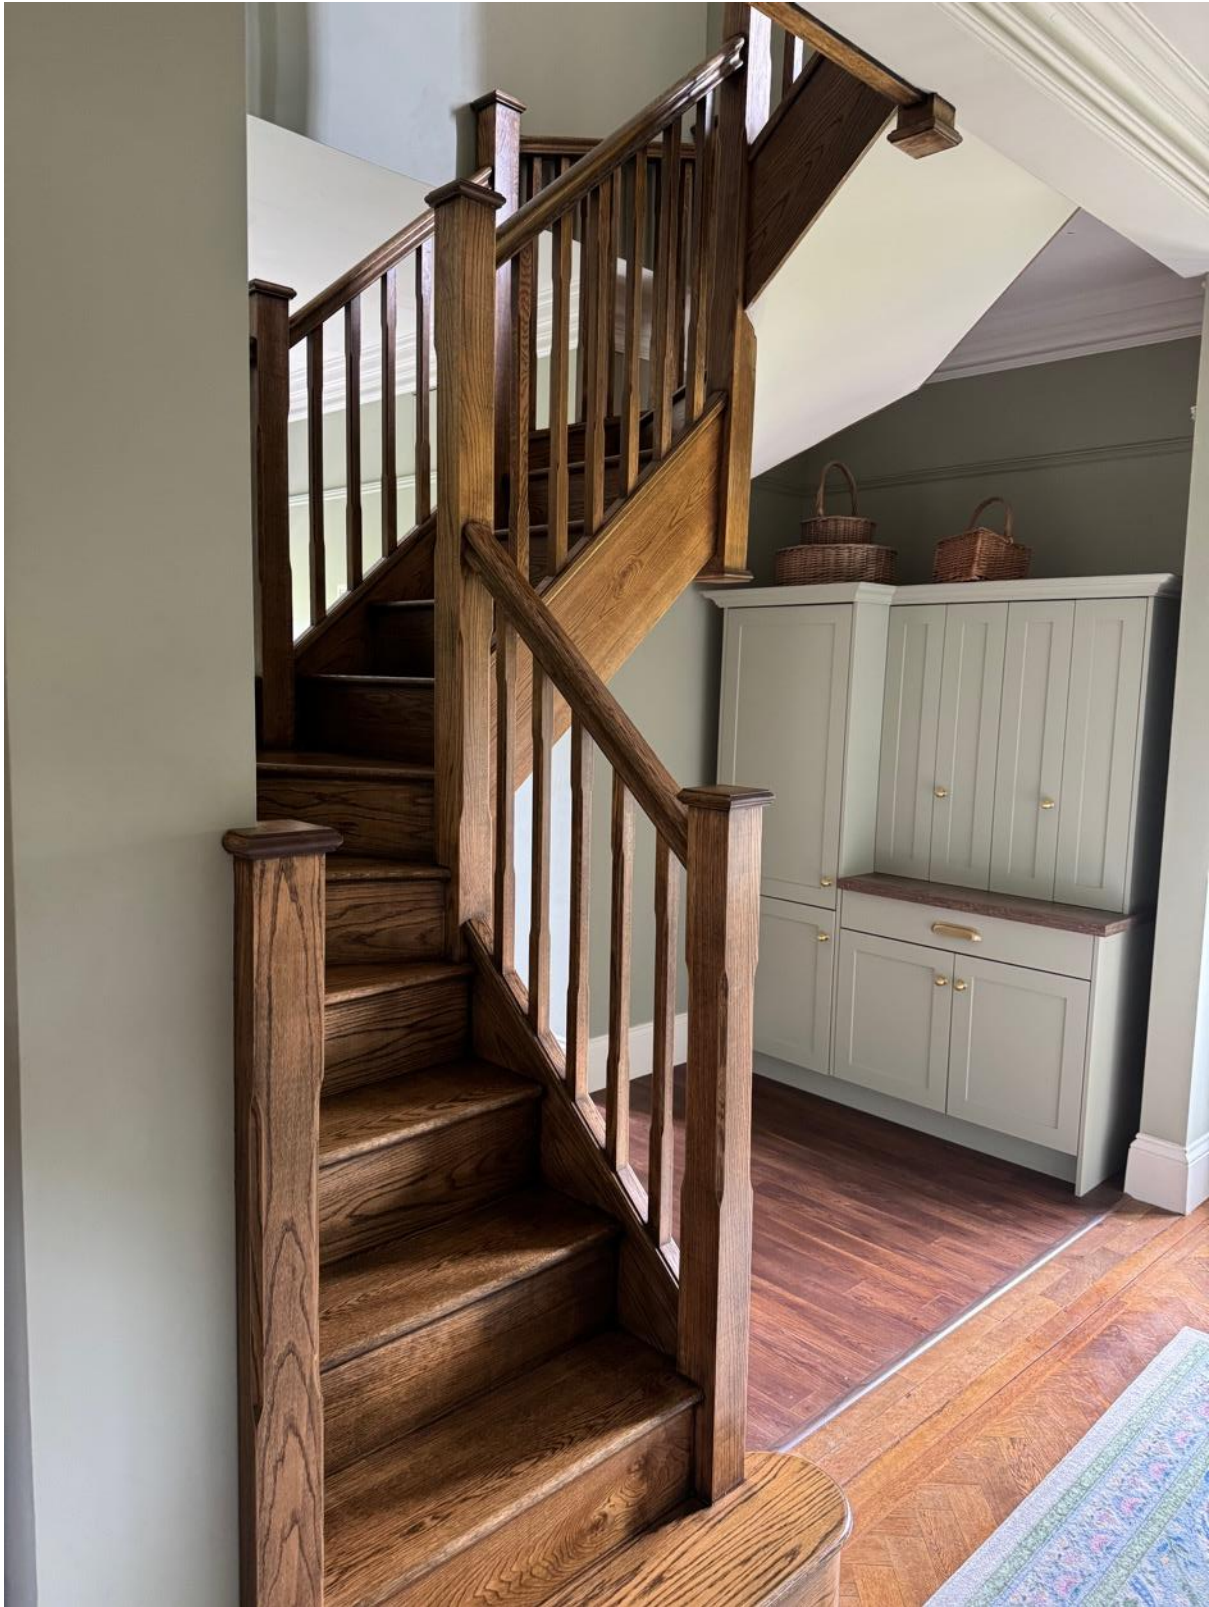
**Figure 25:** The staircase from ground to first floor has already been constructed

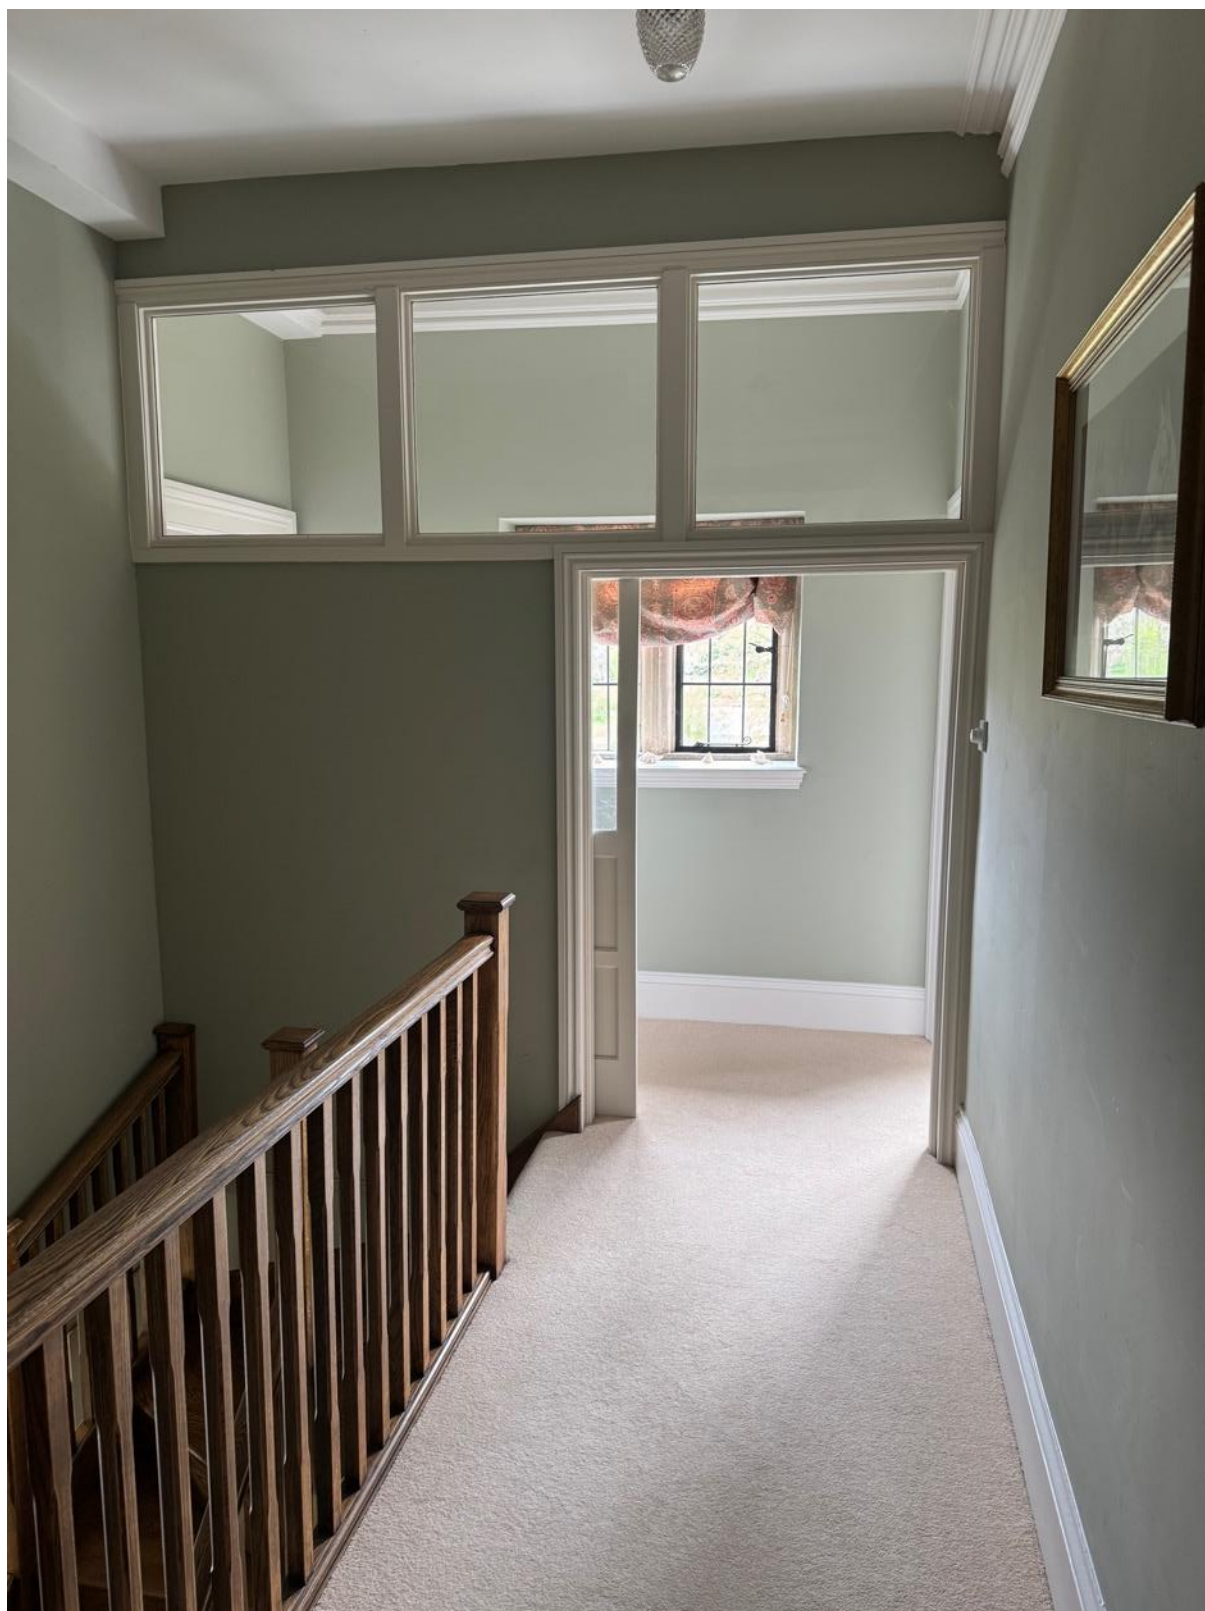
**Figure 26:** New partitions to first floor (allowing access to the bathroom)

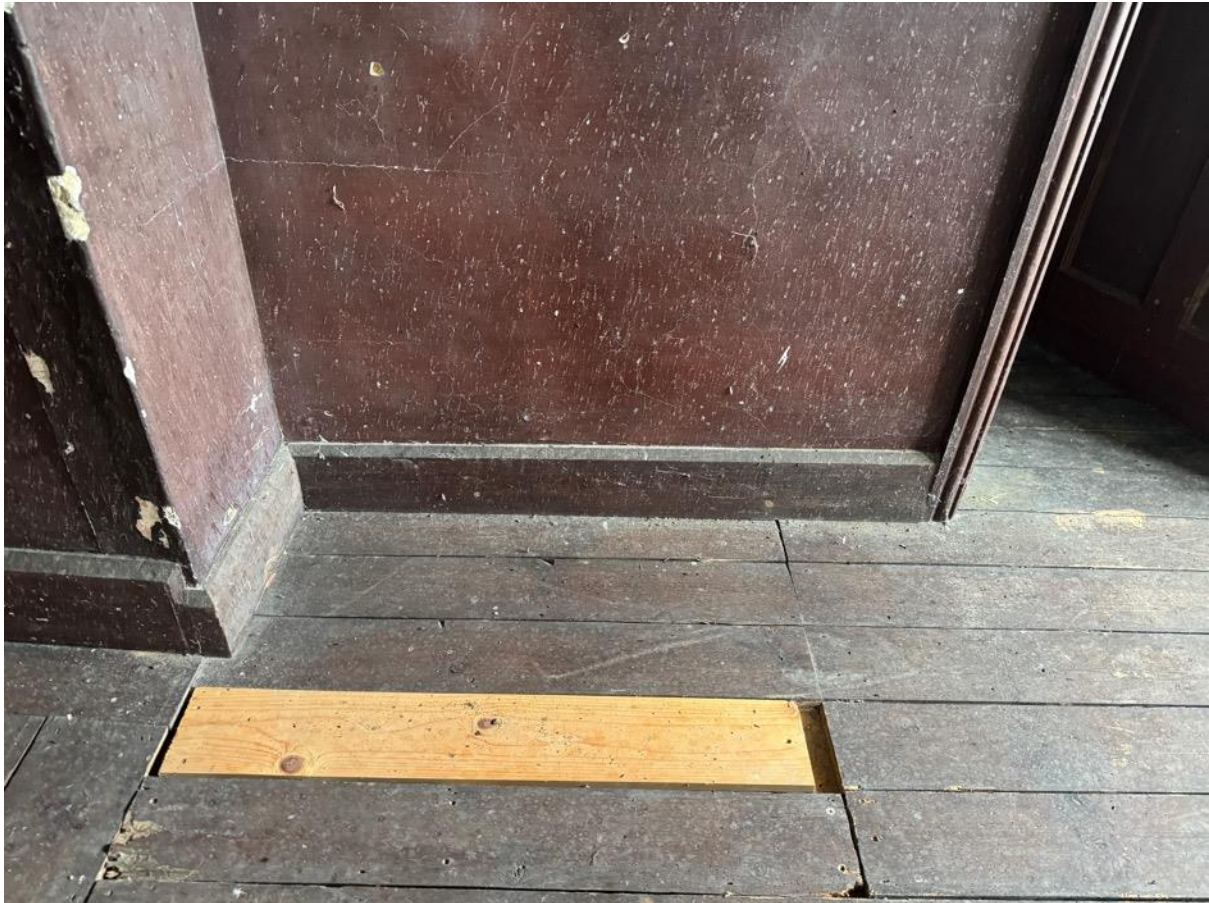
**Figure 27:** Narrow softwood boards – in the area proposed for the new staircase (in front of the door pictured)

- 6.5 The floor make-up of the area to be removed for the second stage of the staircase has been inspected. It was found that the floor finish (narrow softwood boards) (**Figure 27 Appendix D**) is likely to date to the early to mid 20<sup>th</sup> century. Similarly, the construction of the ceilings below (to first floor) comprises a plaster affixed to metal gauze (as opposed to laths) (**Figure 28 Appendix D**). Discussions with the present owner has highlighted the use of this metal gauze as a replacement for lath and plaster in the c1920s extension and it is apparent that there was some work of repair and remodelling as part of the work undertaken to extend the house to the north. The extent of this work is unknown but it is suggested that there was much change and alteration undertaken in the early 20<sup>th</sup> century and later to this part of the building (see paras 3.11 and 3.12) with extensive remodelling of the south elevation.

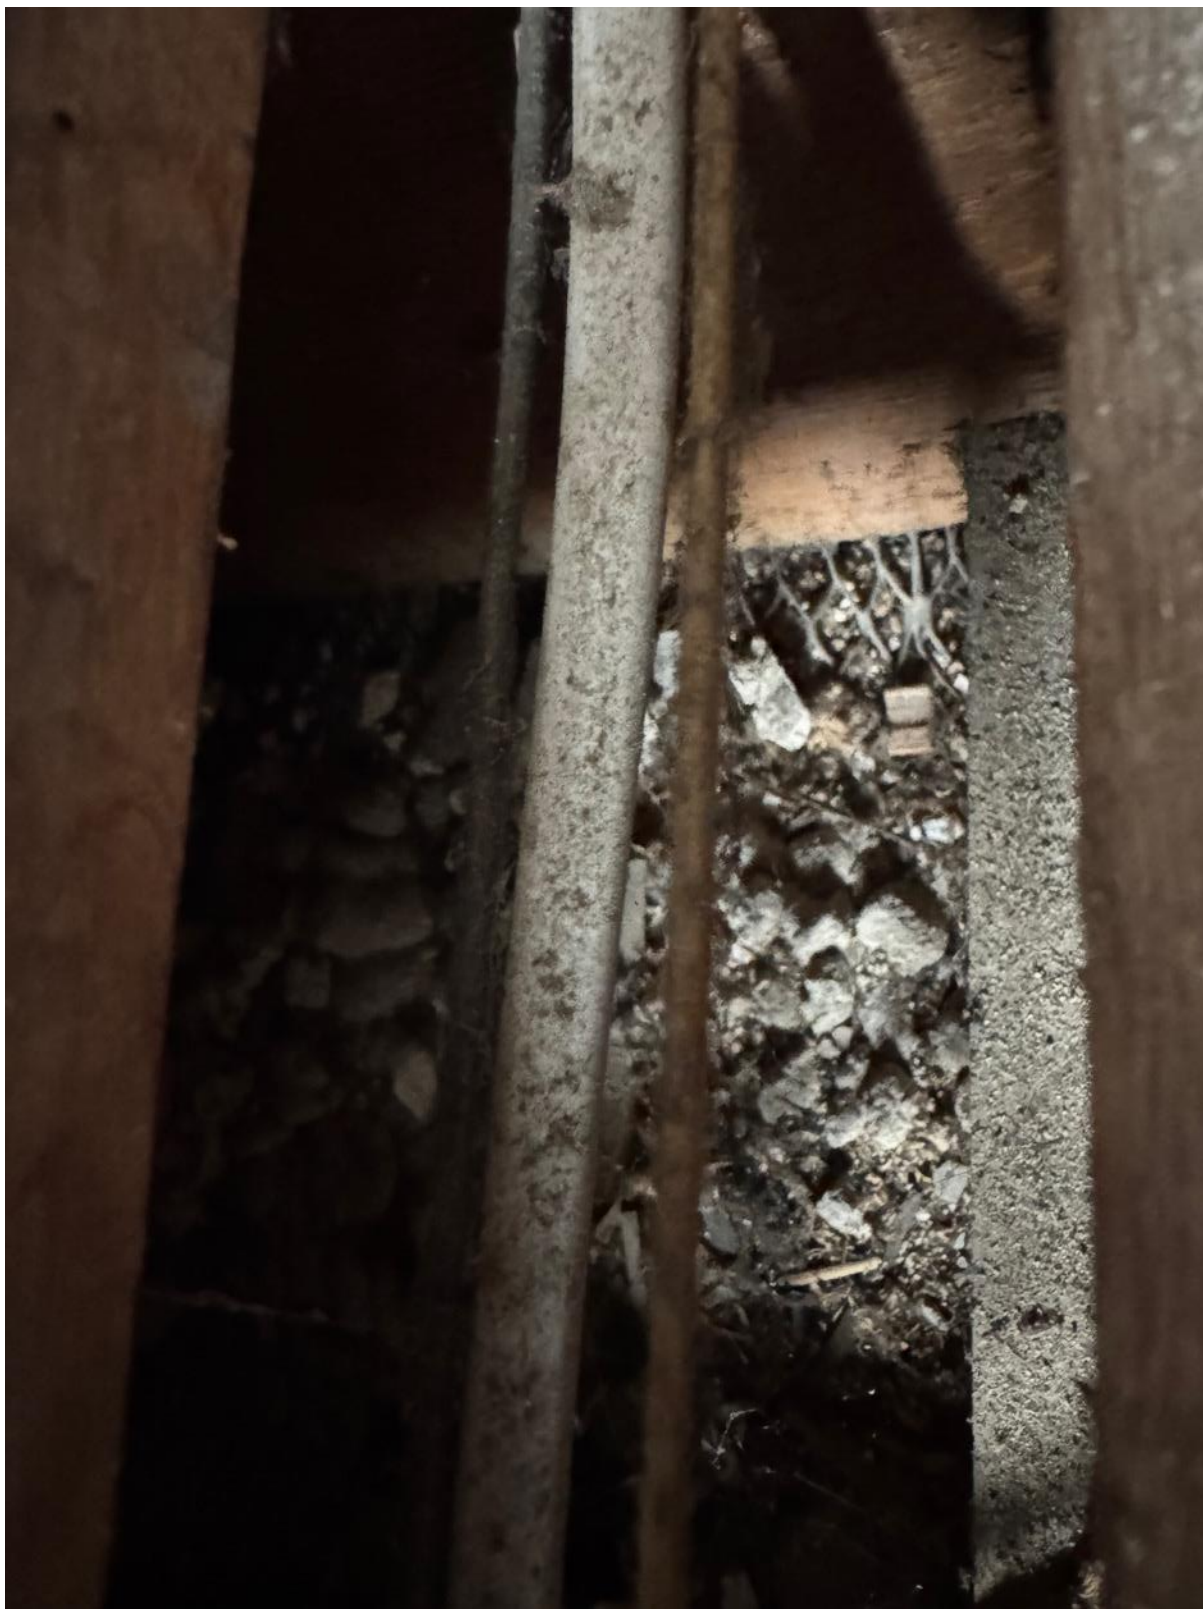
**Figure 28:** Photo taken between the joist showing metal gauze make-up of ceiling to first floor.

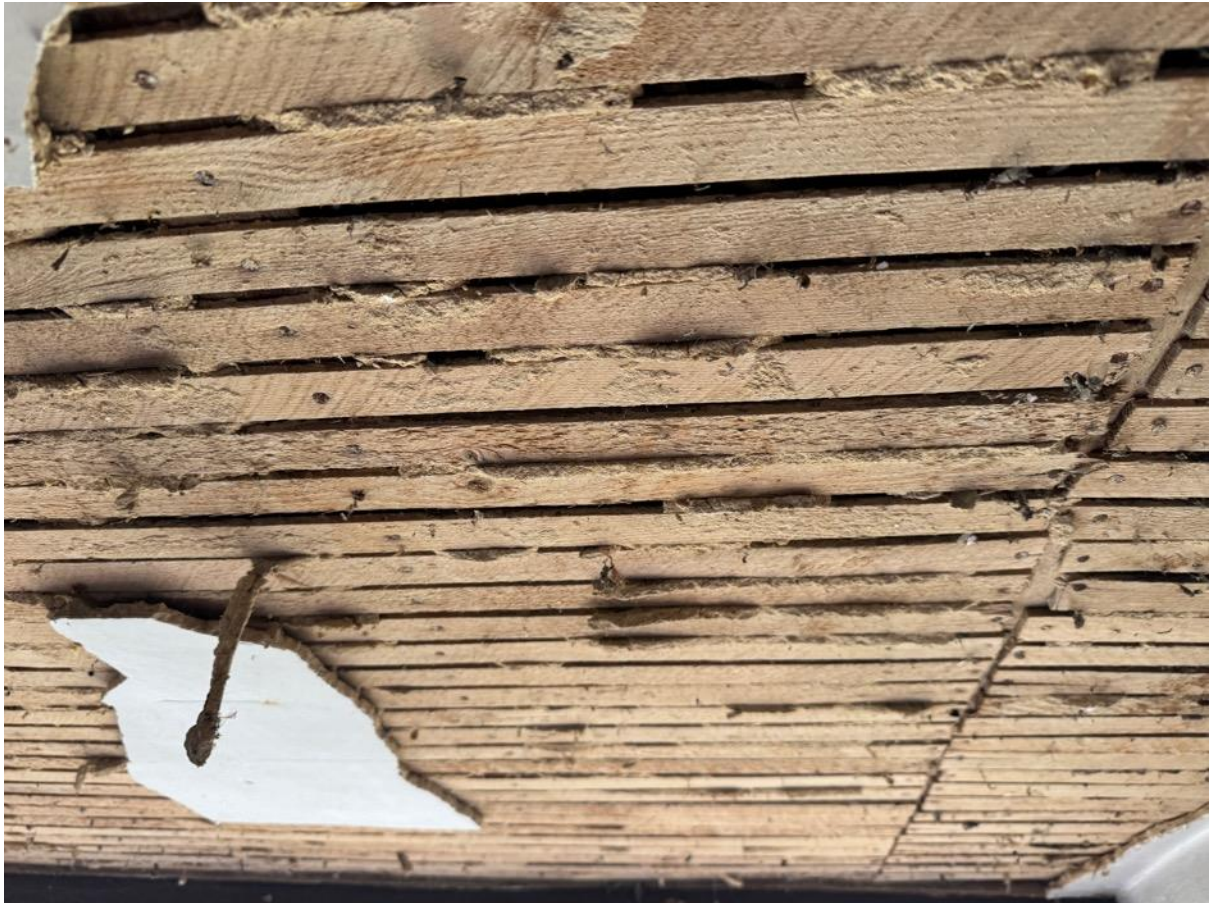
**Figure 29:** Sawn laths to ceiling of dormer window to south-west wing

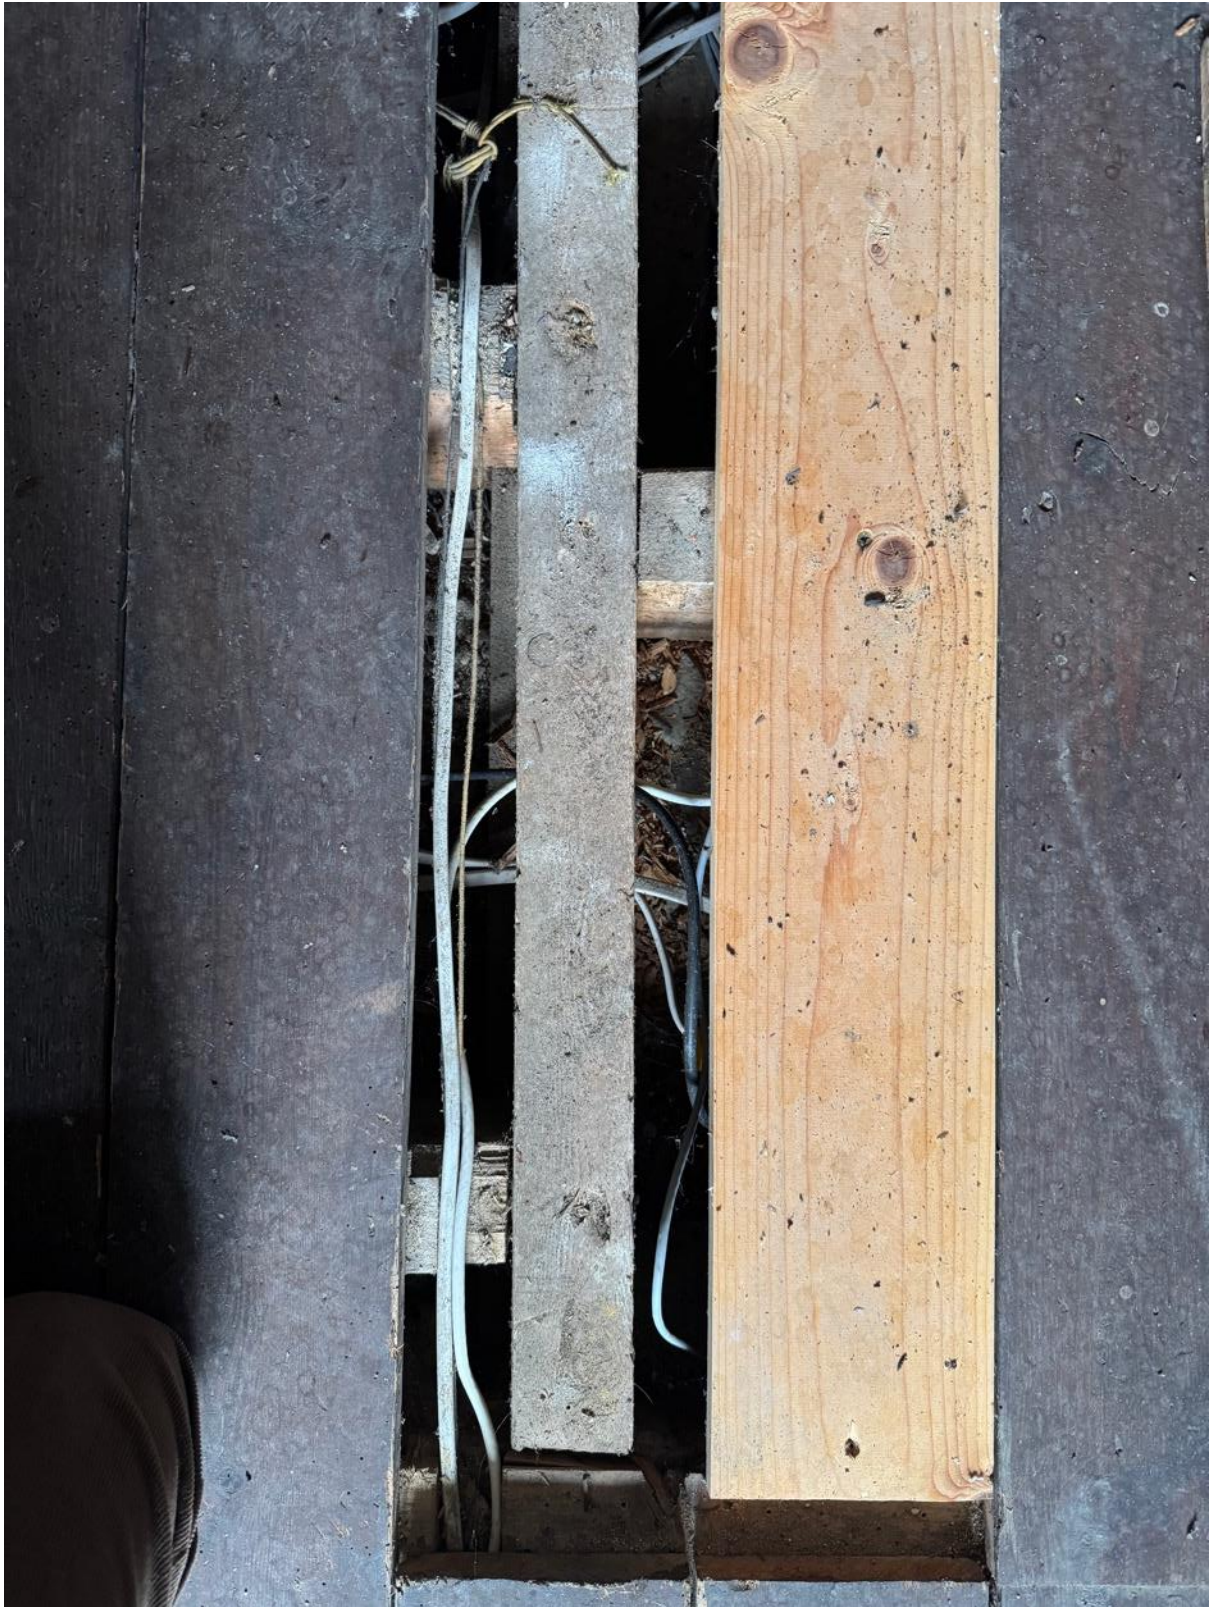
**Figure 30:** Sawn softwood joists in area of floor proposed for staircase installation
