## HERITAGE ASSESSMENT

**KINGS FARM, LIVERY ROAD, WEST WINTERSLOW, SP5 1RG**

**February 2024**

ELAINE MILTON  
HERITAGE & PLANNING LIMITED  
t: 07979 942042  
e: [emilton@emhp.co.uk](mailto:emilton@emhp.co.uk)  
w: [www.emhp.co.uk](http://www.emhp.co.uk)

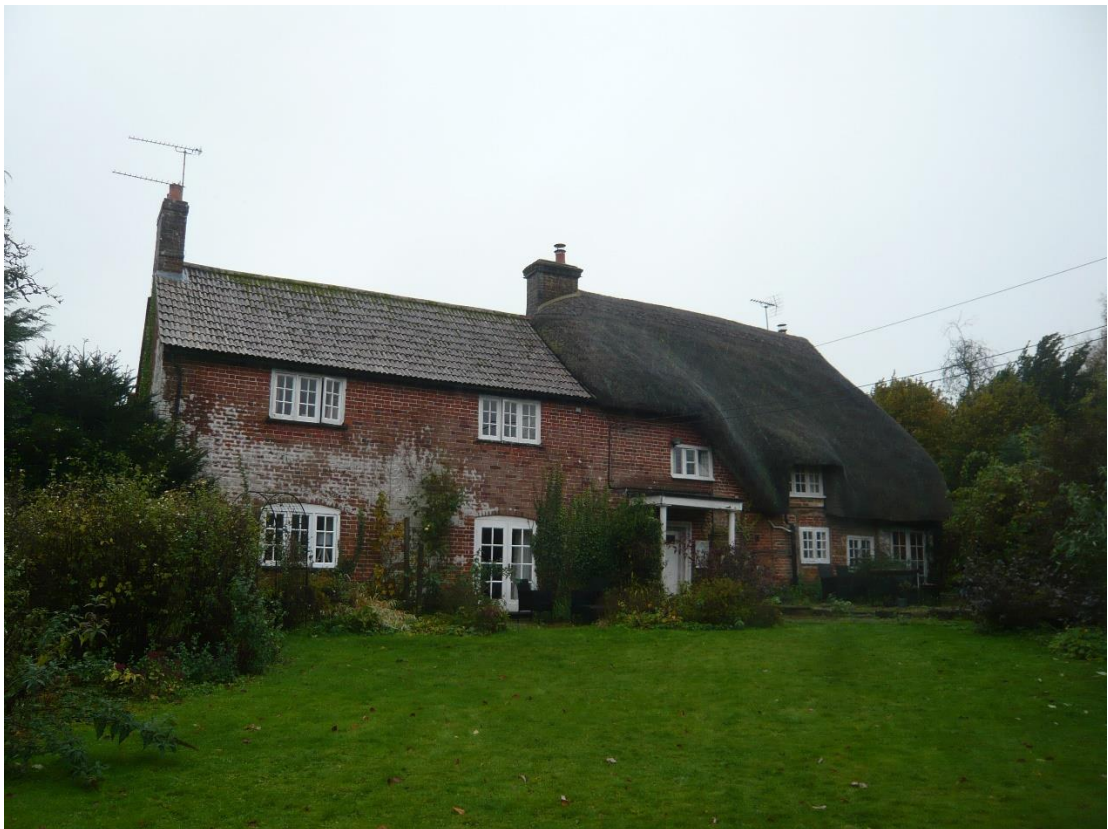
*Fig.3 Front of Kings Farm*

- 3.2 The main entrance (currently unused) is within the southern bay of the thatched element and features a six-panelled door sheltered by a flat-roofed canopy porch supported on cast iron columns.

- 3.1 Kings Farm is an L-plan house set back from the road within a large and landscaped garden. The land is mainly level but rises up to a steep bank within the south-west corner. The house is aligned roughly north-south in the plot with the east being the principal elevation and a cross-wing to the northern end, which sits end-on to the lane (Back Drove). The southern half of the house is two-storey, constructed in red brick laid in Flemish bond and with a gabled roof covered in clay pantiles. The northern element of the house is one-and-a-half storeys, with mainly Flemish bond brick walls but with an exposed timber-framed north wall. It has a hipped and thatched roof. Windows across the building are a mix of timber mullion and transom windows and casement windows. There is a dormer within the east slope and north slope of the thatched roof and two dormers within the west slope of the thatch. A gabled dormer has been inserted in the west slope of the tiled roof.

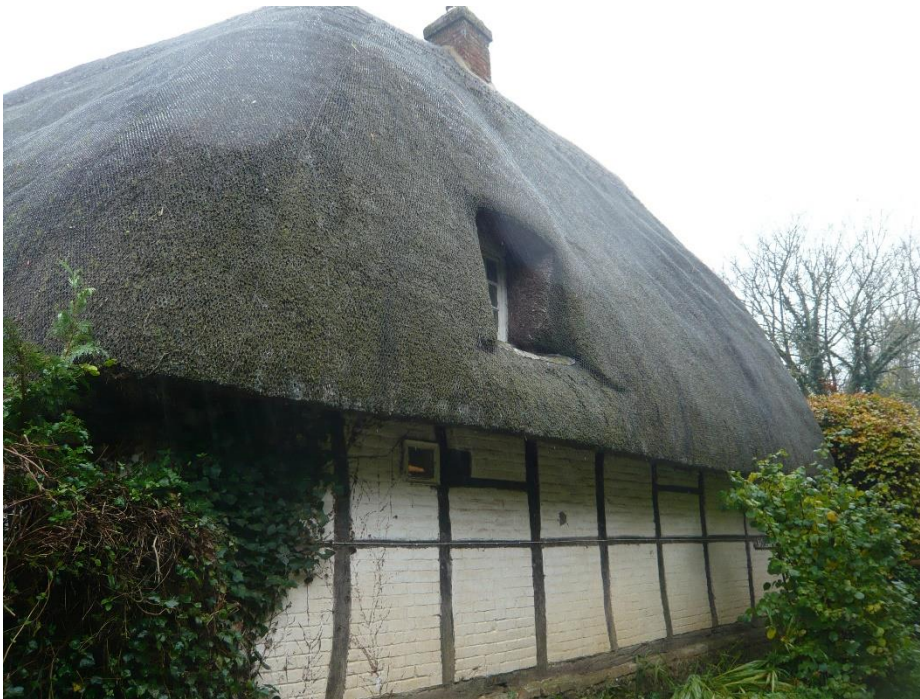
*Fig.4 Exposed timber-framed north wall as seen from Back Drove*

- The building is of aesthetic value as a traditional brick dwelling with some exposed elements of timber-framing and a thatched roof (the thatch is particularly prominent from the lane to the north);

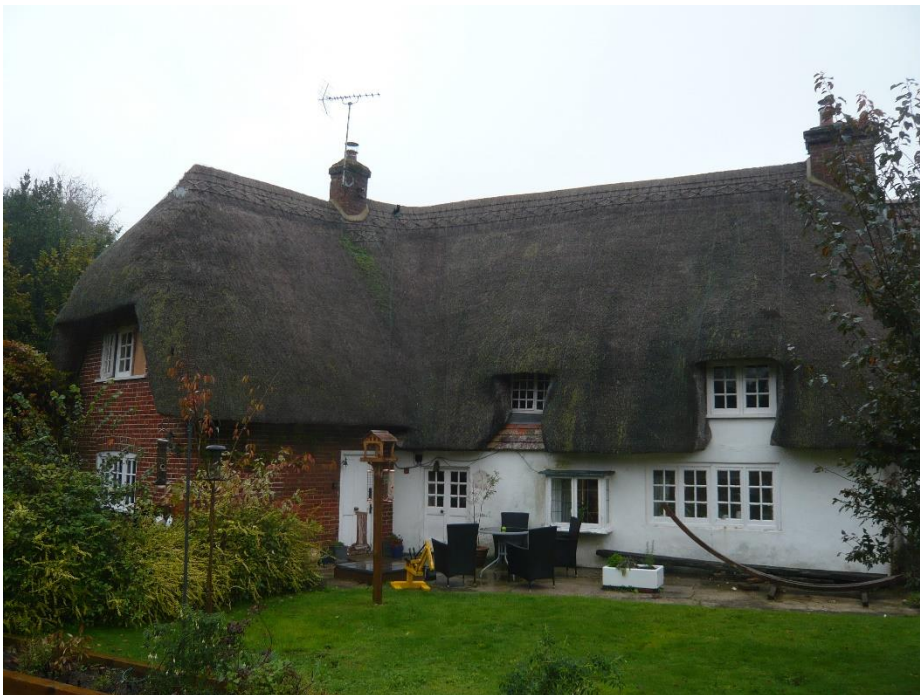
*Fig.5 Rear of the thatched element*

- 3.3 The walls at the rear of the house are rendered and painted. Windows are a mix of casement types. There is a plain four-panel door to the northern cross-wing and half-glazed double doors to the main range. Attached to the southern end of the rear is a single-storey link and outbuilding at right angles. The north wall of the link has timber-cladding and the south wall is rendered and painted. The barn is constructed in a mix of cob, brick, flint and blockwork. It has modern windows and garage door on the north side. There are lean-to sheds attached to the south side and west end.

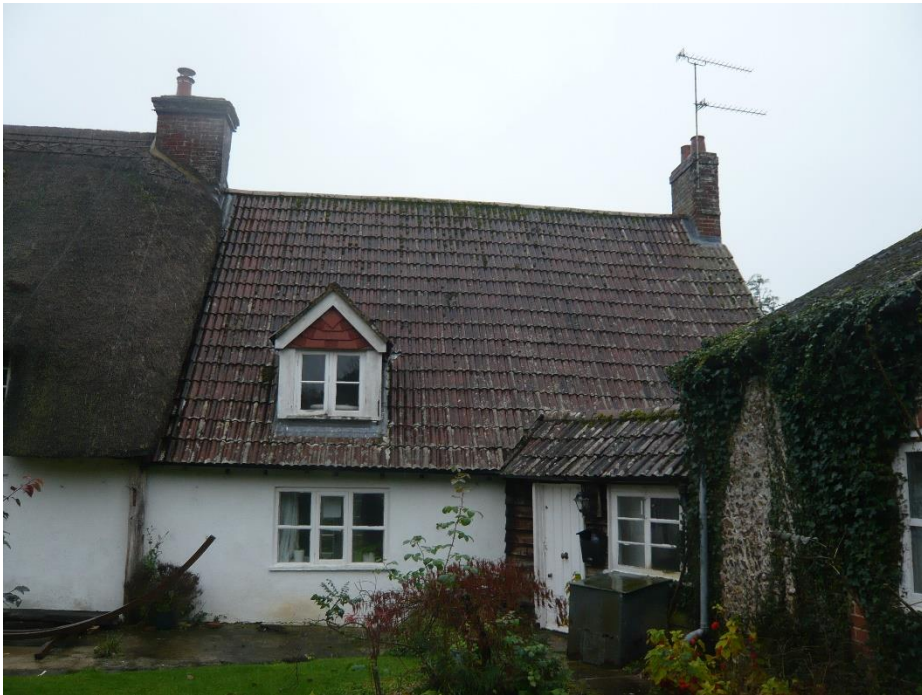
*Fig.6 Rear of the tiled element*

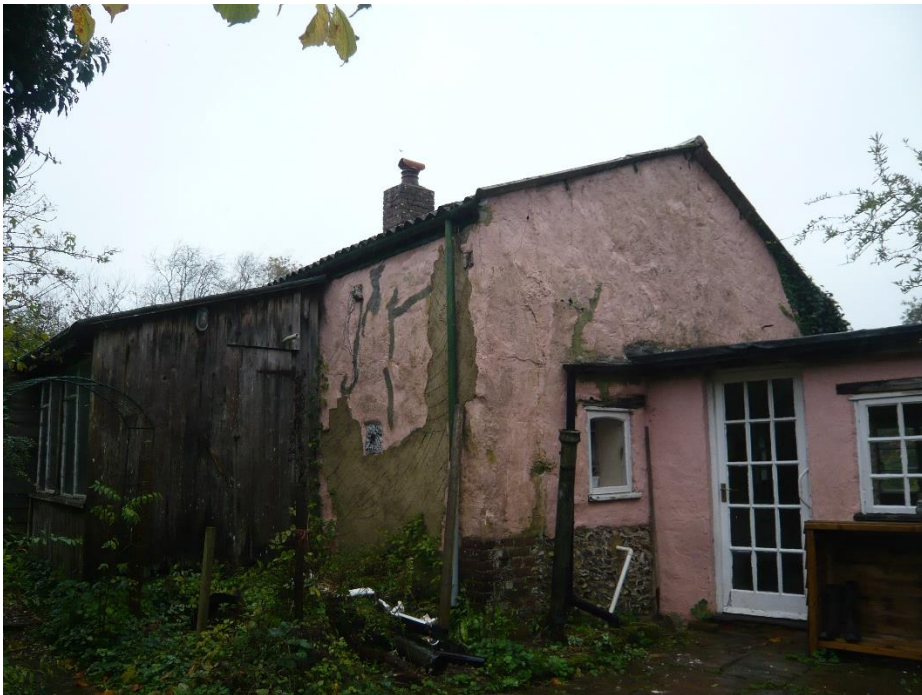
*Fig.7 Link and barn attached to the south-west of the house*

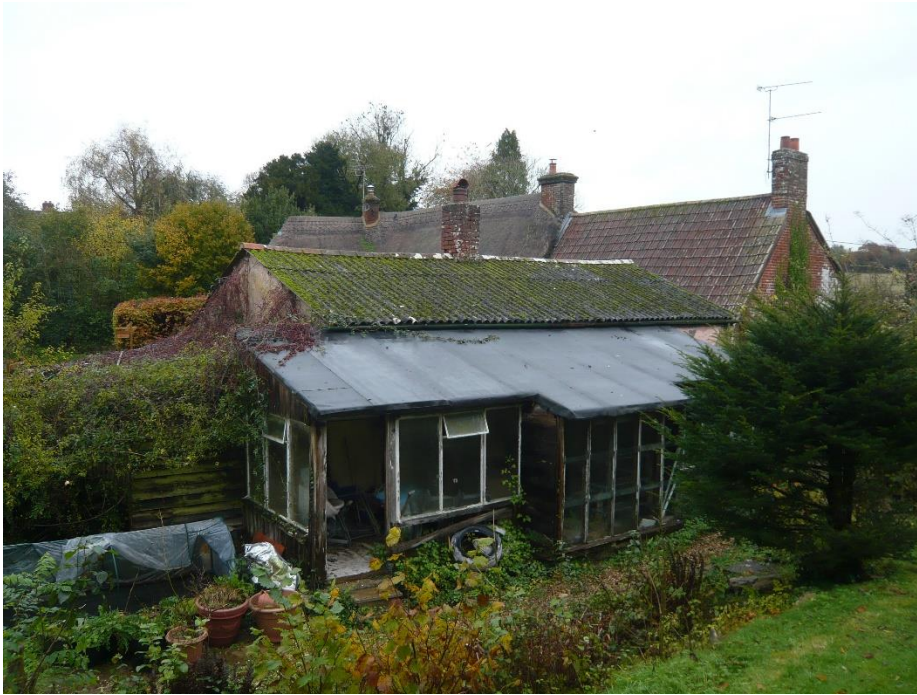
*Fig.8 View from the higher level of the garden looking down on the barn and lean-to shed*

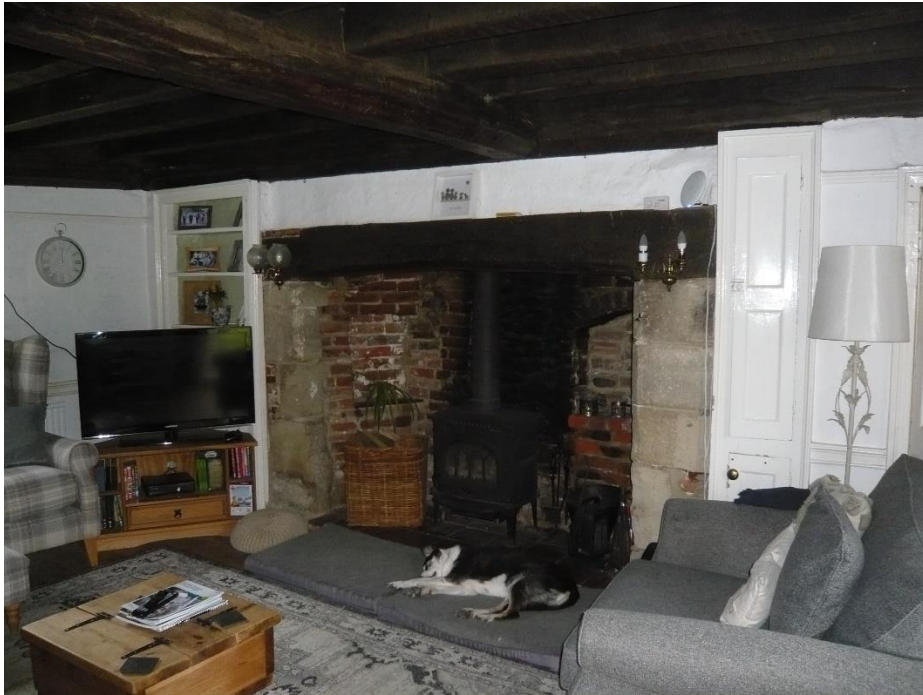
*Fig.9 Fireplace in the Sitting Room*

- 3.4 The main range of the house is a four-bay plan with a central brick chimney stack. The southernmost bay accommodates a Parlour and a staircase. The Parlour has lath and plaster ceiling and a small brick and stone fireplace. The Sitting Room occupies the bay to the north and is served by a large fireplace with stone jambs and a timber bressummer. There is a chamfered axial ceiling beam and exposed joists. The Kitchen/Dining Room to the north has a fireplace with a planted four-centred arch. The ceiling has exposed transverse beam and joists of seemingly various phases. The main entrance lobby is to the east of the Dining Room, with a WC and shower inserted within the northern end. There is a timber-framed partition on the east side of the Kitchen forming the Pantry. To the north of the Kitchen is a secondary stair and lobby.

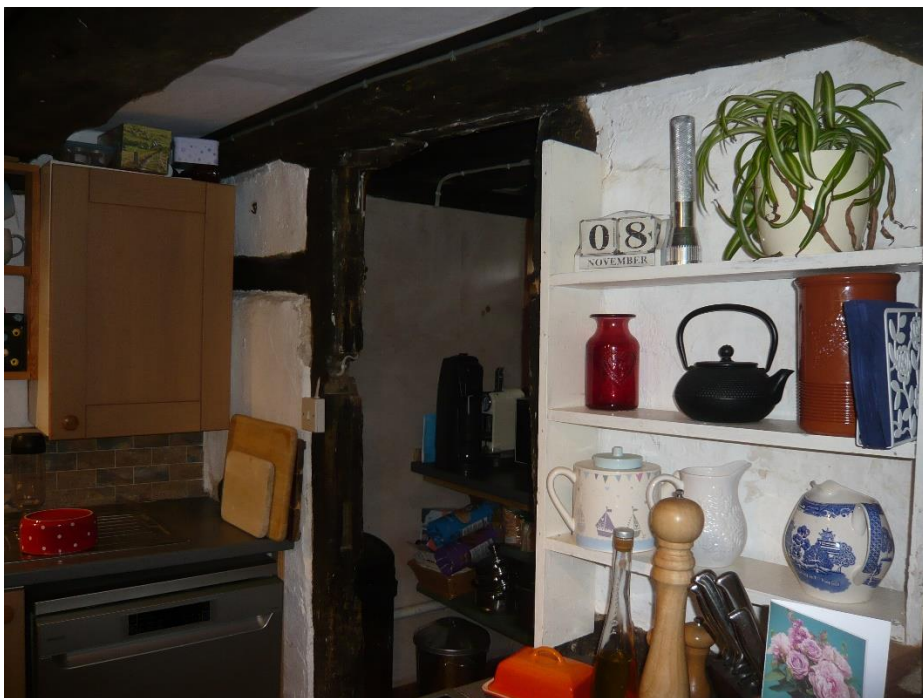
*Fig.10 Timber-framed Pantry wall*

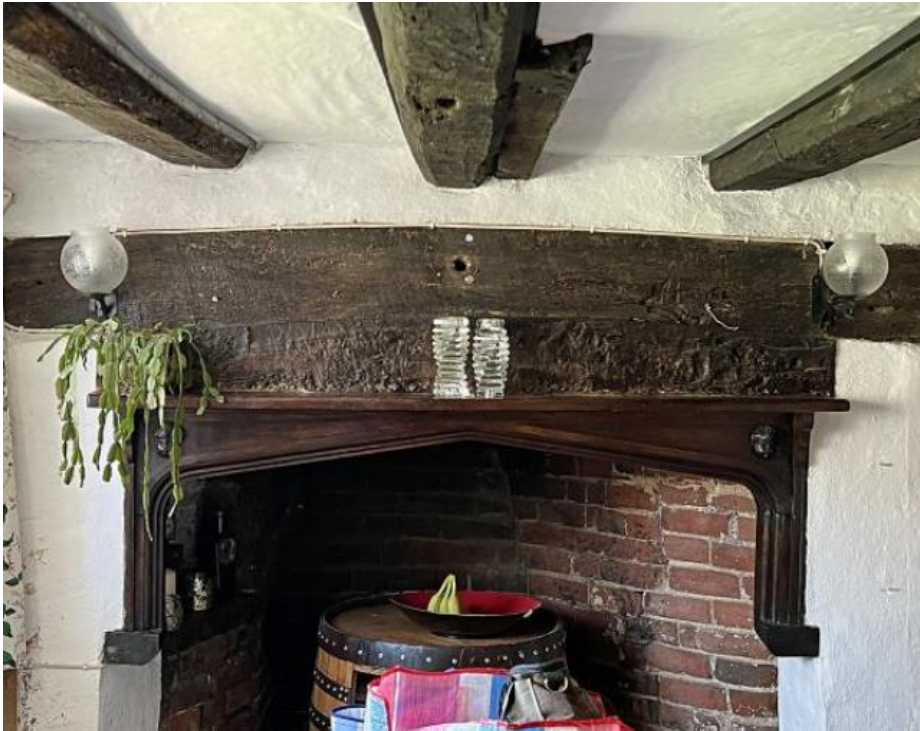
*Fig.11 Dining Room fireplace with planted arch*

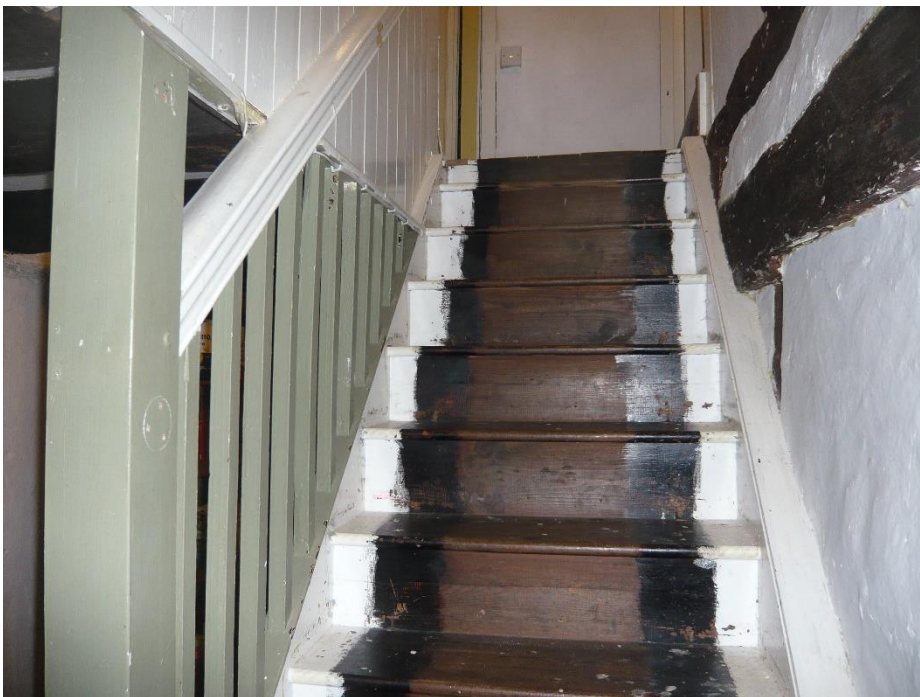
*Fig.12 Secondary staircase within the northern end of the house*

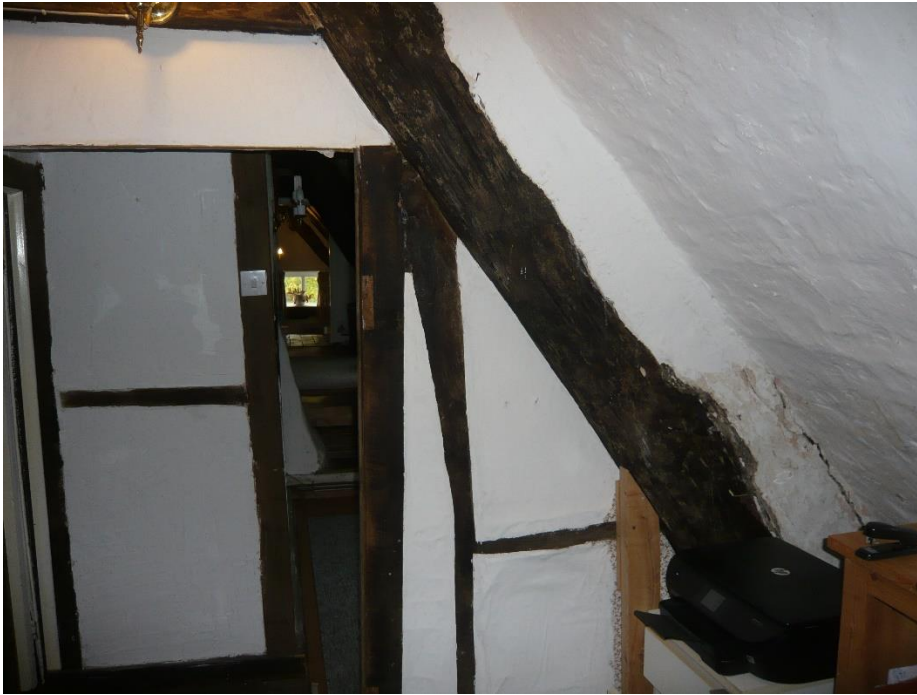
- 3.5 Within the first floor of the main range of the house can be seen the lower blades of the four original full cruck trusses and the undersides of purlins and some rafters. Alongside are timber-framed partitions – mostly faux. The layout of the bedrooms roughly follows the bay divisions. The northernmost bay has been insensitively subdivided by modern partitions.

*Fig.13 Lower blade of one of the original cruck trusses*

- Kings Farm represents a rare surviving example of a mid-C15 cruck-framed open hall house;
- The house retains a high degree of original fabric, including four full cruck trusses with two of the bays retaining the original rafters, wattles and smoke-blackened thatch;

- The trusses have a variety of apex carpentry, including a K-type apex, which is a rare and regionally distinctive type that has provided new evidence for the longevity of its use in the south-west of England;

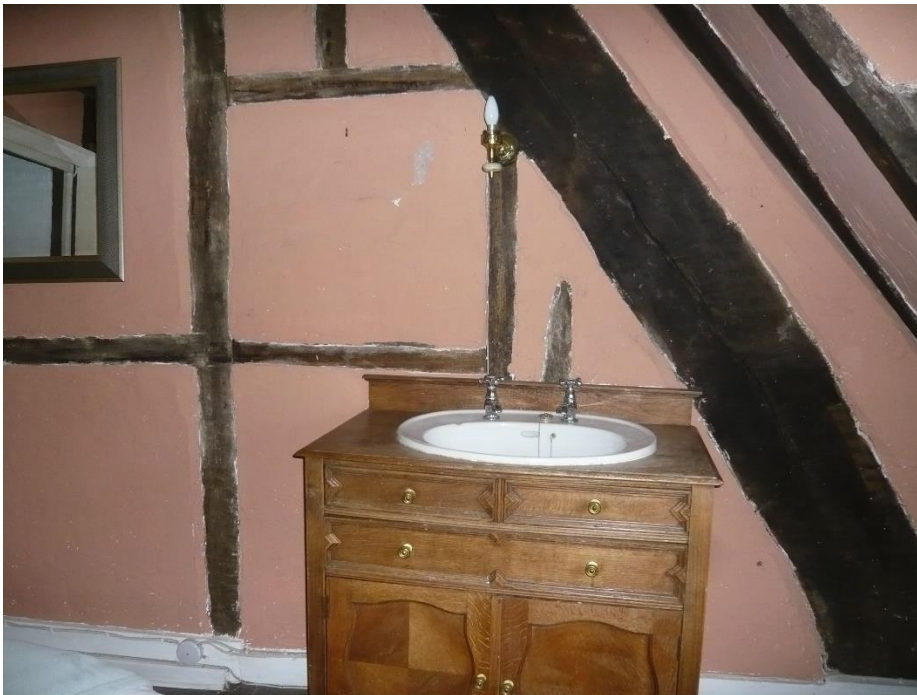
*Fig.14 Some faux timber-framing in one of the first-floor bedrooms*

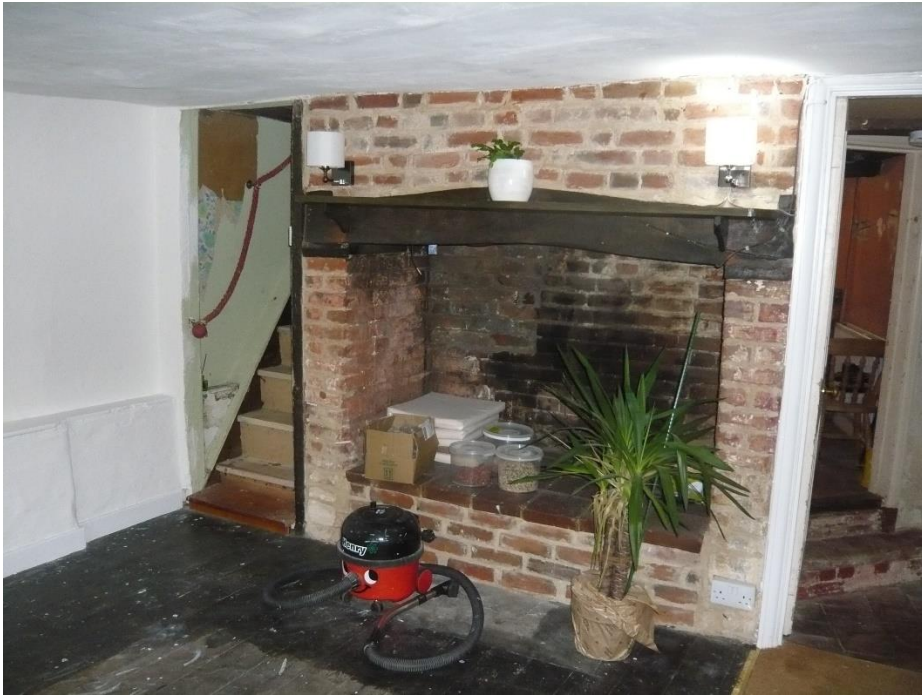
*Fig.15 Western room of the northern cross-wing*

- 3.6 The northern cross-wing of the house has a central brick stack and steep, narrow staircase with a room to either side. The east room has a quarry tiled floor. A landing has been formed with matchboarding at first floor. The first-floor bedrooms are within the loft and have low ceiling heights.

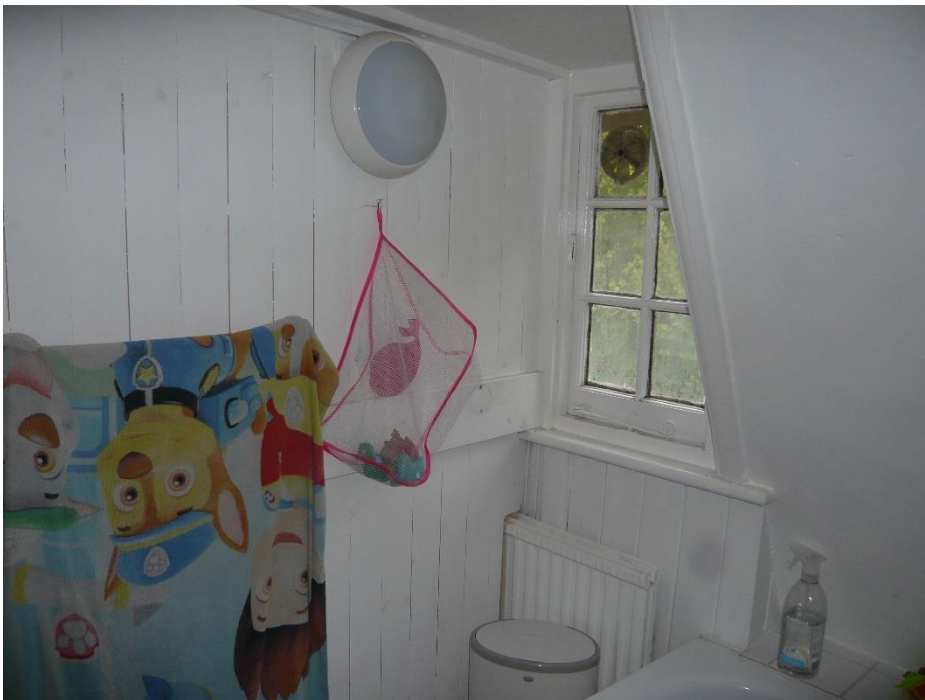
*Fig.16 Matchboard partition in the first floor of the cross-wing; note the restricted ceiling height*

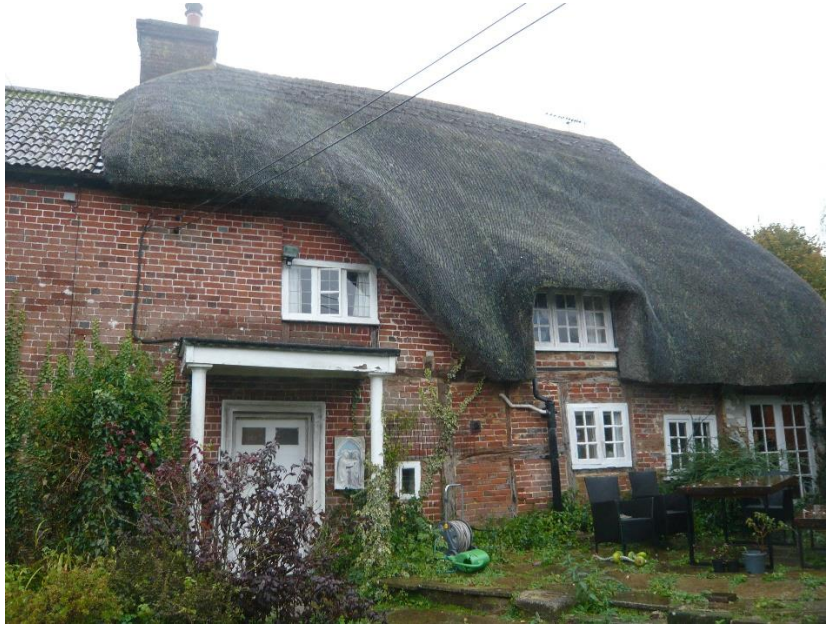
- The C18 six-panel front door is contemporaneous with the brick re-fronting and of value as part of the mid-C18 phase of the house; it is currently unused.

*Fig.17 C18 six-panel front door within C19 flat-roofed canopy porch*

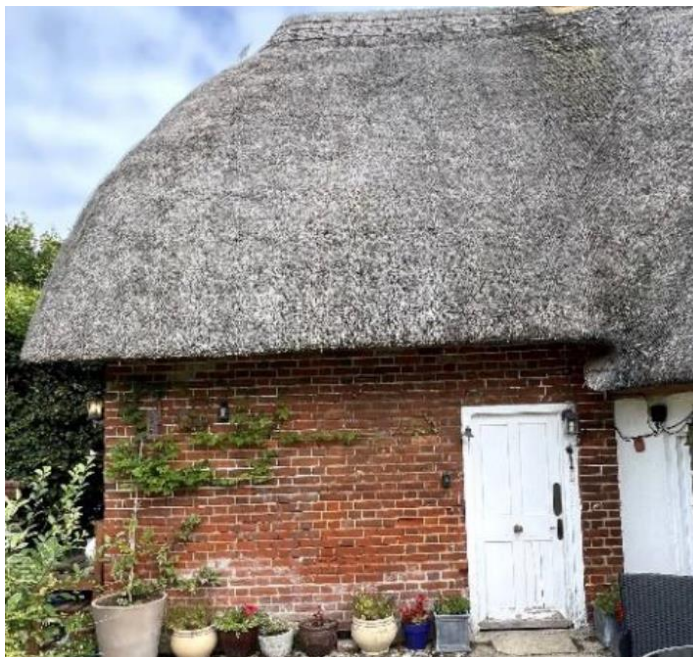
- The rear external door to the former dairy cross-wing is a plain early C20 four-panel door; the door opening was originally further left, as evidenced in the scars in the brickwork; the door is of limited value.

*Fig.18 Inserted early C20 door to the dairy; original opening was to the left*

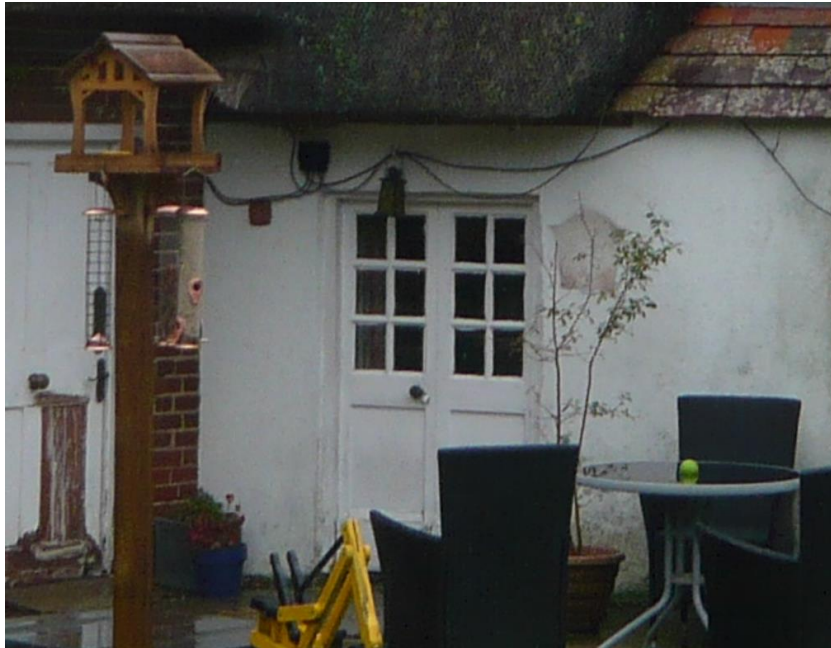
- The half-glazed double doors at the rear into the northern Stair/Lobby are early C20 and not of architectural value.

*Fig.19 Early C20 half-glazed doors on the rear*

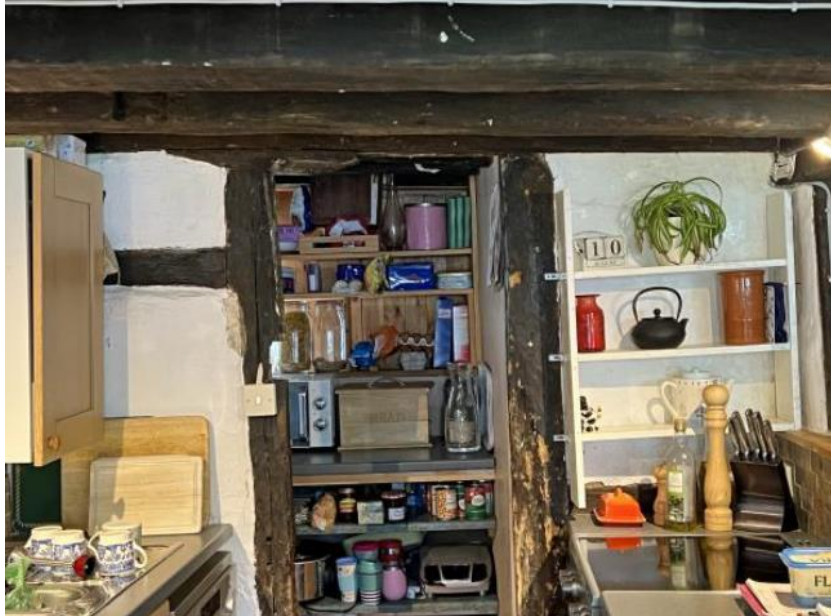
- The timber-framed elements exposed internally are of aesthetic value and aid interpretation of the original house, e.g., the timber-frame partition between the Kitchen and Pantry, which evidences the historic plan form and the space given over to the former loft stair/ladder that existed here in the C15.

*Fig.21 C15 timber-framing of the Pantry - former loft stair/ladder space*

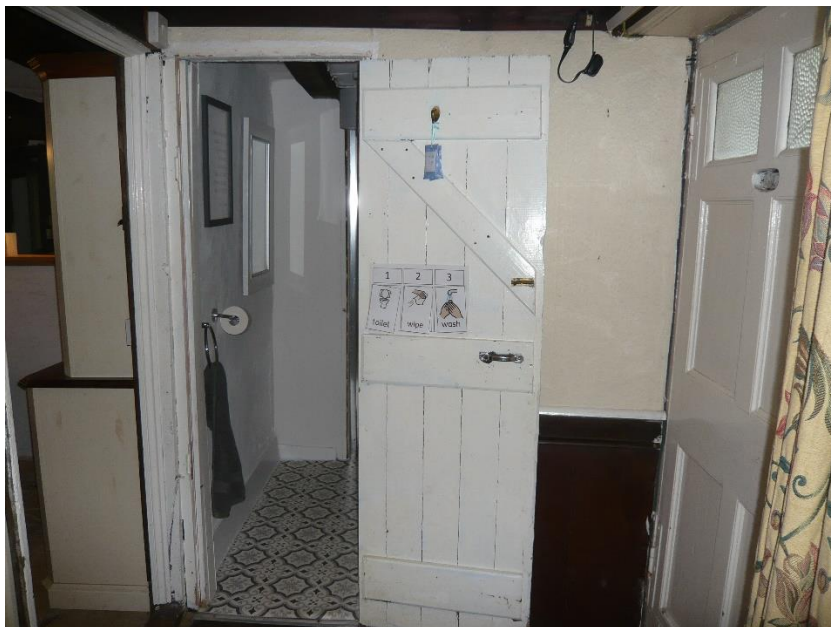
- The modern partitions, e.g., the wall between the Kitchen and Dining Room and the walls forming the WC and shower room to the east of the Dining Room, detract from the legibility and significance of the historic layout.

*Fig.22 Modern partition and door forming the WC within the entrance*

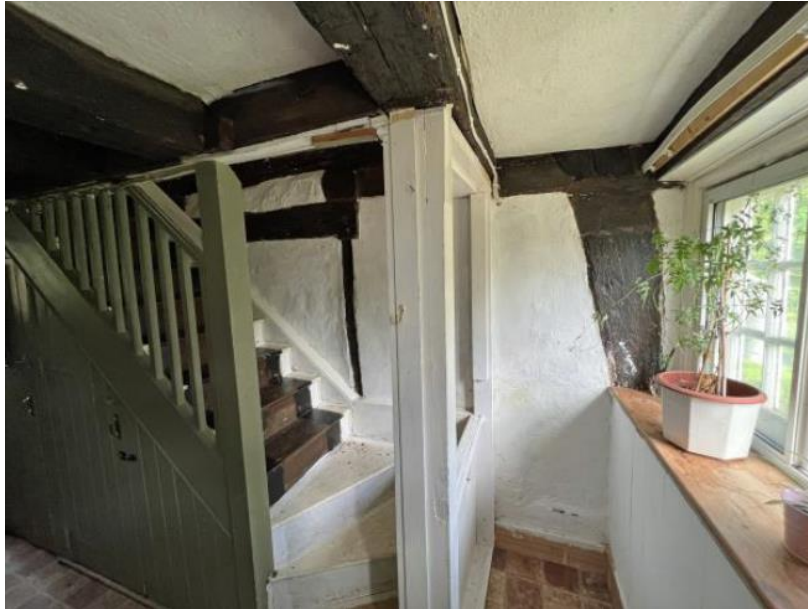
- The late C19 secondary staircase at the northern end of the house is of relatively low intrinsic value but is of value for reflecting the position of the late C18 staircase and plan form.

*Fig.23 Late C19 staircase in likely position of an C18 staircase*

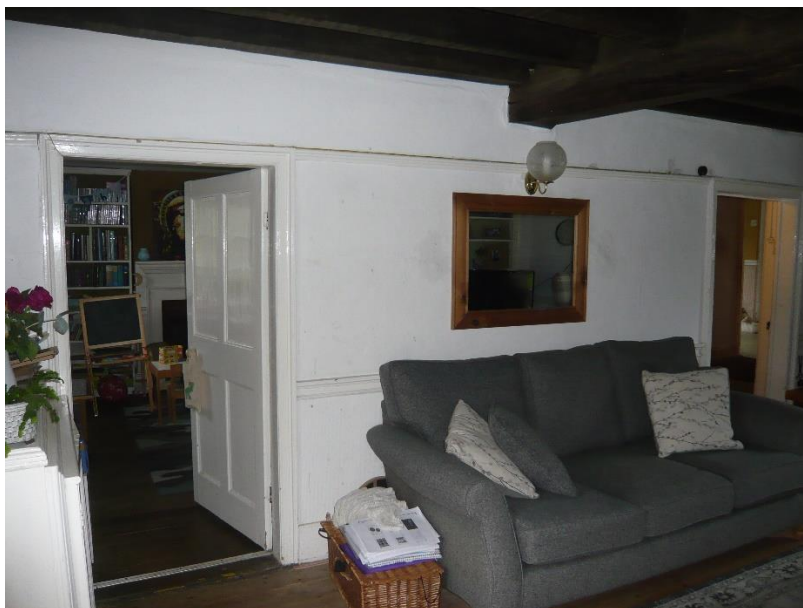
- The door between the Sitting Room and Parlour is of some historic value as a C19 four-panelled door and of architectural value for the symmetry it provides to the Sitting Room. The partitions forming the Parlour are likely to be mid-C18 and therefore of value for this historic fabric and plan form.

*Fig.24 C19 four-panel door to the Parlour on the left*

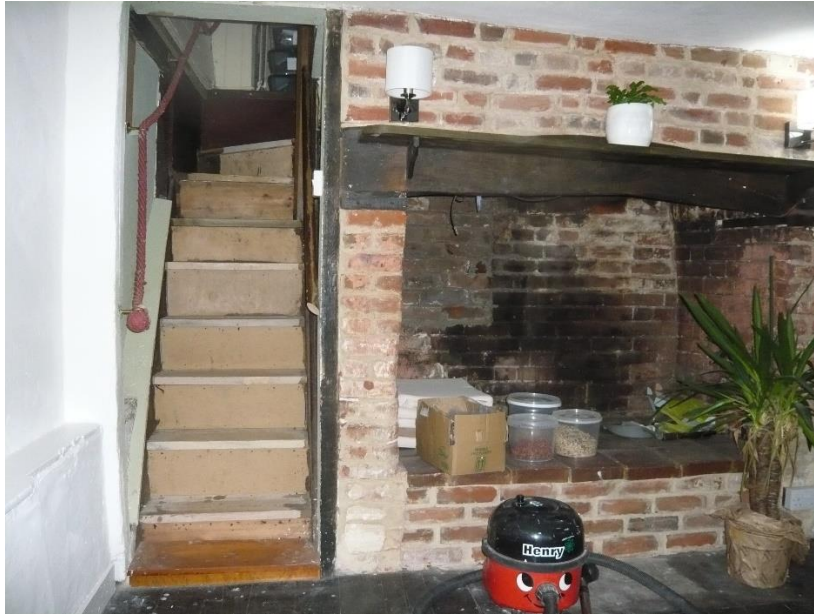
- The narrow, steep staircase within the dairy cross-wing is of value for its C18 fabric and its contribution to the plan form.

*Fig.25 Steep C18 staircase within the former dairy range*

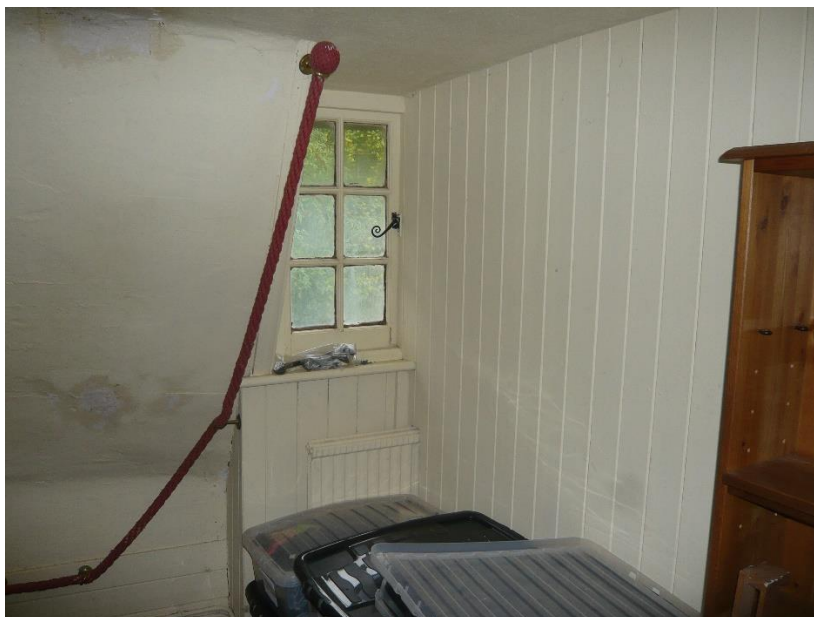
- The matchboard partition creating the landing space is early C20 fabric that obscures the original plan form and bisects a window.

*Fig.26 Early C20 matchboard partition within the first floor of the former dairy range*

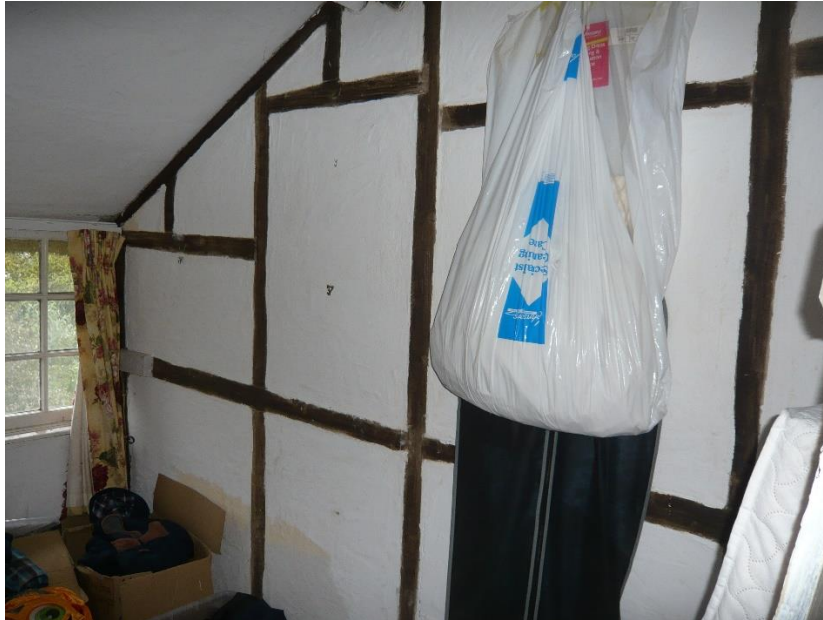
- The C20 partitions within the northern bay of the main house (forming the Study, Box Room and Bathroom) are poor quality and insensitively obscure the original plan form.

*Fig.27 Early C20 faux framing between Box Room and Bathroom*

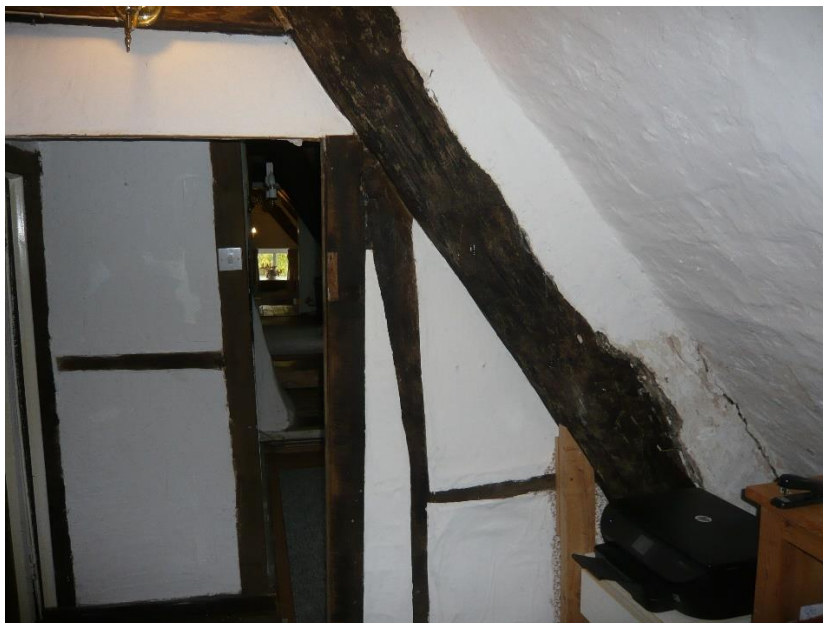
- The partitions forming the two bedrooms in the centre of the first floor are 1960s and not of value.

*Fig.28 View looking south within the first floor corridor – 1960s faux timber-frame partition on the left*

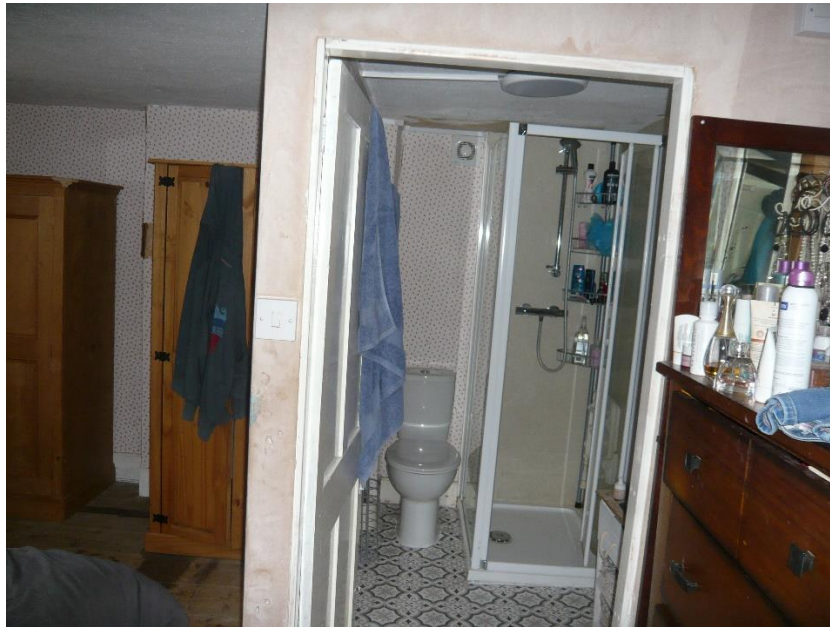
- The en-suite bathroom within the bedroom at the southern end is a modern insertion and detracts from the plan form and proportions of the bedroom (the partition cuts across the chimney breast and affects the setting of the cast iron fireplace).

*Fig.29 Modern partitions forming en-suite within southernmost bedroom*

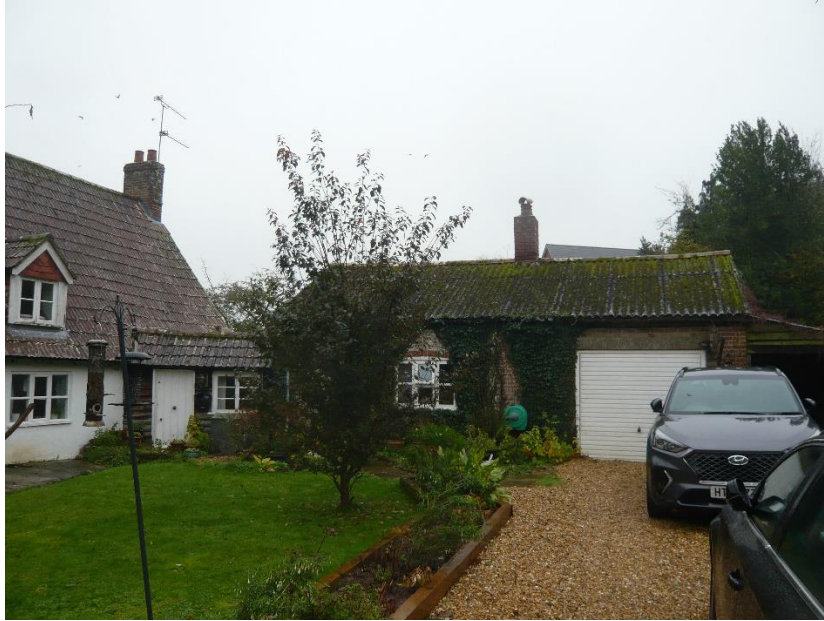
- The barn (excluded from the listing along with the link) is the last vestige of the once larger farmstead and its flint and chalk cob walls provide a record of traditional local building materials and construction methods of non-domestic buildings; however, the building has been much altered to form a garage, utility room and shower and its value is diminished without the rest of the farm buildings; the modern garage doors and dilapidated sheds detract from the setting of the house.

*Fig.30 Looking towards the north side of the barn from the rear garden*

- 6.14 The barn and link - specifically excluded from the listing - offer scope for removal and replacement with something more sympathetic and that provides the house with a spacious family living area, something the house currently lacks. Redevelopment

should follow the guidelines in HEAN2, e.g., subservient to the house, lightweight in appearance and of high-quality design, materials and detailing. Any linking element between the historic house and replacement building, would be best as a minimalist, light-weight structure.
