## Breach of condition 18 of 15/11604/OUT

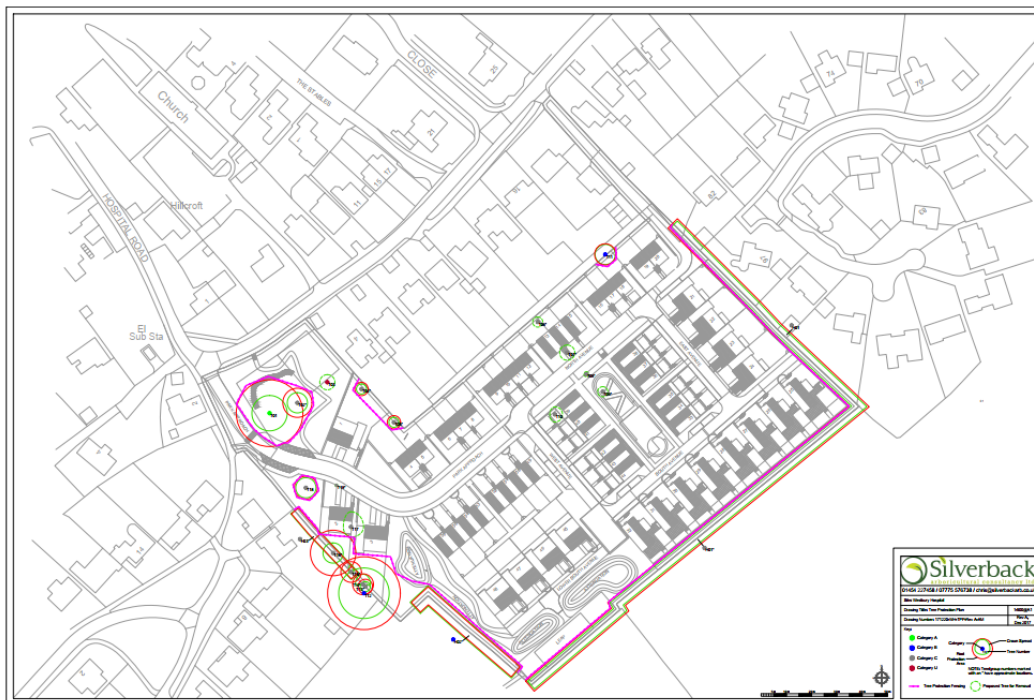
The Tree Protection Plan approved by the discharge of Condition 18 of planning application 15/11604/OUT is shown below.

In order to facilitate the construction and installation of the headwall and associated drainage, the protective fencing would need to be moved and significant excavation carried out within the RPA of the protected Cedar tree.

The addendum to the arb report dated the 11<sup>th</sup> of June clearly identifies that the Silverback Arboricultural Consultancy Limited have had no instruction or involvement in the changes of location of the fencing or supervision of the works carried out within the RPA of the tree.

This breach of planning may have caused the severance of structural and fibrous roots which may result in the loss of a healthy protected tree which will significantly alter the visual landscape upon which the proposed development was partly considered. The condition has not been complied with and future action is required to ensure that the tree's condition is appropriately monitored to avoid concerns relating to risk within a POS, as well as preserving the amenity value and character of the local area.

All information which has not been provided is required to enable the Constructors Project Arboriculturalist to have an accurate measure of the extent of the damage caused and provide a more informed up-to-date addendum. This should include, but is not limited to:

- the location of the underground pipes,
- the area of ground that excavated,
- the method excavation,
- all the materials used to install the headwall and associated infrastructure within the RPA,
- any altering of ground levels,
- the materials used for regrading of the surface during landscaping.

Due to the lack of information, the tree will require annual monitoring for a period of 5 years by a qualified Arboriculturalist, who should have prior access to the above revised addendum. This is considered an appropriate amount of time to determine if the unauthorised construction works have had a negative impact on the roots of the tree and its physiological processes, and if it will need to be replaced.
