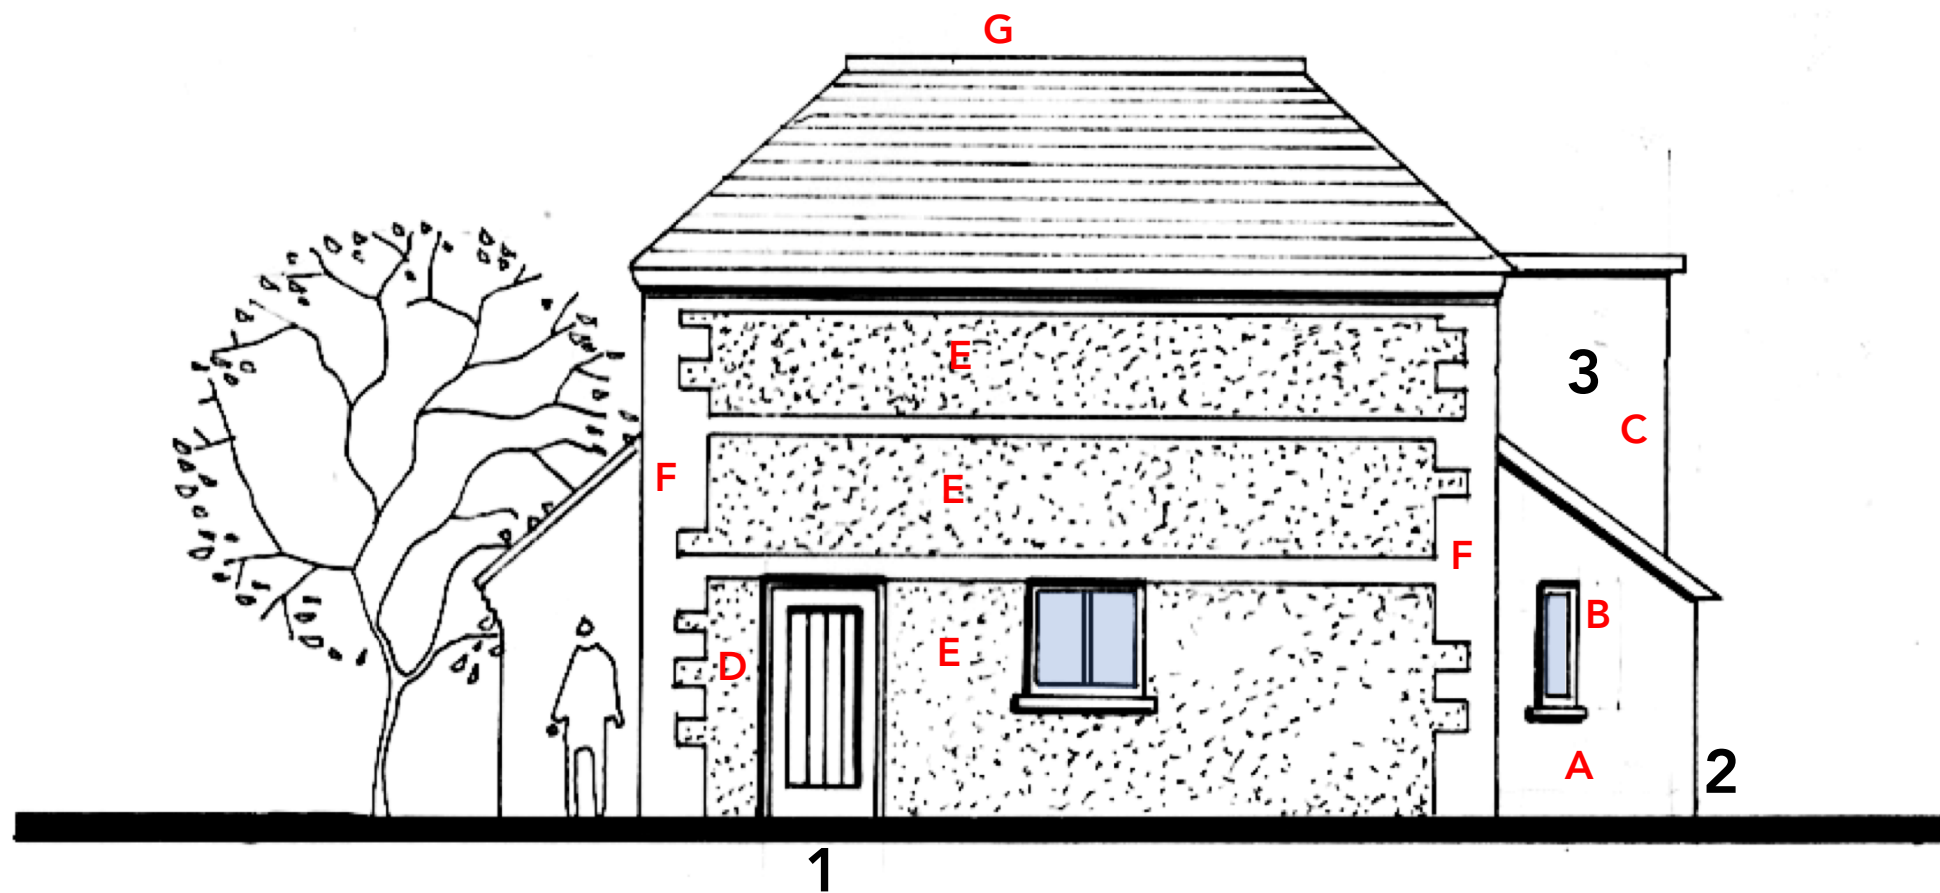
1. Existing window adapted to become new doorway
2. New single storey bathroom extension
3. New double storey rear dormer style extension in background

- A. Brickwork to match existing
- B. New casement timber window
- C. Zinc cladding to dormer side
- D. New oak door
- E. Existing flint walling
- F. Existing brickwork detailing
- G. Existing tiled roofing
