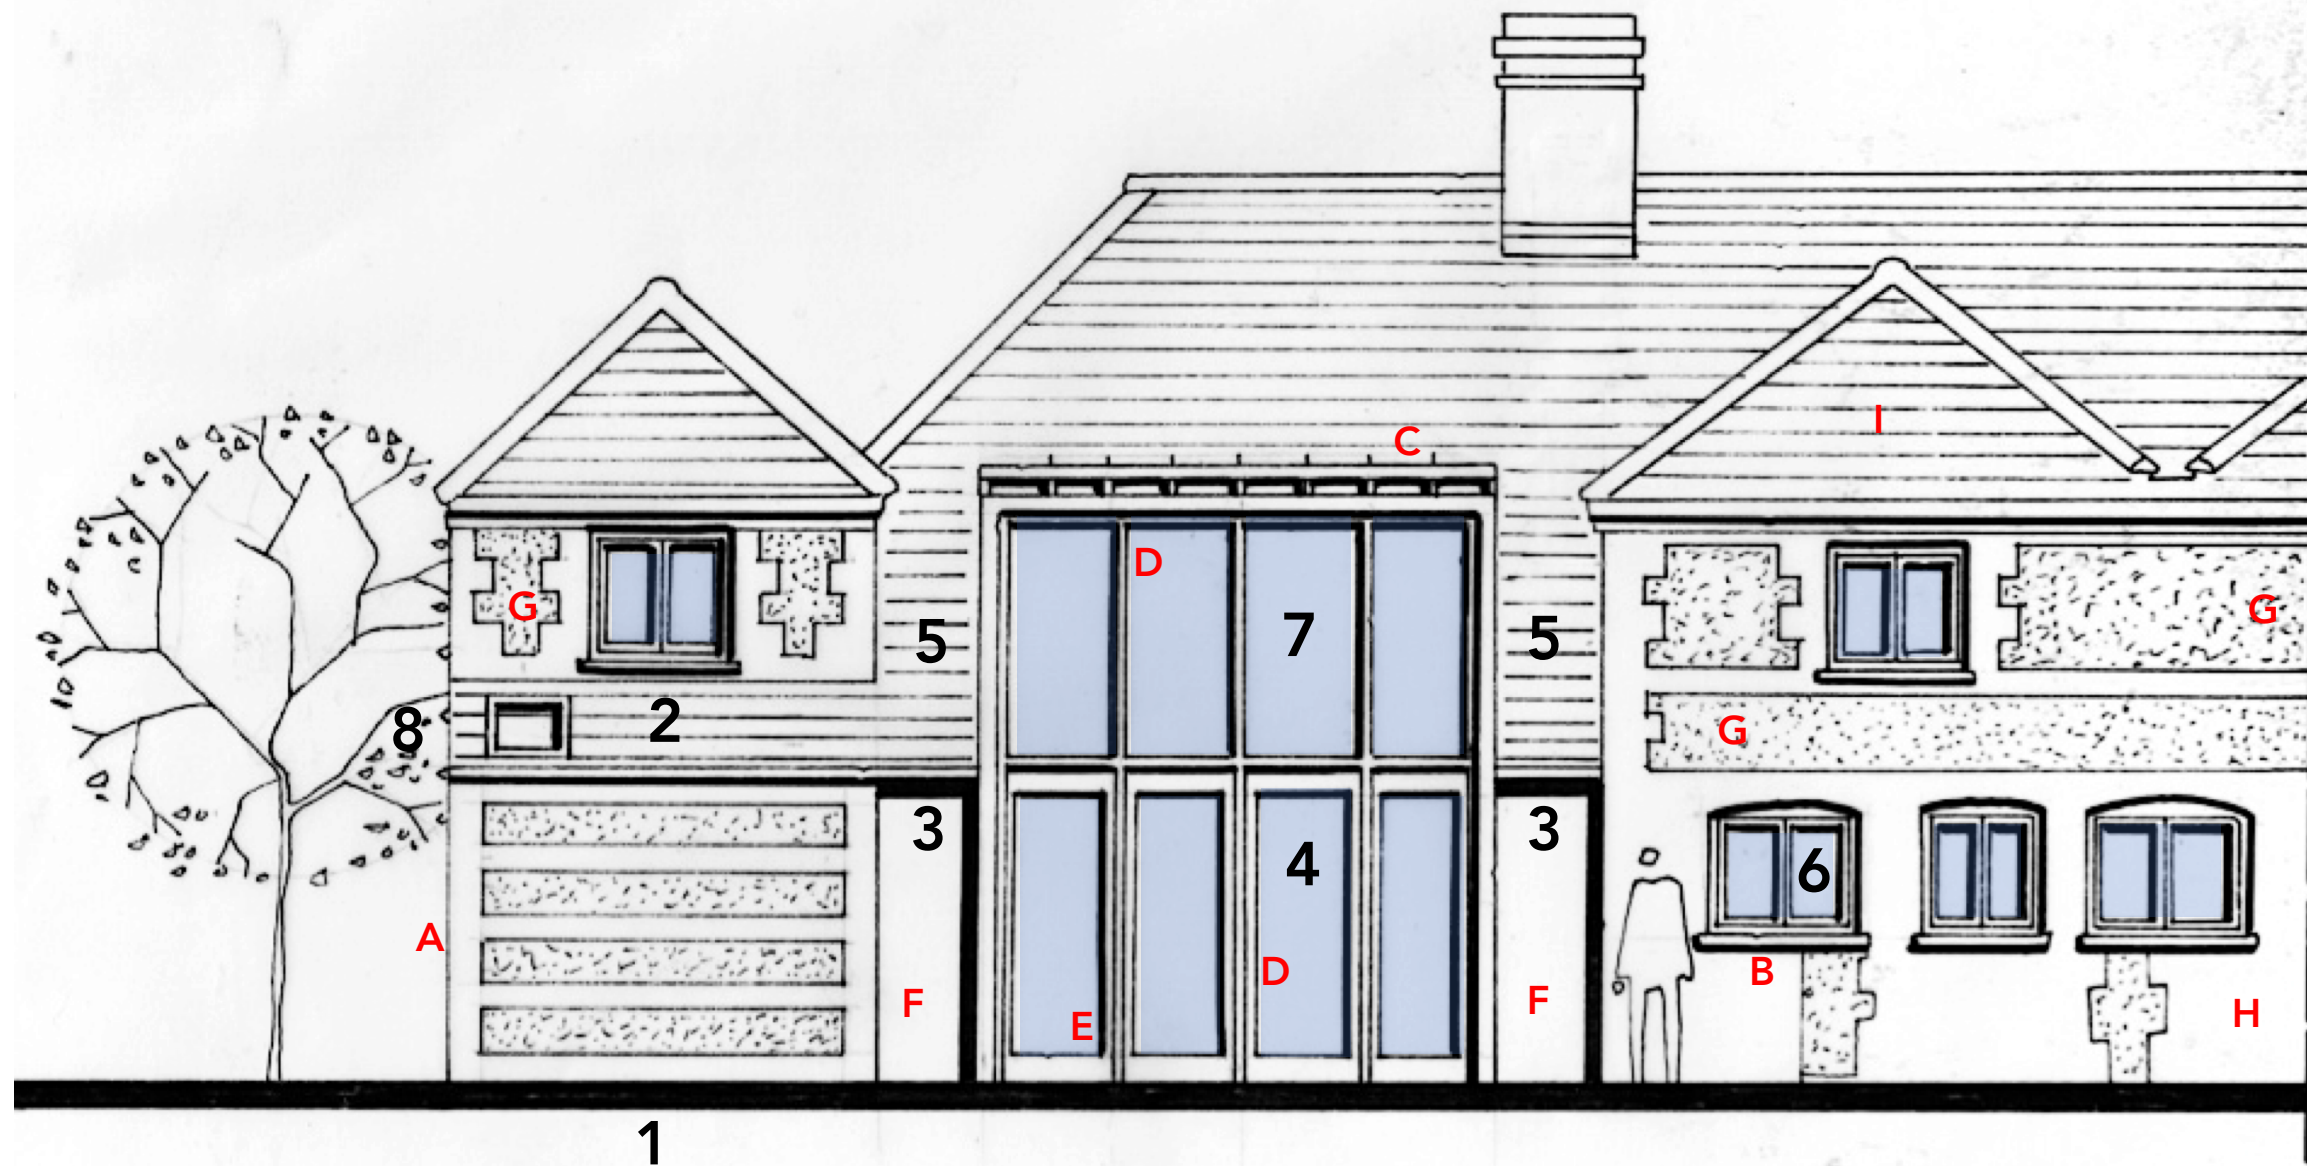
- A. Flint panels and brickwork trims to match existing
- B. New casement timber window
- C. Zinc flashing to roof edge
- D. Timber mullions to new façade
- E. Timber and glass doors
- F. New brickwork to match existing
- G. Existing flint walling
- H. Existing brickwork detailing
- I. Existing tiled roofing

- 1. New single storey bathroom extension
- 2. New sloped roof over bathroom
- 3. New rear wall to dining room
- 4. New glazed doors to dining room
- 5. New sloped roof over dining room
- 6. New window created in rear wall where old doorway has previously been infilled.
- 7. First floor glazed dormer type extension
- 8. New rooflight over shower room
