Drawing Title:  
**TOPOGRAPHIC SURVEY WITH  
GROUND SHADING**

Project: **COLDHARBOUR FARM  
HIGH STREET  
PITTON**

| Scale:<br><b>1:100</b><br>Plotted on A1 | Drawing No:<br><b>LDS/20856 TP2</b><br>© Land Development Services Ltd. 2025 | Revision:<br><b>-</b> |

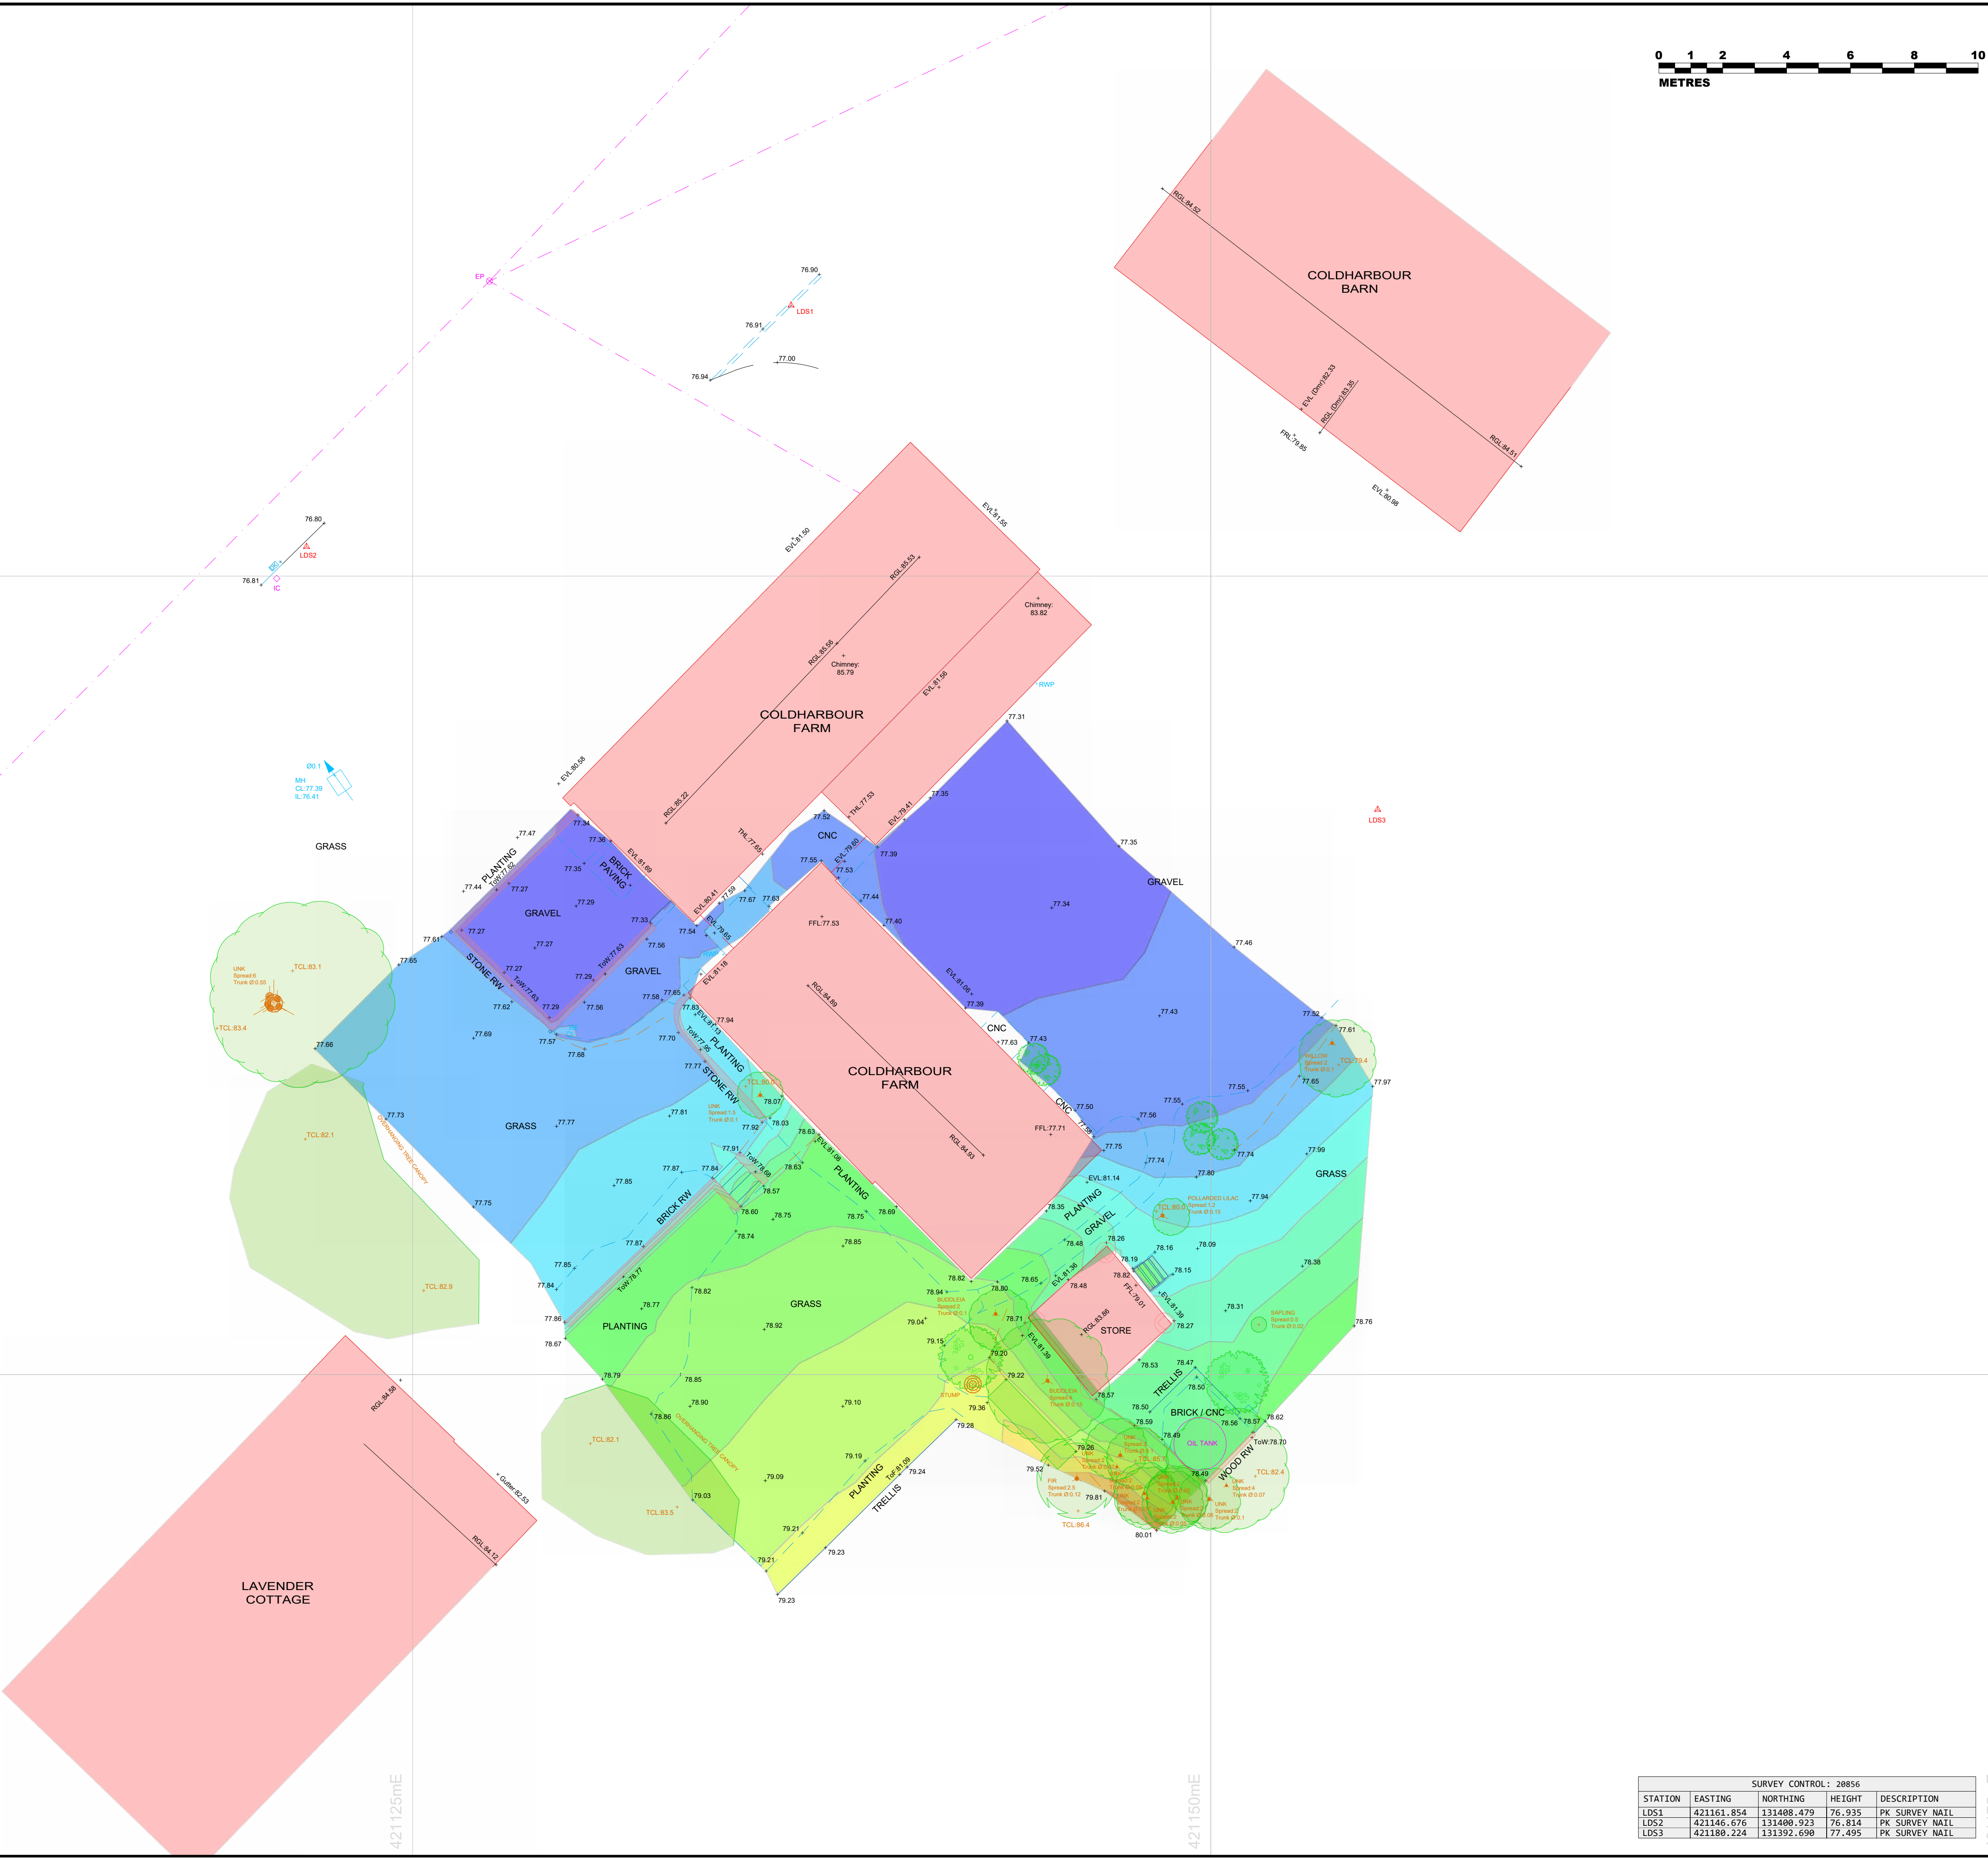
Survey is to OS Grid, located via use of GPS positioning.

Level values in metres, related to Ordnance Datum Newlyn.
