Client: **GUY MOVERLY**

Drawing Title:  
**TOPOGRAPHIC SURVEY**

Project:  
**COLDHARBOUR FARM  
HIGH STREET  
PITTON**

| Scale:<br><b>1:100</b><br>Plotted on A1 | Drawing No:<br><b>LDS/20856 TP1</b><br>© Land Development Services Ltd. 2025 | Revision:<br><b>-</b> |

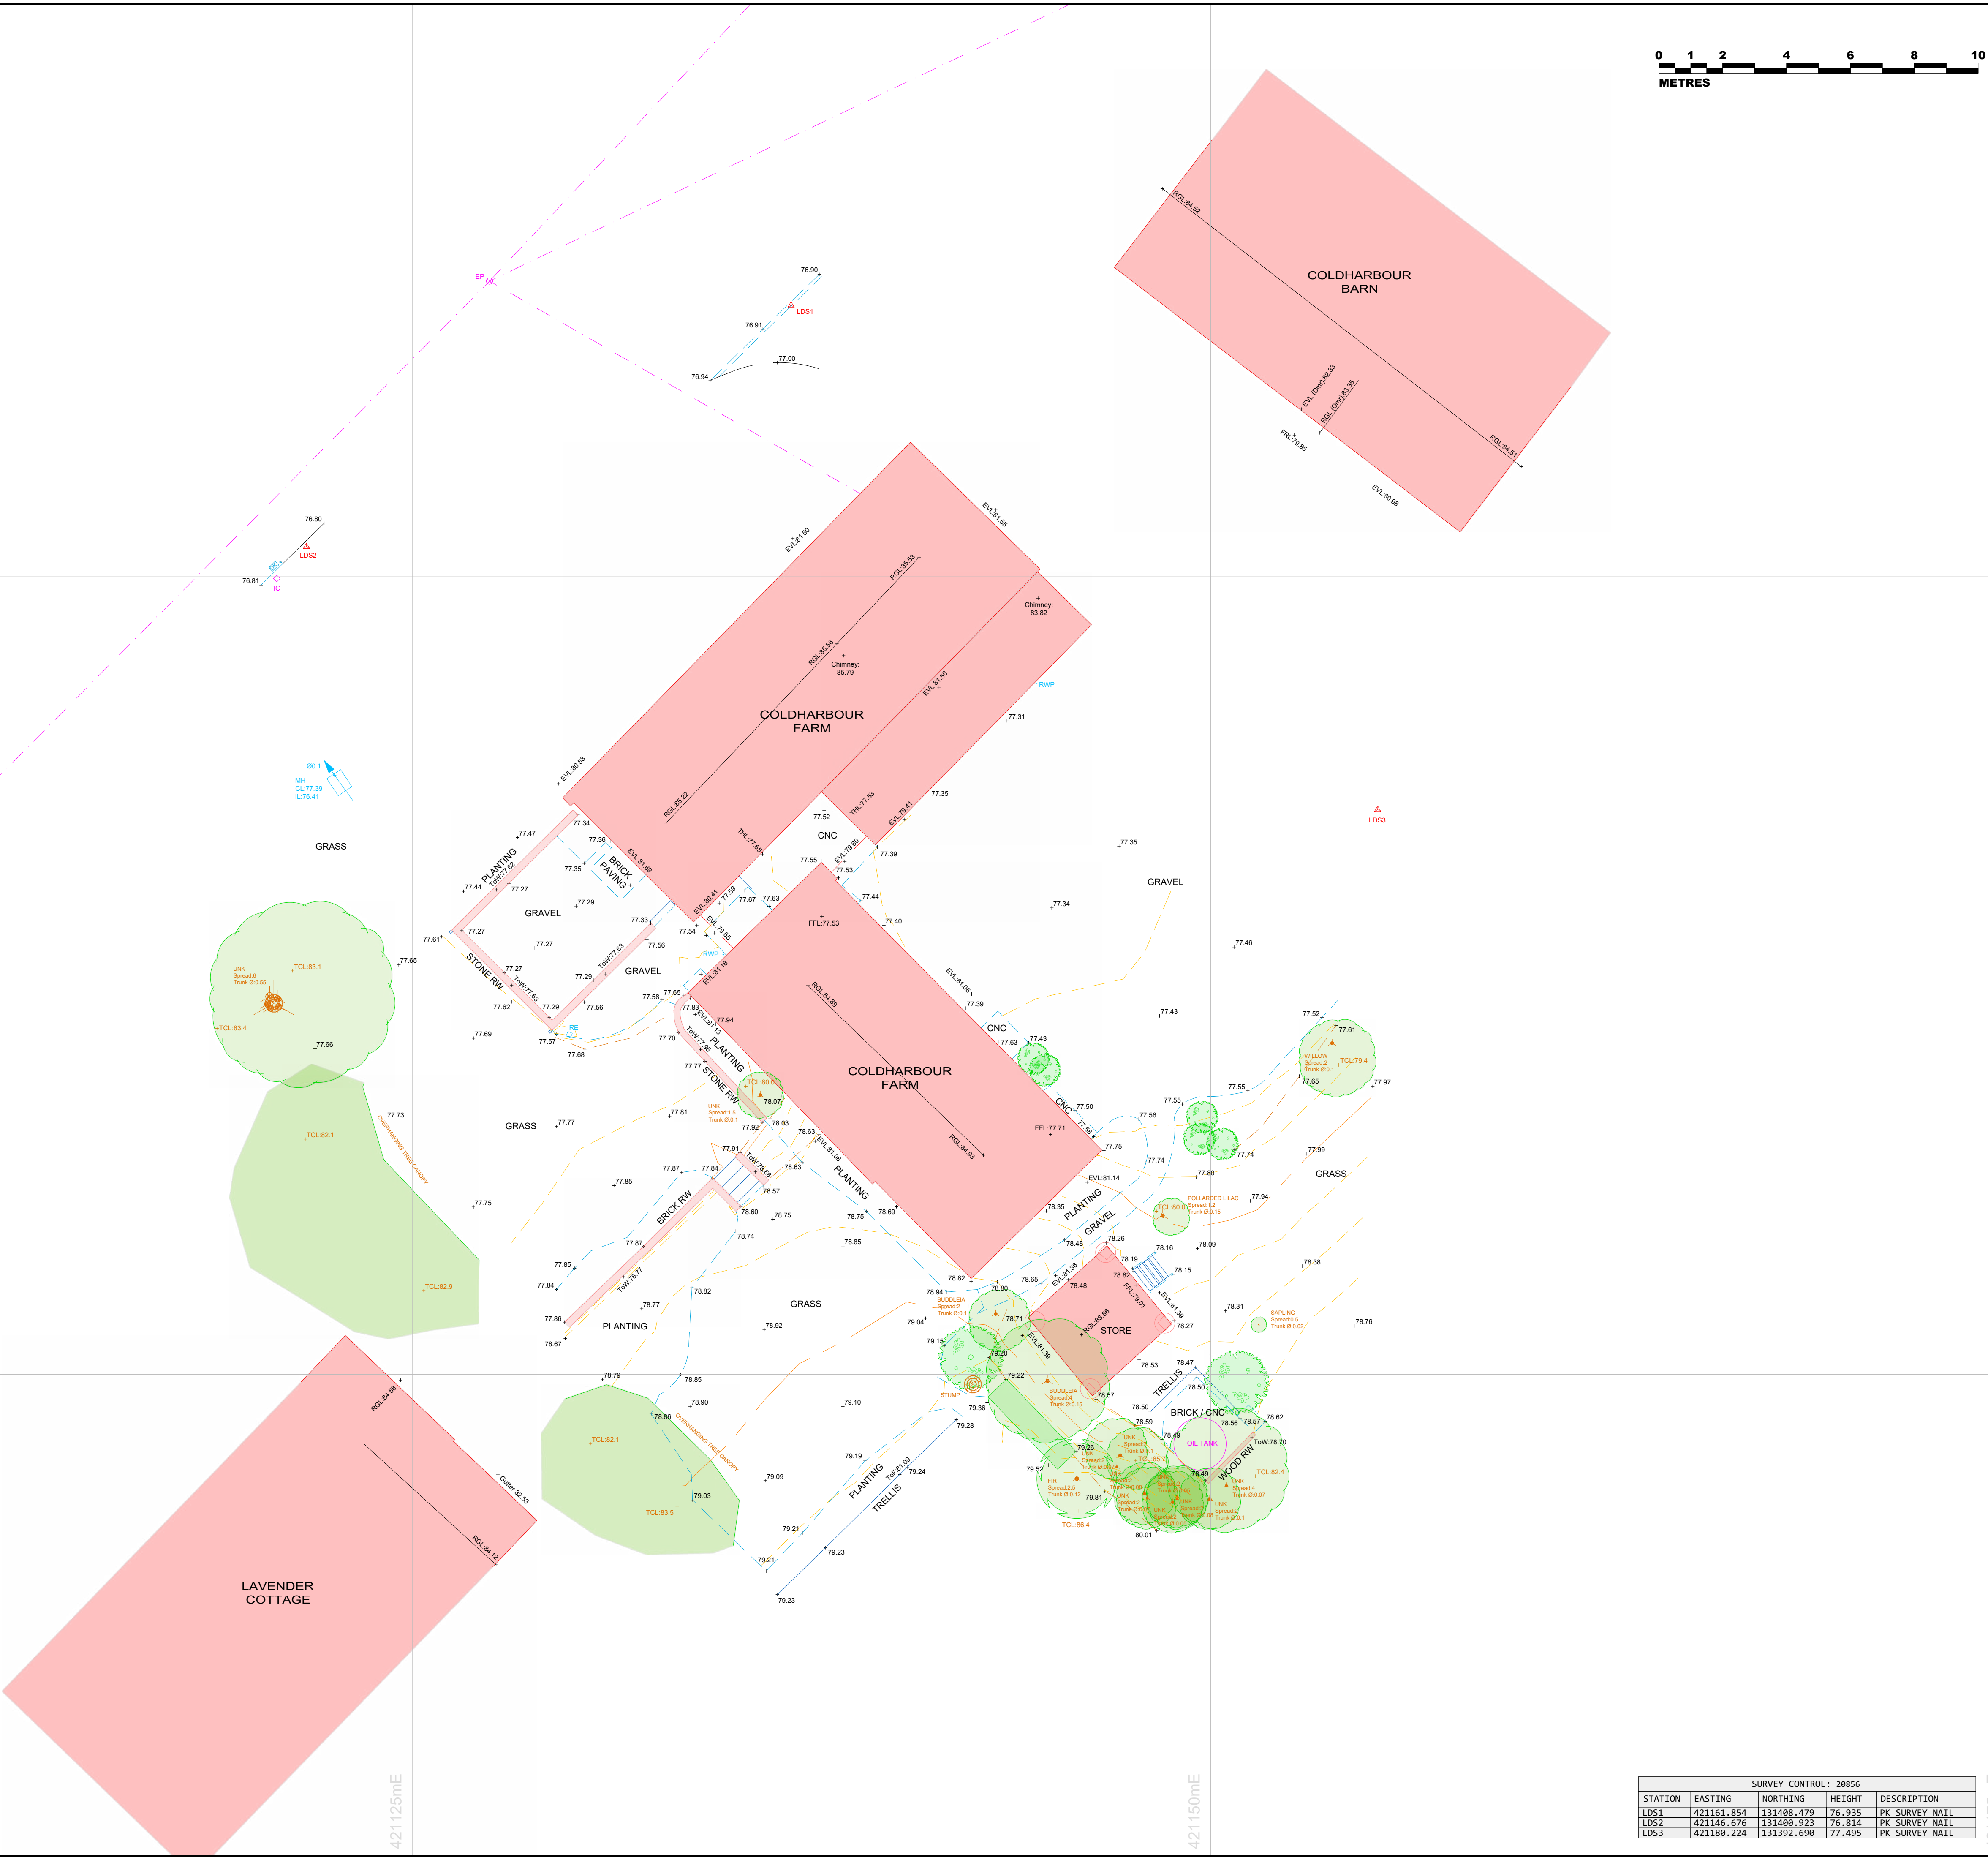
The horizontal & vertical control of this survey is based on Ordnance Survey grid as translated from GPS co-ordinates using the OSTN15 & OSGM15 transformation as supplied by OS. We have applied a reverse scale factor to maintain true ground distances. Vertical values may differ from existing OS benchmarks in the vicinity which should be disregarded. All levels should be taken from LDS survey stations.
