### ARBORICULTURAL IMPACT ASSESSMENT

### METHOD STATEMENT

Site: Land East Grafton, East Grafton, Wiltshire SN8 3DB

Project Reference: East\_Grafton\_SN83DB\_2025\_TPP

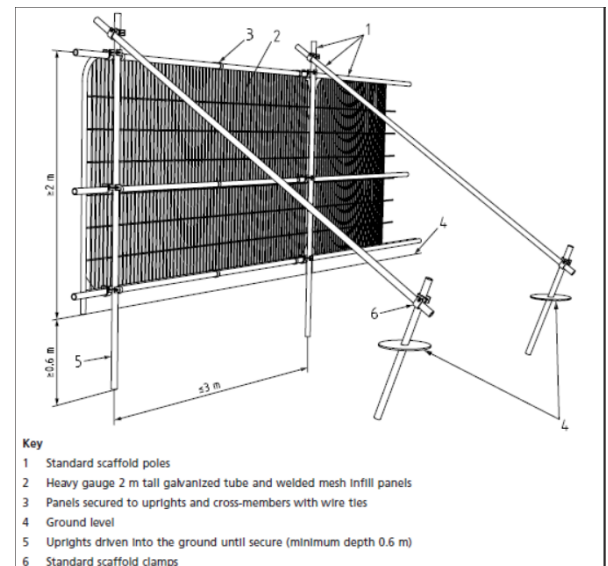
**5.2.3** The barrier is to comprise of a vertical and horizontal framework, well braced to resist impacts, with vertical tubes spaced at a maximum interval of 3m. Weldmesh panels, such as Heras, should be securely fixed with wire or scaffold clamps to this framework. Weldmesh panels on rubber or concrete feet are not resistant to impact and should not be used. Care should be exercised when locating the vertical poles to avoid underground services and, in the case of the bracing poles, also to avoid contact with structural roots. If the presence of underground services precludes the use of driven poles, an alternative specification should be prepared in conjunction with the project arboriculturist that provides an equal level of protection. Such alternatives could include the attachment of the panels to a freestanding scaffold support framework.

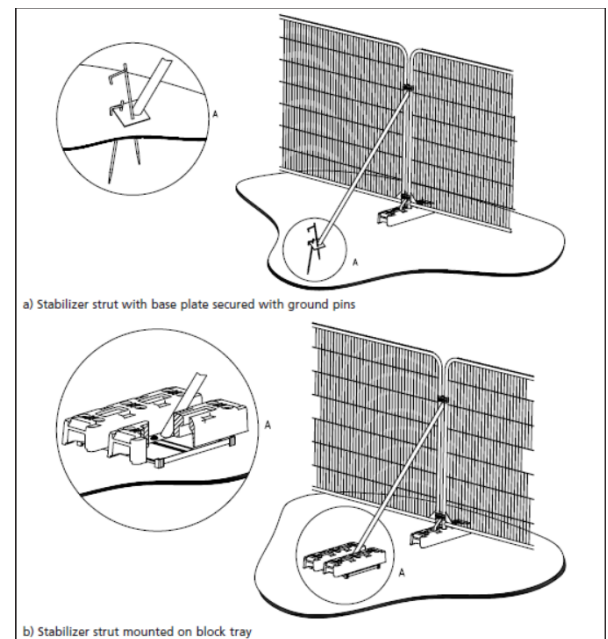
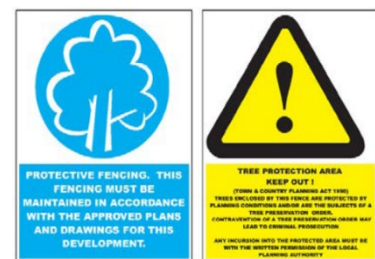
**5.2.5** Where the site circumstances and associated risk of damaging incursion into the RPA do not necessitate the default level of protection, an alternative specification should be prepared by the project arboriculturist and, where relevant, agreed with the local planning authority. For example, 2 m tall welded mesh panels on rubber or concrete feet might provide an adequate level of protection from cars, vans, pedestrians and manually operated plant. In such cases the fence panels should be joined together using a minimum of two anti-tamper couplers, installed so that they can only be removed from inside the fence. The distance between the fence couplers should be at least 1 m and should be uniform throughout the fence. The panels should be supported on the inner side by stabilizer struts, which should normally be attached to a base plate secured with ground pins. Where the fencing is to be erected on retained hard surfacing or it is otherwise unfeasible to use ground pins, e.g. due to the presence of underground services, the stabilizer struts should be mounted on a block tray.

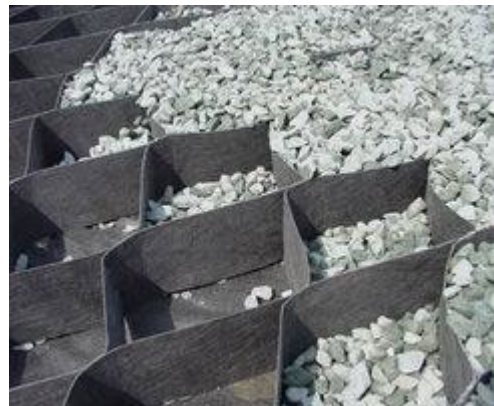
**5.8.3** The most suitable surface will be porous to allow the relatively free movement of gas and water and load spreading to limit compaction damage. The actual specification is an engineering issue that has to be considered in the context of the loadbearing capacity of the soil; this element requires specialised input from the appropriate professional.
