# BURTON, MERE, CLASS Q

## FLOOD RISK ASSESSMENT

| Project No | 25-249-60 |

1.1.1 Calibro has been appointed to undertake a Flood Risk Assessment (FRA) for the change of use from an agricultural building to three residential dwellings. The proposals are to be considered as part of a 'Class Q' planning application.

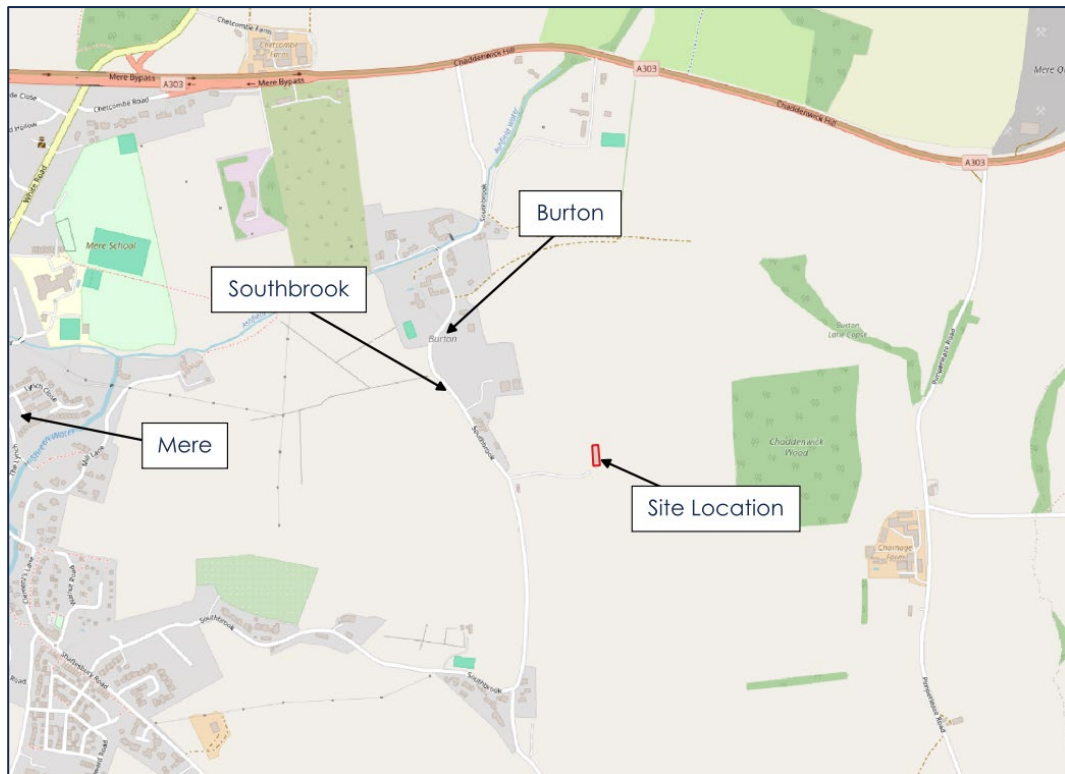
Figure 2-1 Local Context

- 2.1.1 The site is located to the east of the town of Mere, Wiltshire and to the south of Burton, Wiltshire. Access to the site is available via Southbrook to the west of the site. The approximate coordinates at the centre of the site are 382760, 132140 and the closest postcode is BA12 6BR. Figure 2-1 shows the local context of the site.

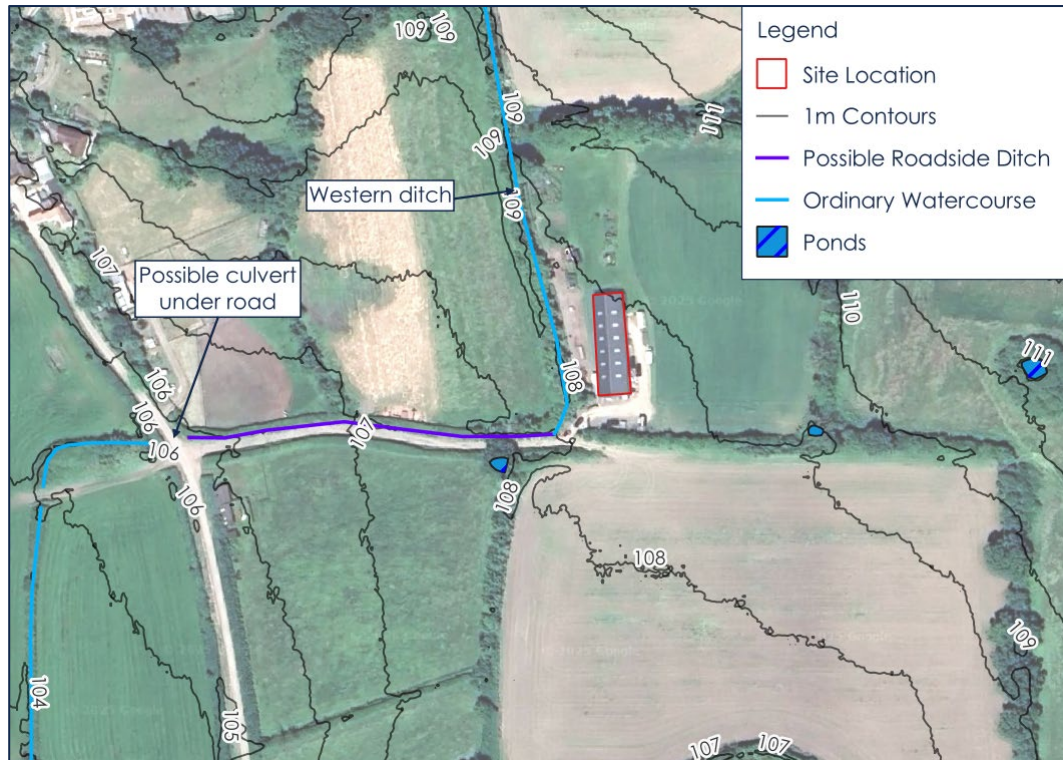
Figure 2-2 Hydrology

- 2.2.1 The nearest watercourse to the site is a small Ordinary watercourse located to the west of the site. This appears to flow into a roadside ditch along the access track to the site. There are multiple ponds that have been identified by OS mapping within the vicinity of the site, as shown in Figure 3-2.

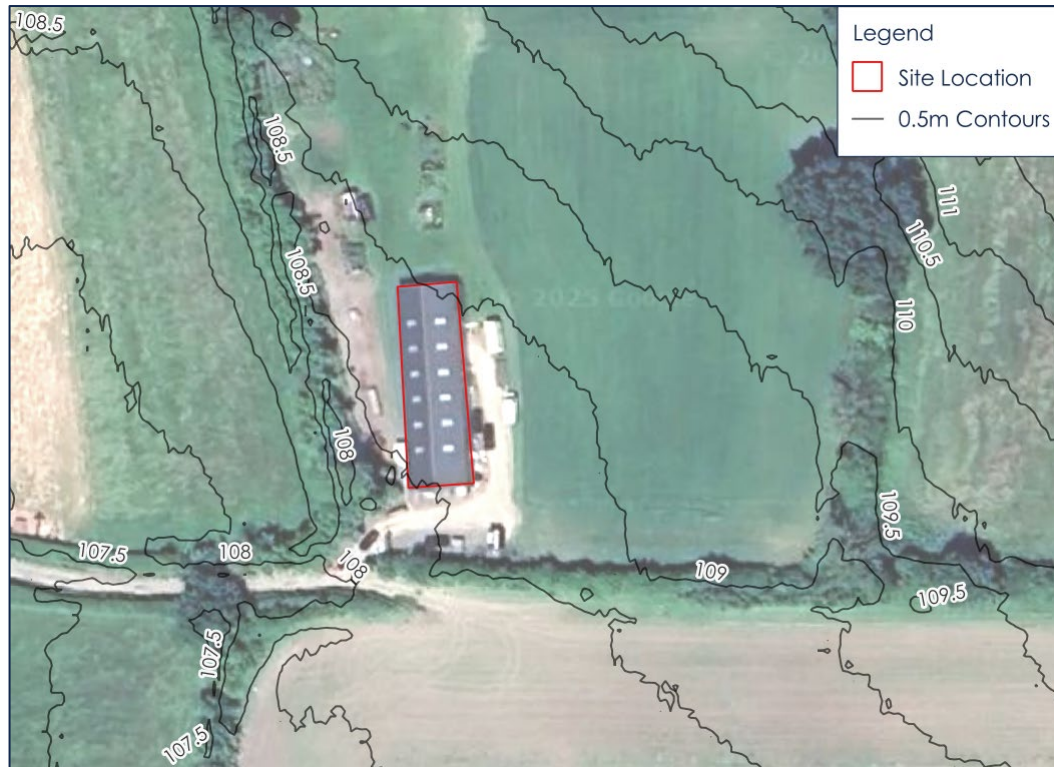
Figure 2-3 Topography

- 2.2.2 In the absence of a topographic survey of the site, readily available LiDAR data has been used to establish the site topography, which is demonstrated in Figure 2-3
- 2.2.3 As shown in Figure 2-3, most of the site is relatively flat but with a gentle gradient to the southwest, with levels close to ranging between 109mAOD and 108.5mAOD. The land surrounding the site also slopes gently to the southwest.

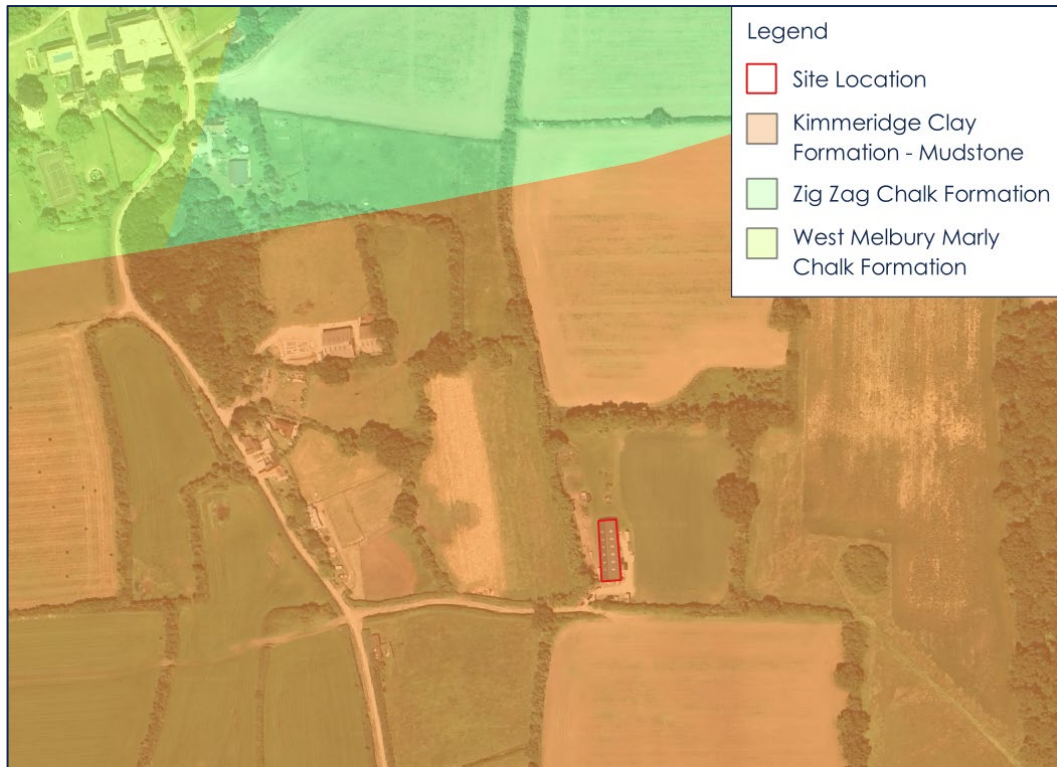
Figure 2-4 BGS Geology

- 2.3.1 Regarding bedrock geology, data held by the British Geological Survey (BGS) shows that the entirety of the site is underlain by 'Kimmeridge Clay Formation - Mudstone' bedrock. Bands of 'Zig Zag Chalk Formation' and 'West Melbury Marly Chalk Formation' bedrock are located to the north of the site. Figure 3-4 shows the bedrock geology at the site.

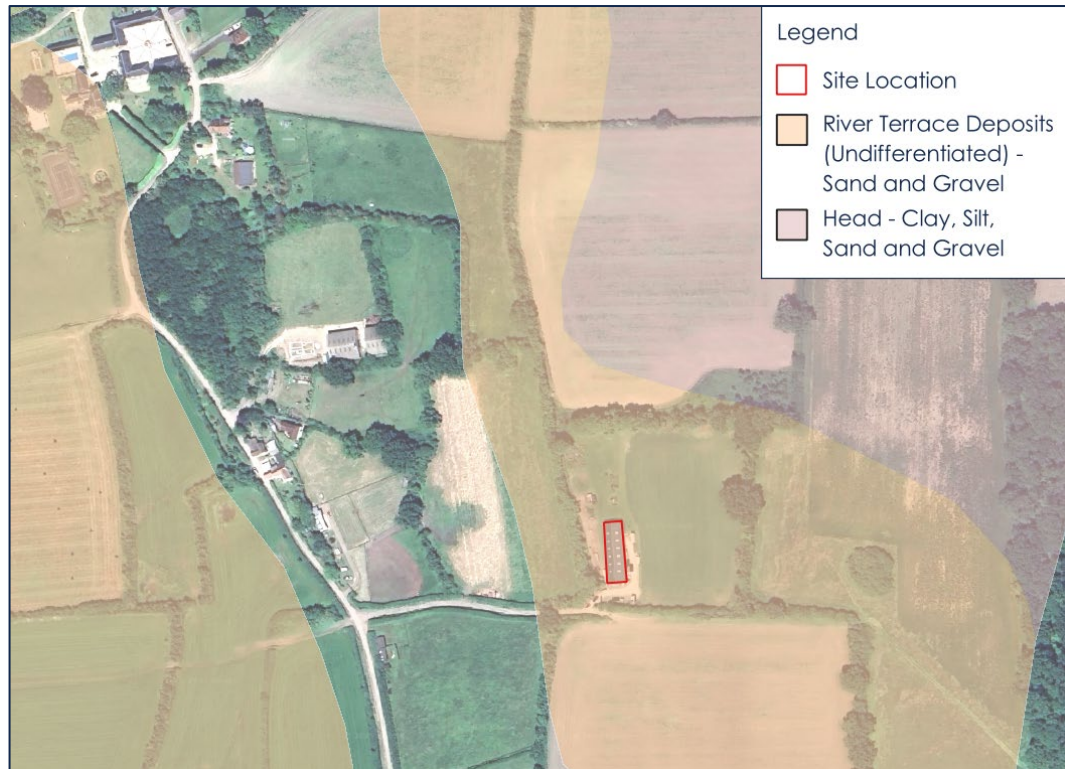
Figure 2-5 BGS Superficial Deposits

- 2.3.2 The BGS Hydrogeology aquifer classification (625k) records the bedrock geology under the site and immediate surrounding areas being 'Rocks with essentially no groundwater'.
- 2.3.3 BGS Superficial Deposits mapping shows that the site is underlain by a band of 'River Terrace Deposits (Undifferentiated) – Sand and Gravel' deposits, with areas to the north of the site being underlain by 'Head – Clay, Silt, Sand and Gravel' superficial deposits. Figure 2-5 shows the superficial geology.

4.5.2 Cross comparison of the superficial deposits shown in Figure 2-5 and the groundwater risk areas shown in Figure 4-3 shows that the high risk band for groundwater flooding correlates with a band of 'River Terrace Deposits (Undifferentiated) – Sand and Gravel' superficial deposits. It is likely that these deposits are permeable and would allow the vertical migration of water if they were to become engaged with groundwater. However, as explained in Section 2.3, the bedrock beneath the site and surrounding areas is unproductive and therefore unlikely to generate sufficient groundwater to rise through the permeable deposits.

- 6.1.7 A comparison of the SFRA groundwater risk mapping and superficial deposits mapping indicates that the area of elevated groundwater risk is associated with a band of 'River Terrace Deposits (Undifferentiated) – Sand and Gravel' superficial deposits.

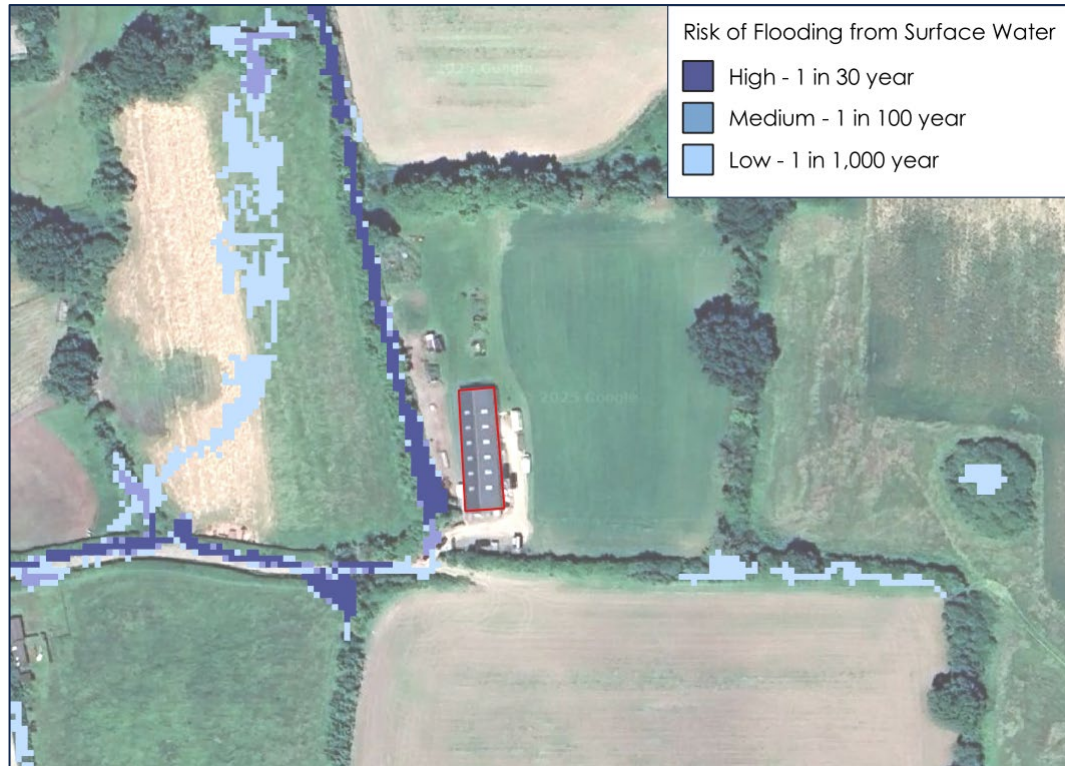
Figure 4-1 RoFSW

- 4.4.1 The Risk of Flooding from Surface Water (RoFSW) dataset indicates areas where surface water is likely to flow and accumulate. The dataset predicts that the site is at Very Low risk of surface water flooding, as shown in Figure 5-1.

- 4.4.2 As shown above, there is surface water flooding shown along the western ditch to the west of the site and the access road to the site, this is likely due to the western ditch and roadside ditch not being properly represented in surface water modelling. It is likely that surface water extents would not exceed the banks of the roadside ditch.

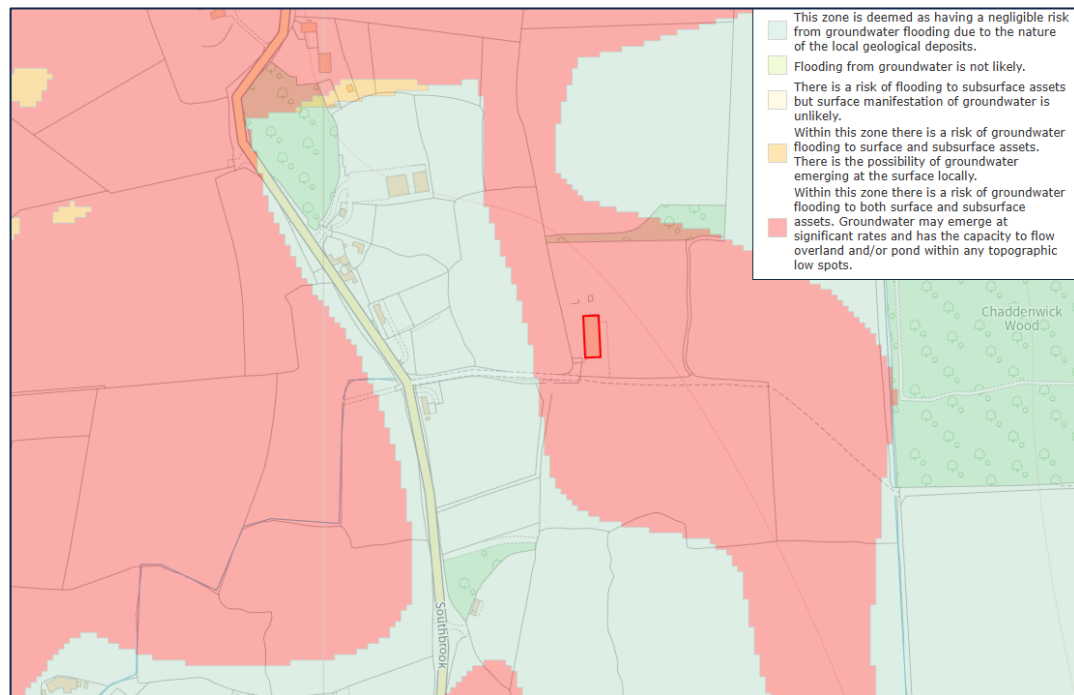
Figure 4-2 Wiltshire SFRA Groundwater Mapping

- 4.5.1 The Wiltshire SFRA contains mapping showing groundwater emergence within the area, the mapping predicts that the site is located in an area of mapped risk of groundwater flooding. Figure 4-3 shows the Wiltshire SFRA groundwater emergence mapping.

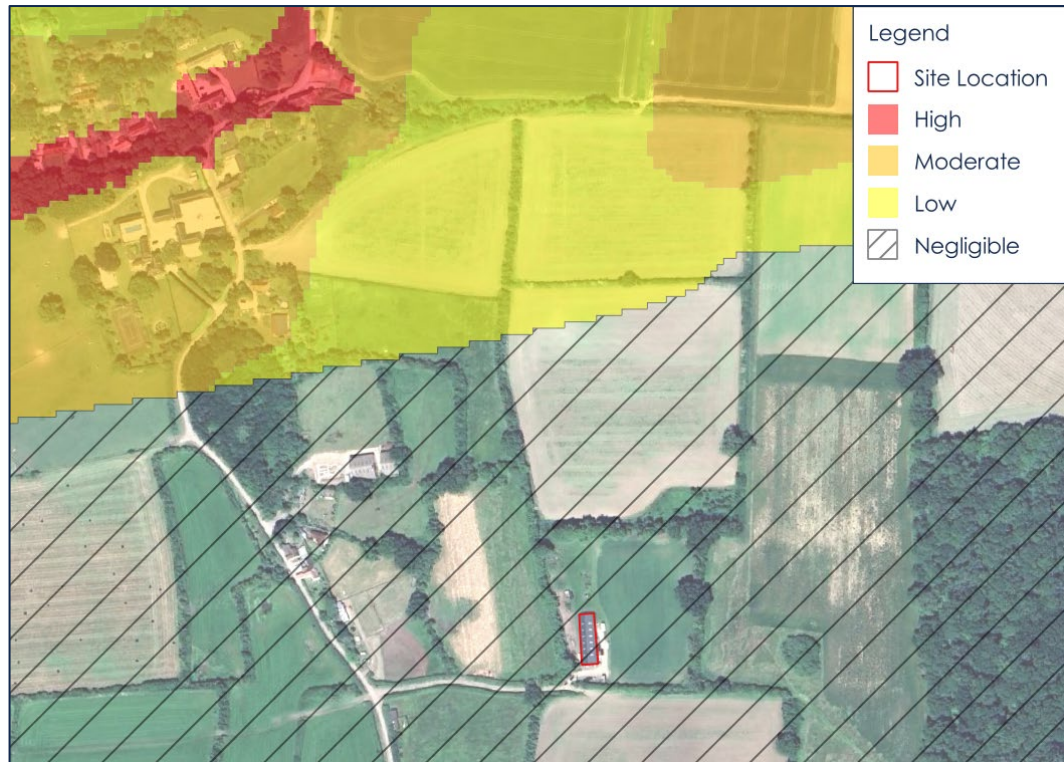
Figure 4-3 GeoSmart Groundwater Flood Risk

4.6.2 GeoSmart data considers topographical and groundwater level data to inform the assessment, together with bespoke hydrogeological and risk models to provide a more accurate assessment of the likely risk of groundwater flooding. The model is calibrated and validated using a national database of recorded groundwater flood events collated by GeoSmart from various sources. The outputs at the site are shown in Figure 4-3.

- 4.6.3 The GeoSmart data shows the site and immediate vicinity lies within a large area of Negligible risk.
- 4.6.4 GeoSmart defines the Negligible risk band as having 'a Negligible risk of groundwater flooding in this area and any groundwater flooding incidence has an annual probability occurrence of less than 1%'.
- 4.6.5 There is an area of mapped groundwater risk located to the north of the site, comparison of the risk area shown in Figure 4-4 and the bedrock geology shown in Figure 2-4 indicates that the area of risk is associated with a transition in the geology between the mudstone bedrock beneath the site and the chalk bedrock to the north of the site. This area of risk is far from the site and consequently the risk from groundwater flooding posed to the site is assessed as being Negligible, with no specific mitigation required.

- 6.1.8 As a result of the above, GeoSmart groundwater mapping was obtained for the site. The mapping indicates that the site and its surrounding areas are located in an area of Negligible groundwater risk.

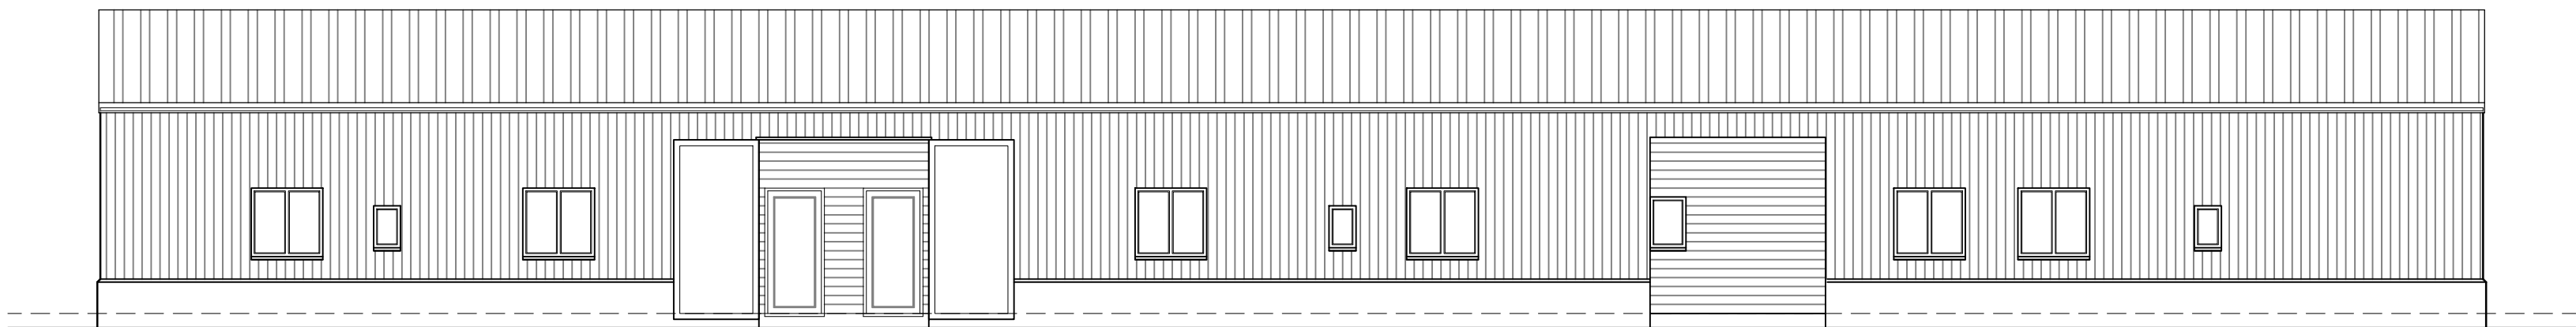
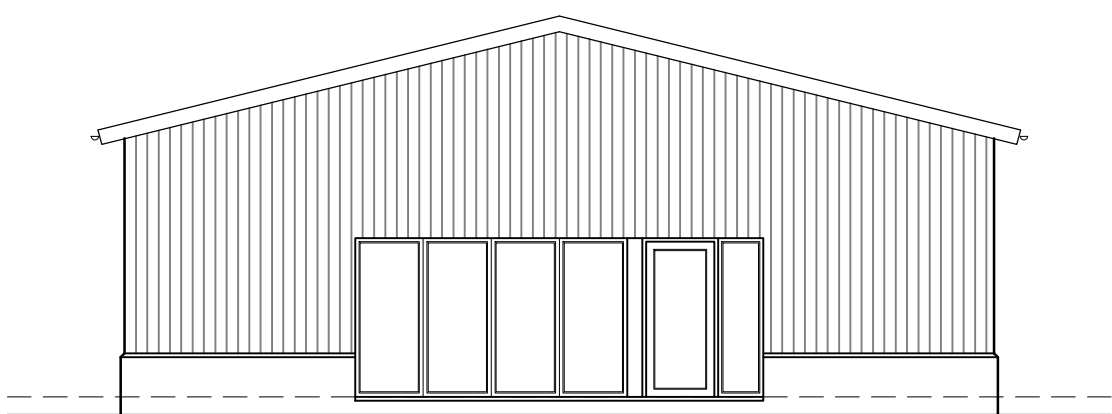
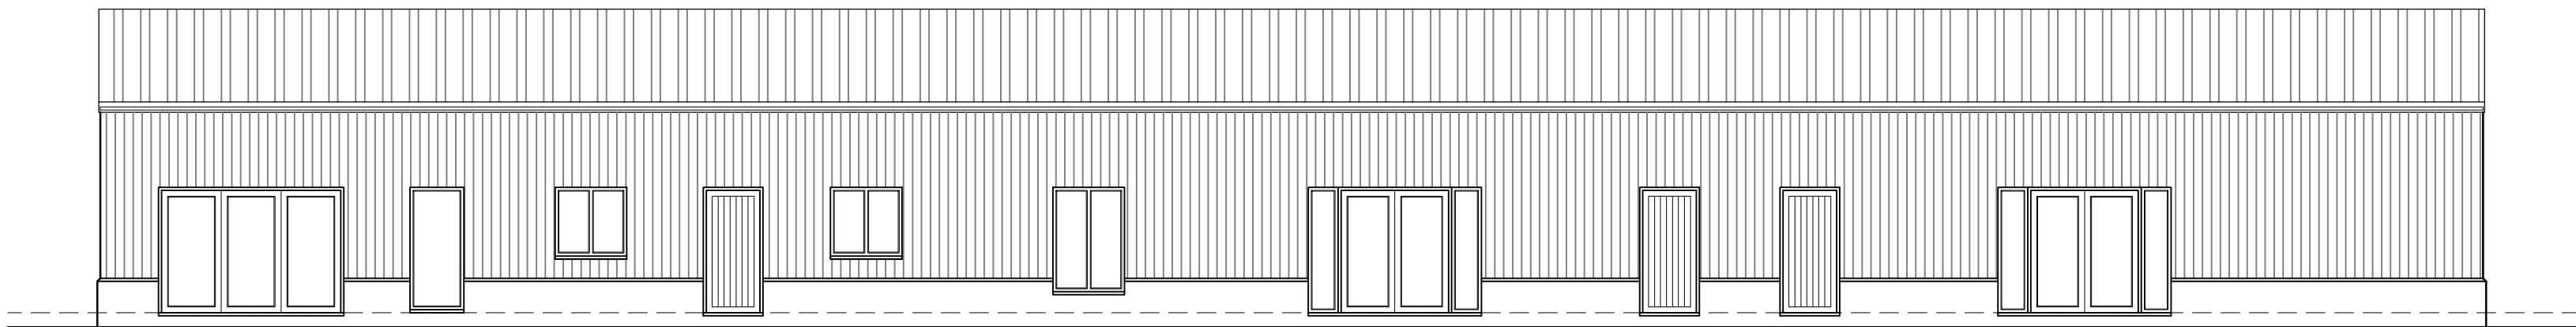
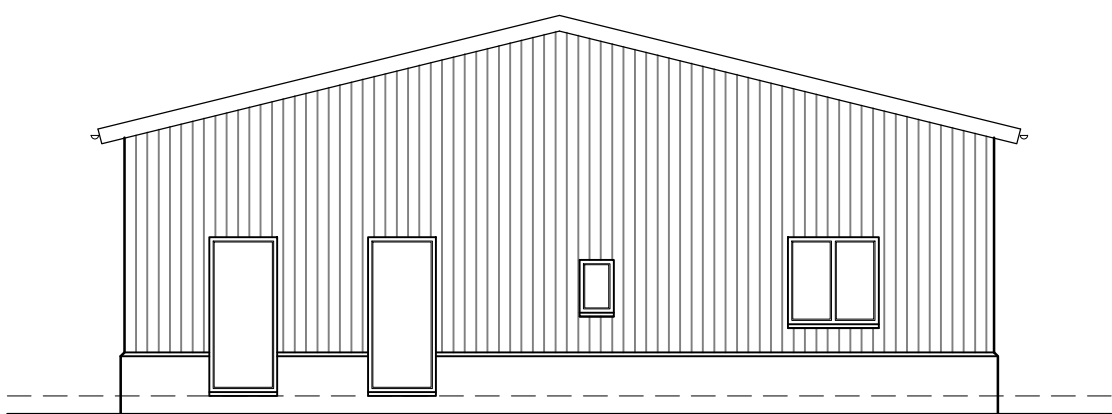
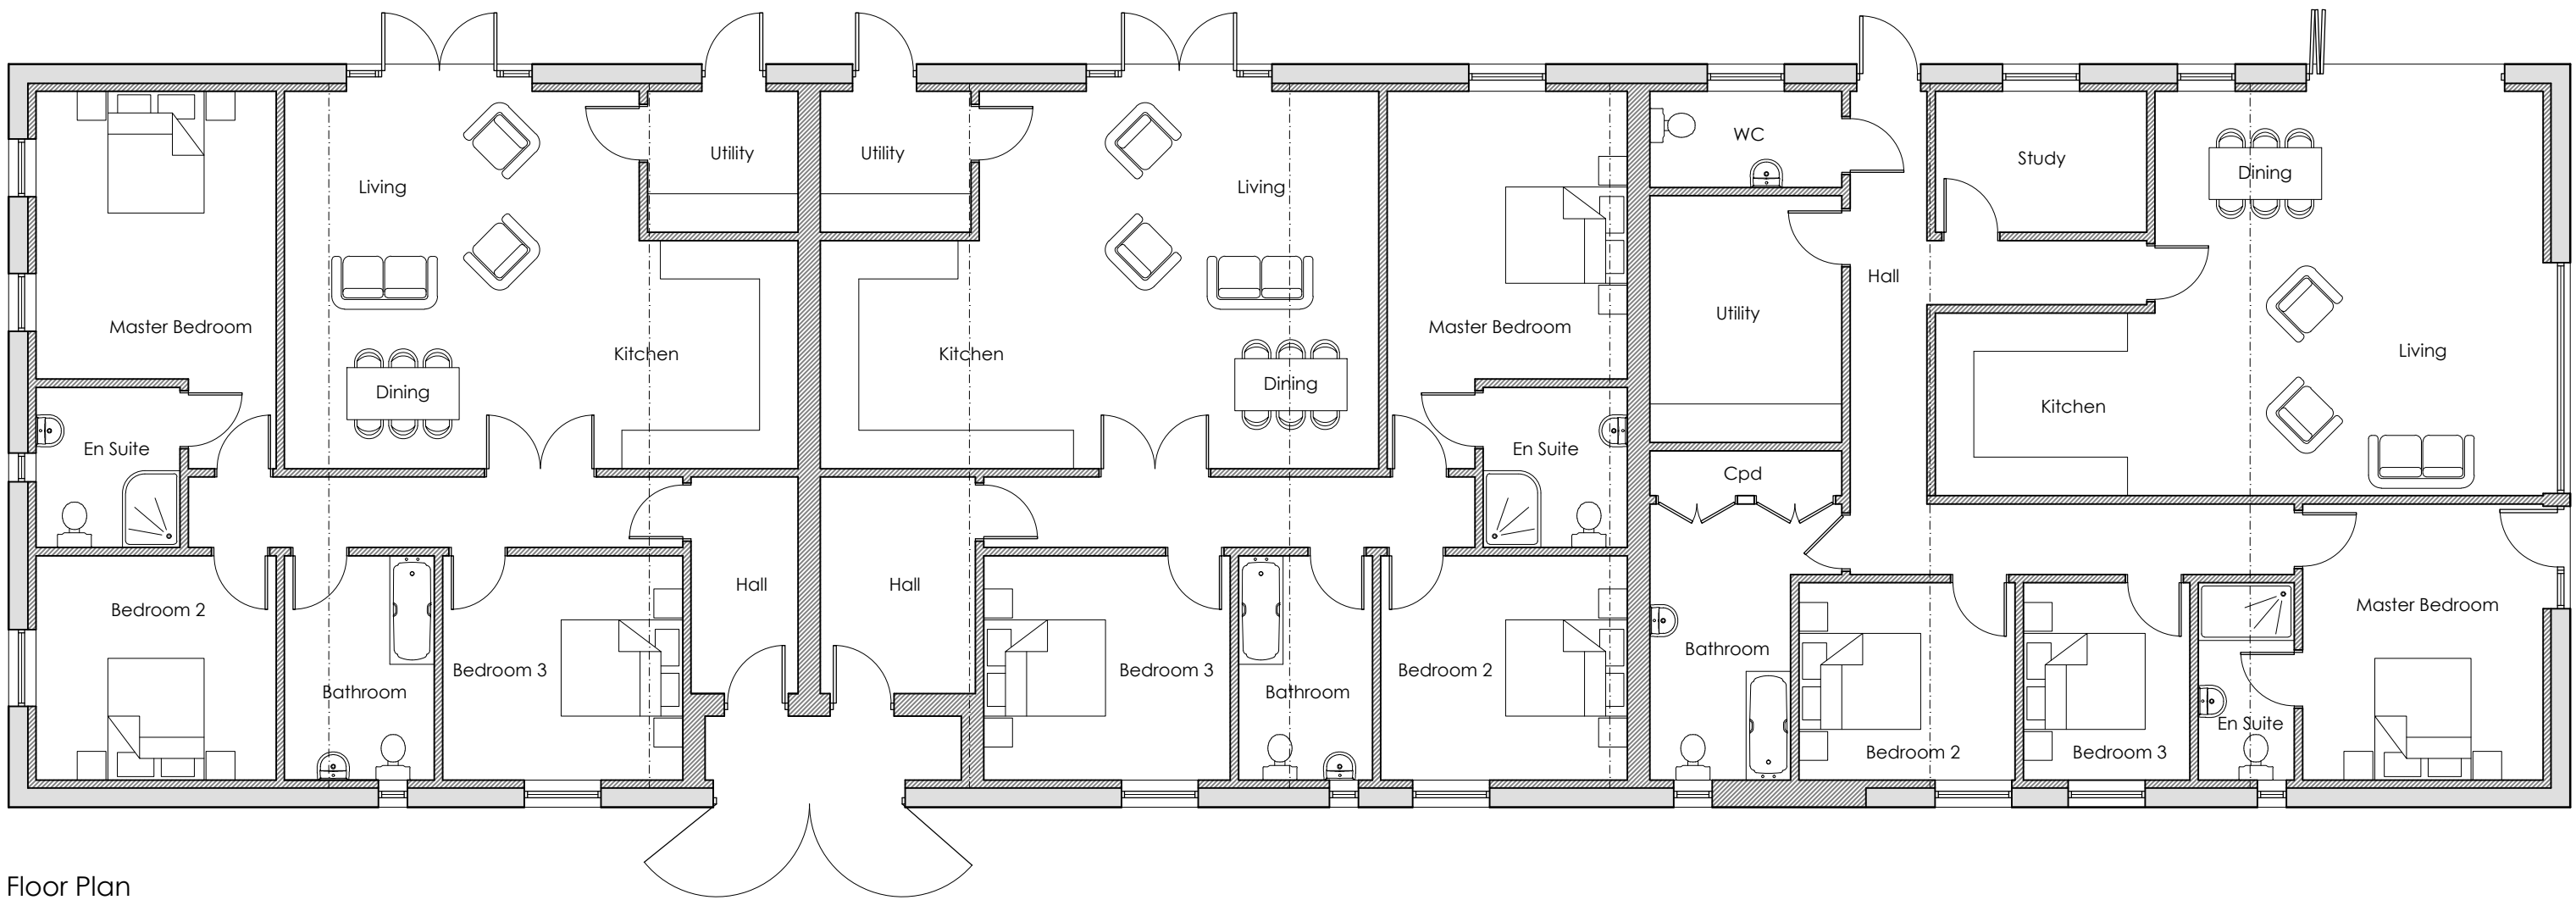
**DRAWING**  
Proposed Floor Plan and Elevations

East Elevation

North Elevation

West Elevation

South Elevation

Floor Plan

- 3.1.1 The proposals are for a 'Class Q' application to change of use from an agricultural barn to three residential dwellings. The works will comprise the refurbishment and modernisation of the building and its interior. No basement accommodation is proposed.
- 3.1.2 It is presumed that there are no proposed changes to the external hardstanding at the site.
- 3.1.3 Site proposals are included in Appendix A.
