**Cereal Partners, Staverton, BA14 6PG**  
**Arboricultural Impact Assessment & Method Statement to BS 5837: 2012**

Dated 12<sup>th</sup> November 2025

**Cereal Partners, Staverton, BA14 6PG**  
**Arboricultural survey to BS 5837: 2012**

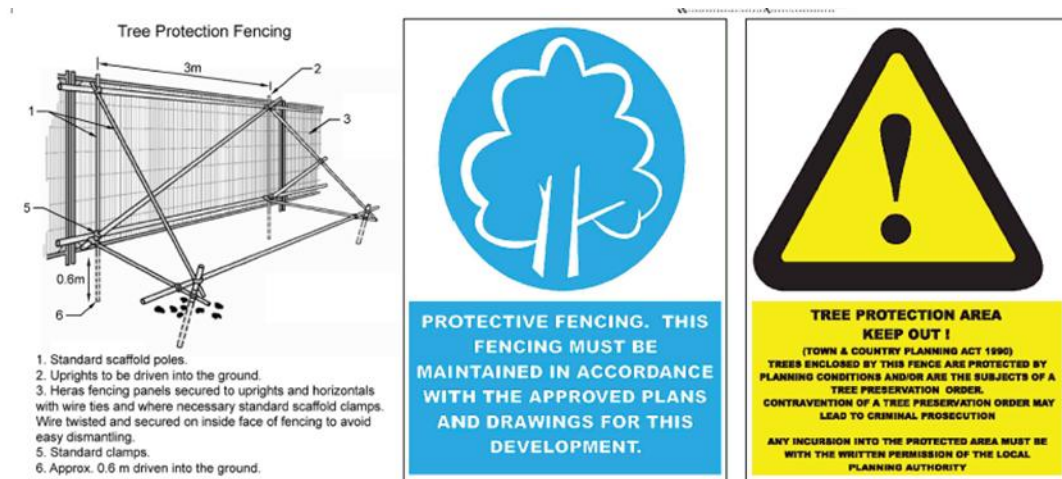
- This will be managed on site by the AC who will mark out where the fencing is to be located.
- The fencing spec to be used on site is seen in the diagram below. The signage must also be placed on the fencing at regular intervals, so any visiting contractors are fully aware of the 'no-go zone'.

- The fencing will be set out as shown in the TPP (Appendix 8.2 to this document).

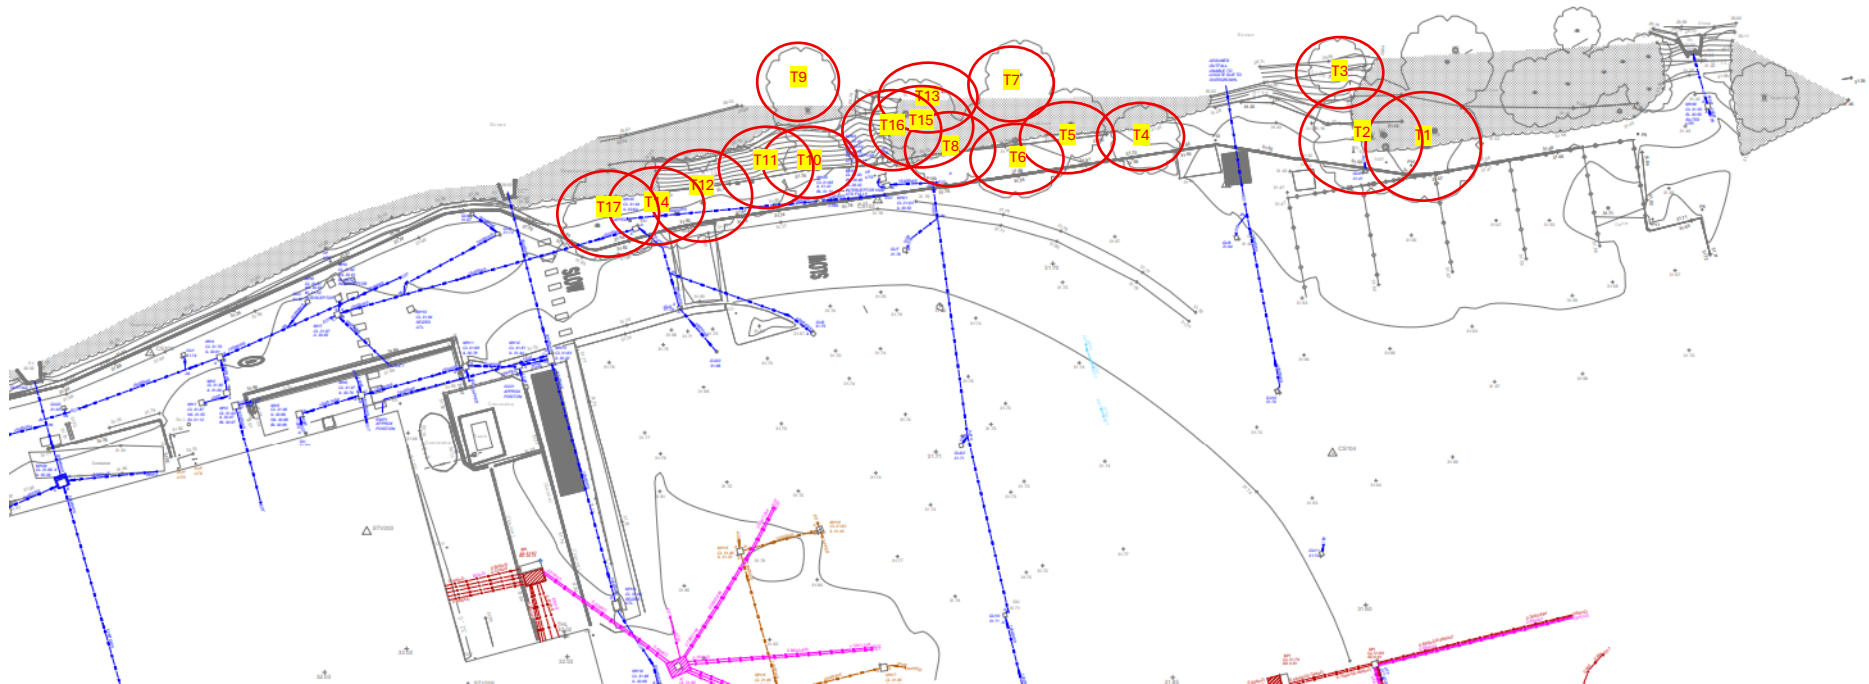
Tree Locations and photos.

Tree location plan is attached along with images where the numbers relate to the table above.

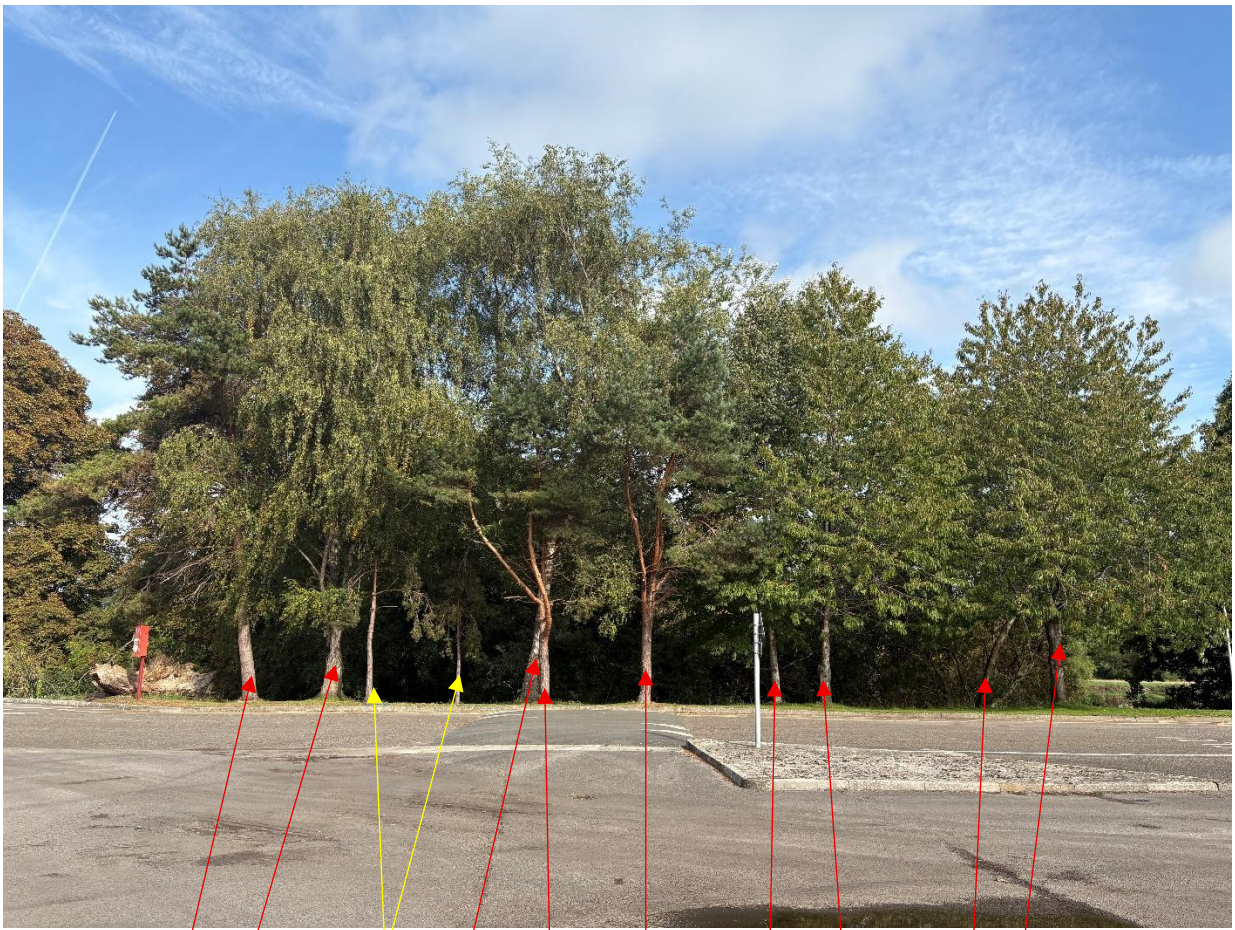
T17 T16 T15 T14 T12 T11 T10 T9 T8

Two smaller diameter trees below relevant diameter.

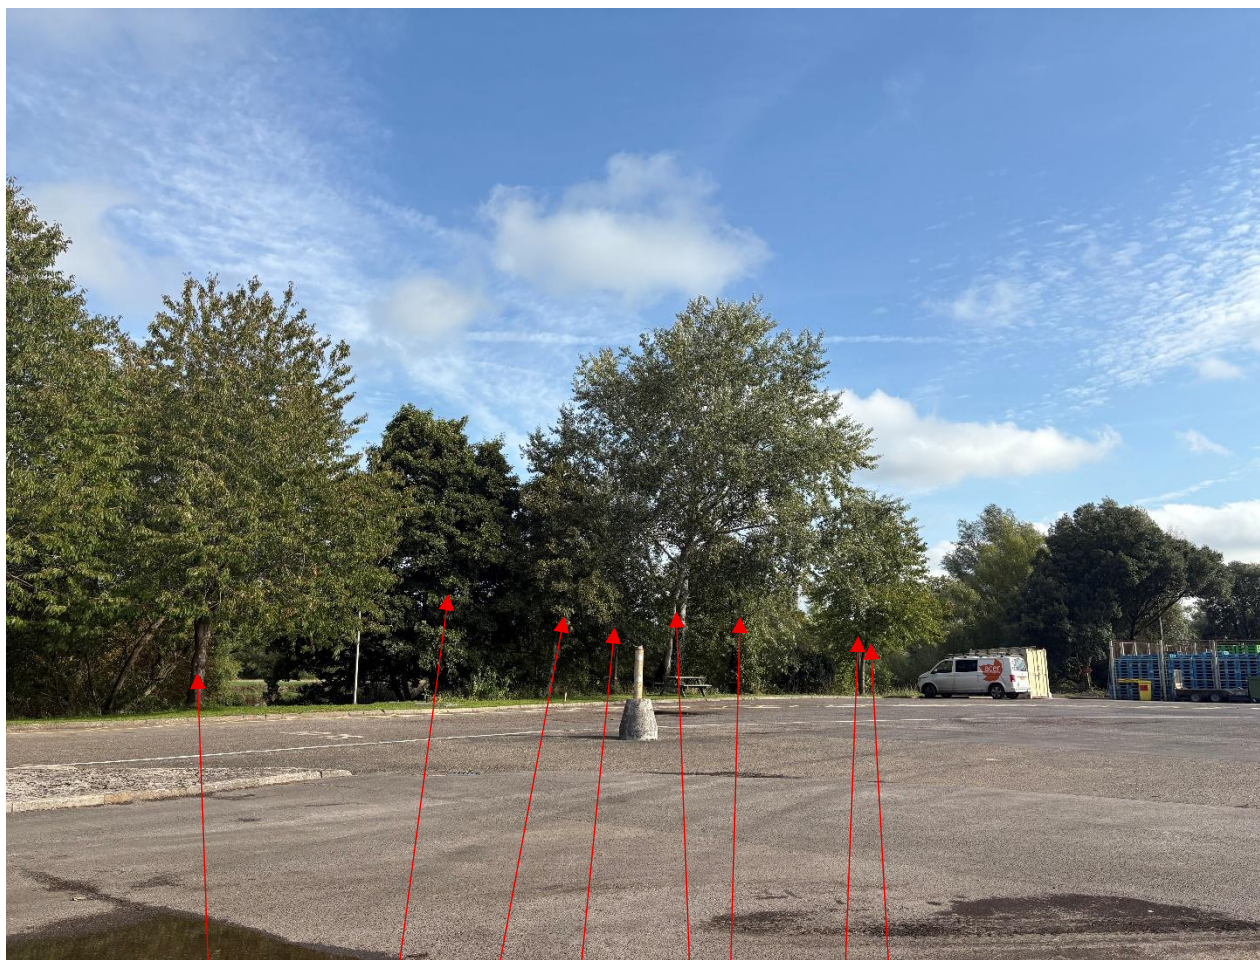
T8

T7

T2

T1

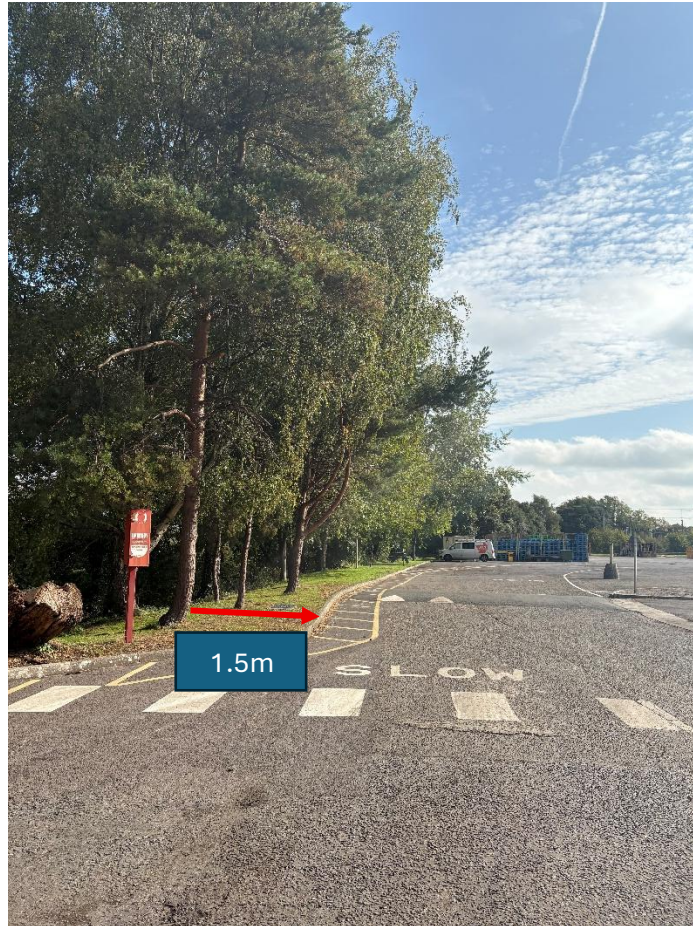
Location of trees in relation to the current kerb.

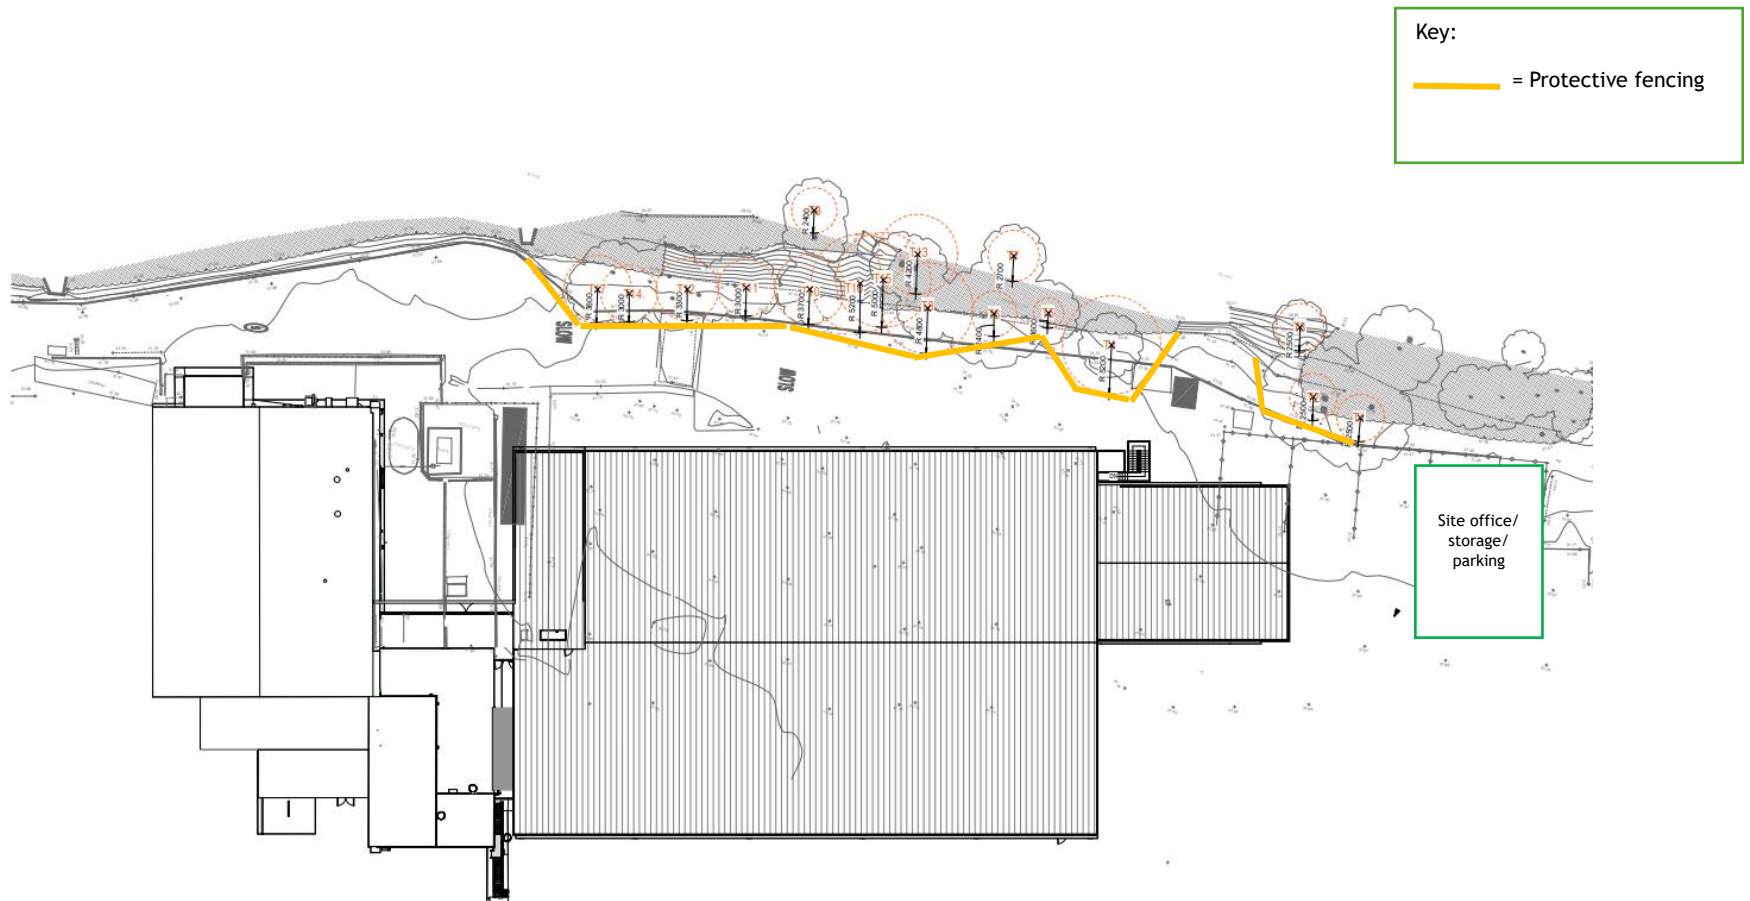
### Tree Protection Plan (dated 11<sup>th</sup> November 2025)

## Appendix 8.2 to Arboricultural Method Statement for Cereal Partners, Staverton, BA14 6PG

As it's always tempting for construction teams to 'store' materials on verges and grass areas out of the construction zone, the trees will be protected with tree protective fencing as seen in Appendix 8.2 the Tree Protection Plan.

- Any materials must be stored away from trees on the hard standing area indicated on the TPP.

- Parking as seen on the TPP.
