**FORMER BARCLAYS' BANK, 3 FORE STREET, TROWBRIDGE**

**Built Heritage Statement**

**Title of project**    **3 Fore Street, Trowbridge, Wiltshire**  
**Client**                **MCH Minibuses Ltd**

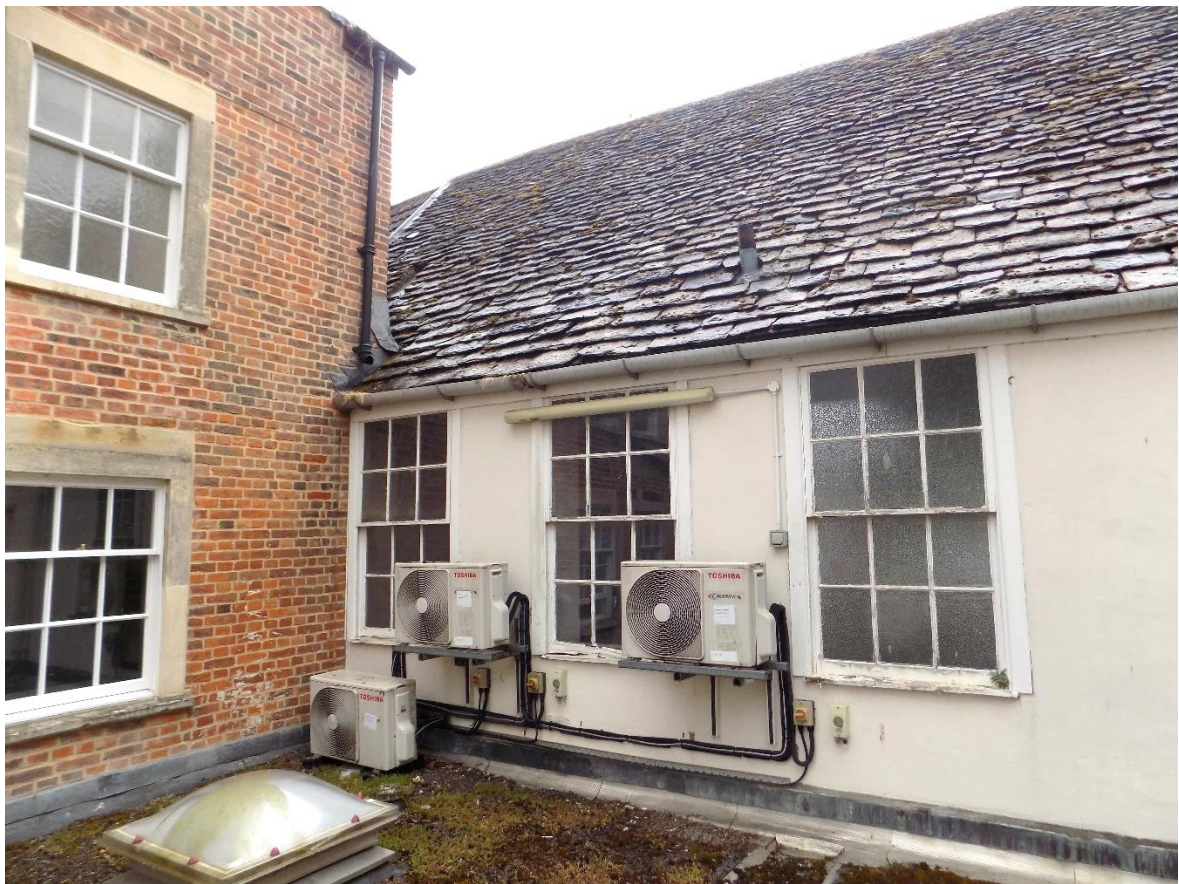
Fig.14: Rear detail, showing sash windows with no horns set flush with the outer face, indicating a likely pre-1850 date. The sills and architraves are modern.

- 5.4 The first-floor rear elevation is of little note, the key features being the three hornless sash windows, which would benefit from conservative repair and more appropriate detailing to the architraves and sills. The historic ground-floor elevation is largely enclosed by the twentieth-century rear extensions. The central projecting bay is wholly enclosed by the extensions.

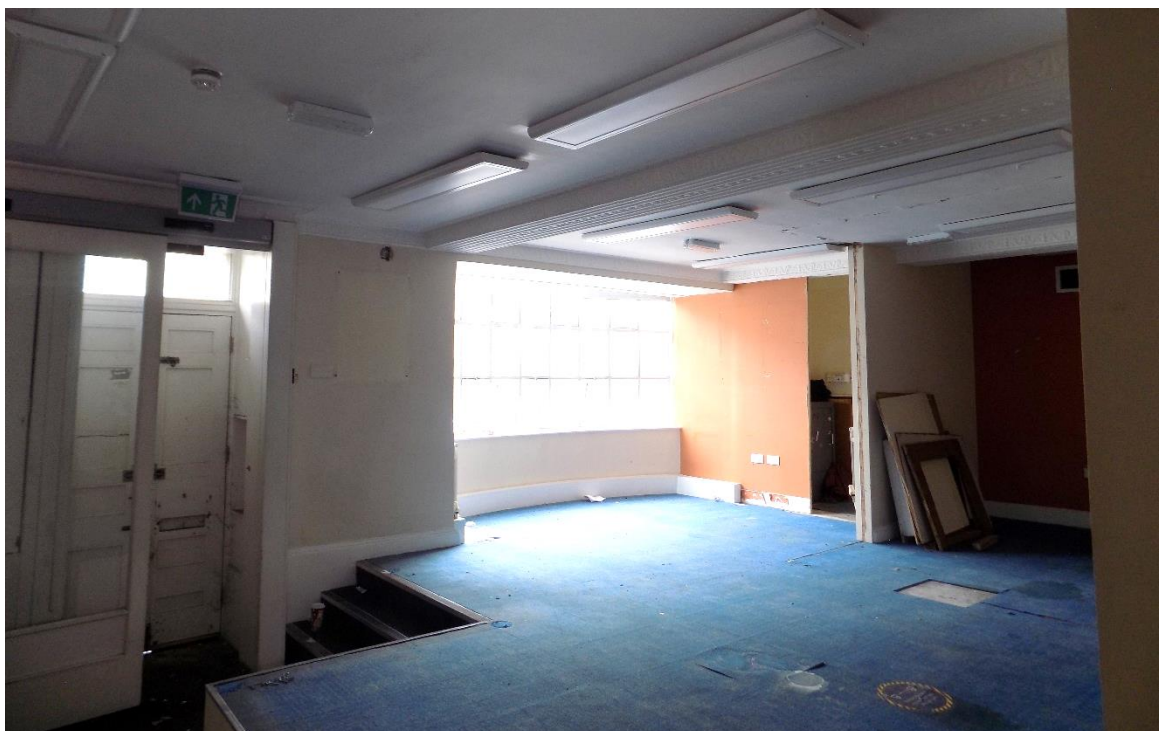
Fig.15: Ground-floor frontage range internal view, showing moulded beams and raised floor.

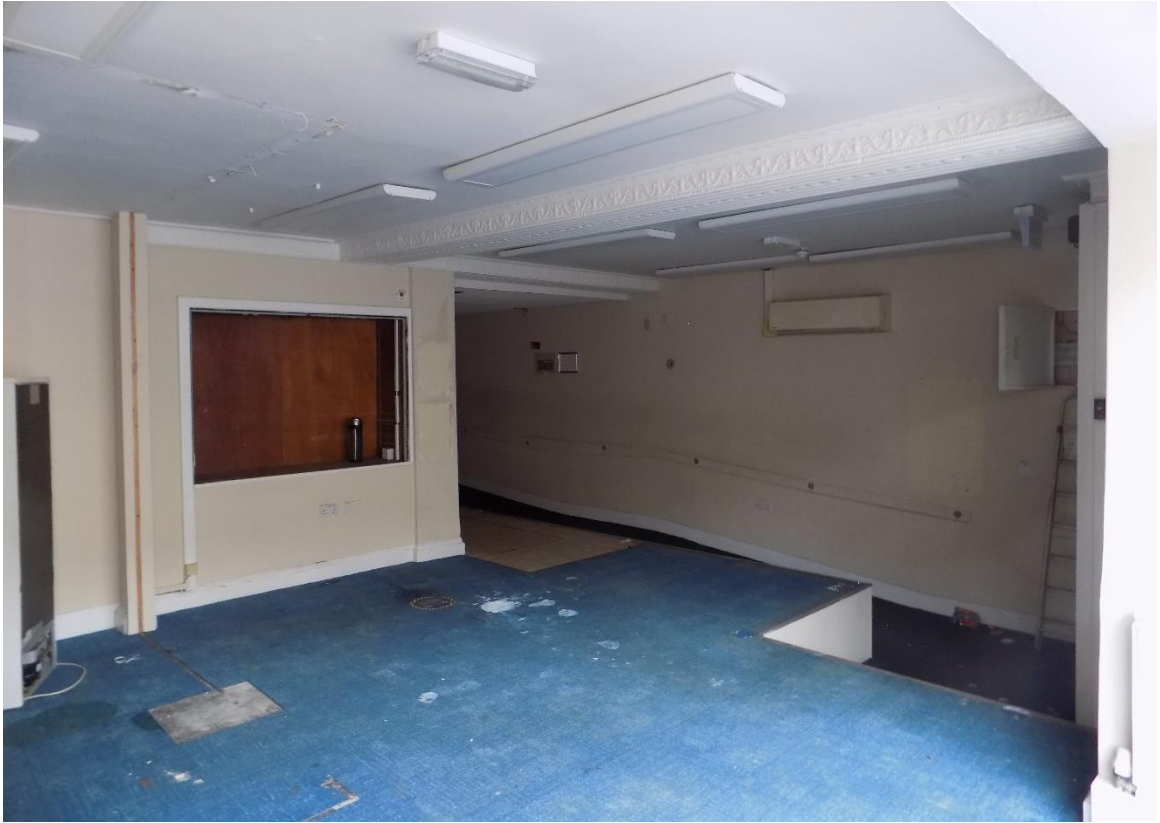
Fig.16: Ground-floor internal view, frontage range, showing moulded beam and raised floor.

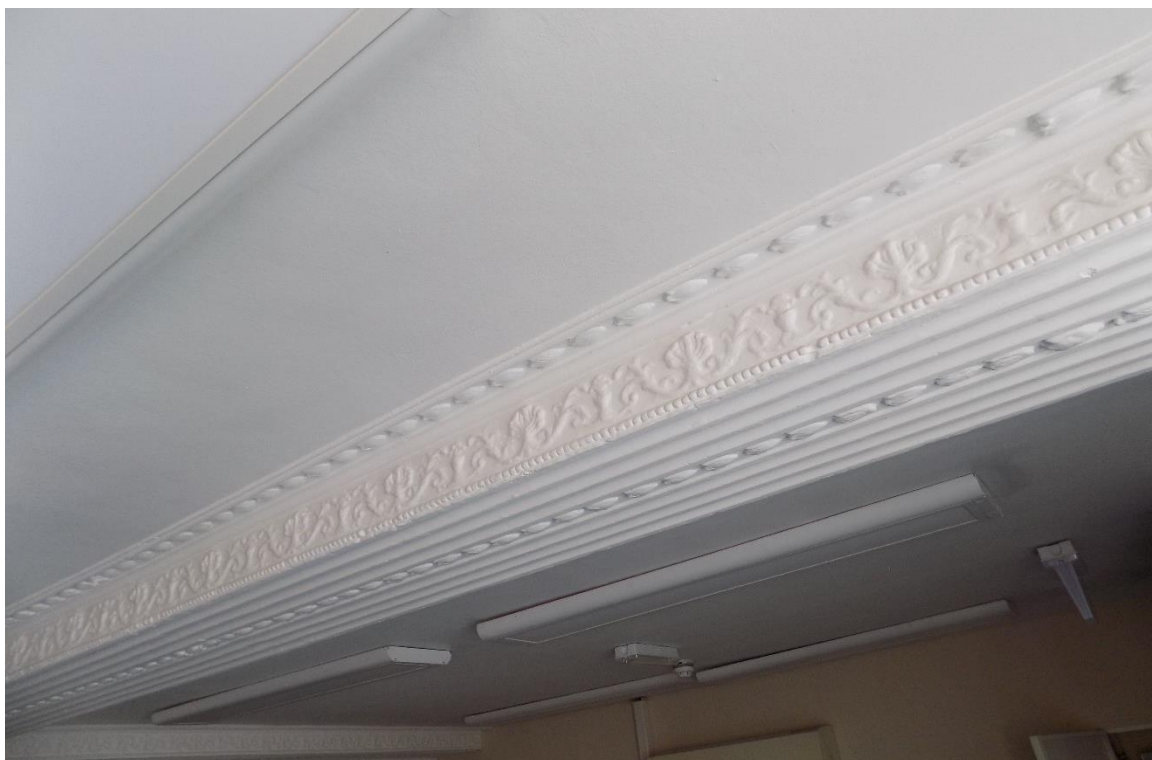
Fig.18: Detail of early eighteenth-century mouldings to beams in ground-floor frontage range.

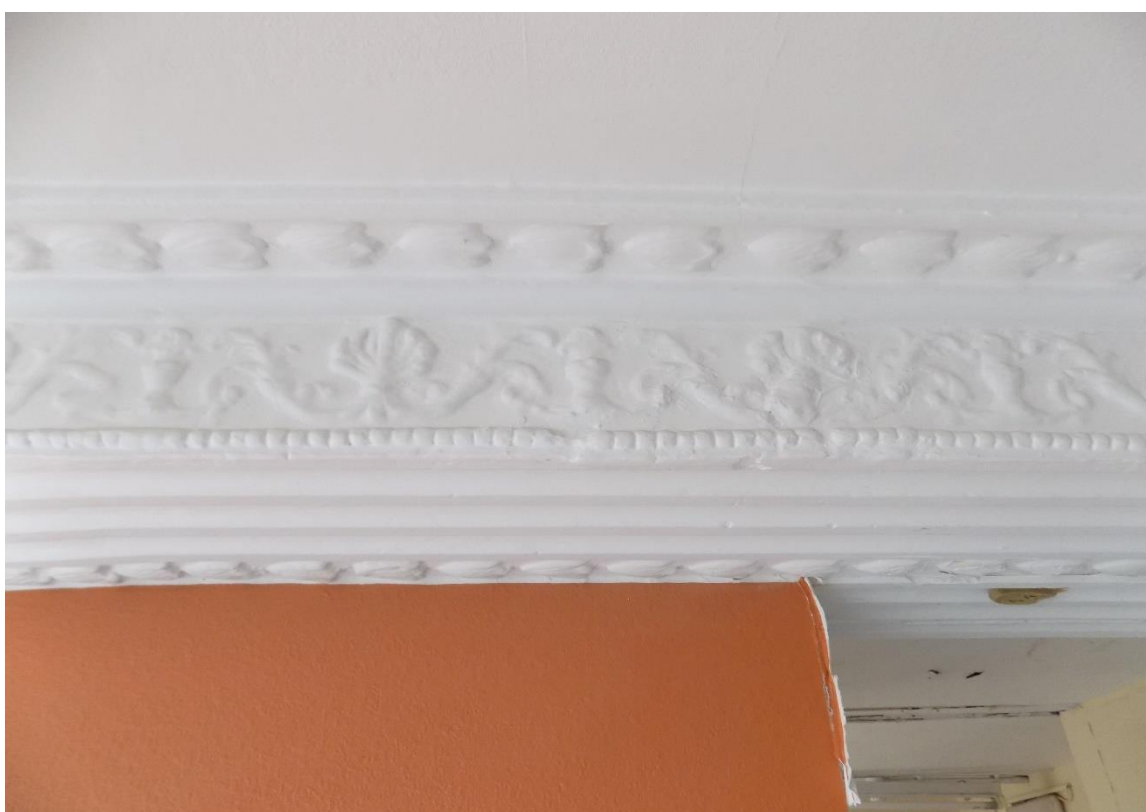
Fig.19: Detail of early eighteenth-century mouldings to beams, showing irregularities.

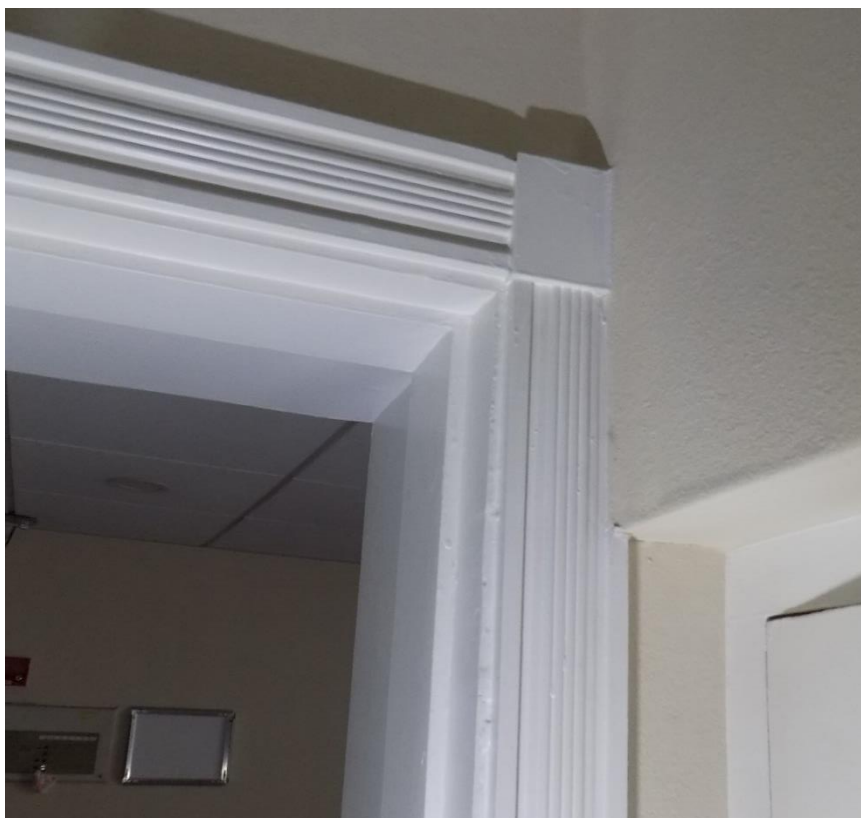
Fig.20: Detail of ground-floor door opening with reeded architraves with corner blocks.

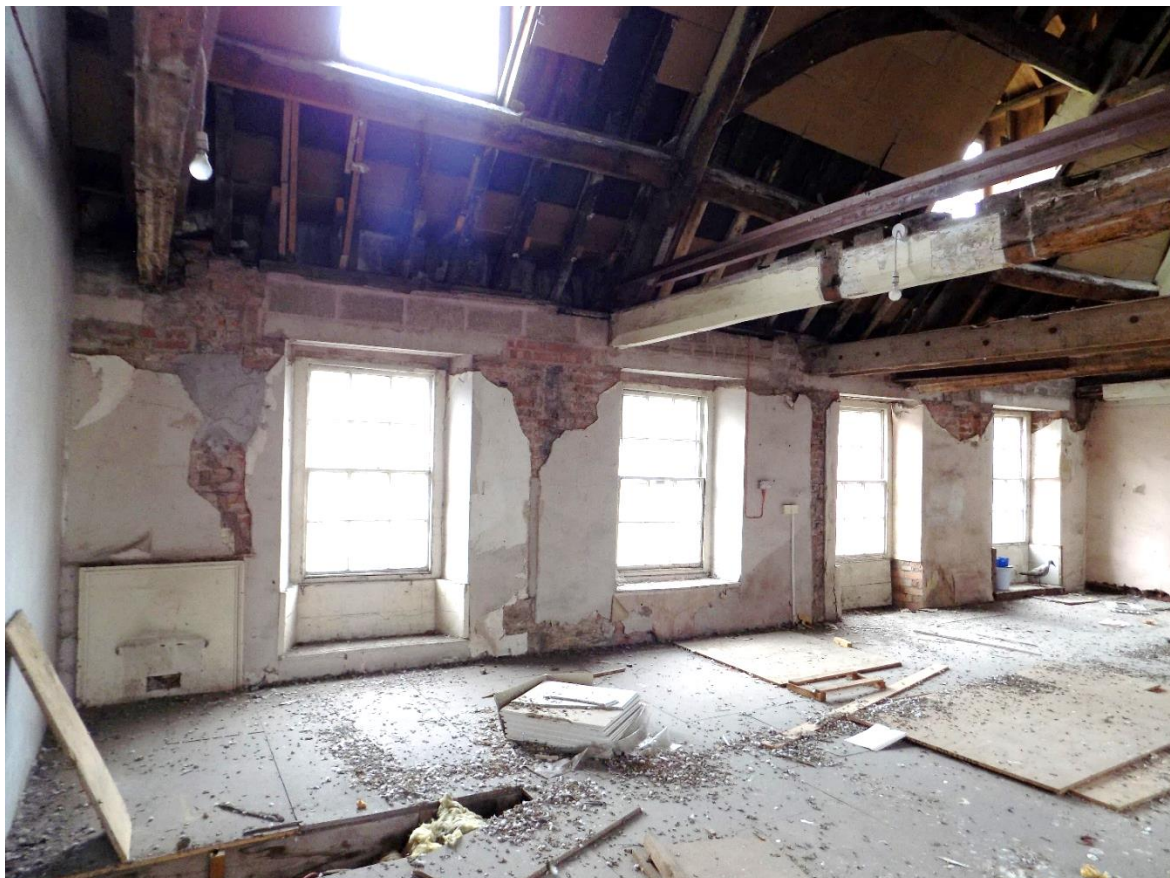
Fig.21: General view of the first floor, looking north-east, showing modern false floor.

- 6.13 Bringing the first and second floors of the frontage into a beneficial use as an apartment is regarded as a significant benefit. Subject to the retention and conservative repair of the windows, the only removal of historic fabric will be the removal of the suspected chimney breast and fire surround on the first floor. The removal of the modern false floor is seen as a significant benefit.

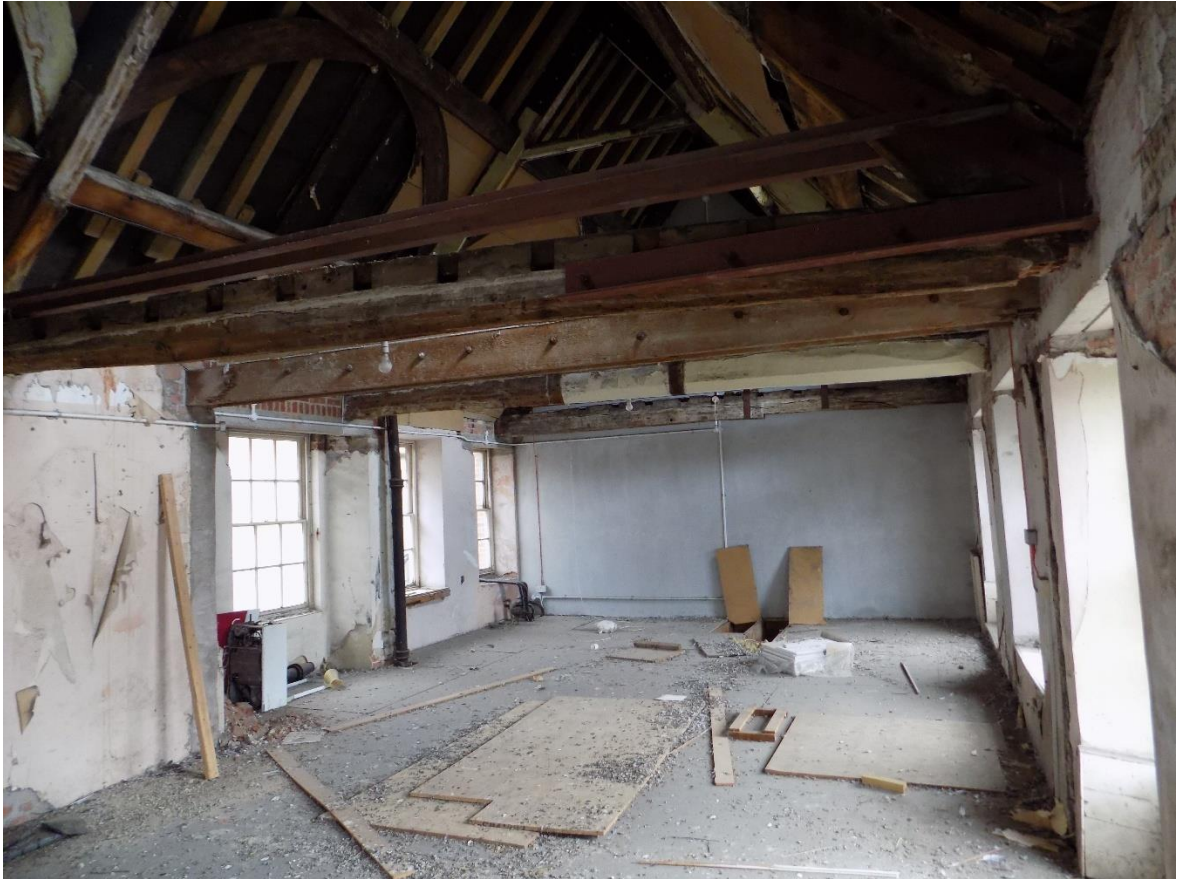
Fig.22: General view of the first floor, looking south-west, showing suspected chimney-breast and recessed window to left.

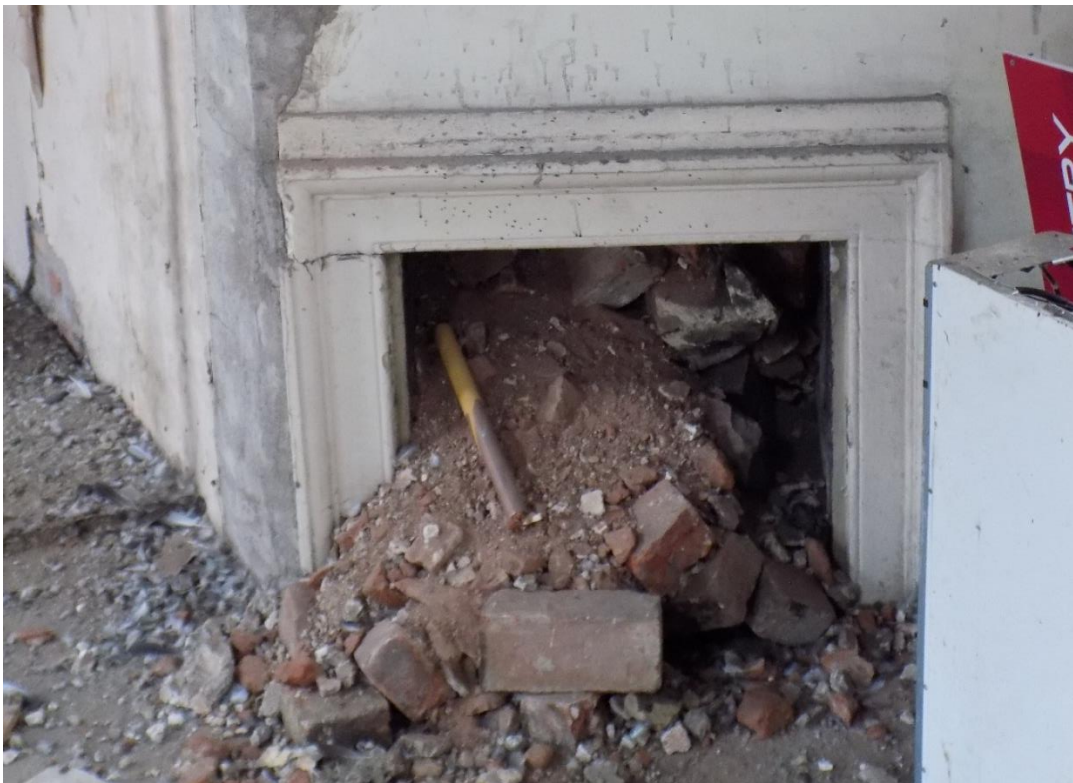
Fig.23: Detail of suspected fireplace, showing ovolo mouldings.

- 4.4 The chimney breast is formed in brick over a single bay with only a single small fireplace to one side at first-floor level [as noted in the pre-app statement: Fig.23]. There are signs of inserted modern brickwork to consolidate the feature, particularly at the wall head, associated with the modern repairs to the roof, the wall heads and window heads across the whole range. It is likely that there were other, larger fireplaces but these have been blocked and the blocking plastered over. The external stack has been lost.

- 4.5 It is likely that the breast is the surviving element of a series of fireplaces, hearths and flues against the rear wall of the frontage range. It has lost its associated external stack and all but one of its fireplaces, and all its hearths. The fireplaces were likely blocked with the early twentieth-century remodelling to change from a residence to banking use, since these elements have been plastered over. Later consolidation works associated with the repair to the roof and consolidation of the wall heads can also be seen in the breast.

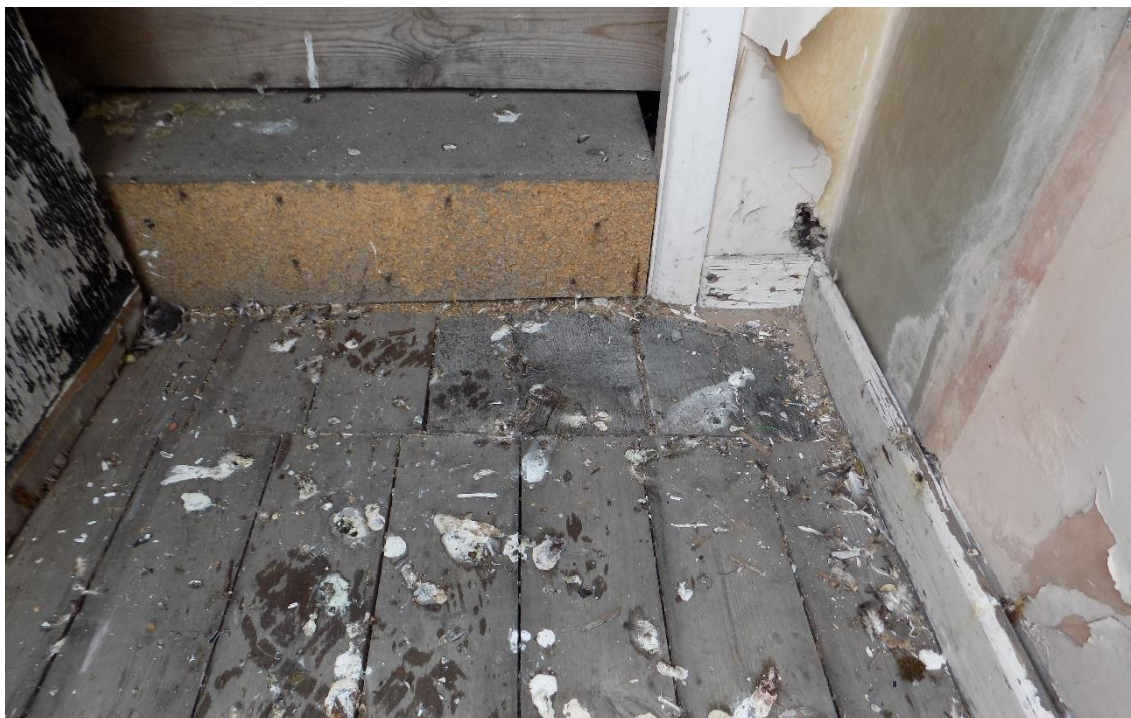
Fig.24: First-floor lobby detail, showing two oak floorboards disappearing under the false floor .

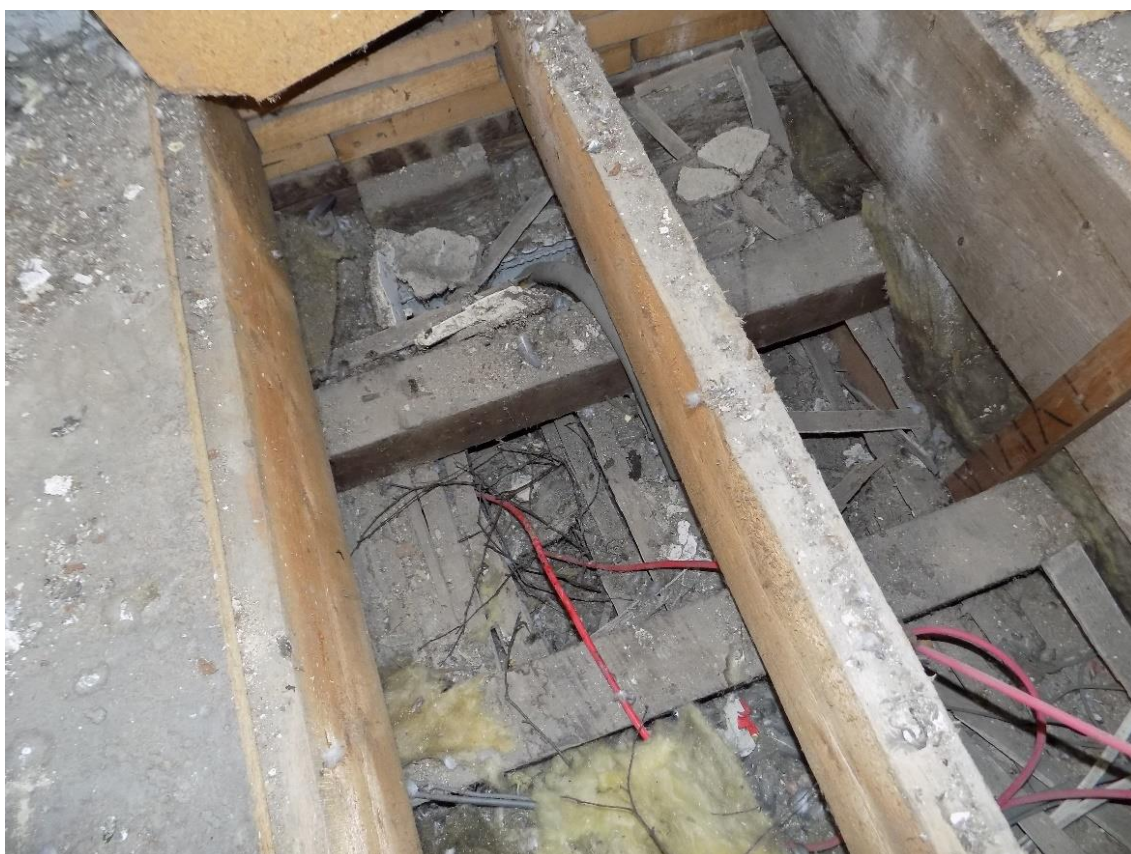
Fig.25: Detail showing oak floor joists beneath the first-floor modern false floor.

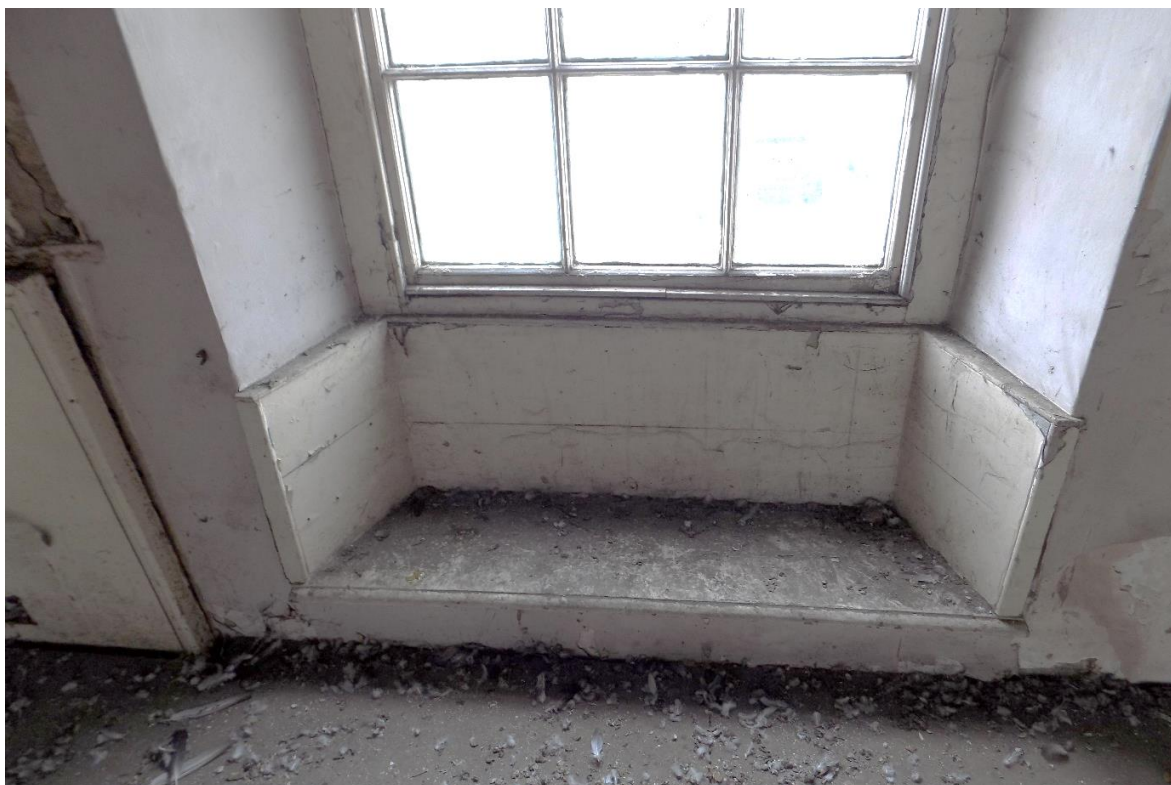
Fig.26: First-floor: Detail of first front-facing window from west, showing historic window seat truncated by false floor.

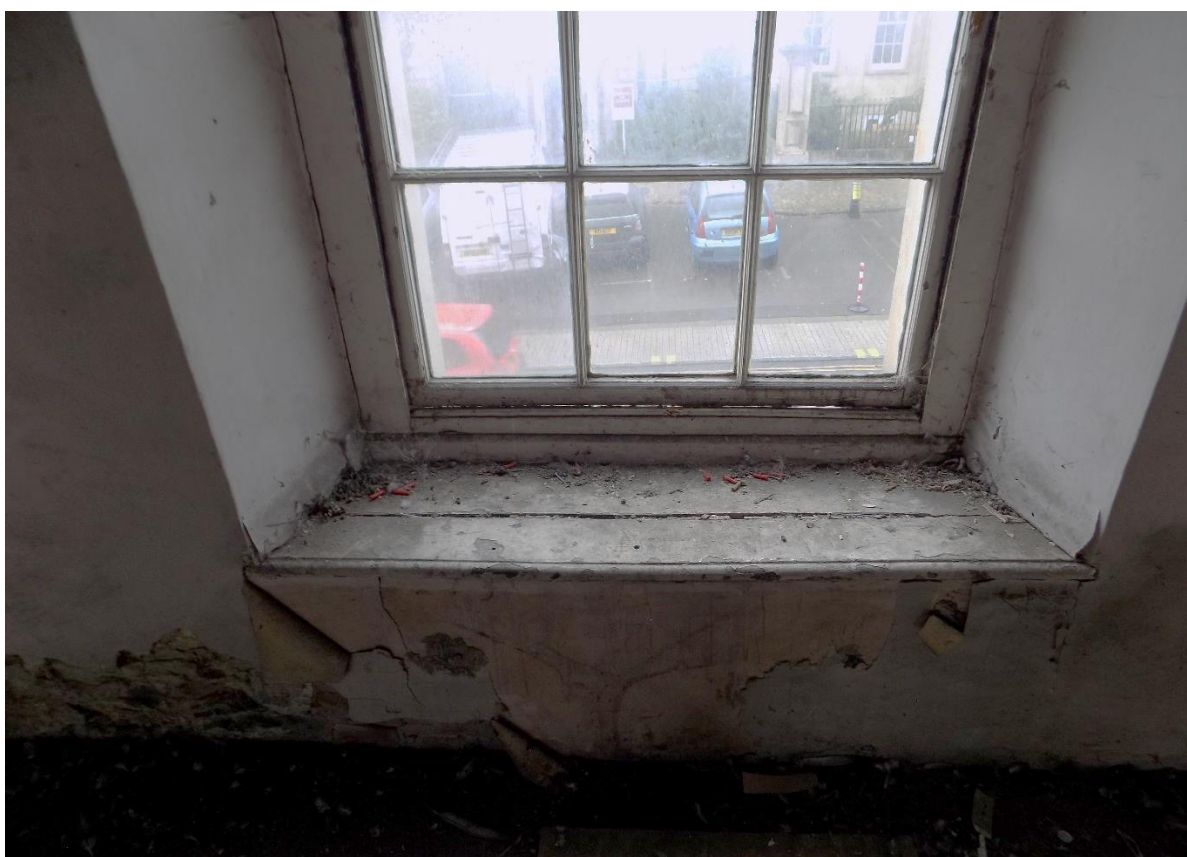
Fig.27: First-floor: Detail of second front-facing window from west, showing historic window sill.

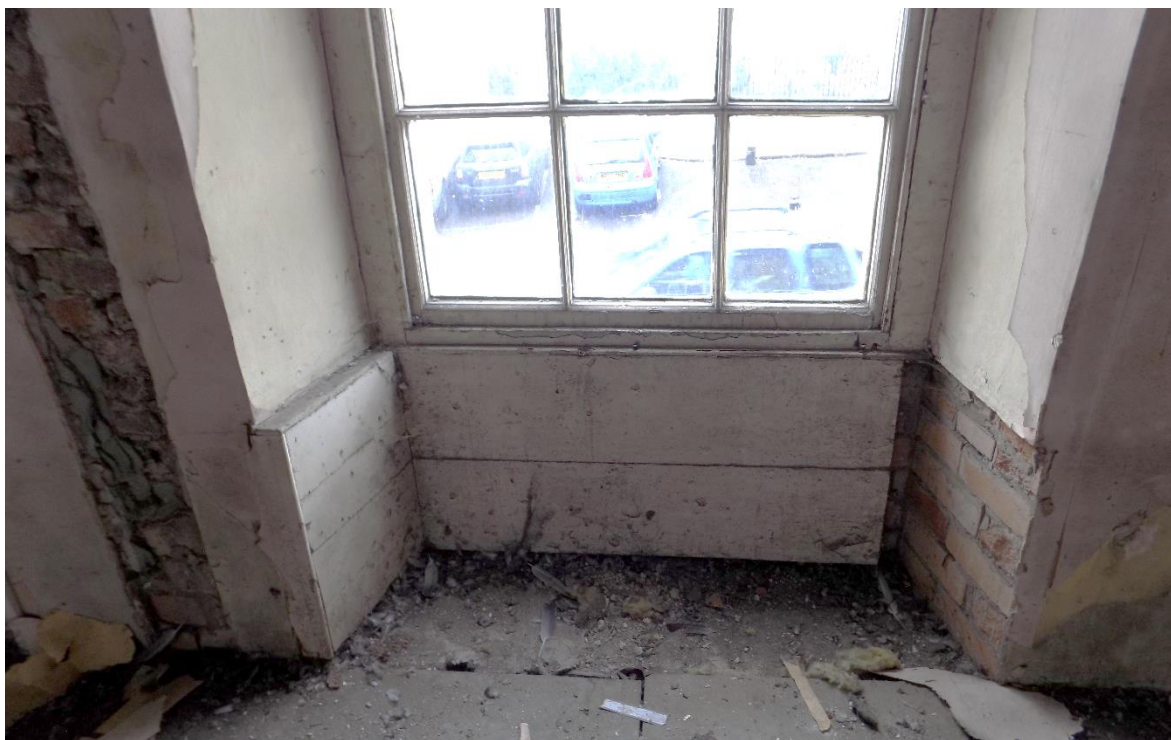
Fig.28: First-floor: Detail of third front-facing window from west, showing historic window seat truncated by false floor.

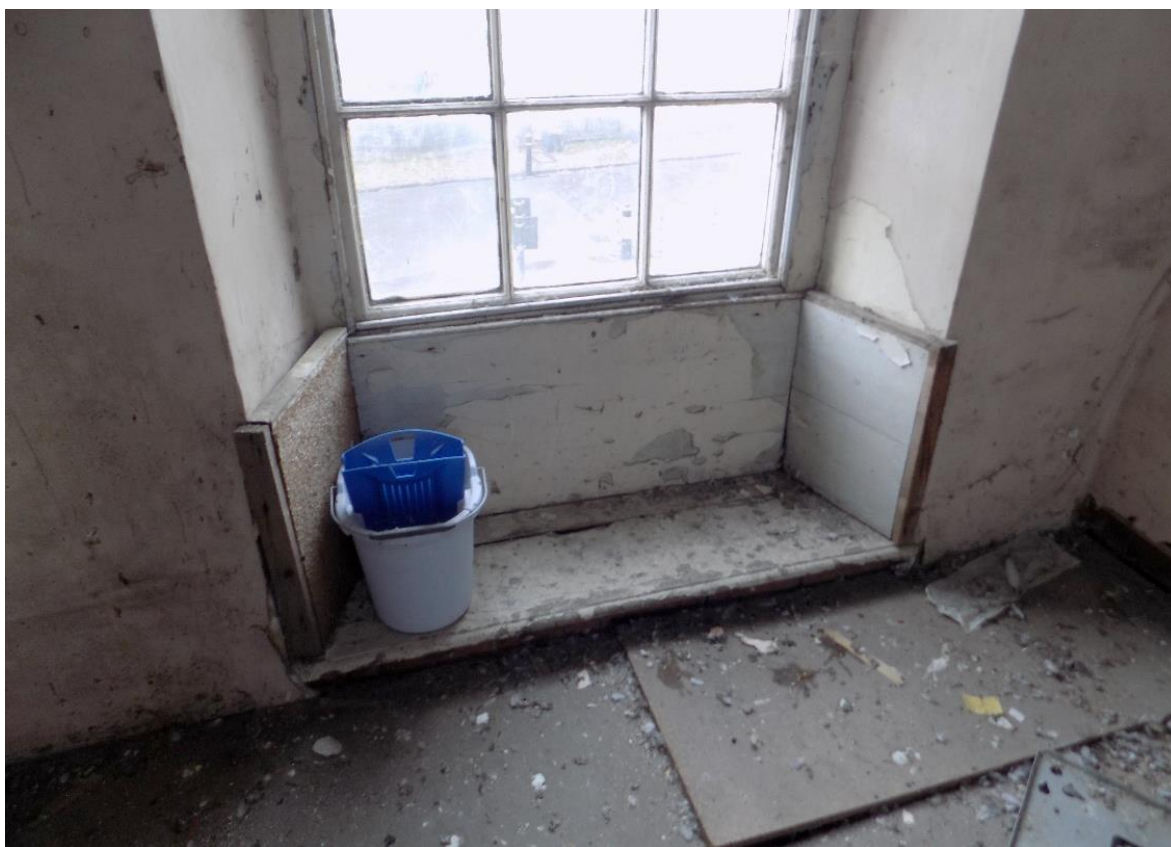
Fig.29: First-floor: Detail of fourth front-facing window from west, showing historic window seat truncated by false floor.

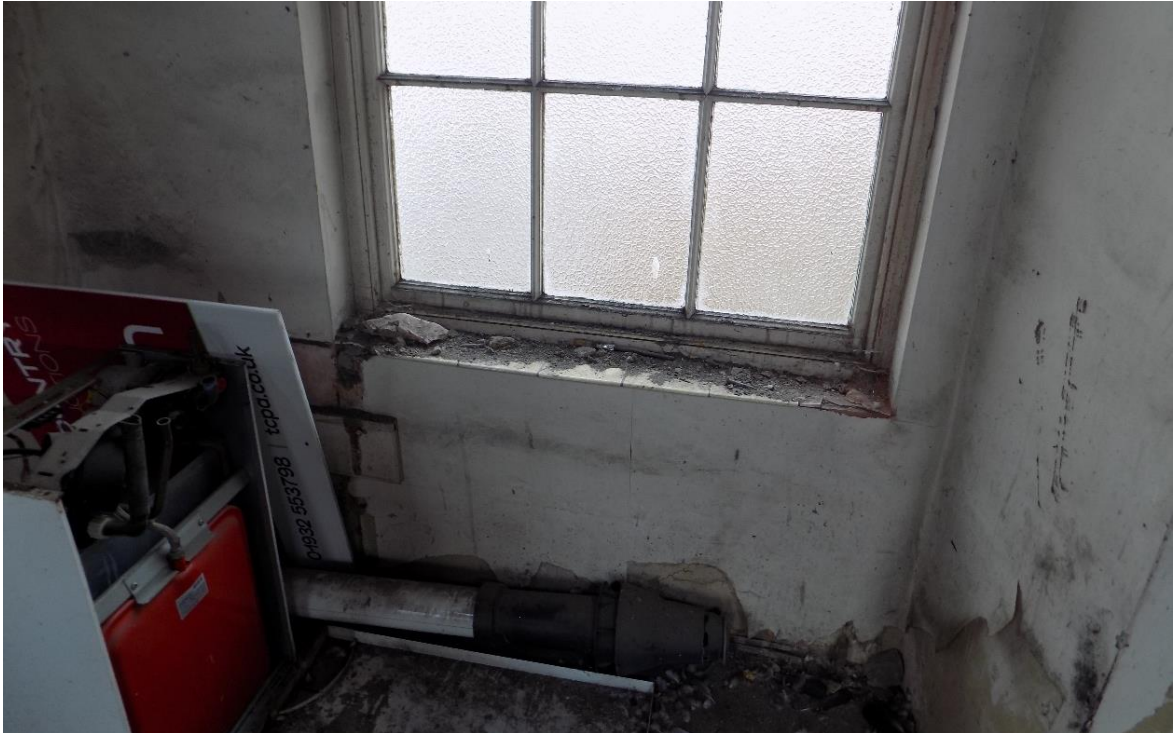
Fig.30: First-floor: Detail of first rear-facing window from west, showing ten-inch wall below and to left.

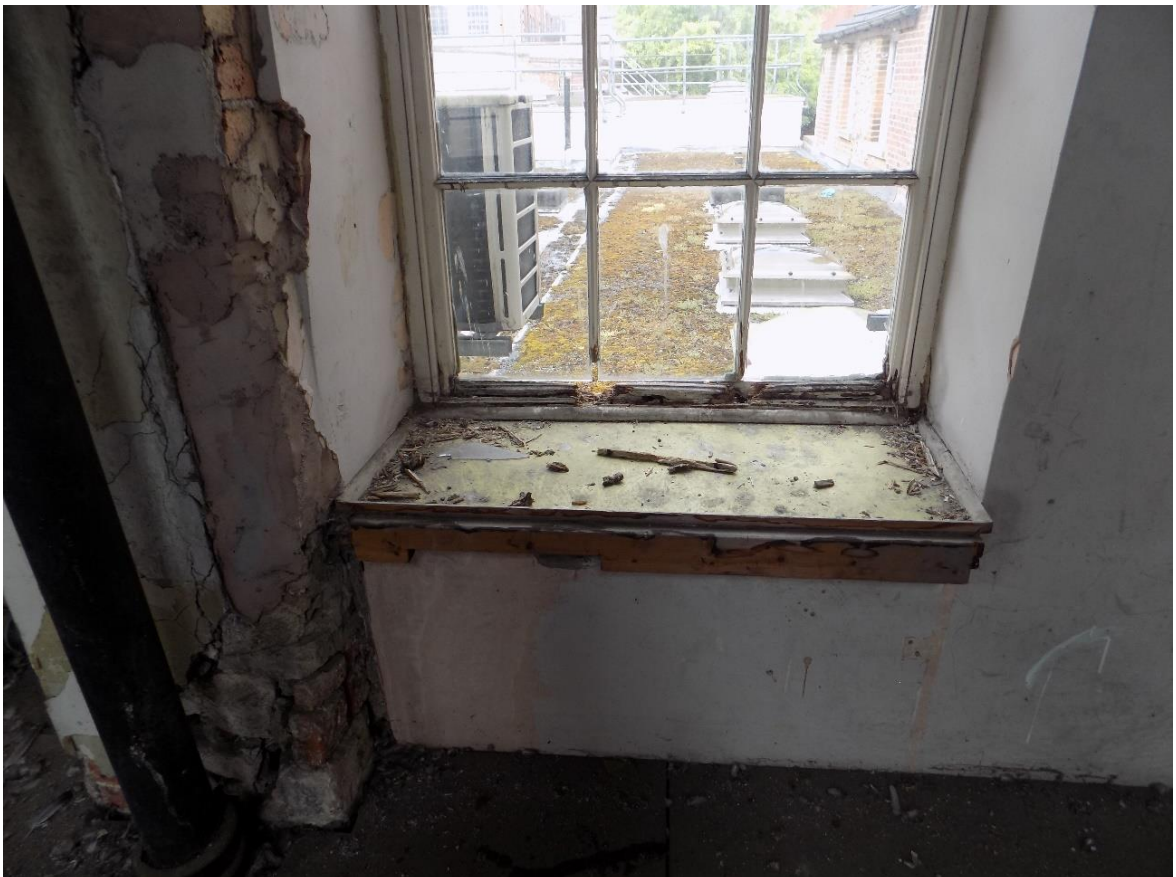
Fig.31: First-floor: Detail of second rear-facing window, showing decayed bottom rail and modern sill.

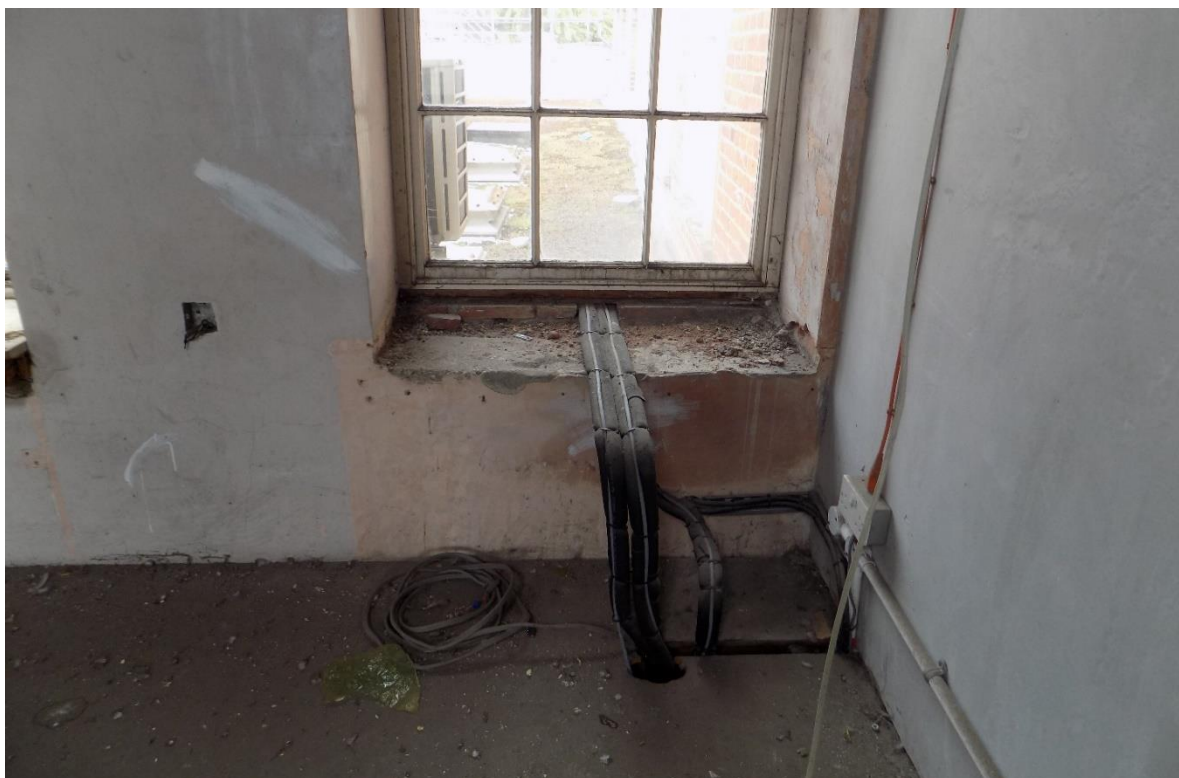
Fig.32: First-floor: Detail of second rear-facing window, showing decayed bottom rail and modern sill.

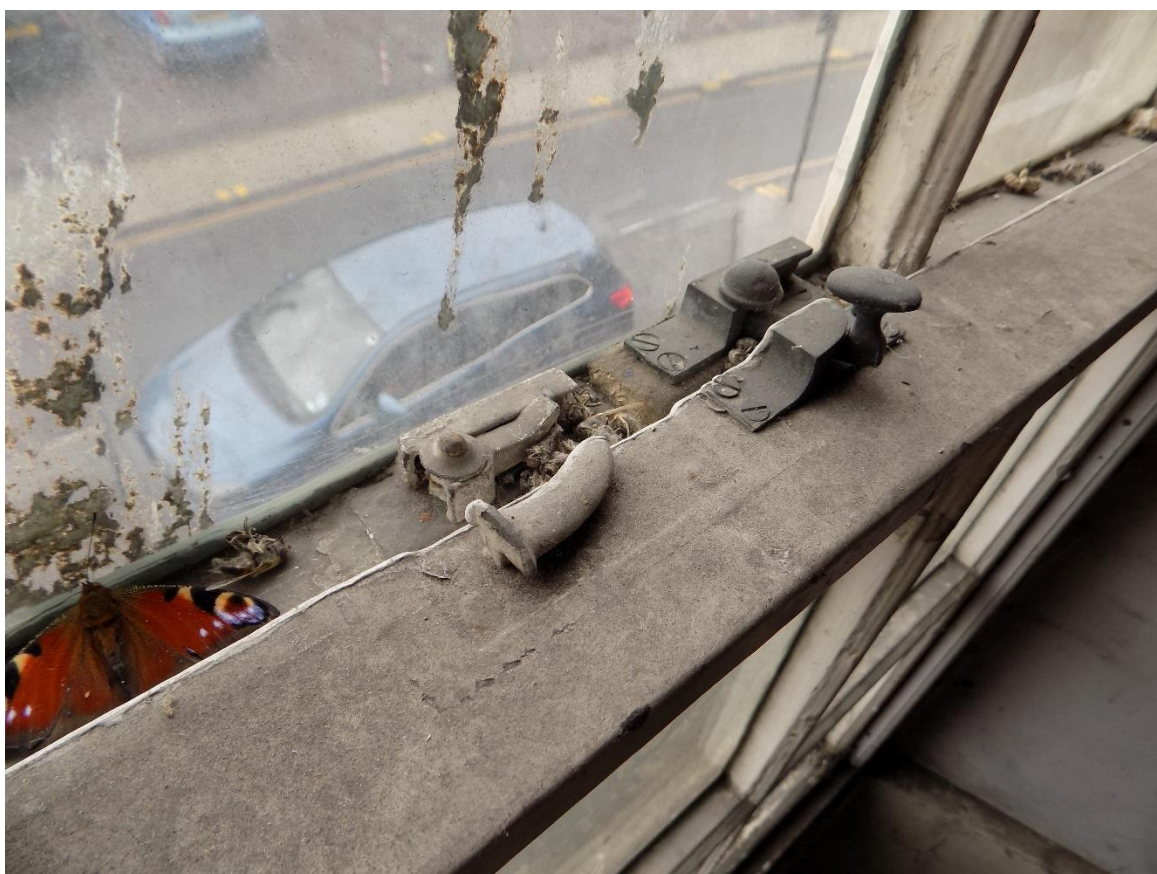
Fig.33: Window detail, showing window catch and early twentieth-century replacement.

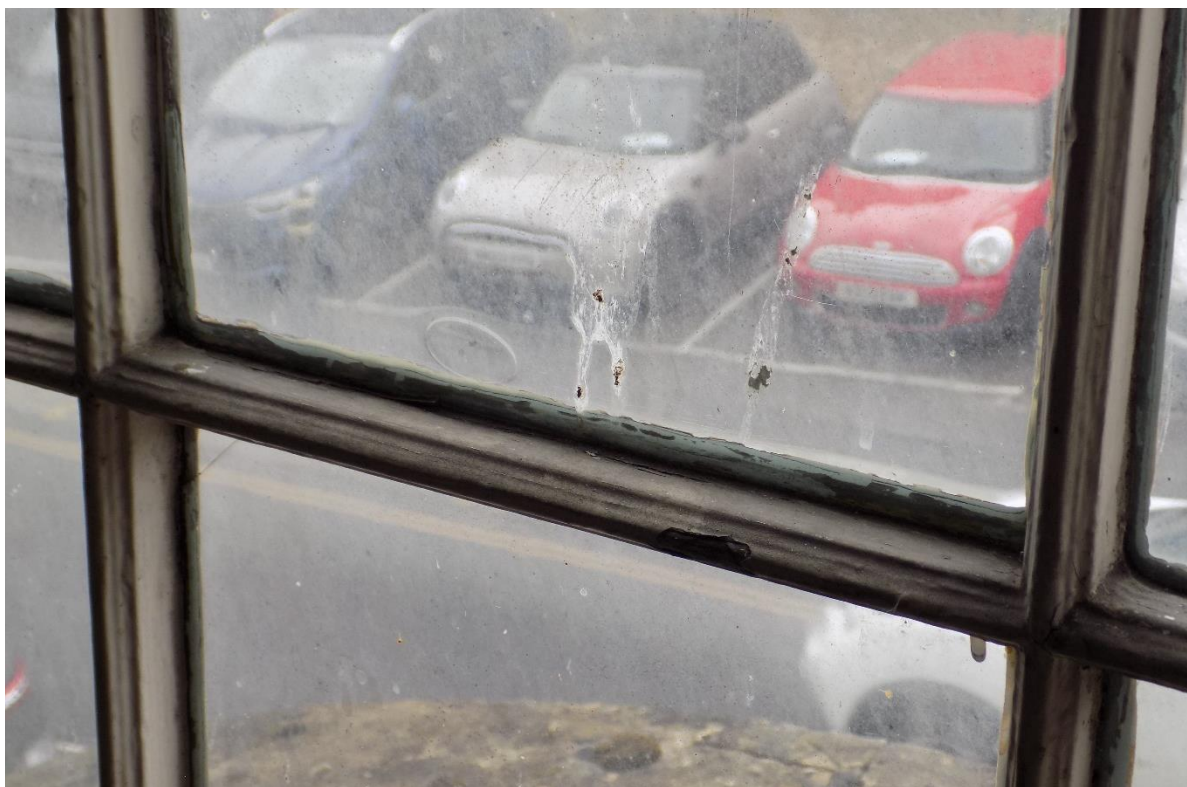
Fig.34: Front-facing window detail showing narrow (c.15mm) ovolo and cavetto glazing bars and bubble in hand-made glass.

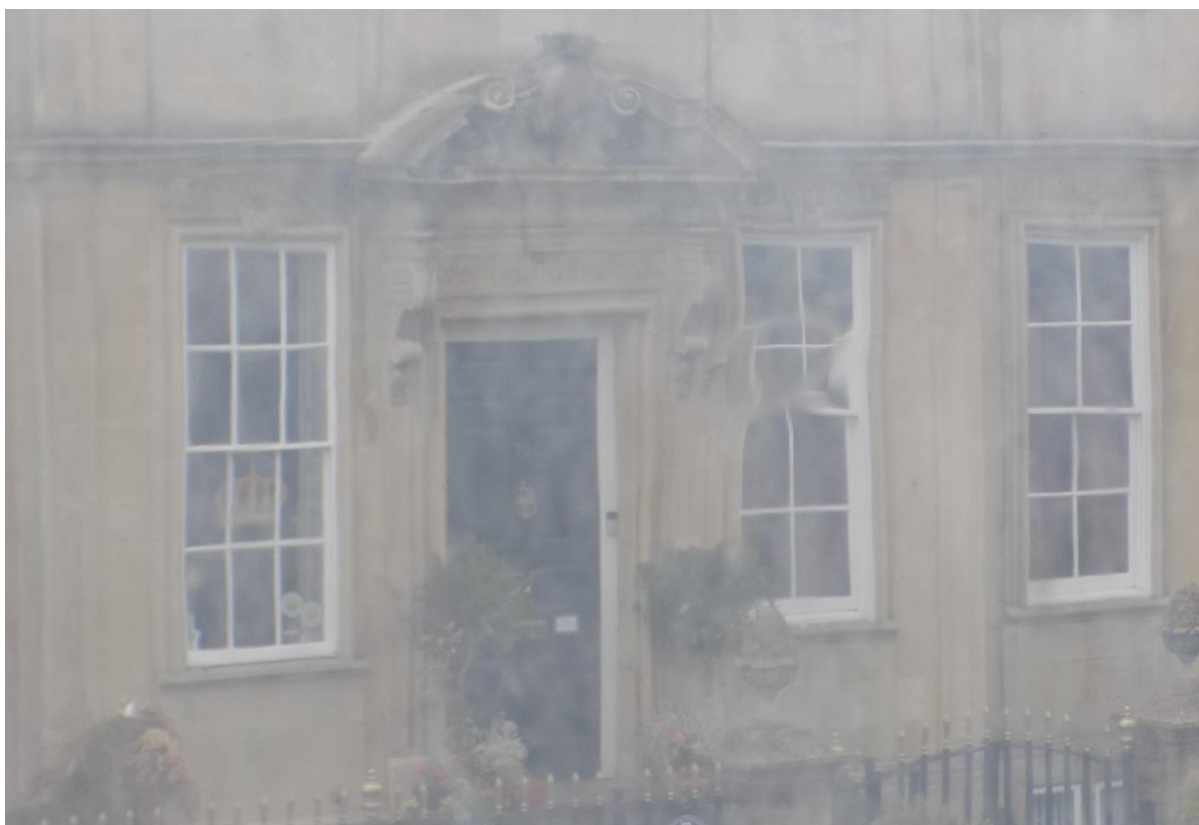
Fig.35: Detail of view through front-facing pane, showing optical deformation typical of hand-made glass.

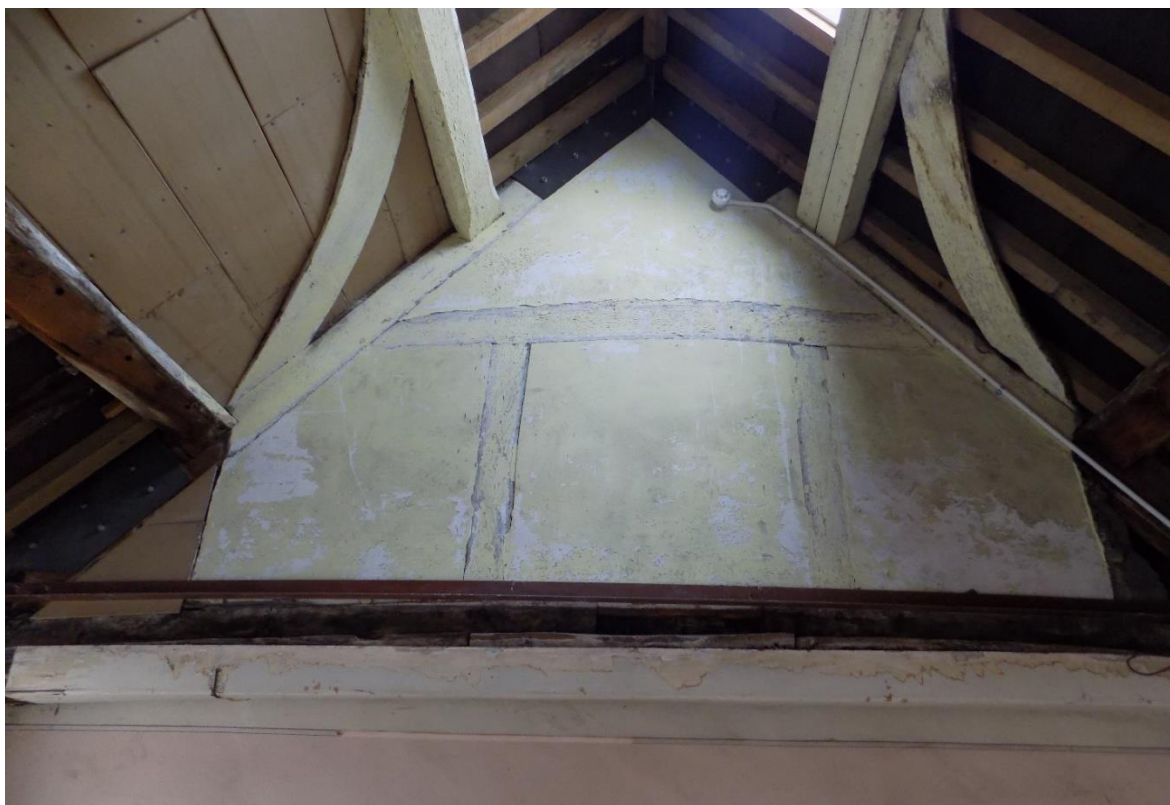
Fig.36: Attic detail showing queen-post collar truss at east end.

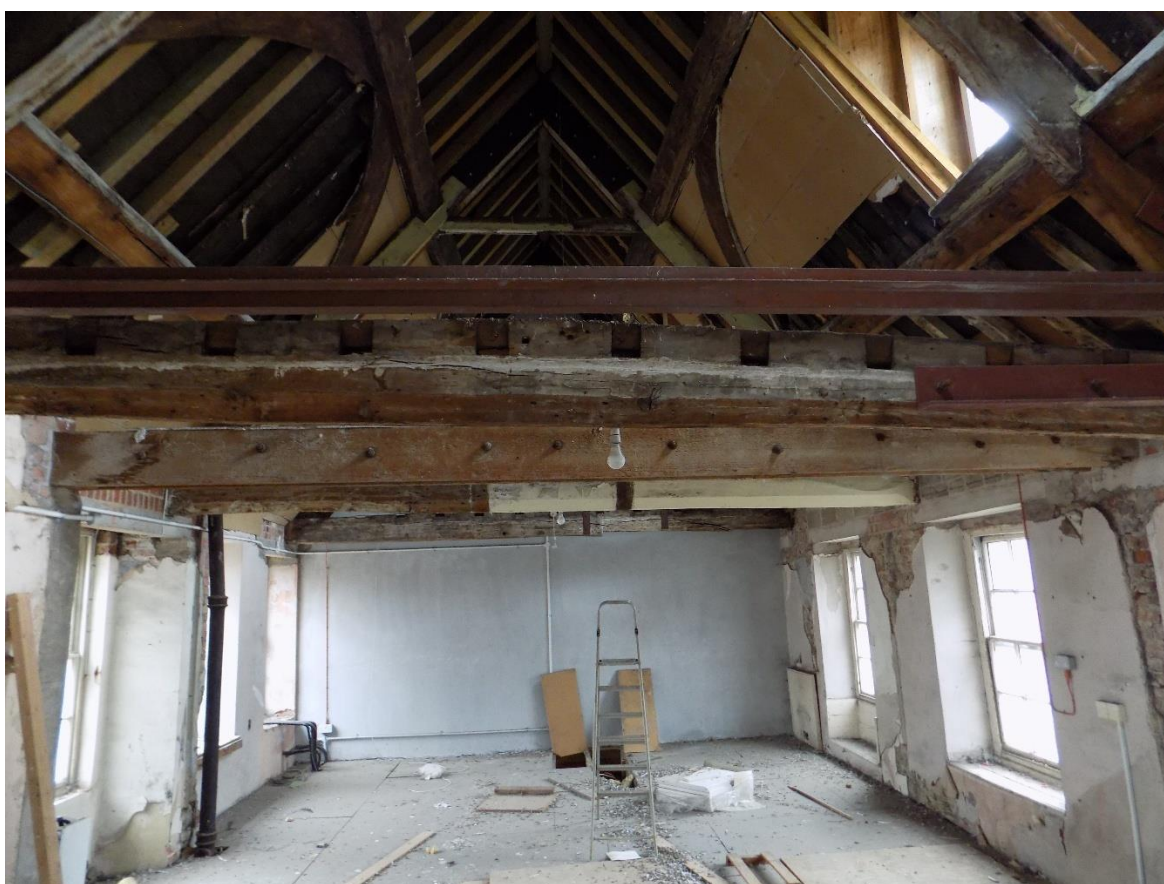
Fig.37: General view of roof, showing truss ties and beam flitched with modern softwood.
