**FORMER BARCLAYS' BANK, 3 FORE STREET, TROWBRIDGE**

**Built Heritage Statement**

**Title of project**    **3 Fore Street, Trowbridge, Wiltshire**  
**Client**                **MCH Minibuses Ltd**

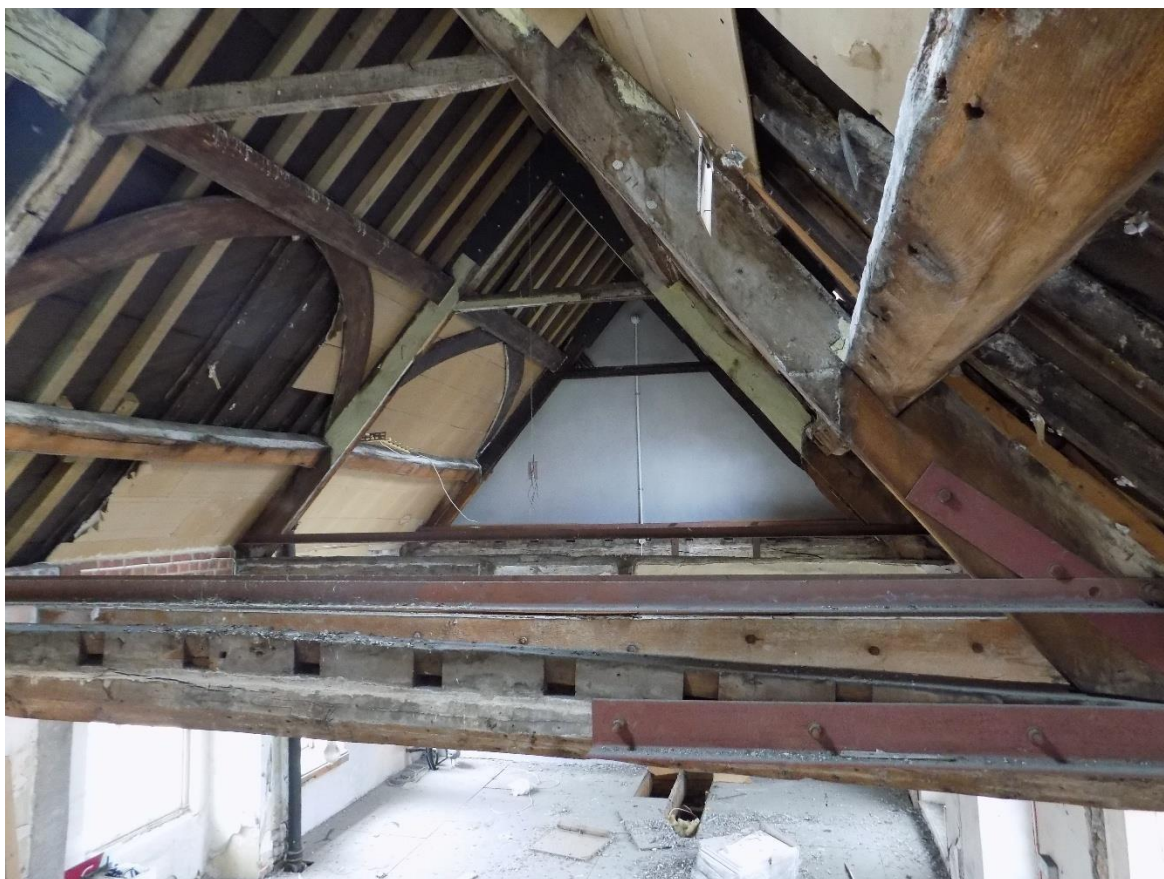
Fig.38: Attic view looking east, showing first tie from east notched for joists along the full length.

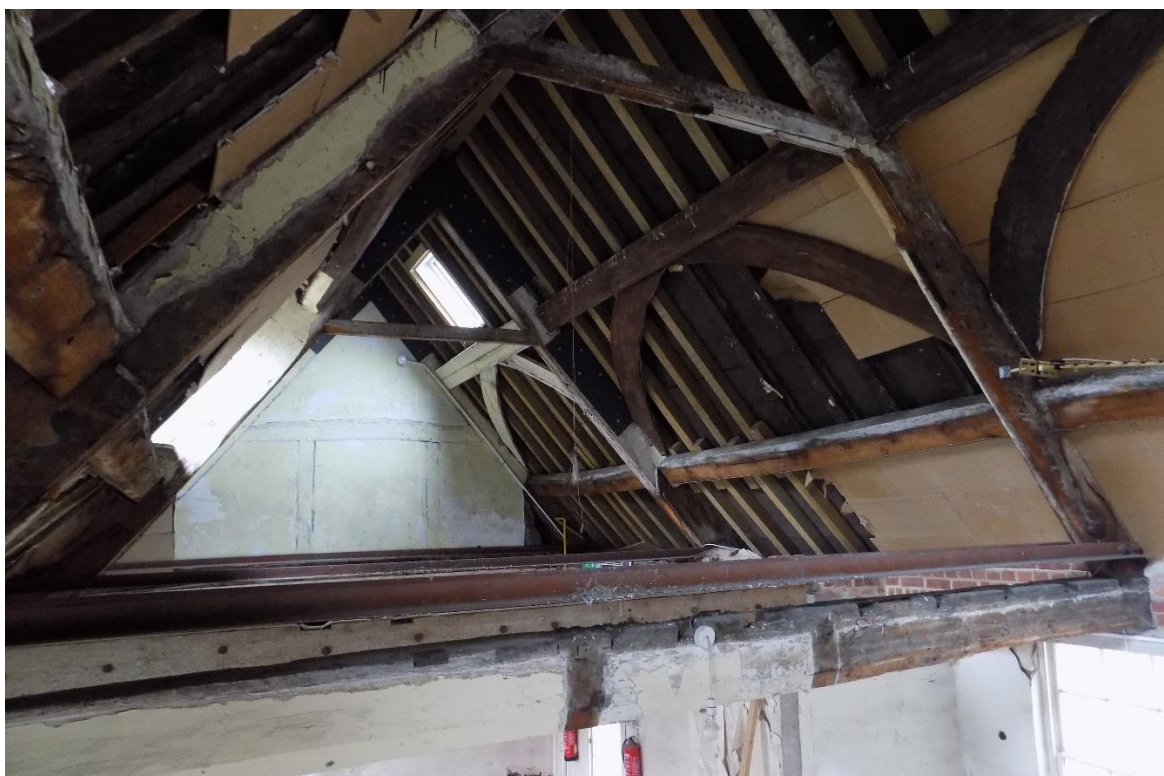
Fig.39: Attic view looking east, showing second tie from east notched for joists at northern end only of eastern face.

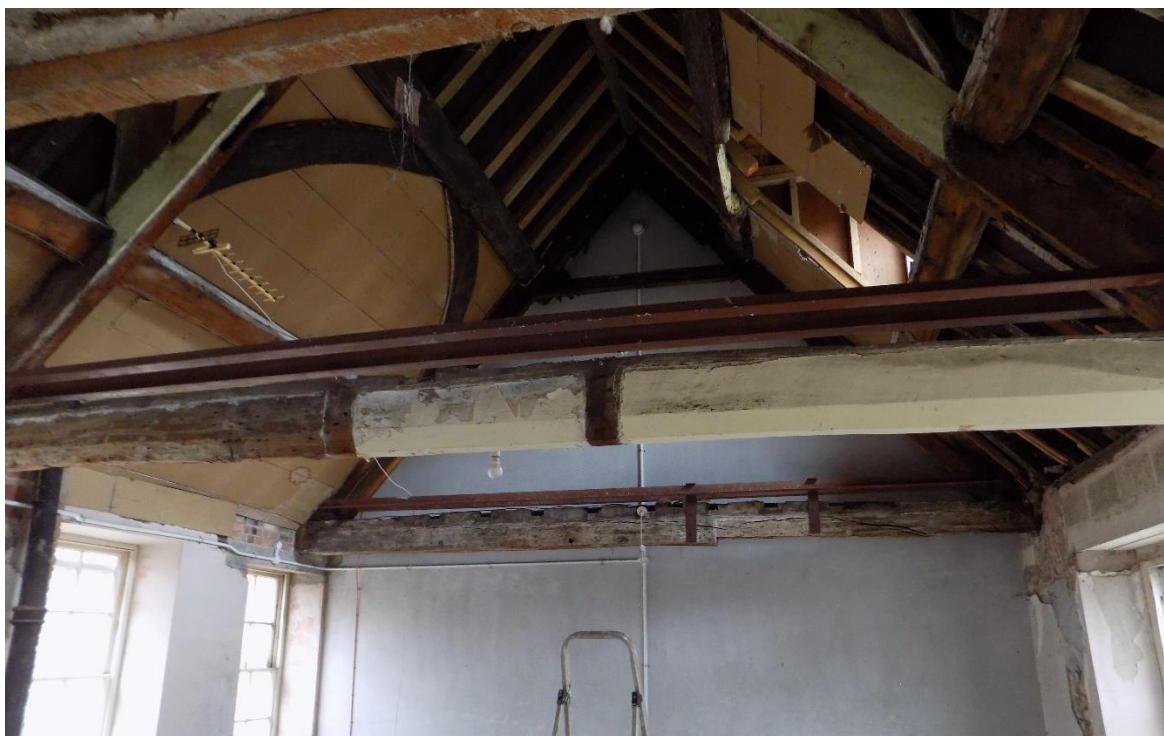
Fig.40: Attic view looking west, showing second tie from east notched for joists at northern end only.

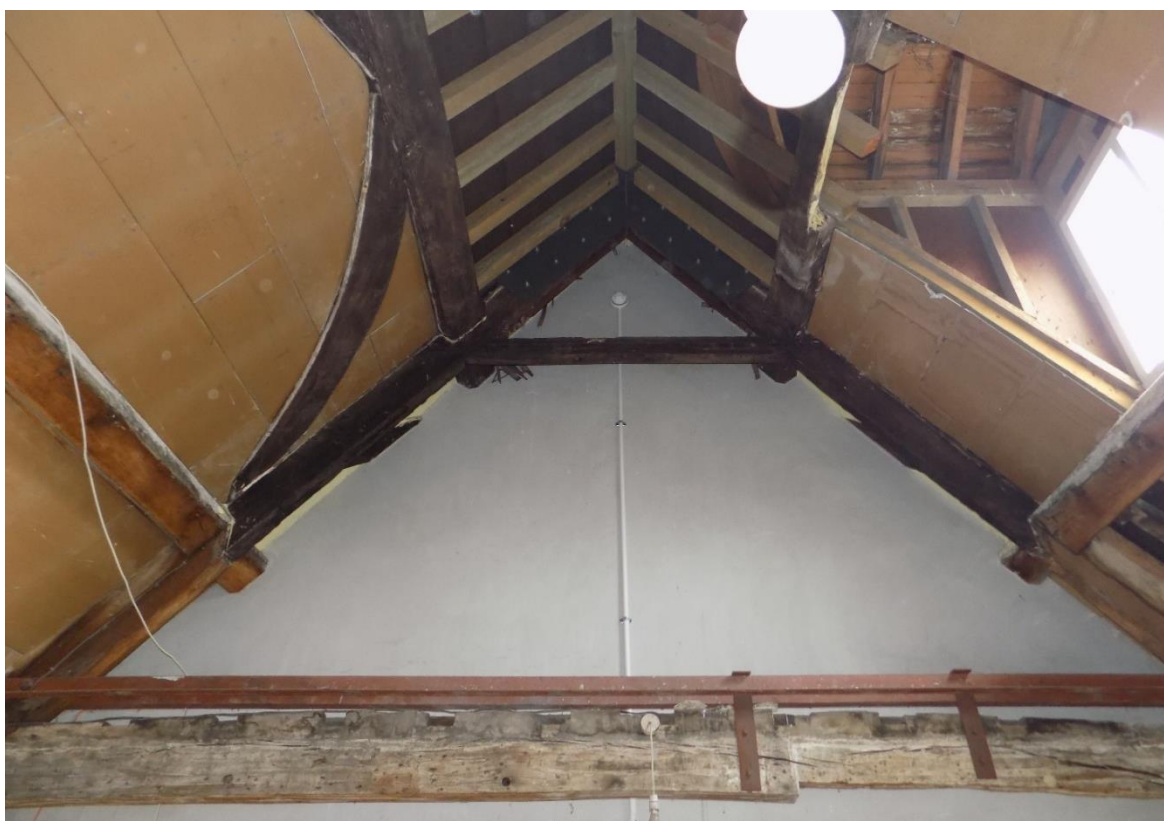
Fig.41 Attic view looking west, showing third tie from east notched for joists along its full length.

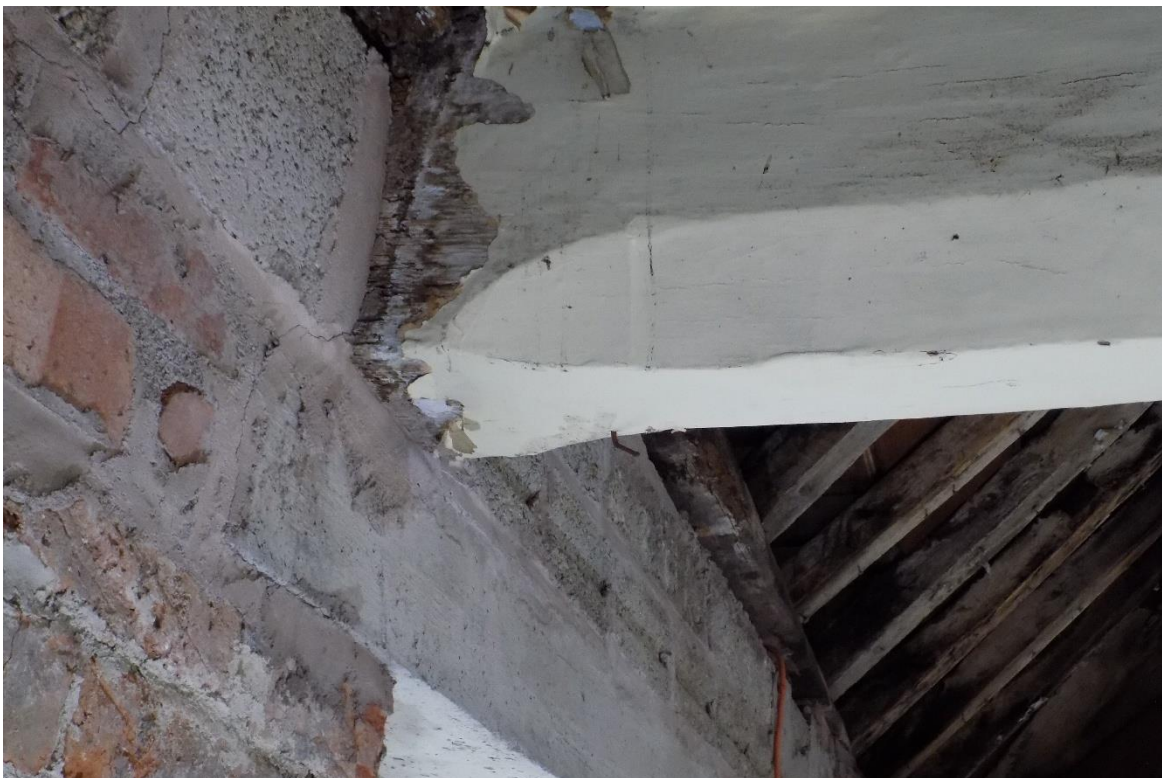
Fig.42: Detail of chamfers and curved step stops to the first and second trusses from the east.

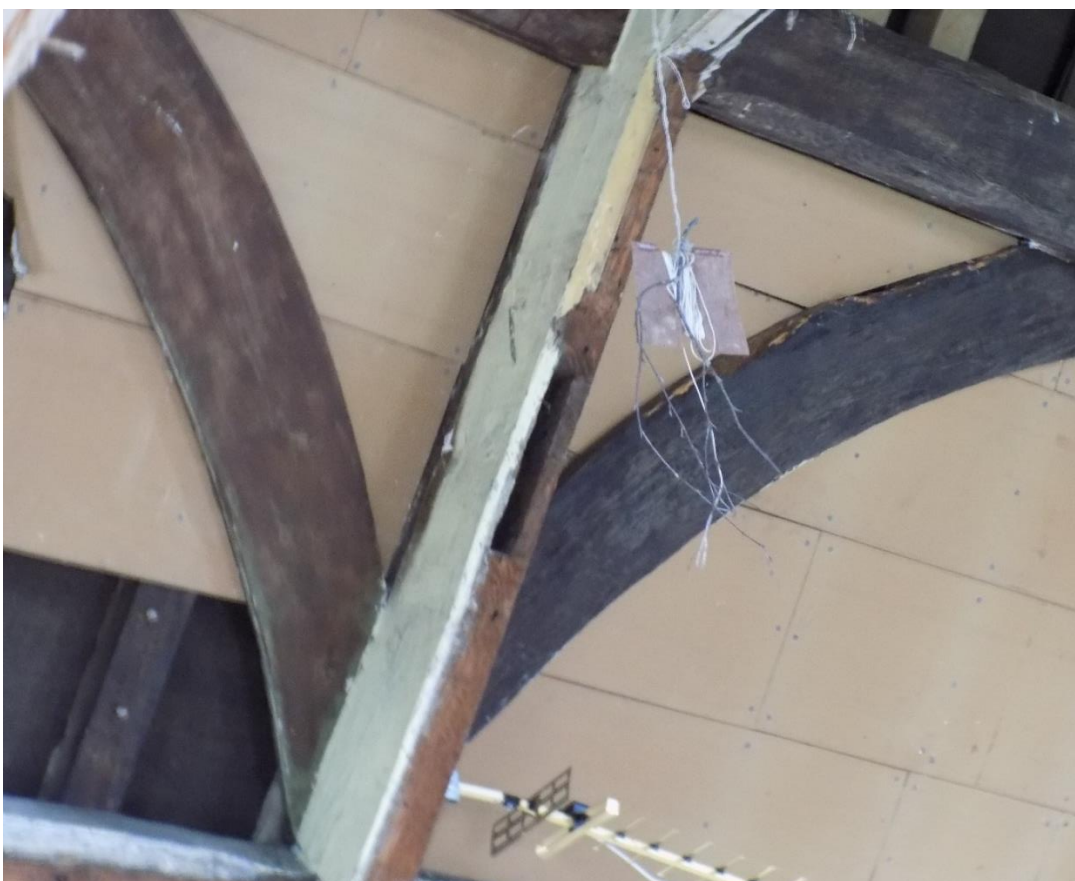
Fig.43: Detail of curved wind-braces and empty mortice for queen posts.

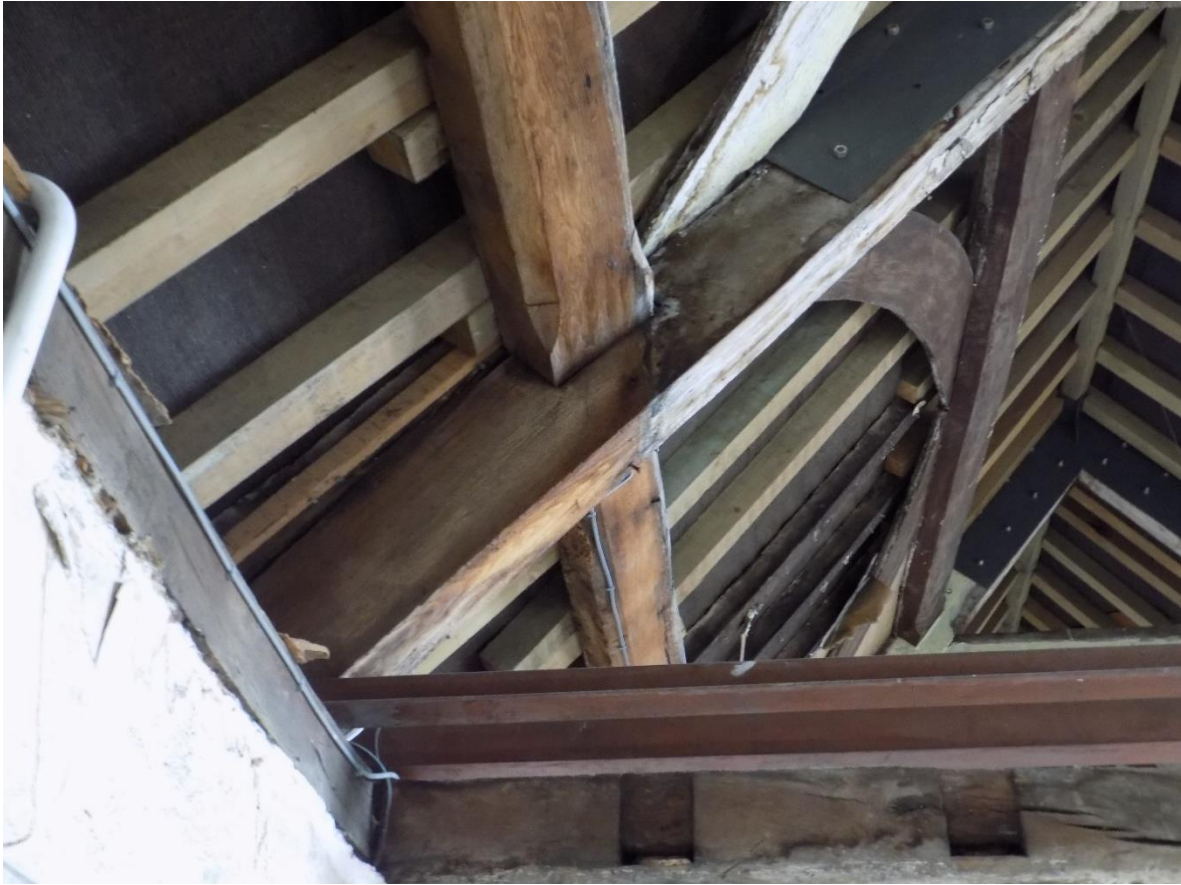
Fig.44: Detail of tenoned purlins with chamfers and curved step stops .

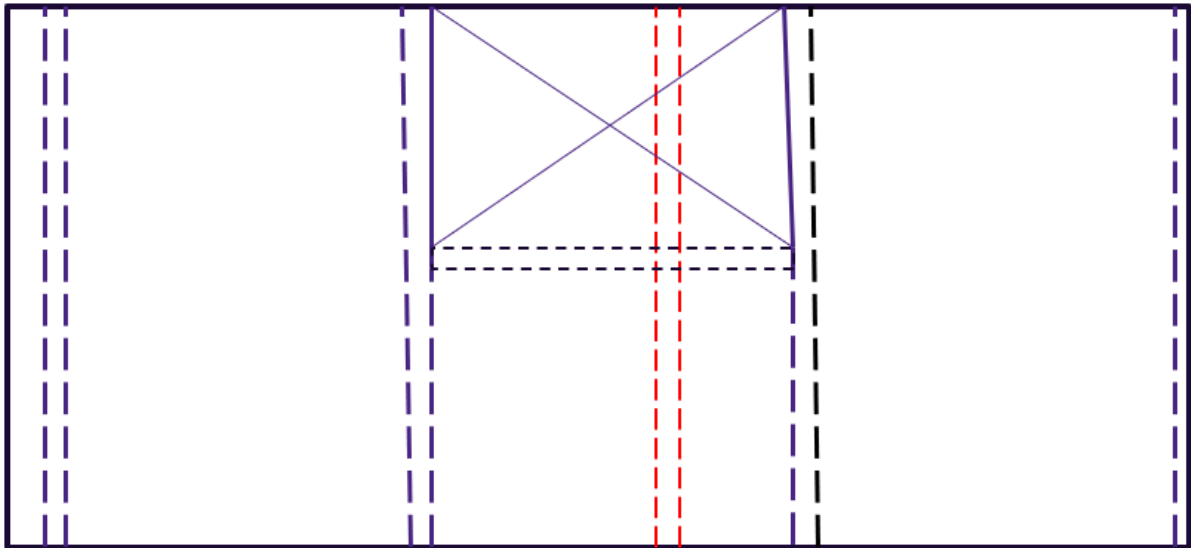
Fig.45: Sketch plan of the attic showing truss ties and inserted flitched trimmer (red). Dashed = trimmer and ties trenched for floor joists; Solid = no joist sockets [not to scale].

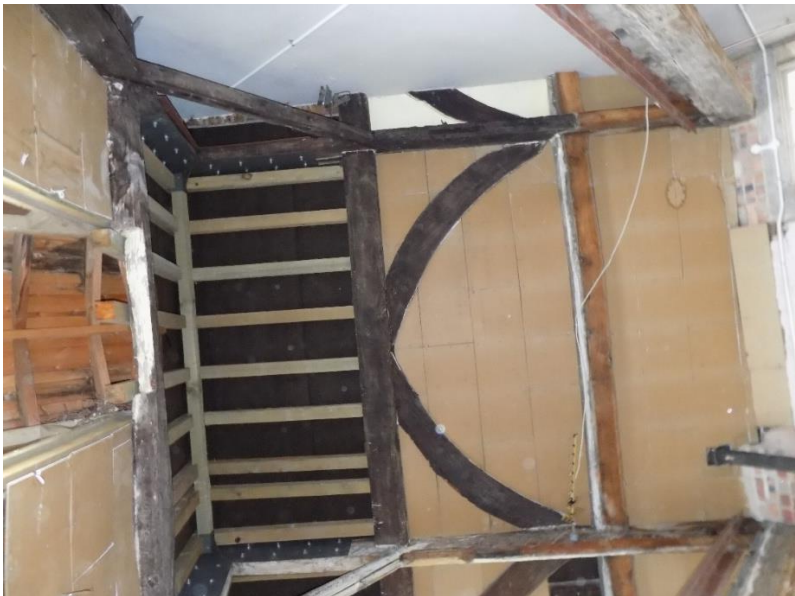
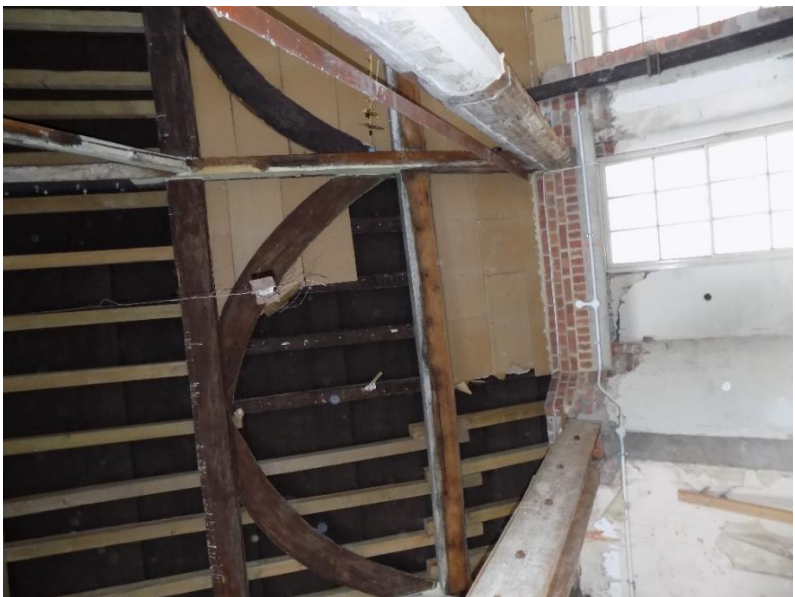
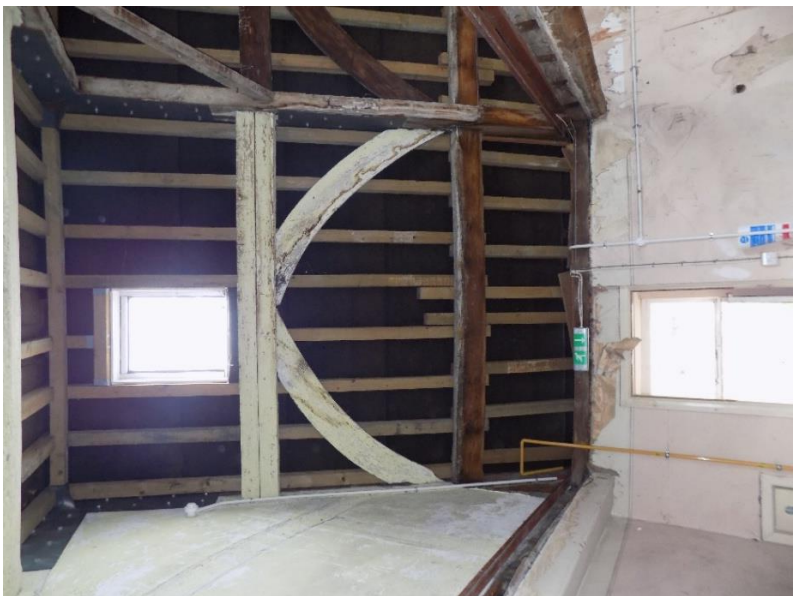
Fig.46: Views of underside of south slope of roof, showing curved wind-braces and extensive replacement of rafters.

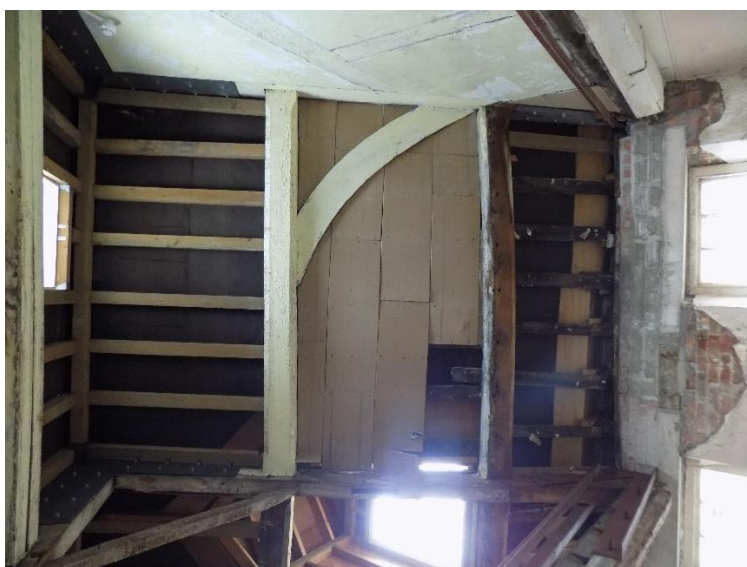
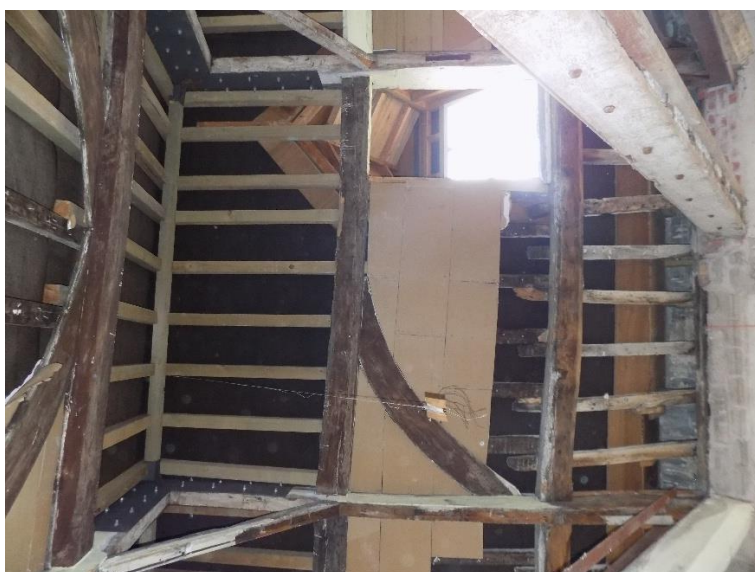
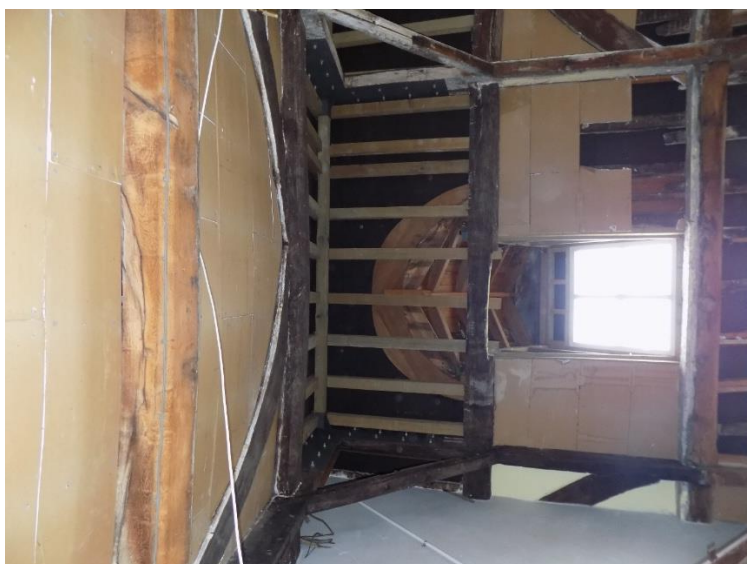
Fig.47: Views of underside of north slope of roof, showing curved wind-braces and extensive replacement of rafters and dormers.

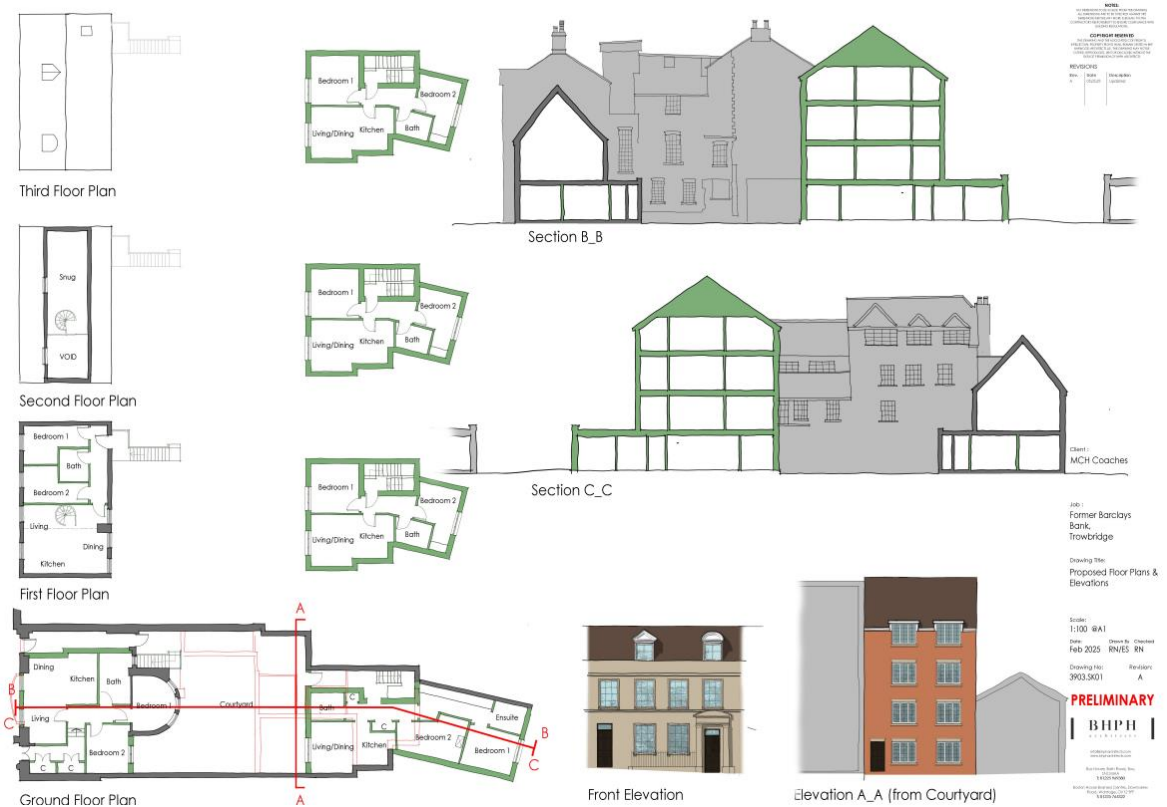
Fig.49: Floor plans and elevations, initial concept plan.
