PROJECT Idover Demesne Farm

DRAWING STATUS Planning/LBC

DRG TITLE IE6 Internal East Elevation Repairs

JOB/DRG No. 381 / 316

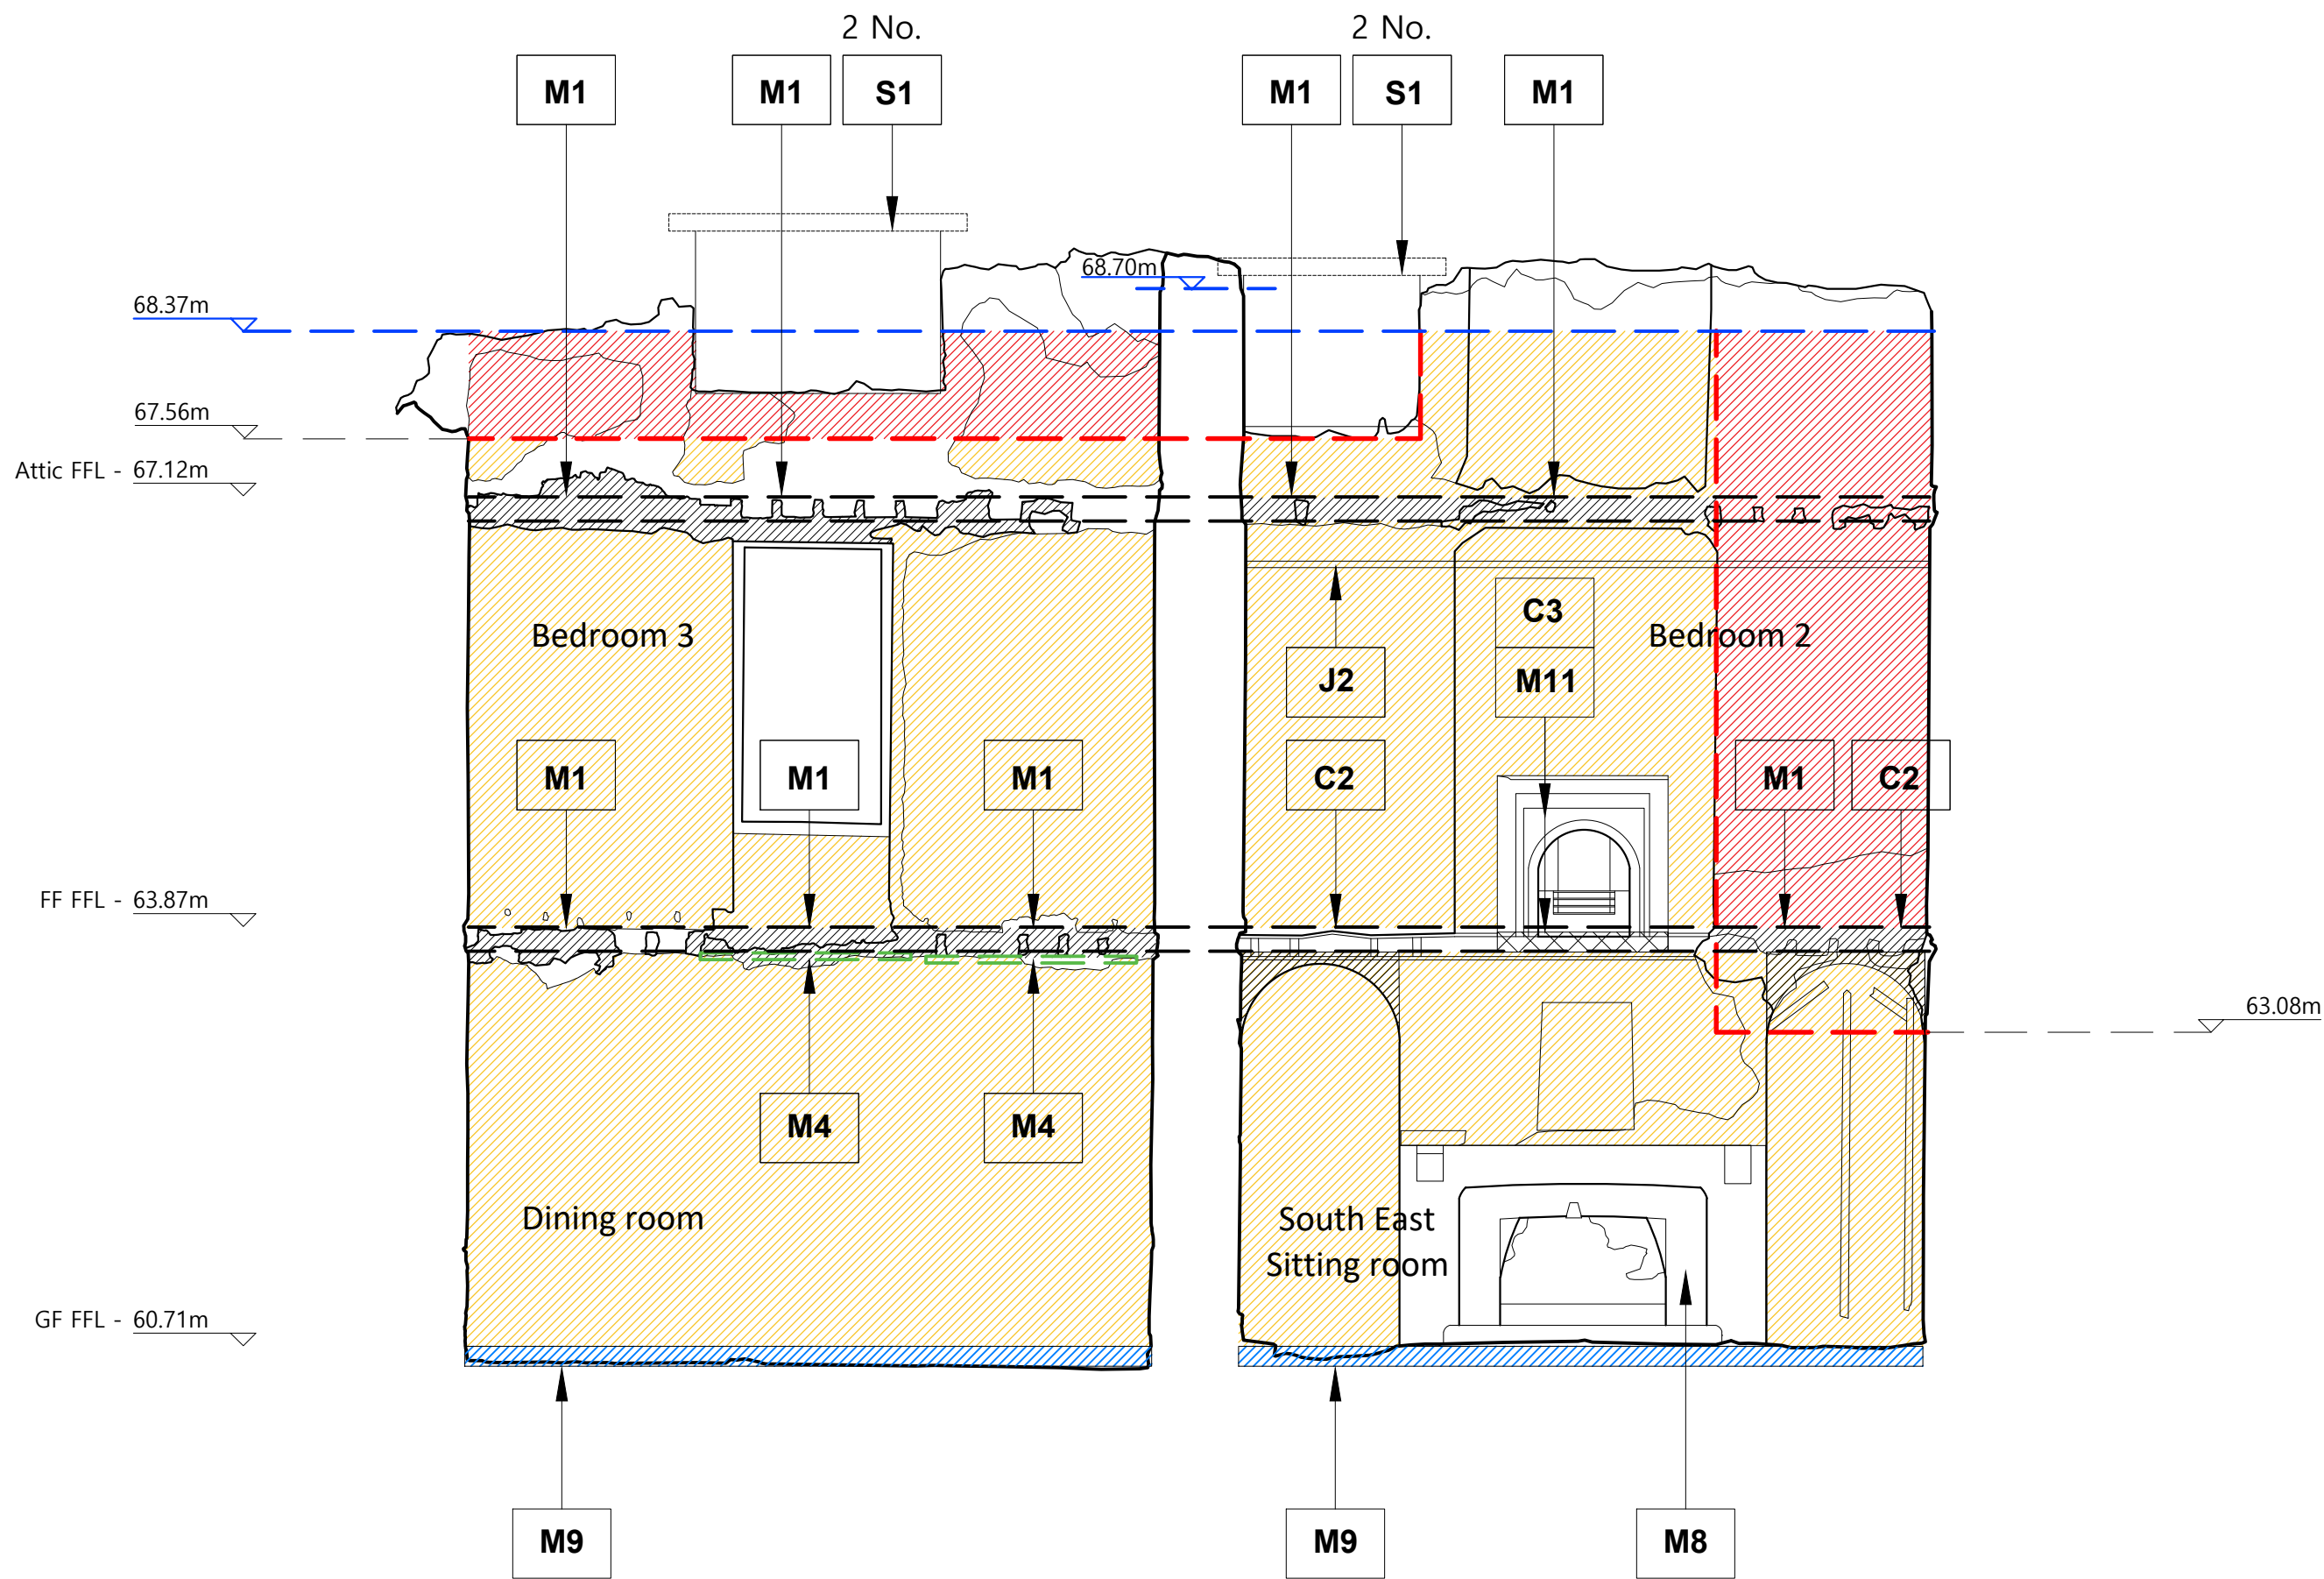
1.0 IE6 - Internal East Elevation

- M1Make good hole around old beam/joist opening
- M4Replace timber bearers in masonry wall with brick
- M6Rebuild masonry wall
- M8Repair stone fireplace
- M9New limecrete floor
- M11Form new constructional hearth

- P1New plaster boxing to replicate historic casing
- P2Remove plaster, carry out deep re-pointing of masonry below 50mm deep

- C2Provide new timber formers for arch
- C3Repair timber fire surround

- S1Replace timber lintel - see Structural Engineers' details

- J2Picture rail reinstated

- M6Rebuild masonry wall
- P2Remove plaster, carry out deep re-pointing of masonry below 50mm deep
