PROJECT Idover Demesne Farm

DRAWING STATUS Planning/LBC

DRG TITLE IE2 Internal West Elevation Repairs

JOB/DRG No. 381 / 312

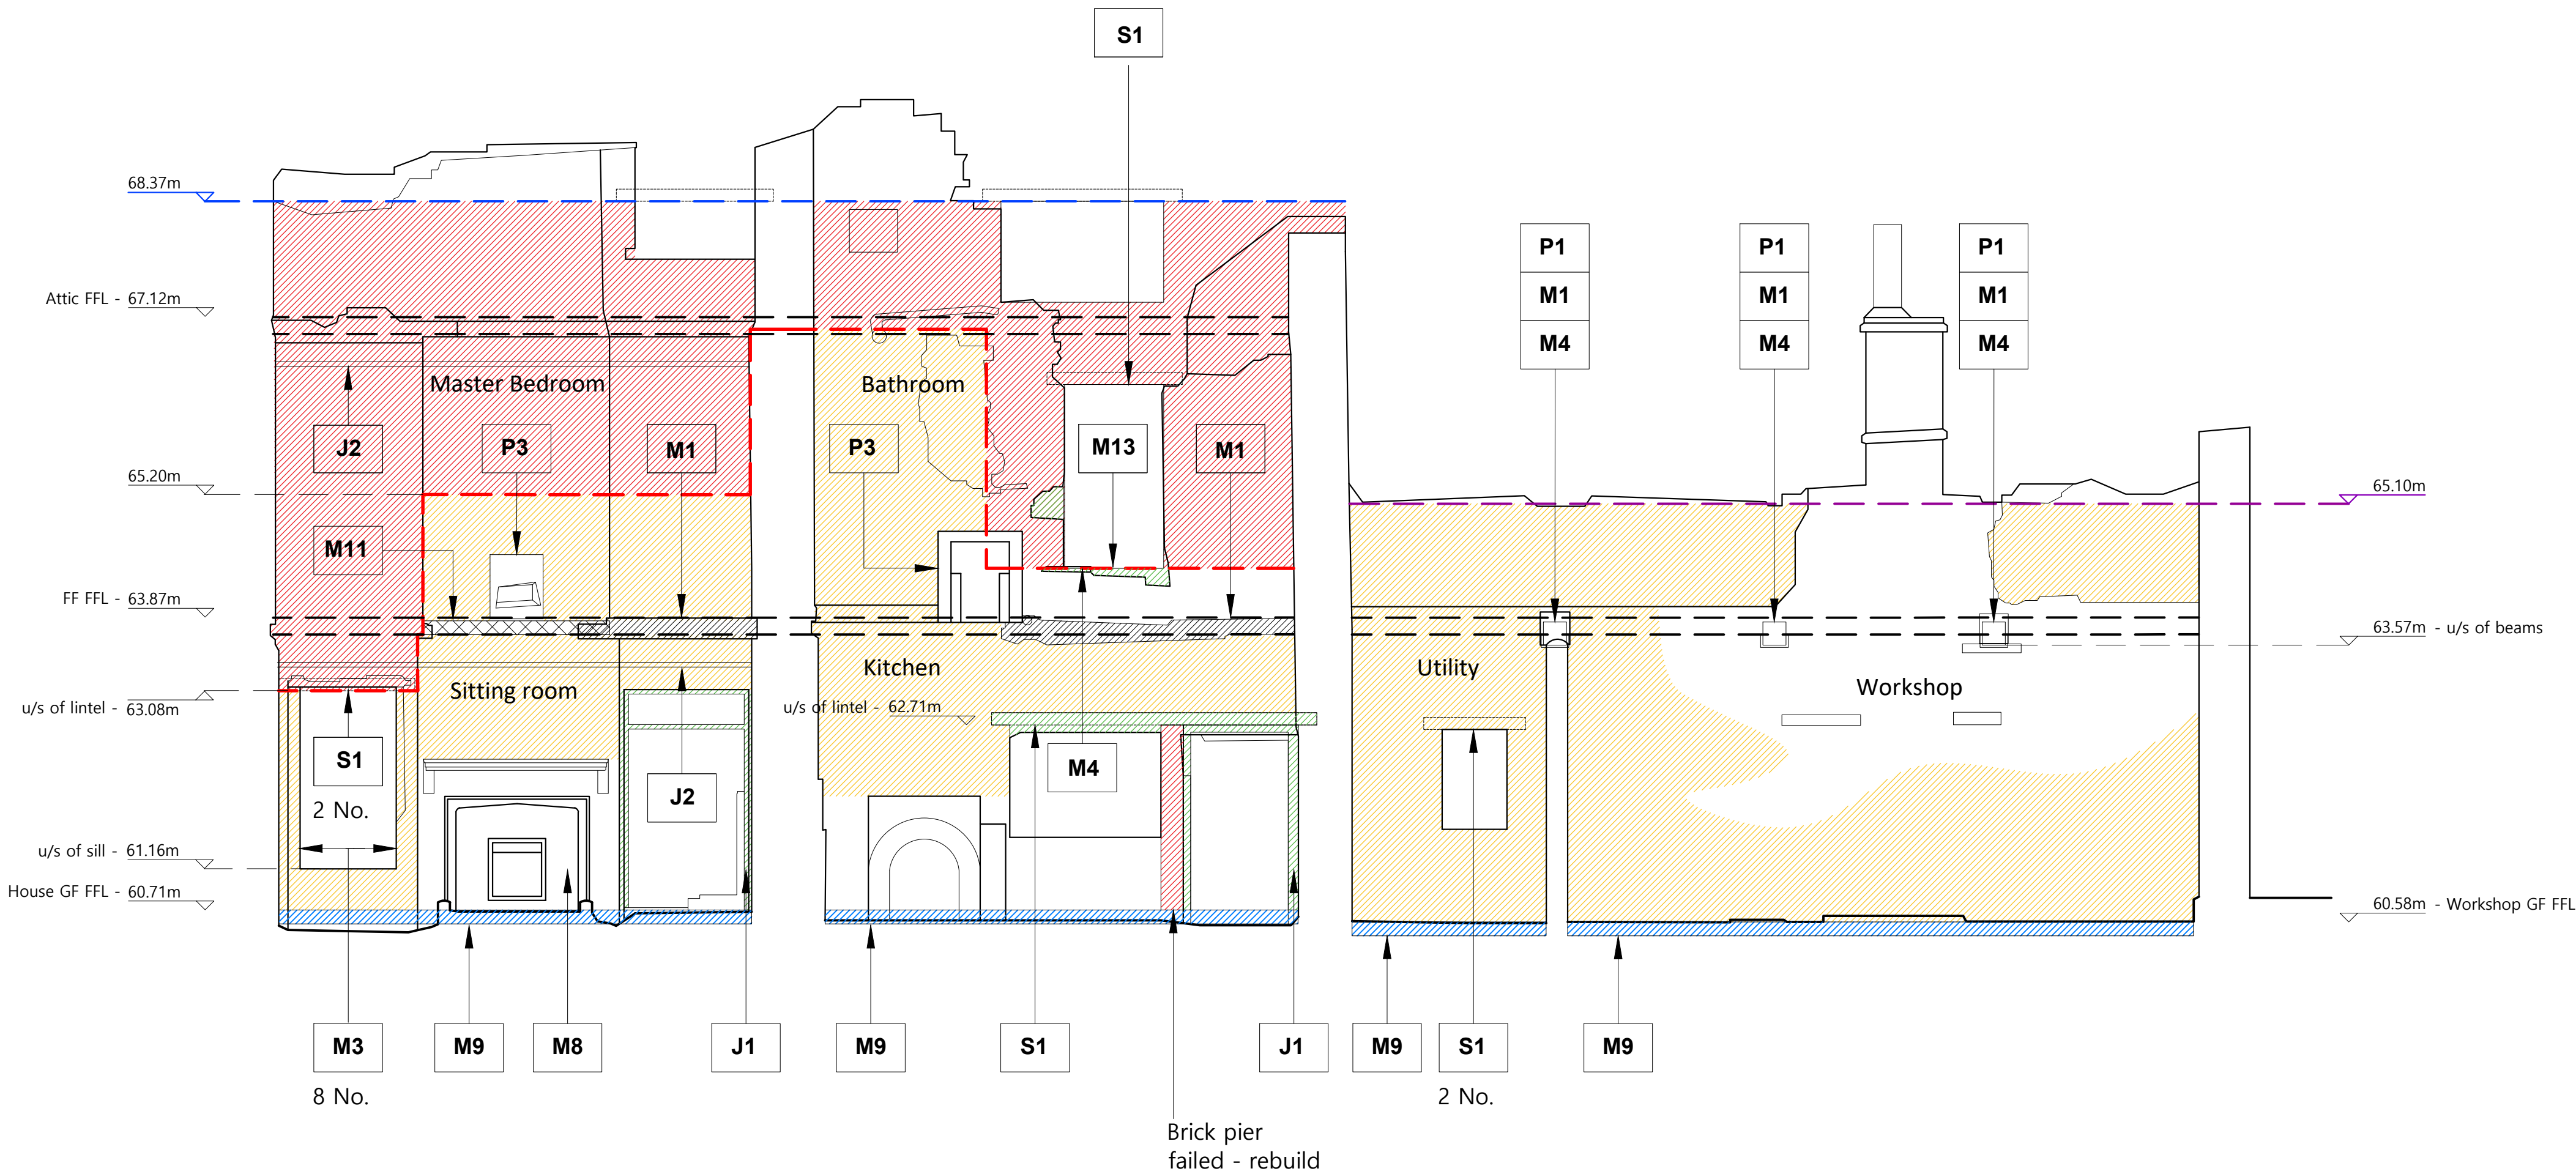
1.0 IE2 - Internal West Elevation

Make good hole around old beam/joist opening
- M2

Infill masonry to depth of wall
- M3

Replace timber bearers in brick wall with masonry
- M4

Replace timber bearers in masonry wall with brick
- M6

Rebuild masonry wall
- M8

Repair stone fireplace
- M9

New limecrete floor
- M11

Form new constructional hearth
- M13

Rebuild sill

New plaster boxing to replicate historic casing
- P2

Remove plaster, carry out deep re-pointing of masonry below 50mm deep
- P3

Flue ventilated and fireplace plastered over

Replace timber lintel - see Structural Engineers' details

New door and frame
- J2

Picture rail reinstated
