PROJECT Idover Demesne Farm

DRAWING STATUS Planning/LBC

DRG TITLE IE3 Long Section - Repairs

JOB/DRG No. 381 / 313

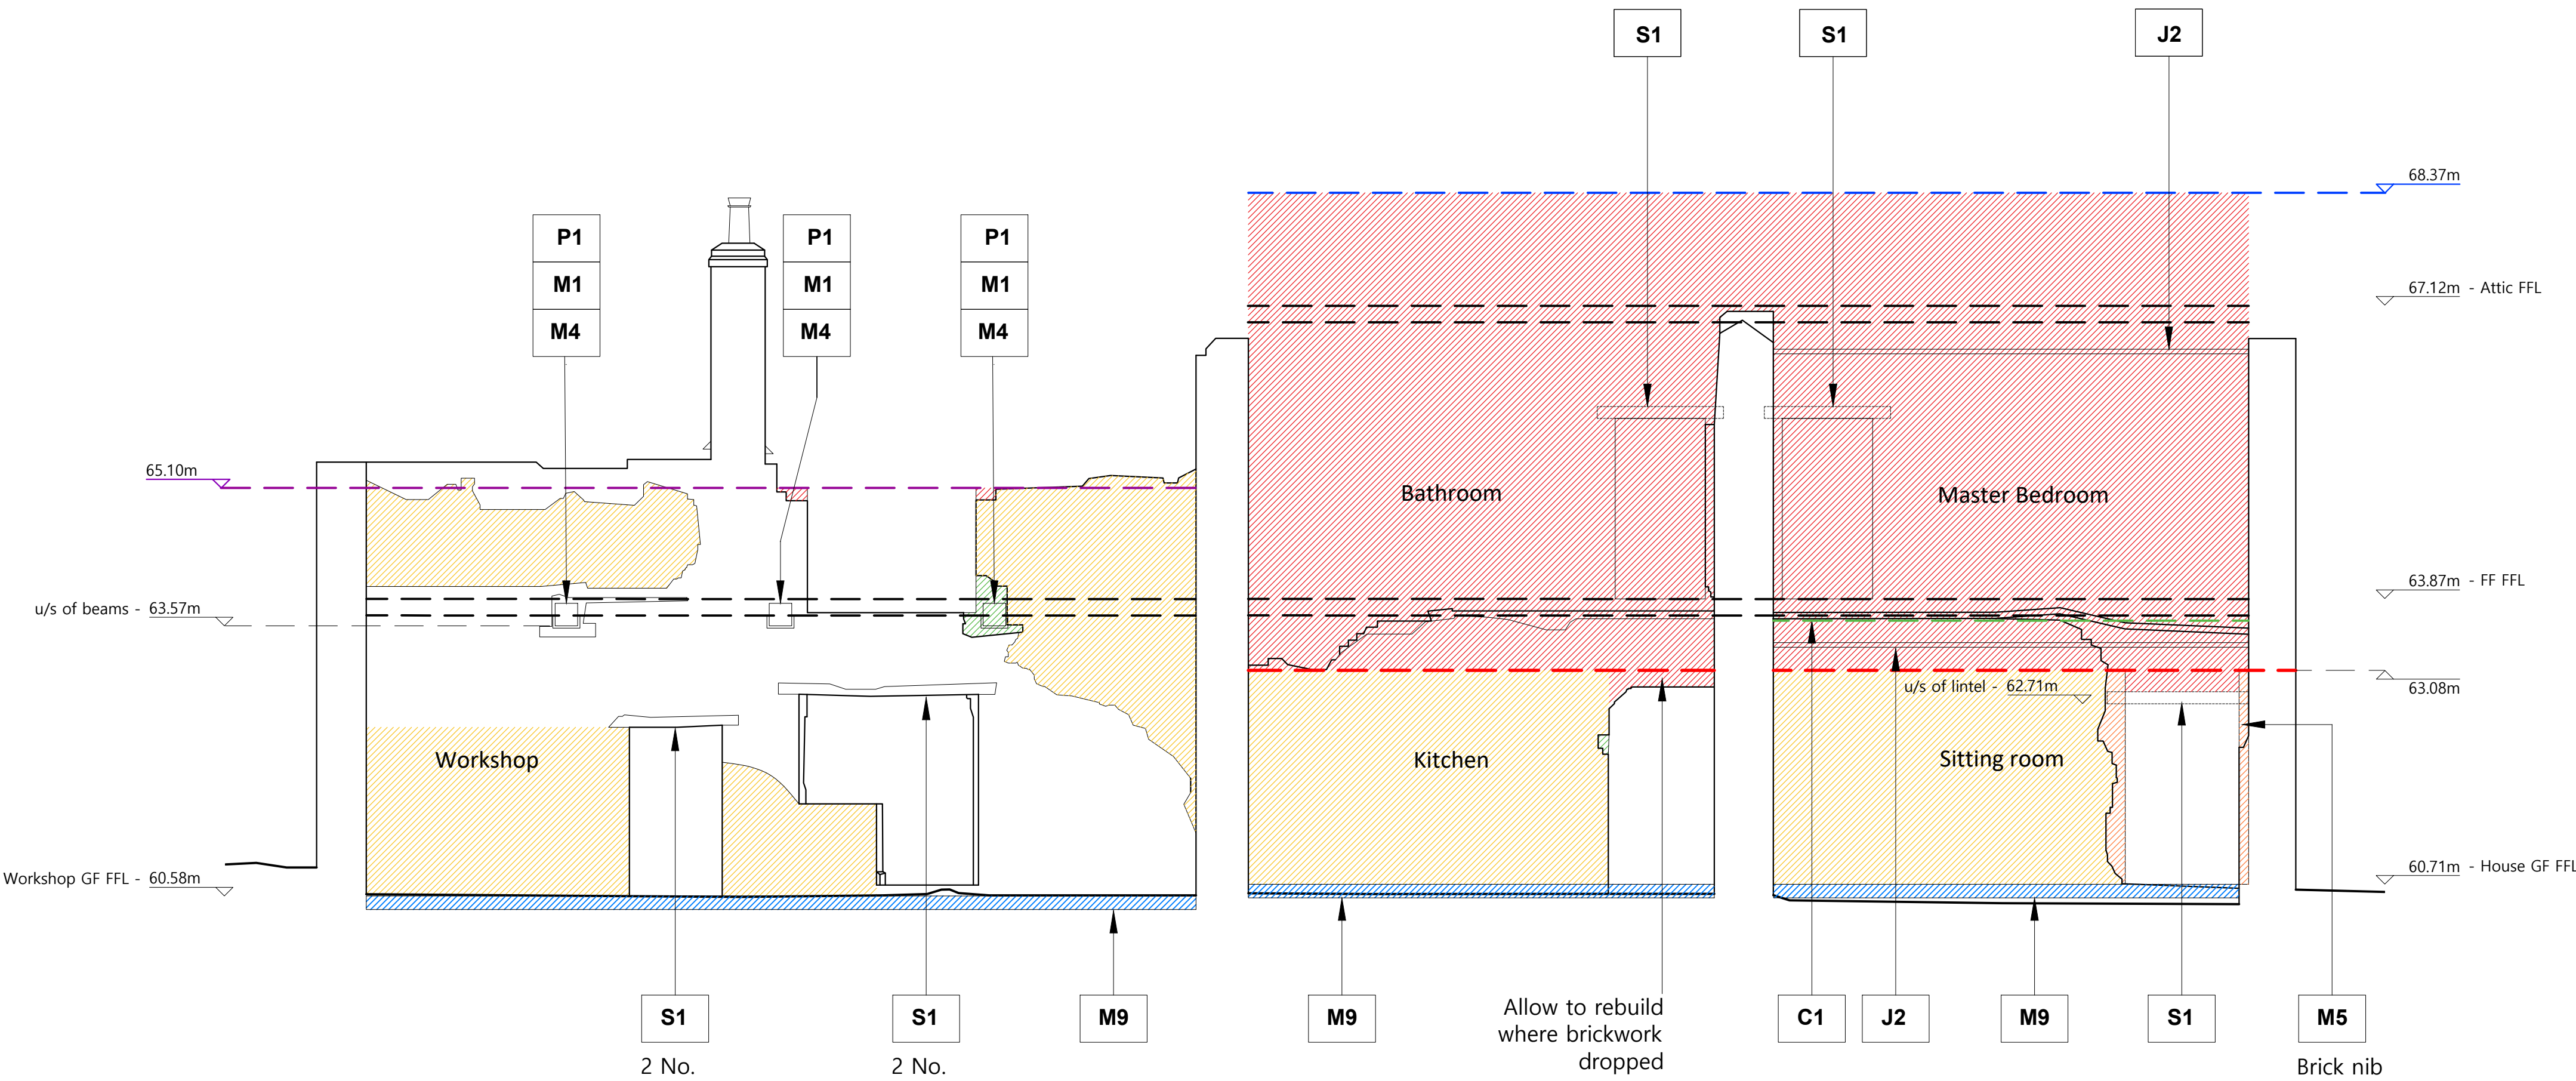
1.0 IE3 - Long Section

Make good hole around old beam/joist opening
- M2

Infill masonry to depth of wall
- M4

Replace timber bearers in masonry wall with brick
- M5

Reform brick wall and opening
- M6

Rebuild masonry wall
- M9

New limecrete floor

New plaster boxing to replicate historic casing
- P2

Remove plaster, carry out deep re-pointing of masonry below 50mm deep

Replace timber plate

Replace timber lintel - see Structural Engineers' details

Picture rail reinstated
