**Batts Farm, Install a new window in an  
old bricked-up door opening**

**Drawing 2: Section through old  
doorway**

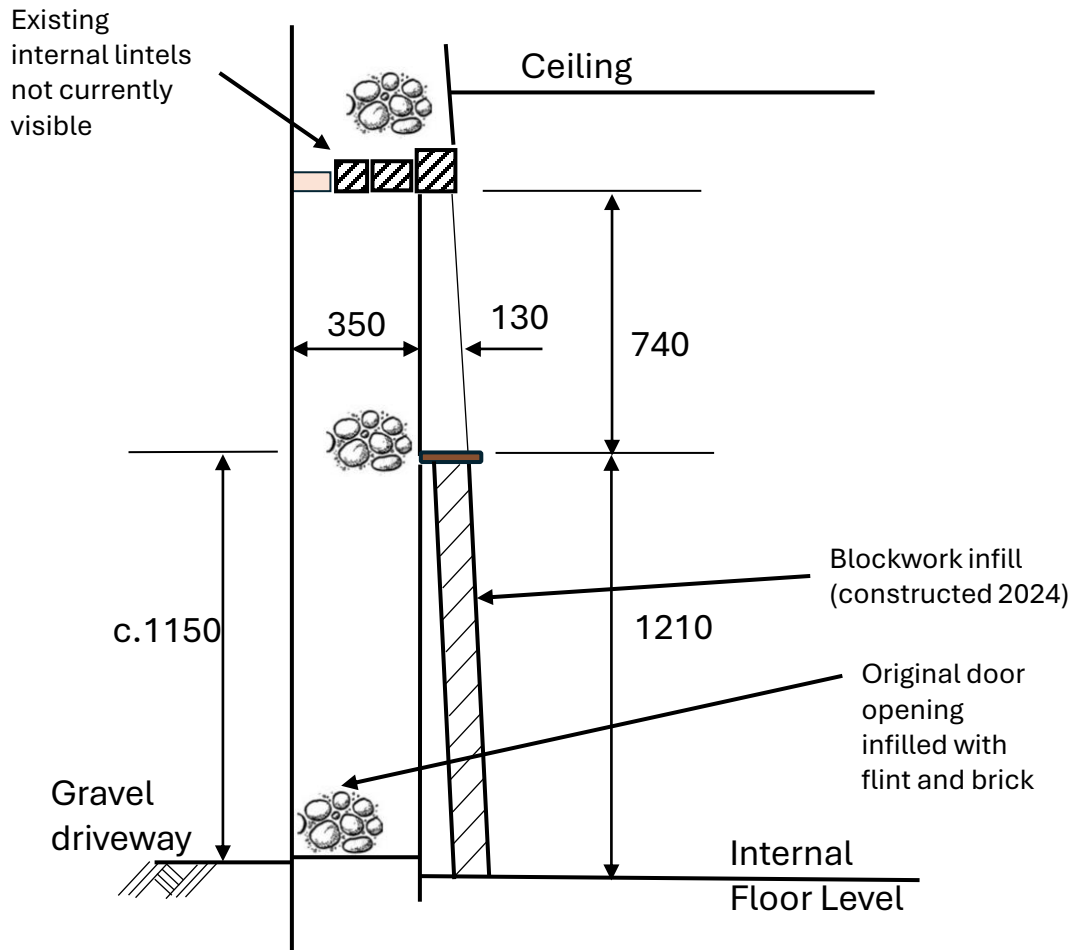
**Section through existing infilled doorway  
(Scale 1:20)**

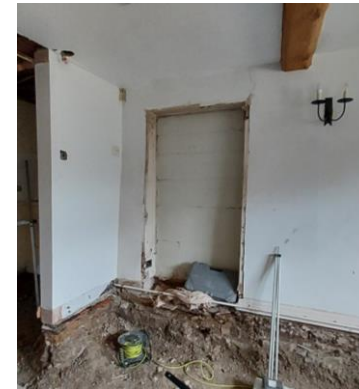
**Original door opening  
exposed during renovations in  
2024**

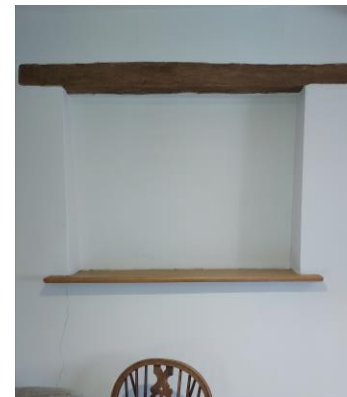
**Door Opening in 2026  
- bottom half of door has been filled  
in to form opening for a future  
window**
