# **BS5837 Tree Survey and Arboricultural Impact Assessment at**

**Highwood, Lowden Hill Chippenham SN15 2BT**

**On behalf of International Design Group**

**18<sup>th</sup> September 2025**

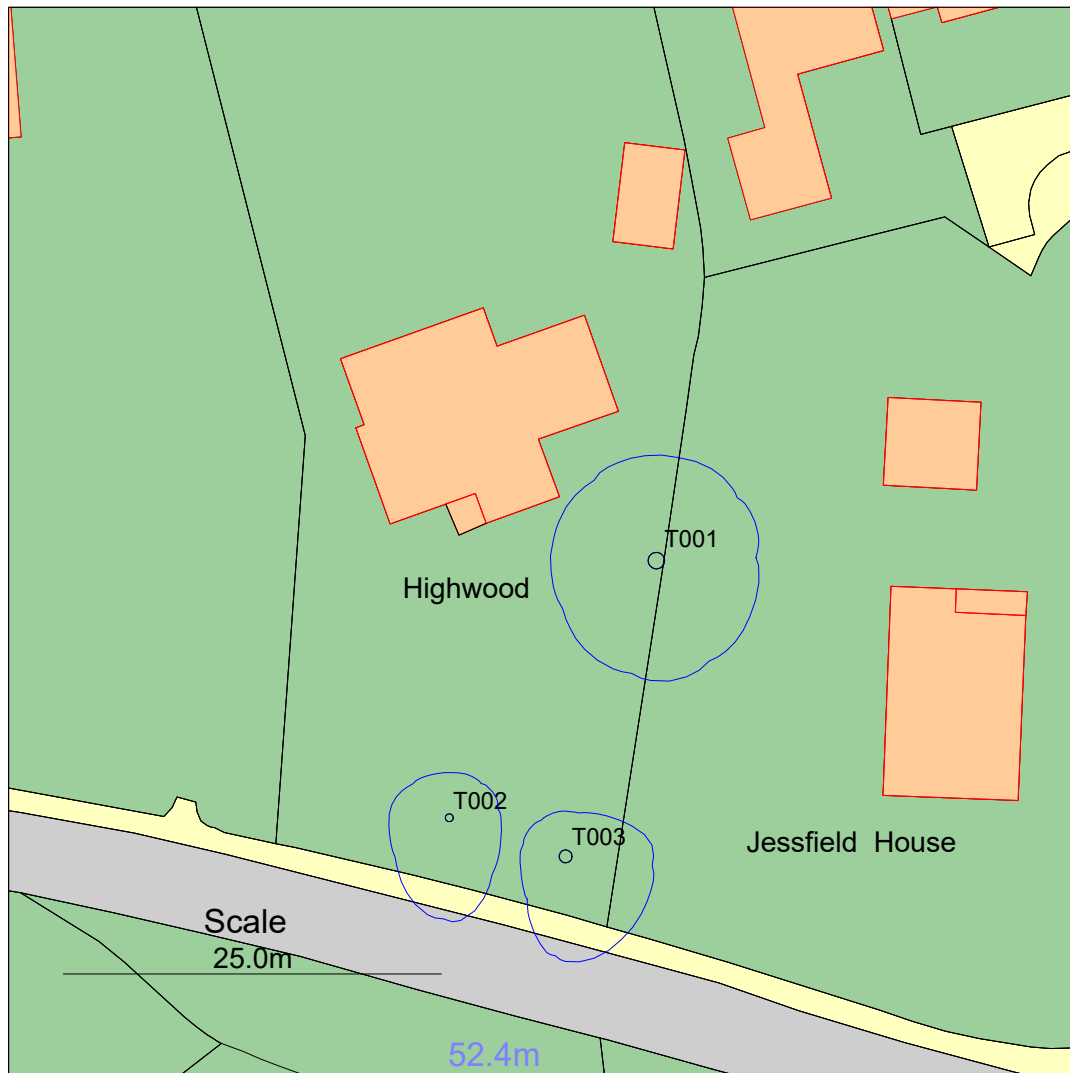
Highwood Tree Location Plan

- 3.1. The site is within the curtilage of Highwood Lowden Hill Chippenham SN15 2BT. The site is bordered by closed board fencing on the East. The area immediately to the south of the planned structure is a retaining wall which then drops down to the public road and pavement. To the west is the driveway from the public road which leads up to the house which is N/NW of the planned development.
- 3.2 The tree locations are shown on the Tree Location Plan (Appendix 4)

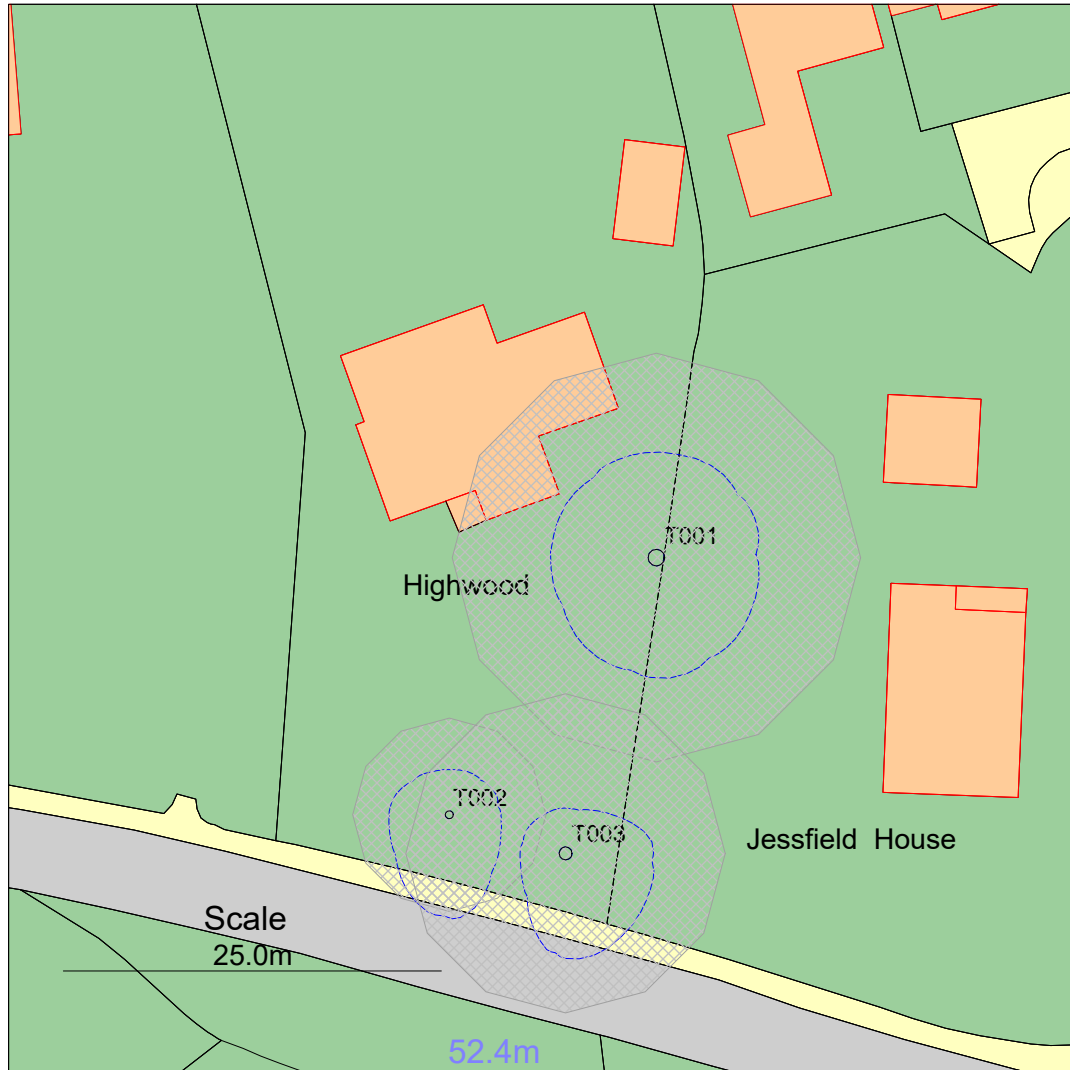
Highwood Tree Root Protection Areas

8.1. The proposed development encroaches into the RPA of T1, T2 and T3. Therefore, non-traditional foundations must be employed.

The plan located to the rear of this report shows the approximate extent of Root Protection Areas (RPAs) marked in grey hatching. The RPAs have been calculated in accordance with the methodology set out within Appendices C and D of BS5837: 2012, using the stem diameter dimensions obtained during the site visit.

To minimise the impact upon T1, T2, T3 ground screws, piles or steel sleeved mini piles must be used to reduce the potential impact (excavation/root severance, compaction, removal of water source) upon the retained tree roots.

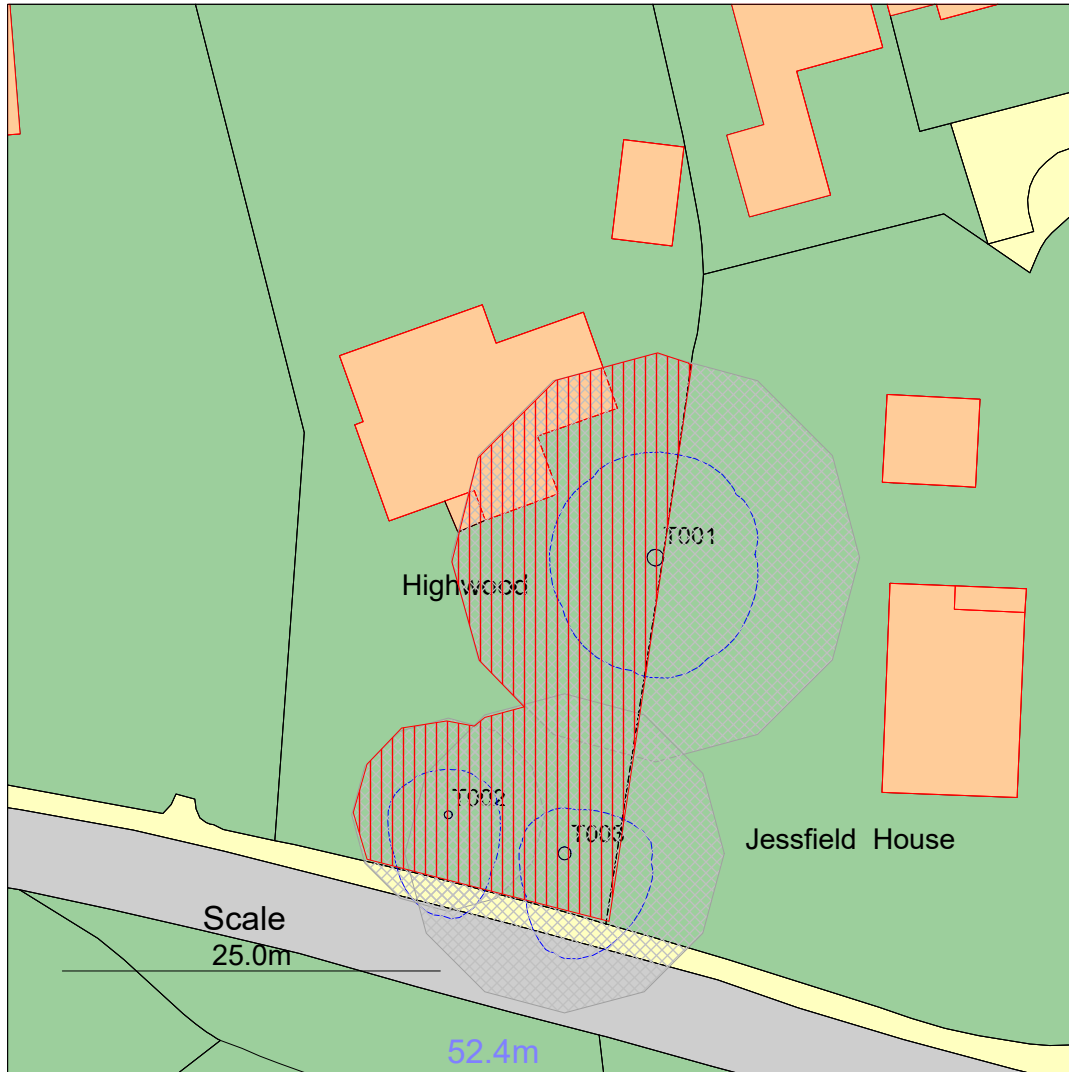
Highwood Tree Protection Plan

9.1. The arboricultural features of the site are to be retained and tree protection measures must be utilised to minimise the impact of the proposals upon the trees. The principles and details of the Arboricultural Impact Assessment Appendix 1: Method Statement and Appendix 6: Tree Protection Plan must be followed to reduce the impact upon the retained trees.

10.1. Following any permission from the Local Planning Authority, the principles and details of the Arboricultural Impact Assessment Appendix 1: Method Statement and Appendix 6: Tree Protection Plan are followed to reduce the potential for harm to the retained trees during development.

4. Ground protection must be used to access the site across the RPA of retained trees and installed prior to works commencing. Ground protection must be maintained for the duration of any demolition or construction works and considered sacrosanct and must not be removed or altered without prior recommendation by an Arboricultural Consultant and written approval by the LPA.
