## **DESIGN AND ACCESS STATEMENT**

Goulters Mill, Nettleton, Wiltshire, SN14 7LL

January 2026

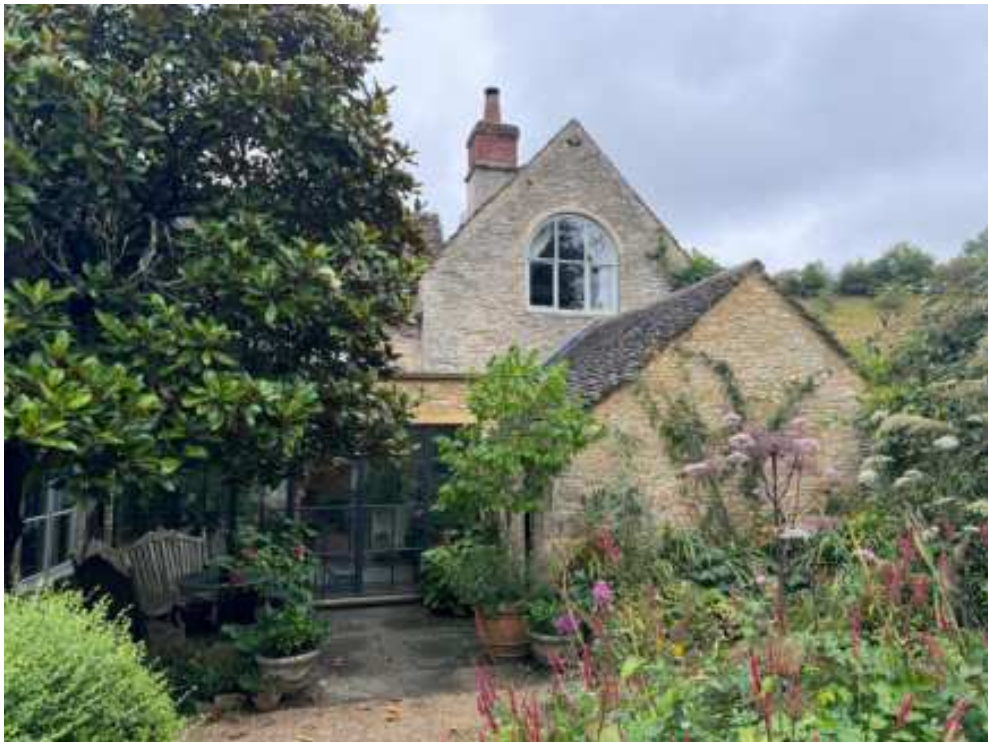
**Image 1.3** – View of existing arched window on barn gable

The extension design uses the existing southern most building [formerly a barn] as its design brief and reflects the gable end design with a smaller arched window set into a dormer [see images]. The new north facing elevation will be double gabled with a small lead roof section between.

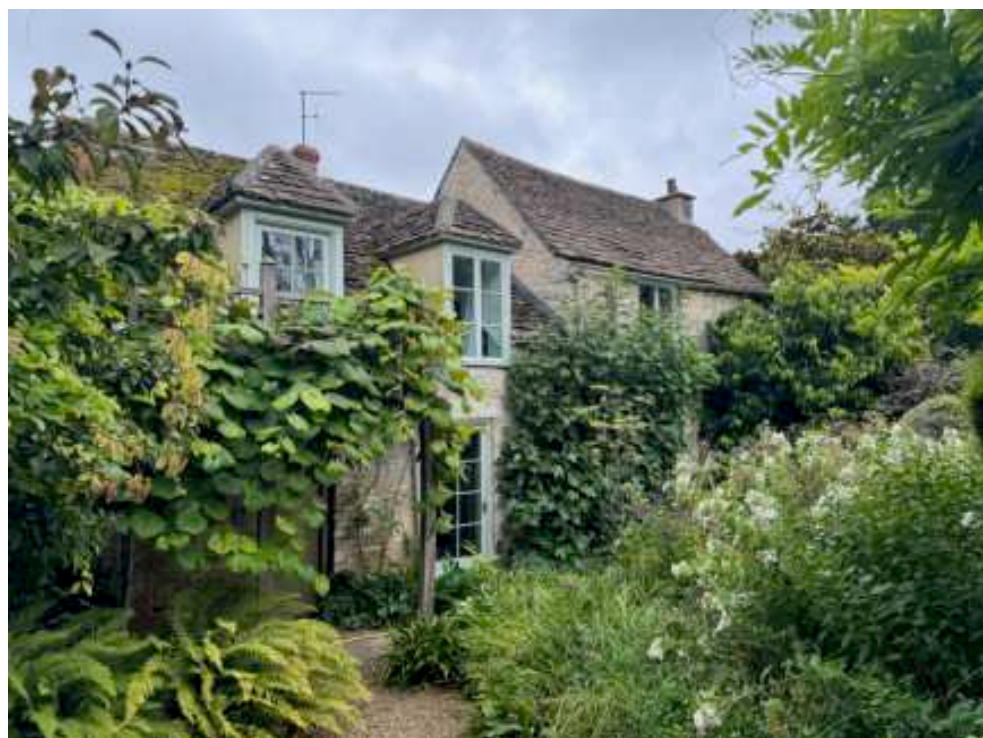
**Image 1.4** – View of garden elevation, nearest building roof line to be raised.

The design involves removing the roof of the existing end building, raising the walls and roof to finish 150mm below the retained roof levels. This enables the internal first floor level to be raised to level with the other internal floors and allows the internal ceiling height of the new ground floor sitting room to be raised from 2080mm to an acceptable height of 2400-2600mm depending on site constrictions.

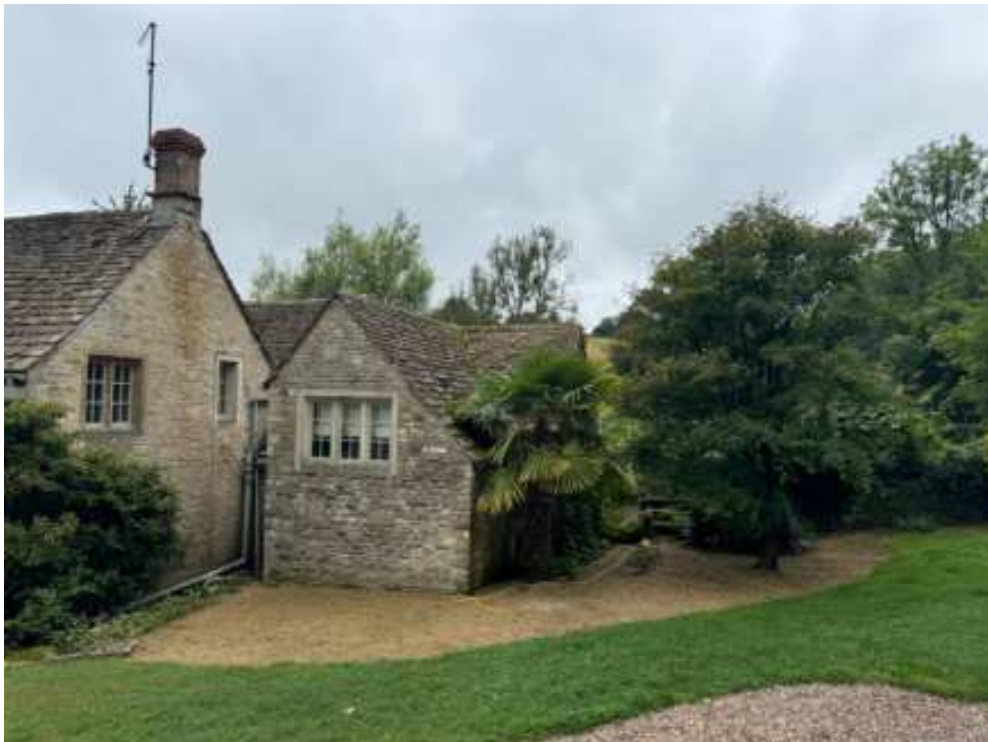
**Image 1.5** – View from farmyard showing building to be raised and enlarged.

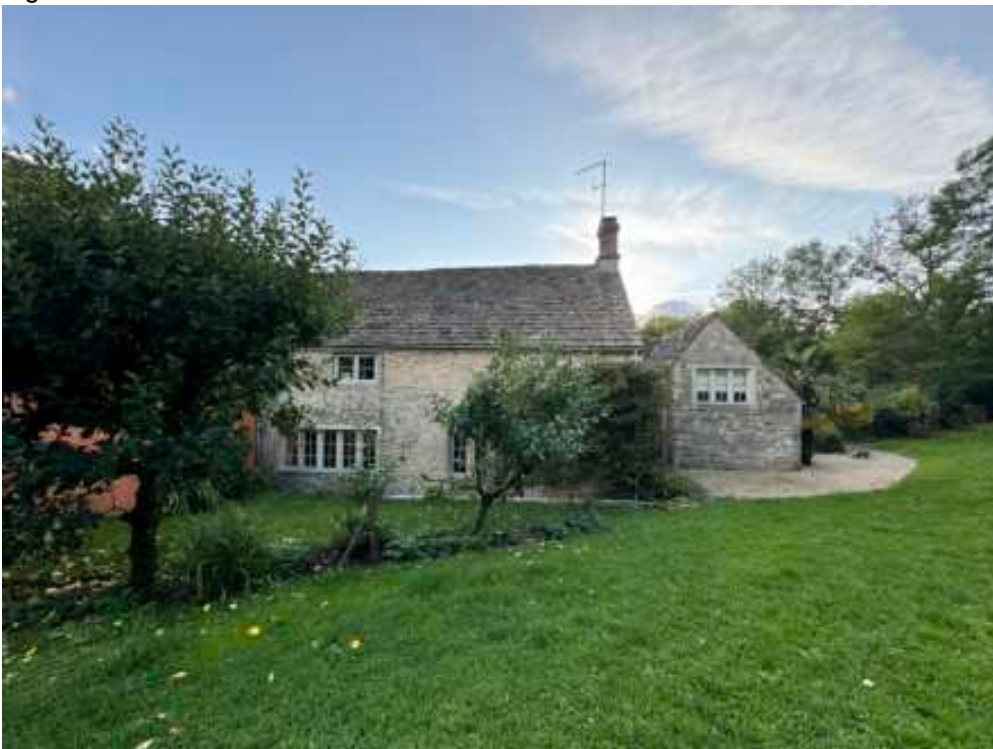
**Image 1.6** – View of central section of house, roof line to be continued on new extended building

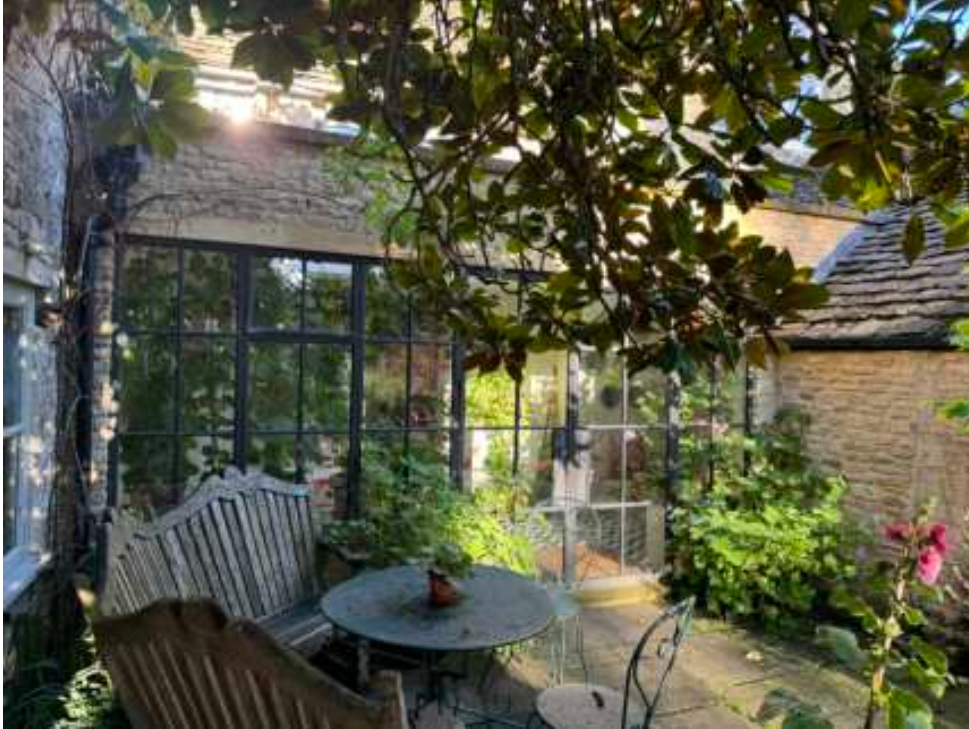
**Image 1.7** – Conservatory built in 2017/8

The last new work to the house was in 2017 and included an 2 storey rebuilding of a bathroom and new bootroom [see the orange lime rendered element seen in images] and the rebuilding of the conservatory opening onto the garden [see images]. See Full Planning Consent 17/05188/FUL.

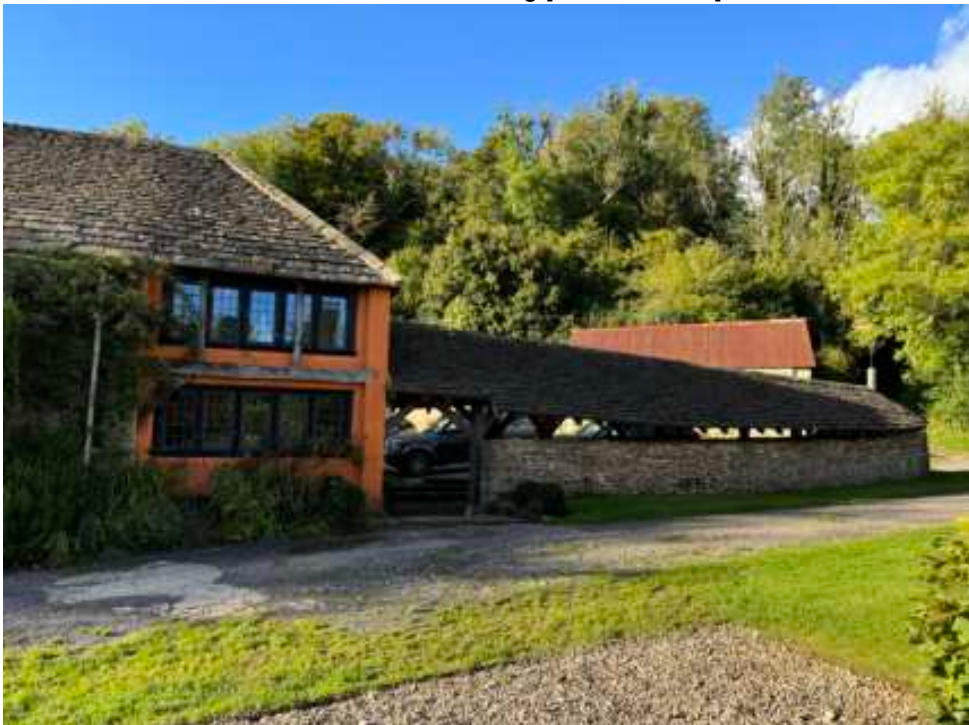
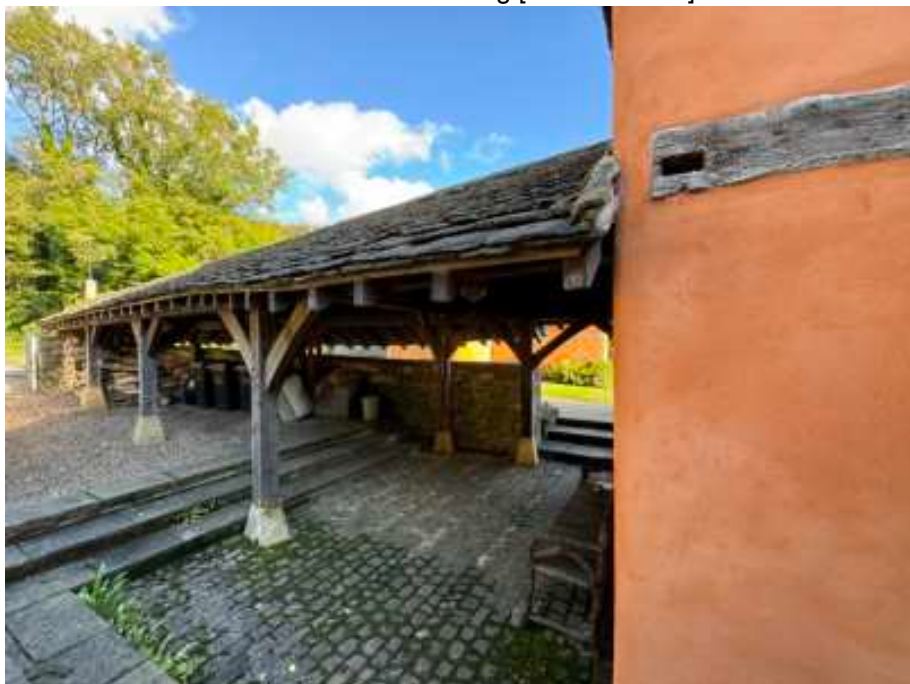
**Image 1.8** – Oak framed structure and infill building [in lime render] built in 2017/8

**Image 1.9** – Oak framed structure and infill building [in lime render] built in 2017/8
