Our Ref: 18067/EO/RPT/06/01  
Date: July 2025

**Re: 18067 – Old Manor Farm, Wedhampton, SN10 3RR – Barn 6**

## **Summary:**

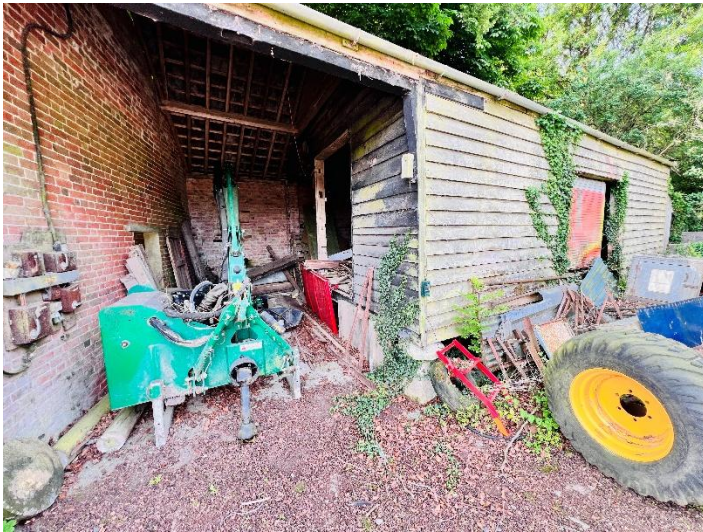
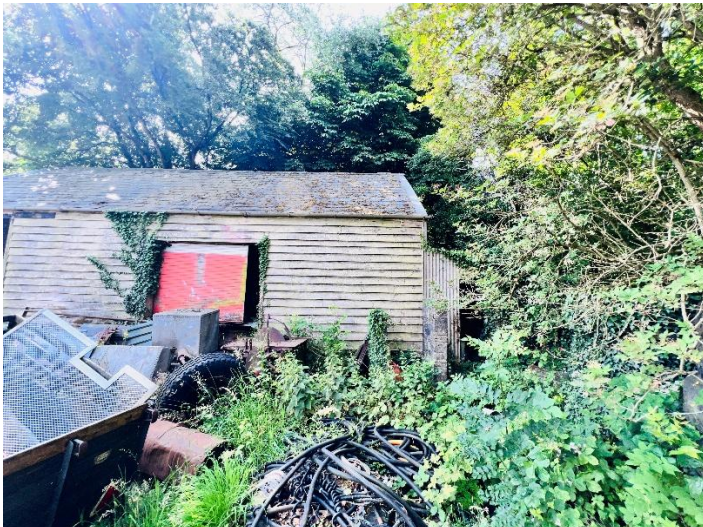
The existing building structure is an agricultural barn consisting of a duo-pitched roof, supported on a masonry wall at the rear and a series of timber posts to the front elevation. The roof is formed of common timber rafters, which span onto purlins, which in turn span between principal timber trusses. The wall at the rear is of solid brick construction. The ground floor is a stepped concrete ground-bearing slab, which appears to be of adequate construction to sustain the loadings associated with heavy-duty agricultural loadings.

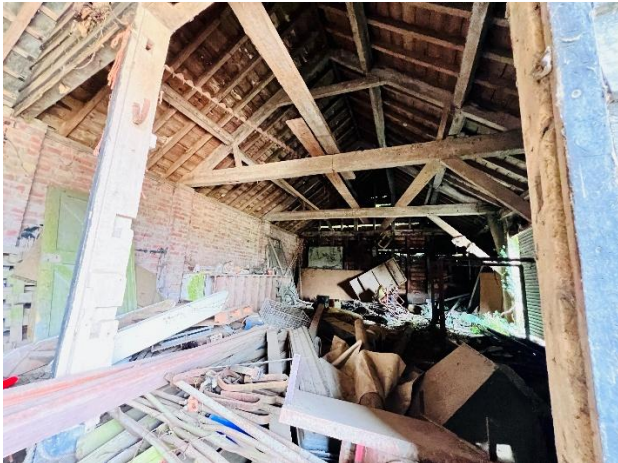
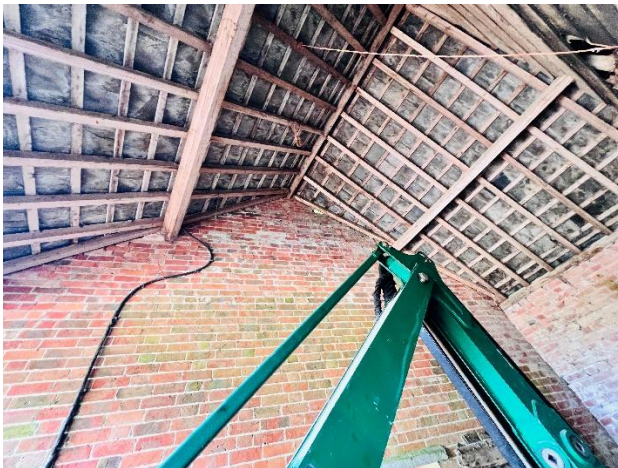
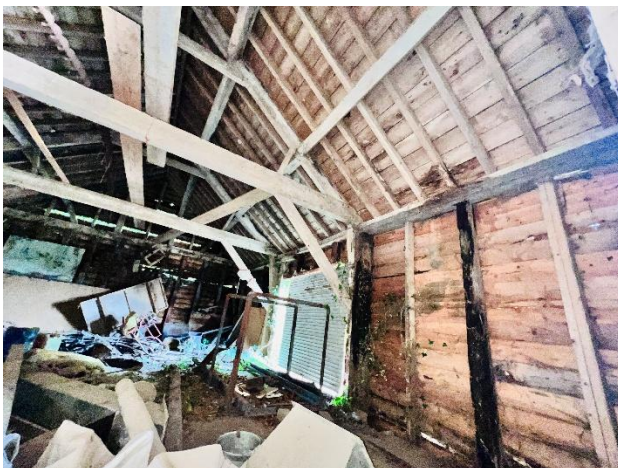
The timber framing at the front elevation was seen to have deteriorated; the supporting timber post was seen to be damaged and rotting at its base, and should be replaced with a like-for-like timber.
