16 January 2026  
**Our Ref:** WT 122-25 AIA

**Re: Tree information relating to planning application at 75 Bulford Road, Durrington, Salisbury, SP4 8EU**

## **Appendix 1 - The Tree protection Plan WTP1:** Illustrating tree protection and management proposals

DRAWING NO: **WTP1**  
DRAWING TITLE: Tree Protection Plan

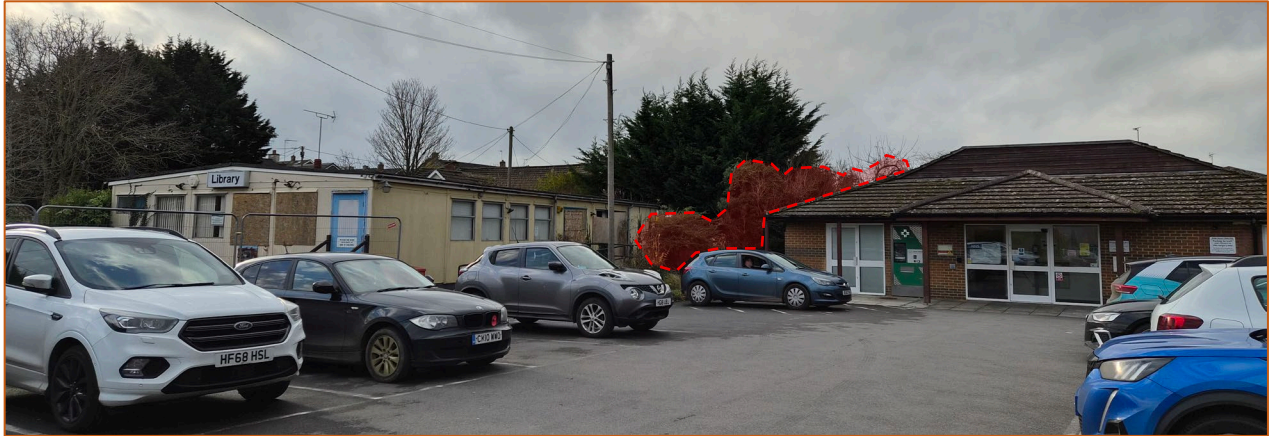
**Image 1:** T001, T002 and T003 (indicated by the red annotation) do not provide any significant amenity when viewed from outside the site boundaries

appropriate, provided necessary mitigation options to minimise harm to their health and amenity value. To facilitate the proposal, three large shrubs (T001, T002 and T003) will need to be removed. However, they are all low-quality (BS5837 category C) that do not offer any significant amenity when viewed from outside the site (Image 1). In this case, the retained cypress trees behind will easily buffer these losses and continue to provide useful cover for the rear boundary.

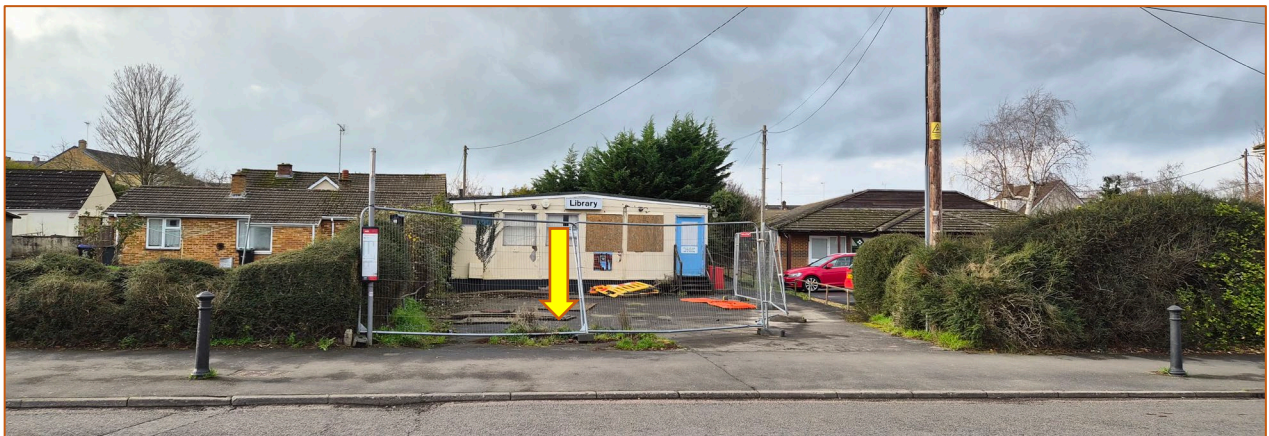
**Image 2:** Materials can be delivered to the front of the site and stored on the existing hard standing

The main construction works are all outside the RPAs of the boundary trees so there is unlikely to be any adverse effects on trees from construction works. Materials can be delivered to site using the existing access and there is plenty of space to store and move them to the working areas, with no significant harm to trees (Image 2).

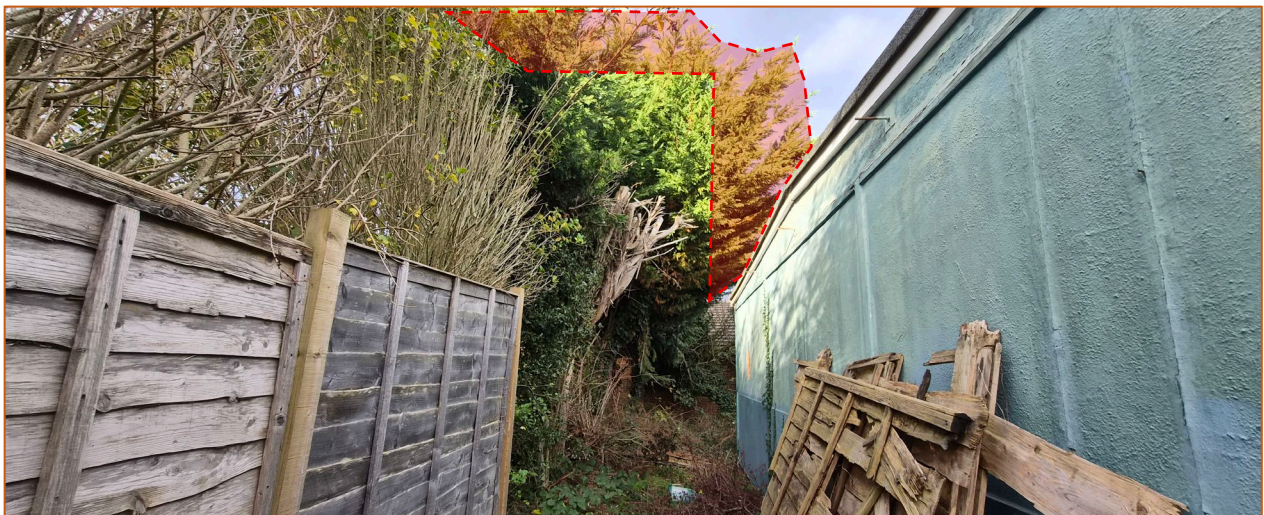
**Image 3:** There is scope to maintain the existing hedge/boundary cover by reducing and maintaining the height and sides

**Post occupancy pressures on trees:** The location and character of the proposal has been achieved in consideration of all the site factors, including the presence of trees. In reference to BS5837:2012 recommendations paragraph 5.3.4 and its sub paragraphs, any issues relating to shading, privacy and screening, direct damage, future pressure for removal and seasonal nuisance have been factored into the design to minimise any post occupancy pressure on trees. In this case, the proposal has been designed so that the new structures will be further from the trees than before to provide reasonable garden space at the rear of the property. If more room is required by the new occupants, there is further scope to maintain the existing hedge/boundary cover by reducing and maintaining the height and sides (Image 3). In taking a balanced approach, this is unlikely to adversely affect their health or current amenity value, and these trees will continue to provide screening whilst still allowing new occupants to have normal use of their property. In the context of all these points, I believe that the development proposal is unlikely to bring new pressures on these trees.

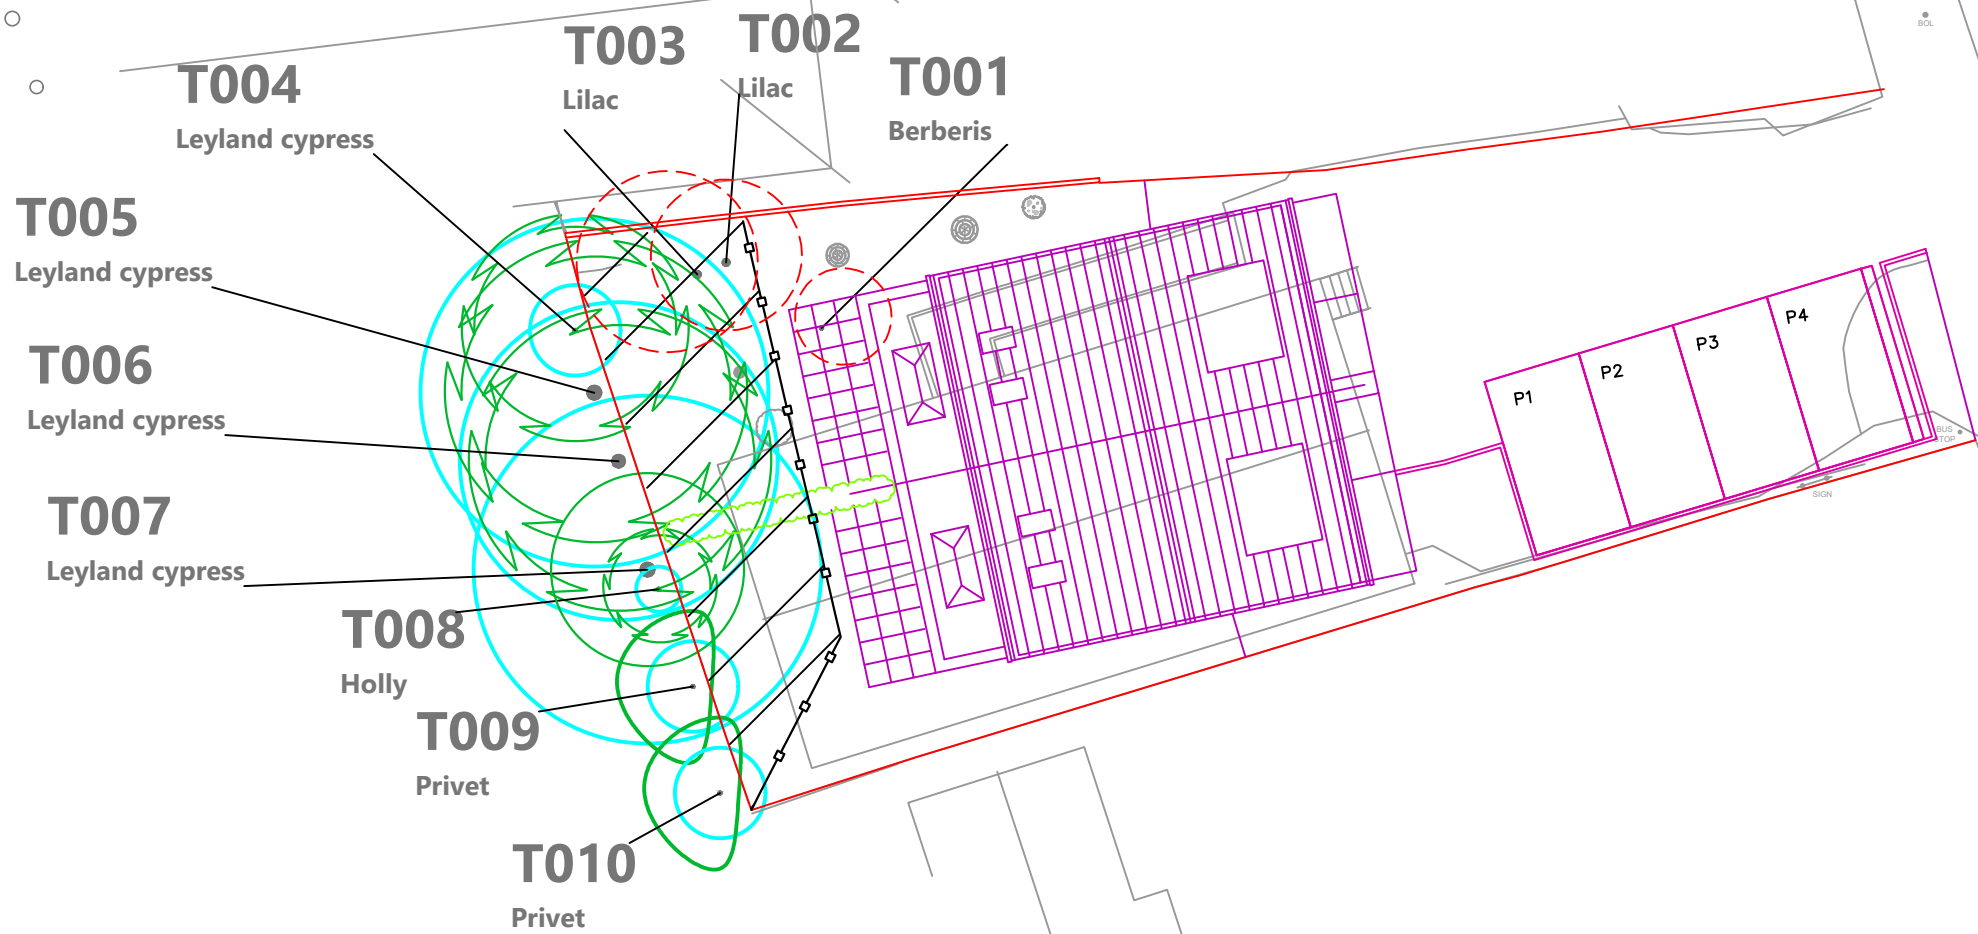
LOCATION OF TREES, CATEGORISATION & DEVELOPMENT AT:  
75 Bulford Road, Durrington, Salisbury, SP4 8EU

I enclose plan WTP1, which is an adapted version of the plan provided by Larkham Design, (drawing number 934 – New Proposals - RevA). It has been annotated to identify all the relevant trees and show the areas where appropriate tree protection applies. This plan is illustrative, and the precise location of protective measures may need to be modified in the context of the site conditions at the time of implementation.

**Collection of tree information:** I inspected each tree and have indicated the numbering on the tree protection plan (WTP1) in Appendix 1. For each tree, I collected information on species, height, diameter, maturity and potential for contribution to amenity in a development context. As advocated in BS 5837, each tree was then allocated to one of four categories which reflected its suitability as a material constraint on development:

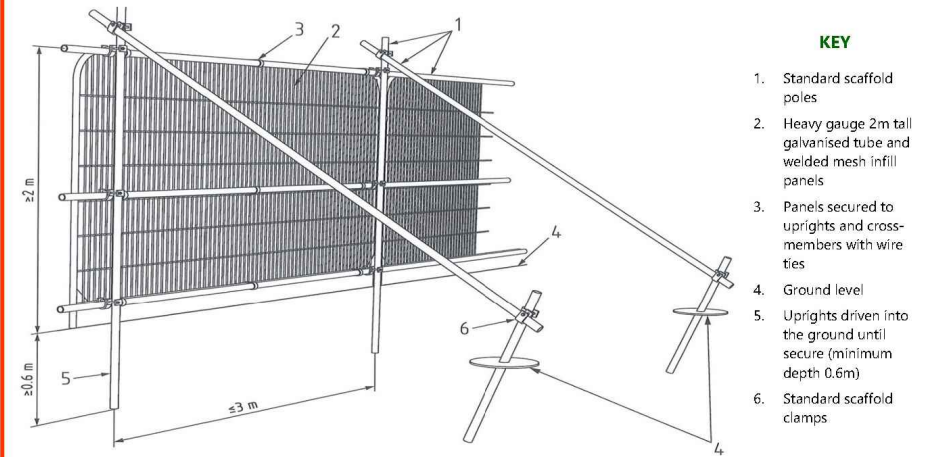
Extract from BS5837: 2012 Figure 2—Default specifications for tree protective fencing.

Protective barriers are not to be moved without written consent from the Local Planning Authority (LPA) and any adjustments should be under direct supervision of the project Arboriculturist to maintain the Root Protection Area (RPA) of each tree. No materials, chemicals, machinery or vehicles must be stored within the protected area as defined on the Tree Protection Plan.

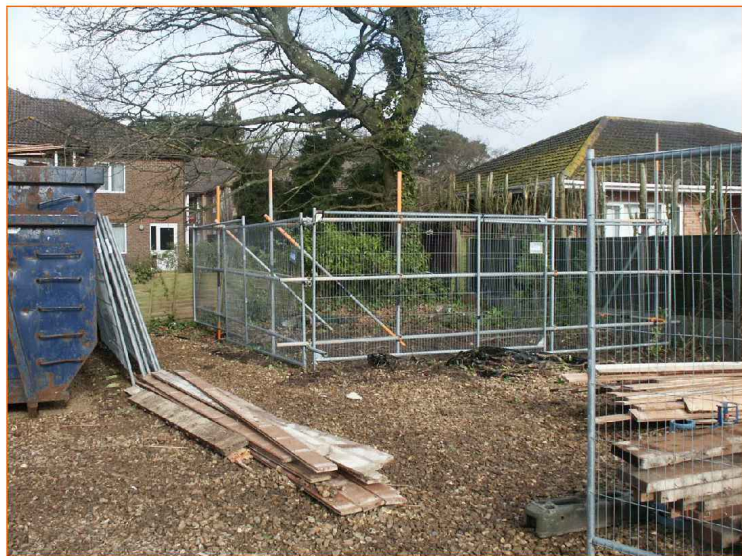
Image 1: Scaffold and Heras panels can provide standard protection that is fit for purpose.

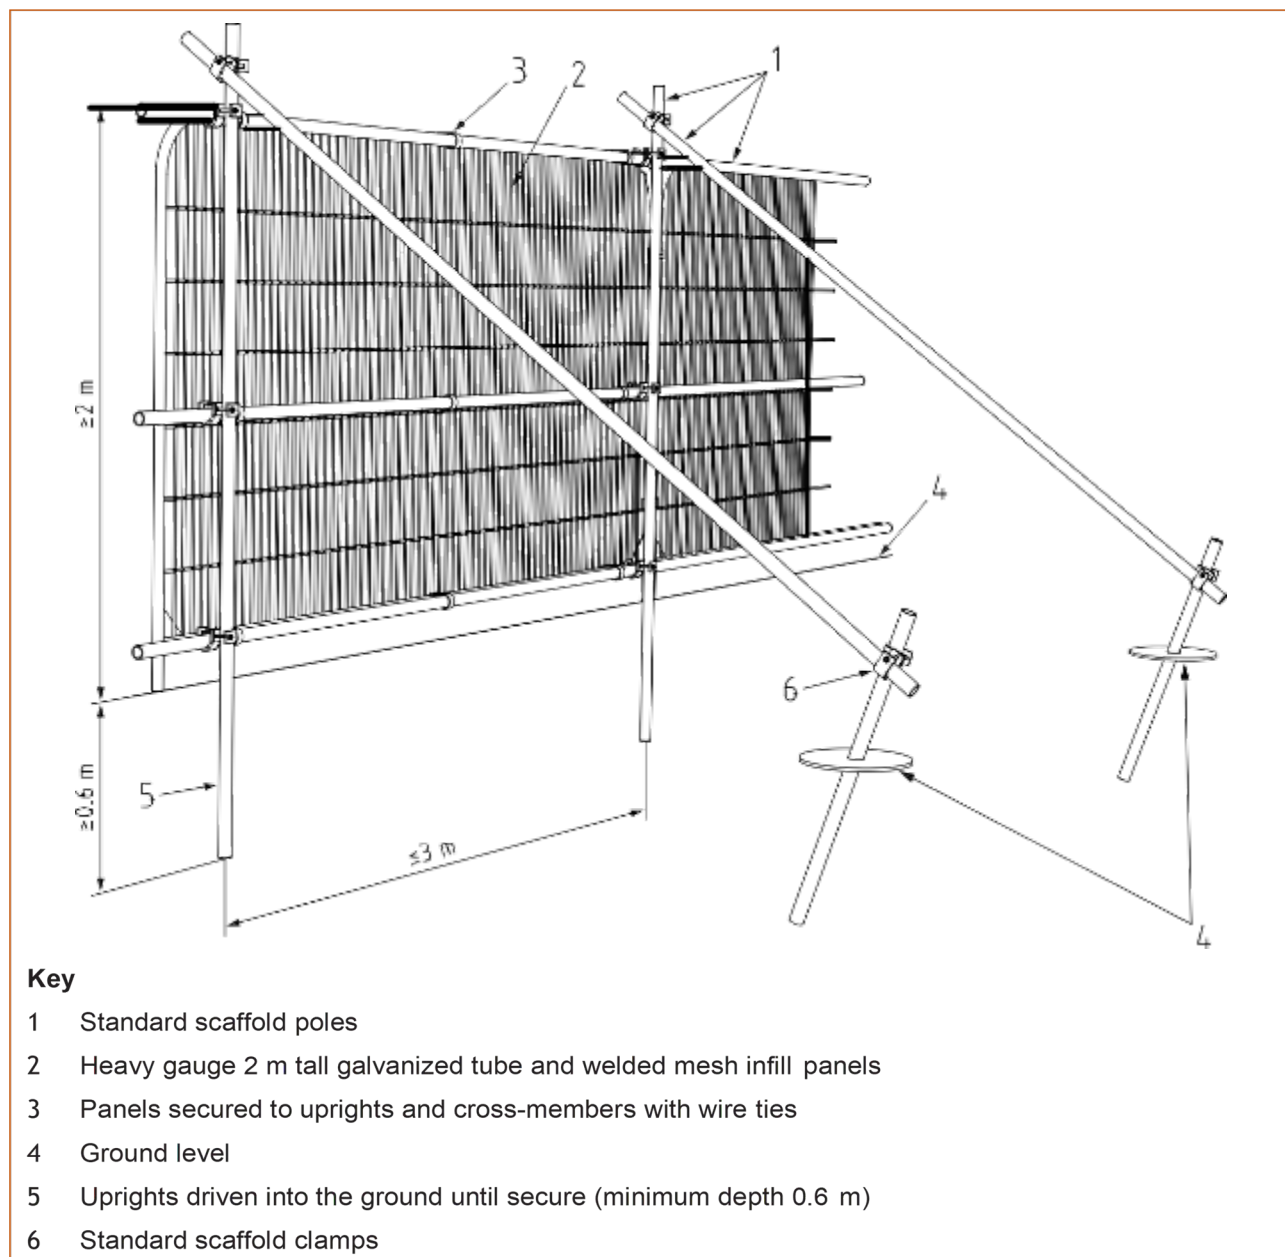
Extract from BS5837: 2012 Figure 3: Examples of above-ground stabilizing systems

**Installing Barriers:** Tree Protective barriers must be fit for purpose, and once installed must not be moved without written consent from the Local Planning Authority (LPA). If it is absolutely necessary for any adjustments, they should be under direct supervision of the project Arboriculturist to maintain the Root Protection Area (RPA) of each tree. No materials, chemicals, machinery or vehicles must be stored within the protected area as defined on the Tree Protection Plan. On this site, all exposed rooting areas should be protected by barriers (while vulnerable to damage), in accordance with BS 5837 figures 2 and 3 below until there is no risk of damage from the development activity. This work should be subject to arboricultural supervision.

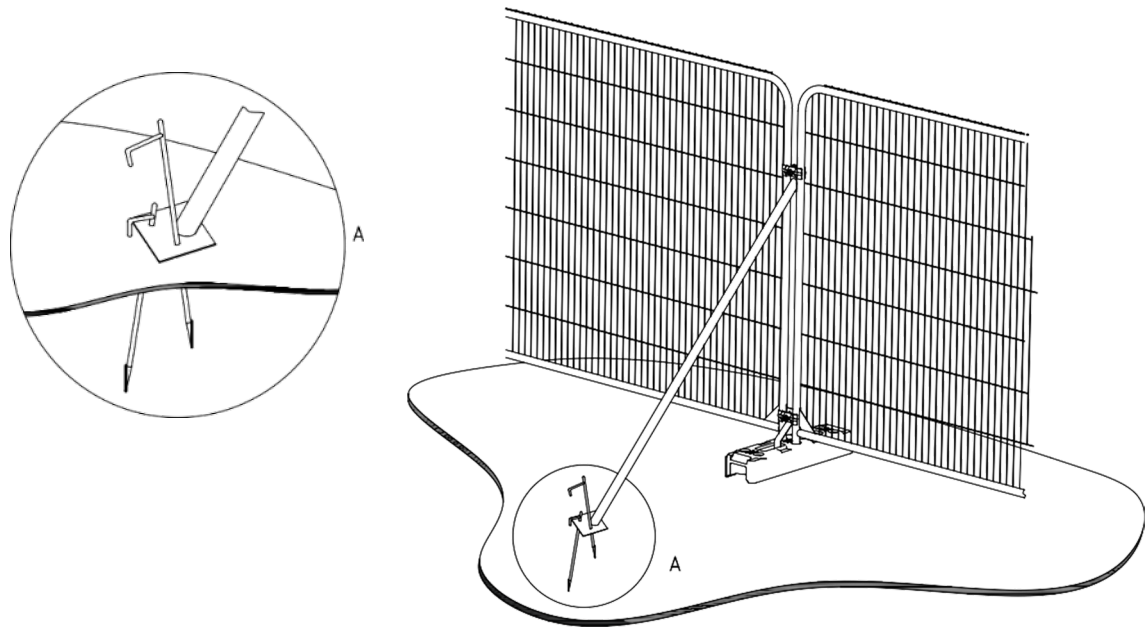
a. Stabilizer strut with base plate secured with ground pins

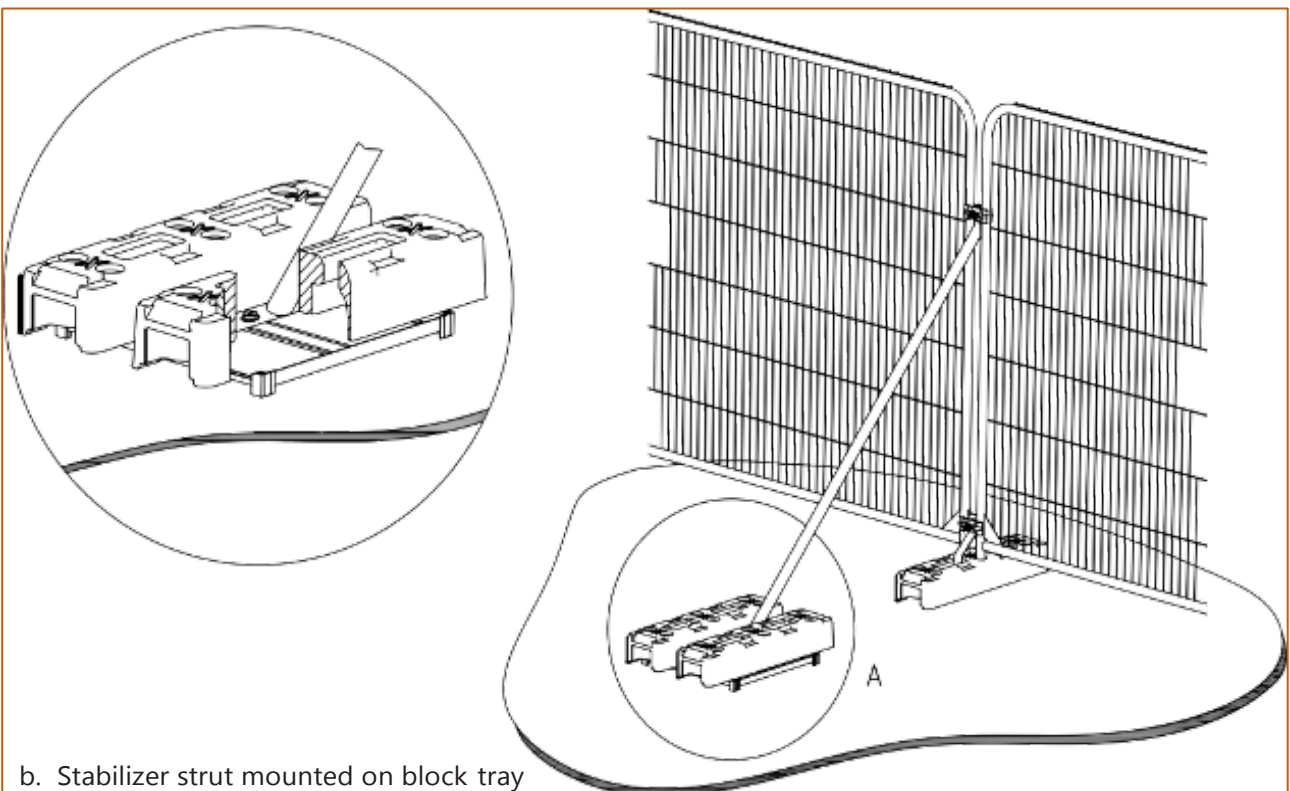
b. Stabilizer strut mounted on block tray

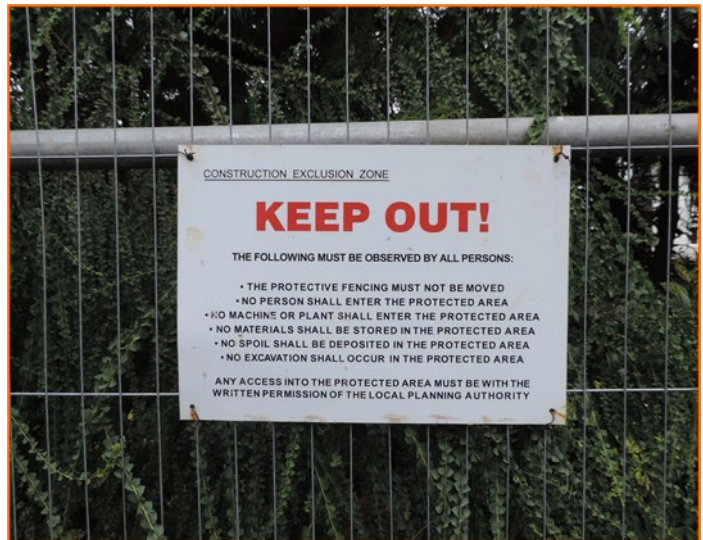
**Picture 1:** All barriers should be labelled to keep working activities outside the Construction Exclusion Zones (CEZs).

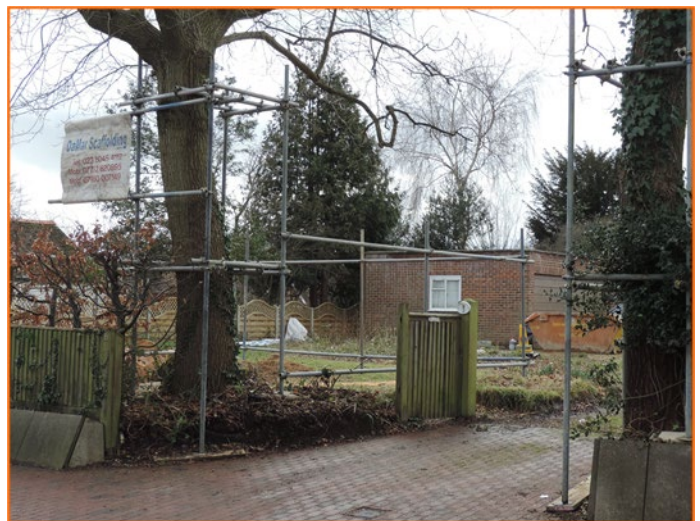
**Picture 2:** Scaffolding supports and board coverings erected around the trunks of trees can provide suitable protection against traffic turning into the site.

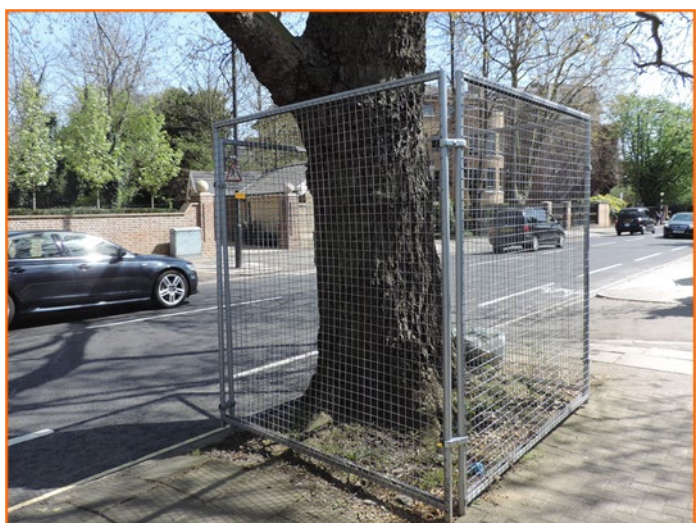
**Picture 3:** Temporary barriers are useful around individual trees where construction activities only occur during a short period.

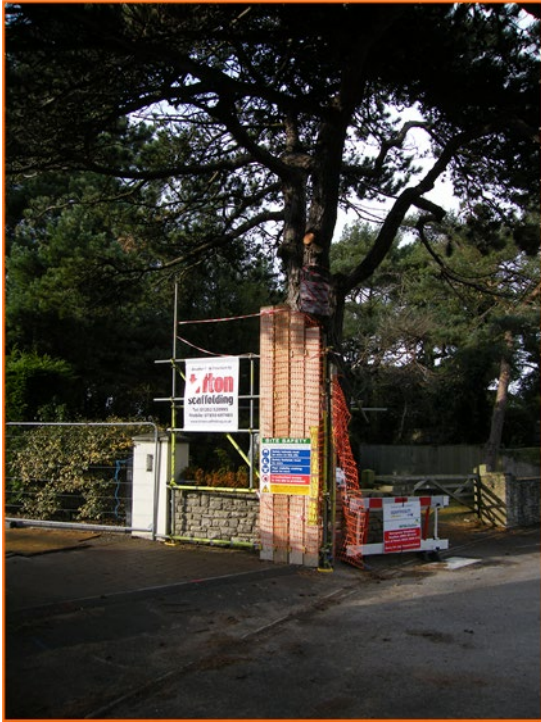
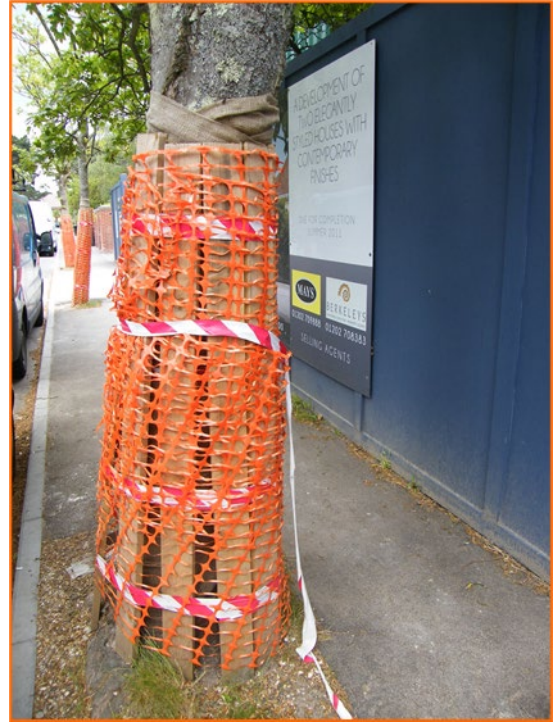
**Pictures 4 & 5:** Wooden boards carefully secured around the trunks can provide good protection where access is limited.

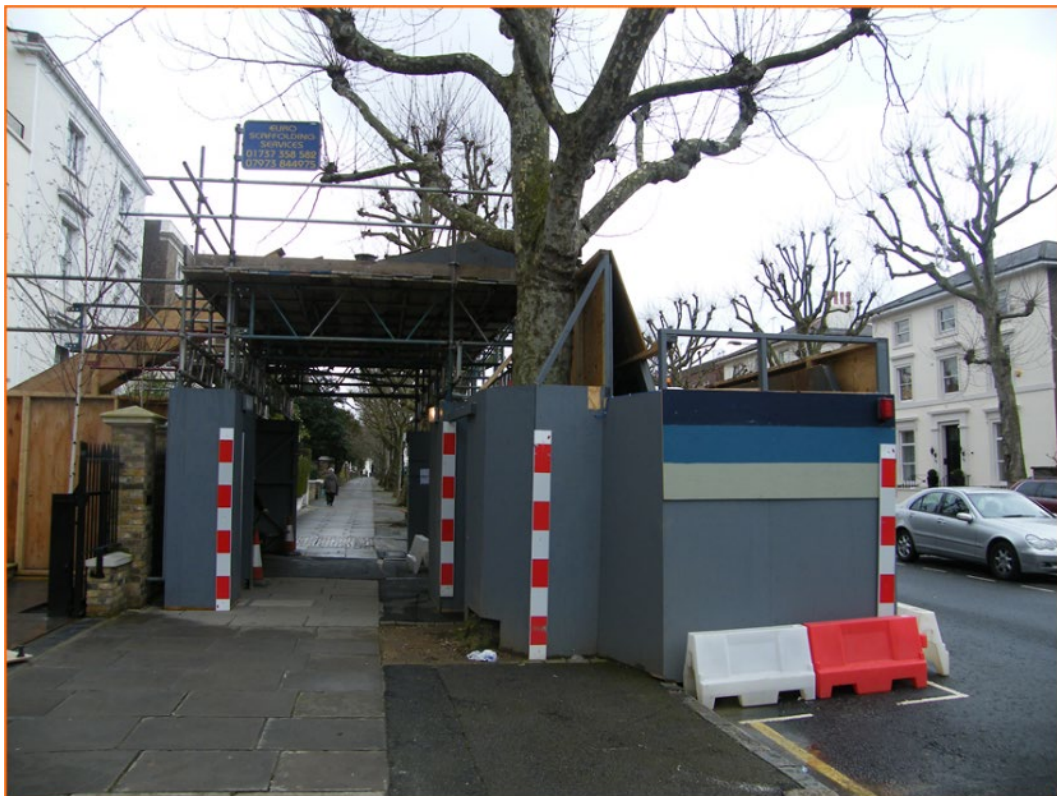
**Picture 6:** Where trees are off site, or public access is required through the work zone, boxing around the tree may be feasible.

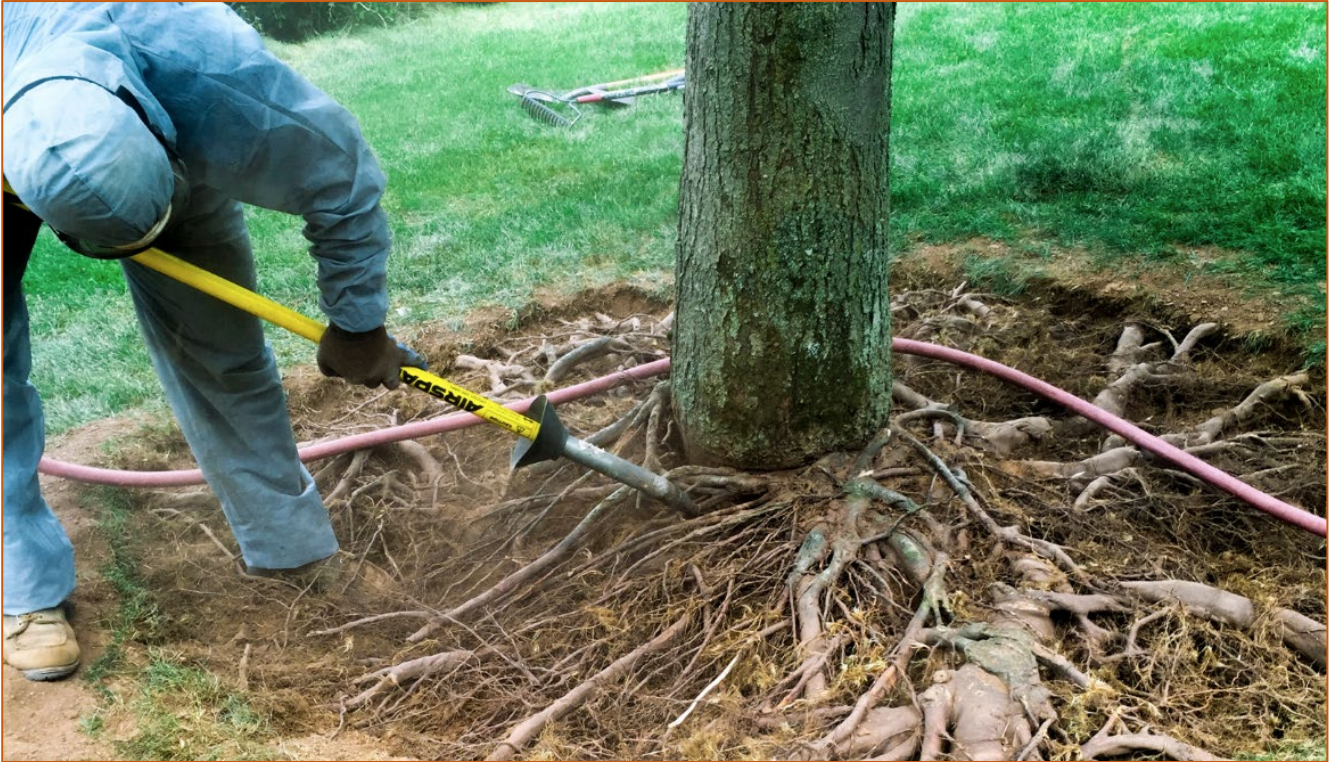
**Excavations within RPAs:** All excavation must be carried out carefully using hand tools, taking care not to damage the bark and wood of any roots. Specialist tools for removing soil around roots using compressed air may be an appropriate alternative to hand digging, such as an air spade excavator (Image below), if available.

All soil removal must be undertaken with care to minimise the disturbance of roots beyond the immediate area of excavation. Where possible, fibrous roots should be retained or displaced temporarily beyond the excavation without damage.
