PROJECT: Bulford Manor Wall

SHEET: Condition Drawing C - Vegetation

DRAWING NO: V1013 - PRA - ZZ - XX - DR - A - 30004

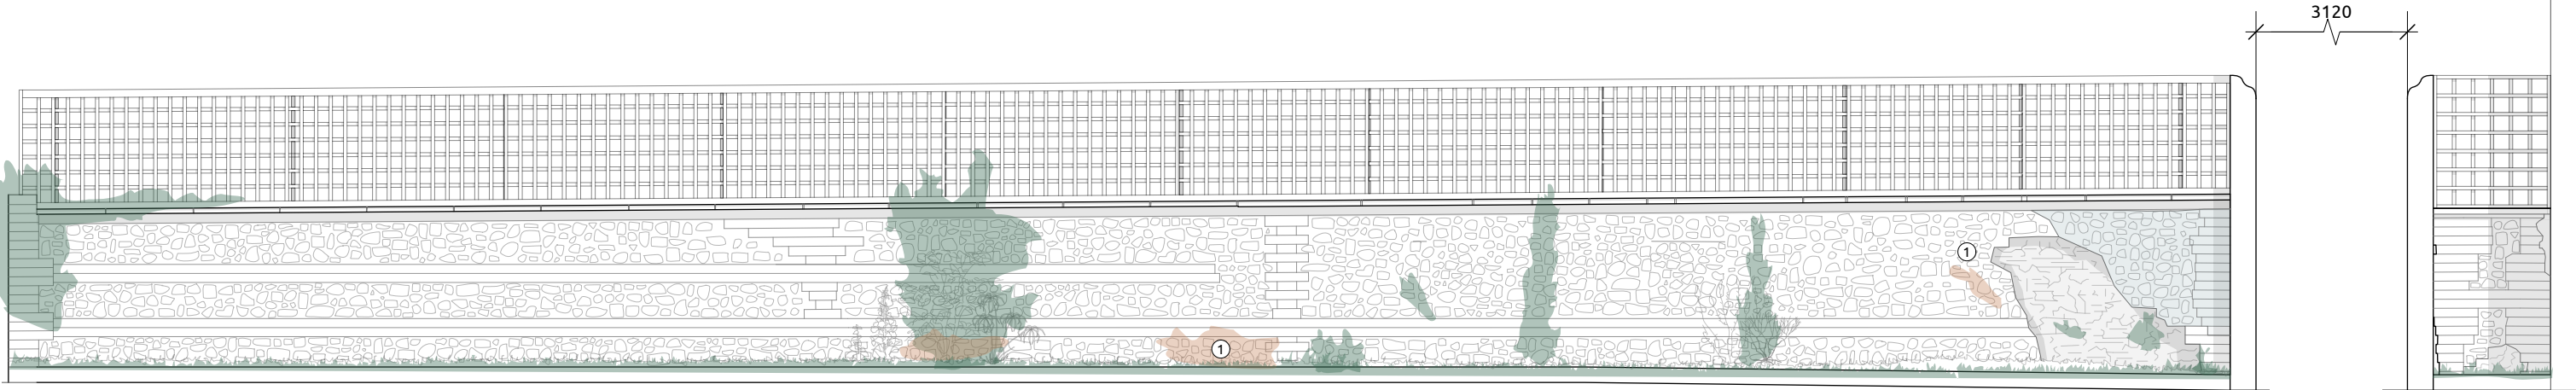
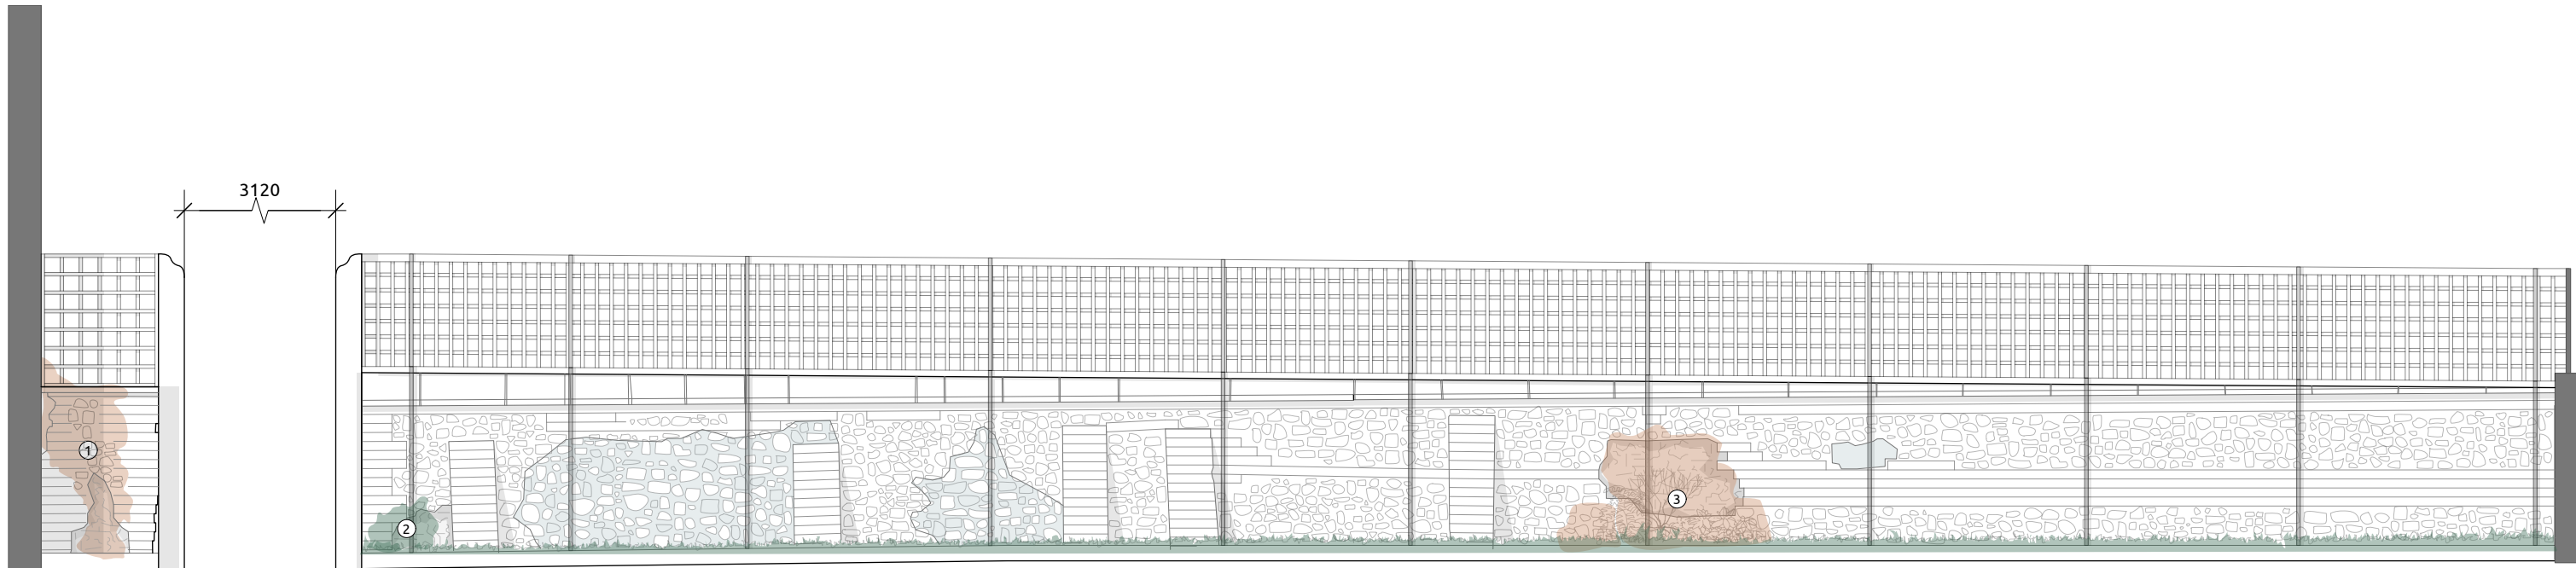
Front Elevation

C - Vegetation

- Vegetation
- Woody vegetation
- ① Woody vegetation growth through failed section of wall.
- ② Vegetation growing through area with missing mortar.
- ③ Woody vegetation growth through loose flintwork and partially collapsed section of wall.
