PROJECT: Bulford Manor Wall

SHEET: Flint and Brickwork Rear Elevation

DRAWING NO: V1013 - PRA - ZZ - XX - DR - A - 30010

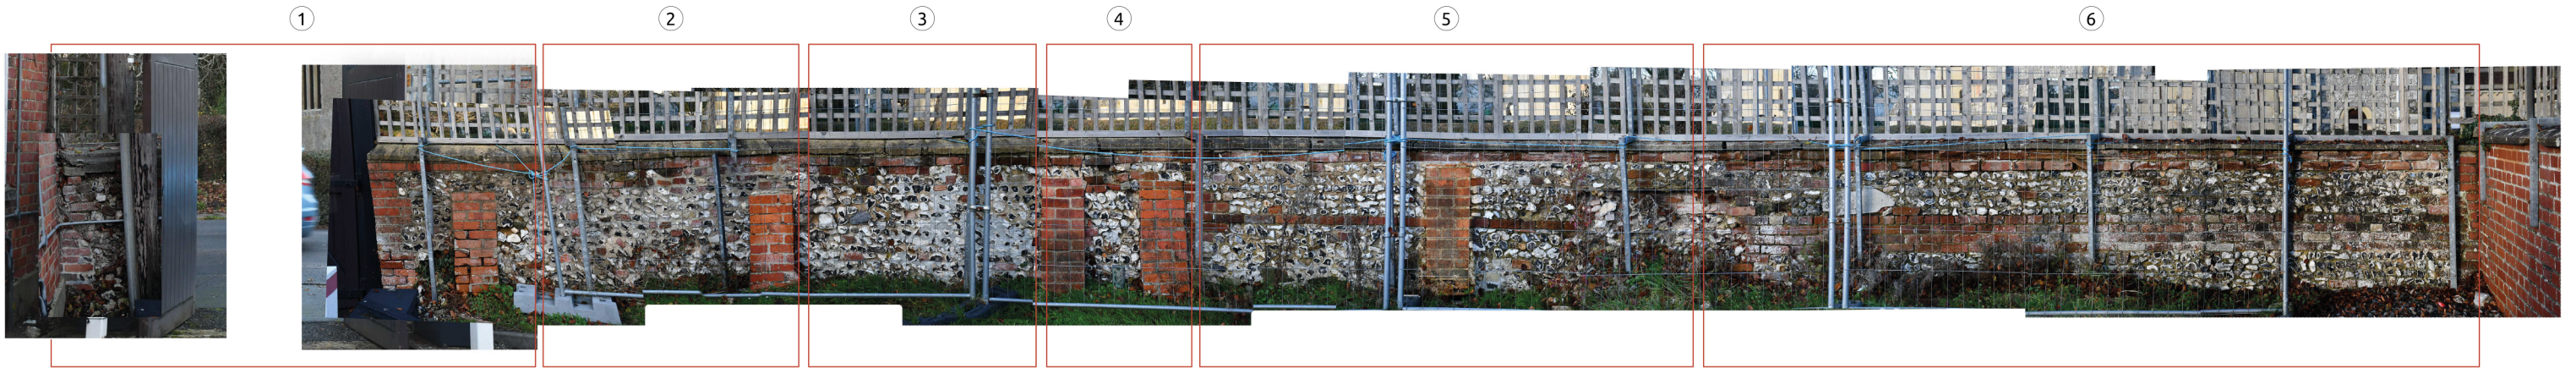
①  
Areas of the wall on either side of the gate are built with brick quoins and coursed field flint, with one course of brick below the stone coping.

④  
Roughly coursed field flint with one brick course below the coping, and two courses of brick connecting the tops of the buttresses.

②  
Area 2 is built using coursed field flint and brick fragments in a bungarooosh style. There is one course of brick below the coping.

⑤  
Coursed field flint with a central brick stretcher band and one course below the stone coping. There are occasional bricks in with the field flint, and an area of brick repair to the right of the buttress.

③  
Similar to area 2, with slightly less brick. One course of brick below the stone coping.

⑥  
Two courses of brick below the stone coping, and a band of four courses of brick centrally. The bottom two courses in the band are stretchers, while the top two are mostly headers. Coursed field flint inbetween.

**Note:**  
Flintwork to be carried out by a suitably experienced flint worker.
