# The Old Vicarage, 4 Rookes Lane, Potterne SN10 5NF

## Design and Access and Heritage Statement

February 2026

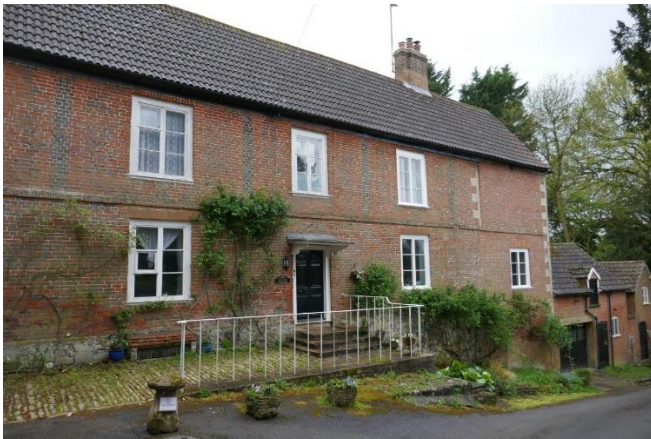
Front elevation

- 2.4. As noted in the official Listing, the property has evolved over time and this is evident on the road frontage with an extension clearly visible to the right of the property with the original extent of the property denoted by stone quoins at first floor level. The top floor dormer windows situated on the rear elevation, and the side (western elevation) casement window are suspected to have formed part of the general 2 storey addition to the property, as referred to in the Listing above, and when a secondary staircase was added extending up to second floor and in connection with beneficial use of the top floor roof space as bedrooms and bathroom space.

- 3.1. The front façade is of architectural and historical importance and makes a positive contribution to the character of the area in its setting because of its historic form, scale and materials.

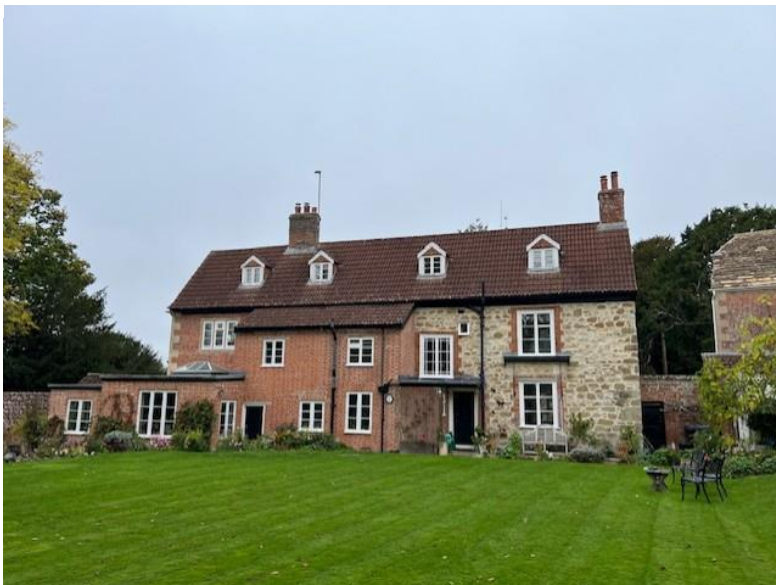
Rear elevation

- 3.2. The rear façade is deemed less important in conservation terms particularly as it has already been significantly adapted. The areas of original wall to the East should be preserved. The existing extensions have been remodelled in part under consents granted in 2018, to enhance the character of the building as a whole and include new windows at ground floor.

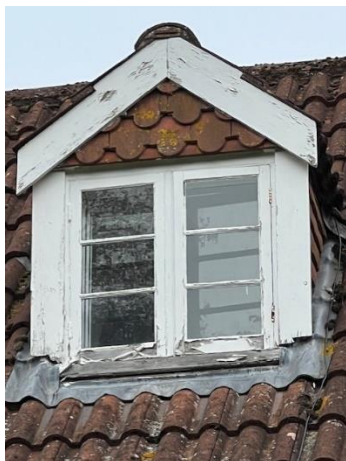
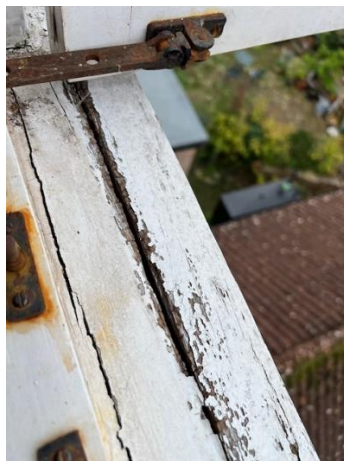
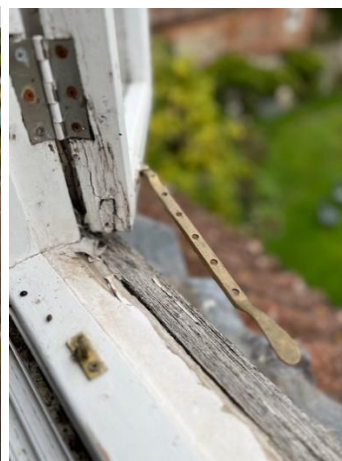
Exterior

- 2.7. The garden is mostly laid to lawn with some established beds, mature trees and vegetable areas.
- 2.8. The existing windows impacted by the proposal are considered not original, with mixed profiles/detailing, possibly replacements during the 1970's and generally in very poor condition, exacerbated by being south facing. Most of the poor grade timber is suffering from extensive degradation, splitting and swelling rendering the windows beyond repair and refurbishment, with most opening leaves ill fitting. Some window leaves have unfortunately been repeatedly painted over in the past, making them incapable of being opened. Some illustrative photos are set out below

5.2. The proposal helps to improve the general appearance and condition of these windows which have weathered badly and will utilize materials and architectural features in keeping with the previous windows and sympathetic to the design intent elsewhere across this façade.

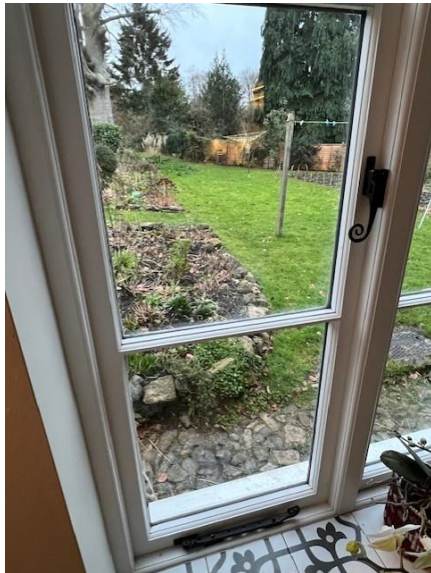
construction/material design for these top floor windows with a spray-painted white finish. Glazing will be slimline double-glazed units with timber mullions and glazing bars, to the same specification as windows installed at ground floor in 2018. Window furniture will match those installed at ground floor in photo below

Typical ground floor window design installed in 2018.

- 6.2. The proposed replacement windows seek to preserve the fabric of this Grade II Listed Building ensuring its future beneficial use and protection.
- 6.3. The appearance of the replacement windows will closely match the existing units, and match the specification deployed across various ground floor windows consented and installed in 2018 on the rear elevation.
7. Listed building consent is therefore sought for this proposal.
