Proposed Works to Purton House, Church End, Purton. SN5 4EB

Planning, Design, and Access Statement including Heritage Impact Assessment V.1

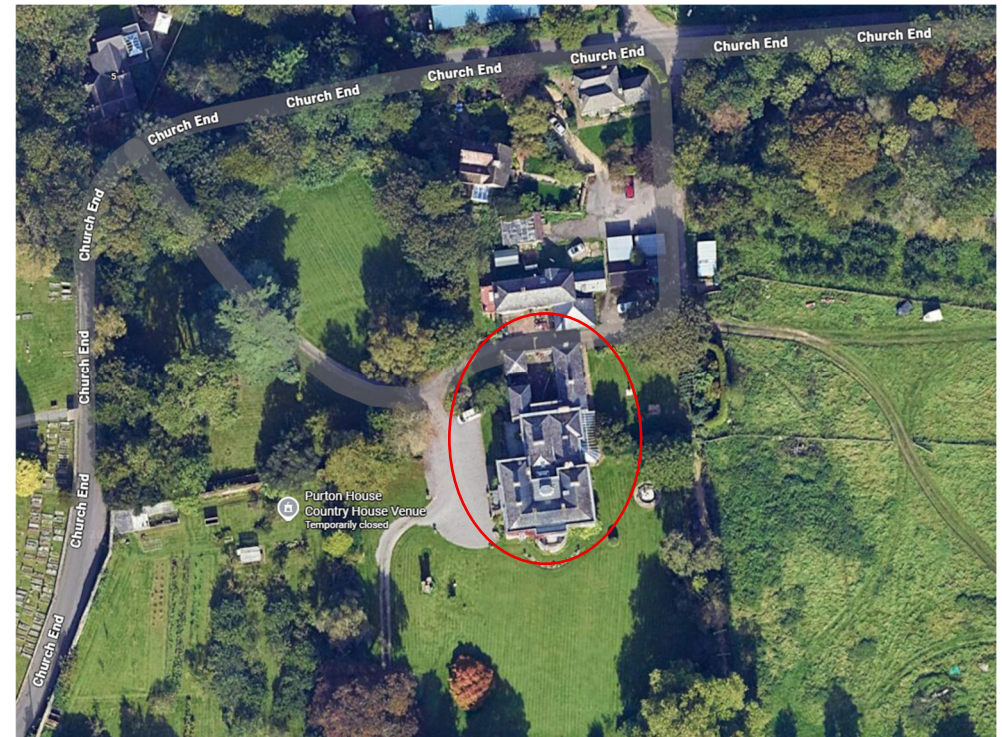
Figure 1. Aerial View of Purton House

Purton House comprises the original house c.1840, the building extends by 3 bays set back from original façade and then a later rear extension of service buildings around a yard.

The site is currently accessed from Church End with a private drive leading to parking for the house and looping back on to Church End past other properties which will have access rights along this drive.
