## Catchment Sensitive Farming Assessment Form

| <b>Farm address, postcode and telephone number(s)</b> | Oakwood Farm, Upper Minety, Wiltshire, SN16 9PY |

**Plan of works**

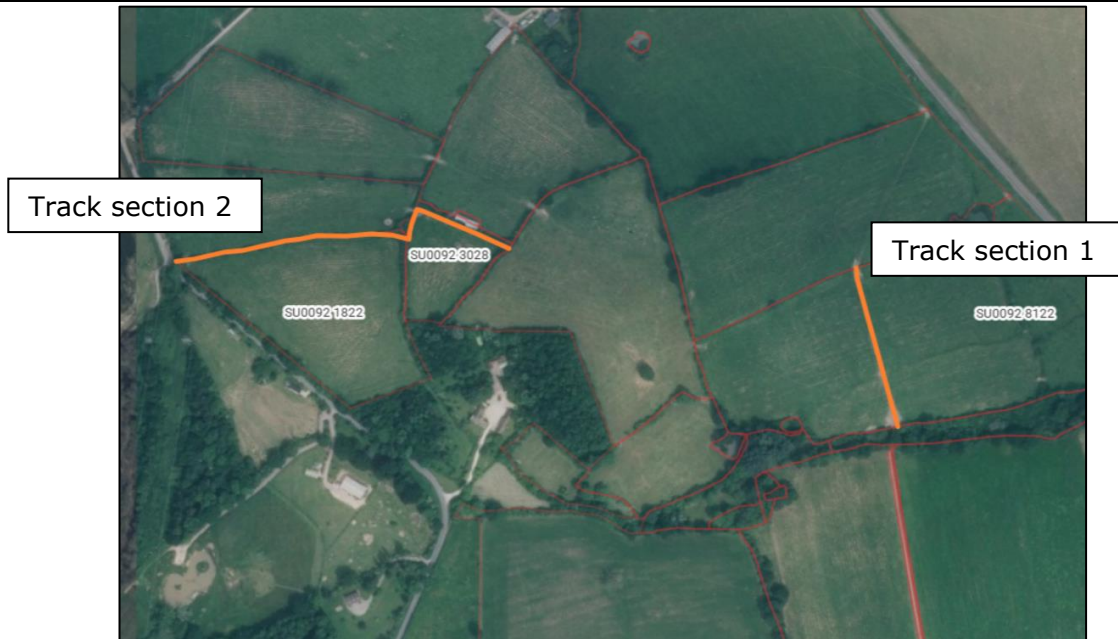
- The applicant proposes two lengths of hardcore track, for frequently used routes moving livestock on the holding, these currently having an unmade surface.
- Track section 1 is a length of 160 metres through parcel SU0092 8122. This will provide a continuation from an existing track south of this parcel, back towards the yard. Going straight through this parcel, the applicant considered different route options, and this is by far the shortest option across this parcel and for accessing surrounding land parcels.
- Track section 2 is a length of 360 metres through parcels SU0092 1822 and SU0092 3028. There is road access at the west edge of 1822 and this track section will provide effective access to the surrounding grazing parcels. The track route is adjacent to the field boundary in both these parcels.

*Proposed track routes shown in red above.*

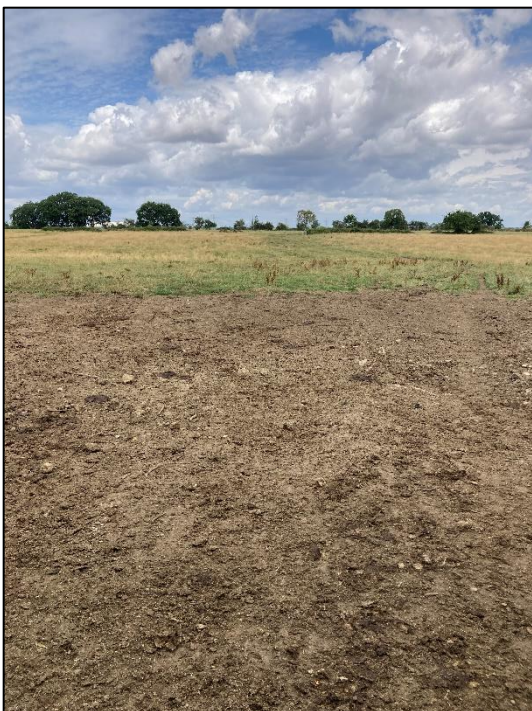
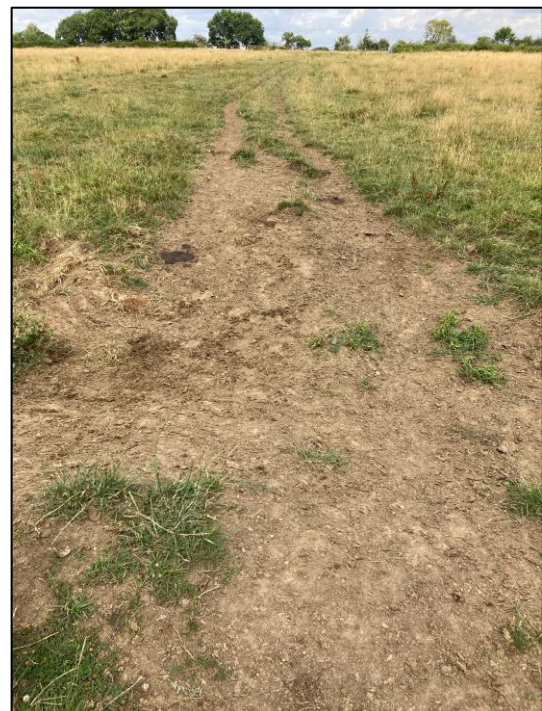
Track section 1:

The site visit was taken during a prolonged dry period, even so there was evidence of ground damage currently occurring with livestock movements (and vehicular movements to access the livestock) in this area of the holding. The bare ground is evident in the photos below, this increasing the risk of contaminated runoff and sediment (and sediment bound phosphate) being lost to nearby receptors.

- In view of the soil type in this area the applicant has been advised that a geotextile membrane will be required.
- With both track sections having little slope, cross drains will not be required to control runoff. A slight continual camber on the track will shed water and this should be into vegetation (grassland beside the track).

The proposed tracks will address the current issue of ground damage and bare ground occurring, from which sediment (and bound phosphate) contaminated runoff can result. Given the proximity to ditches and ultimately the connectivity with the Swill Brook, the hardcore surface preventing bare ground will minimise the risk to that sensitive receptor. With the high phosphate status of the Swill brook, and phosphates being targeted in this area, the proposal will help to address local pollutant priorities.

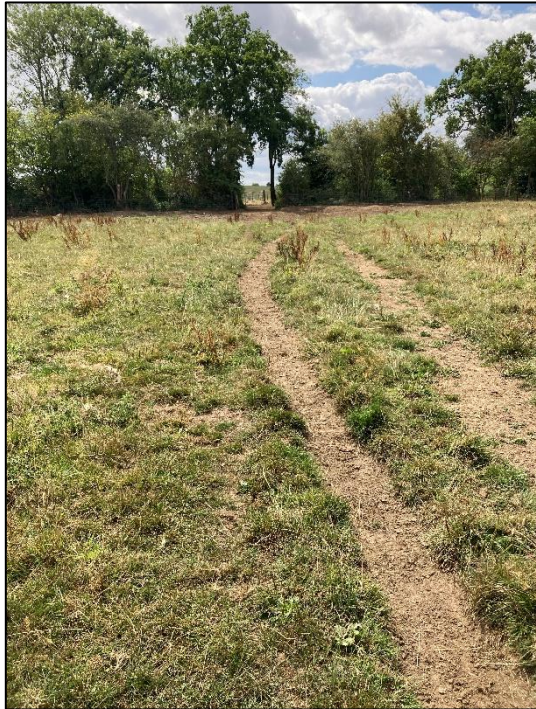
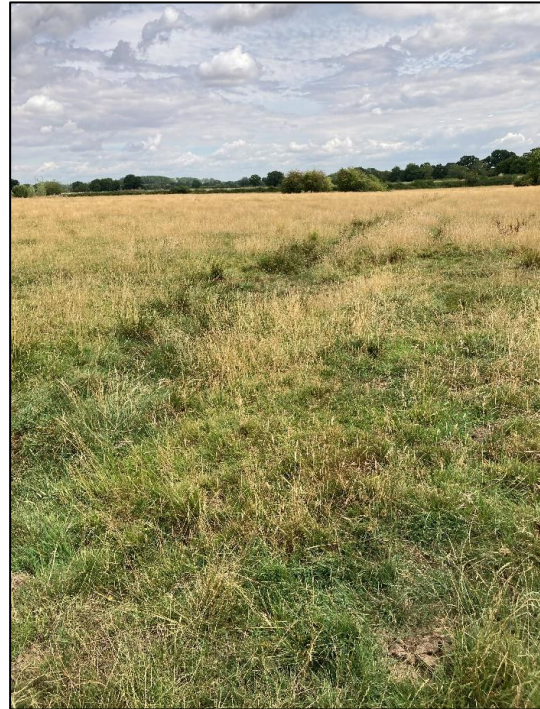
Surface water connectivity in parcel 8122 where this track section has been proposed is significant, including a ditch along the southern edge of the parcel (in the tree line in the photo below left) and at the north end of the proposed track.

There is also a ditch approximately halfway along and perpendicular to the proposed track route. This was dry during the visit, but the applicant explained there can be significant flow here, and that they plan to construct a culvert in this section. This area is shown in the photo below right – a depression in the field is clear.

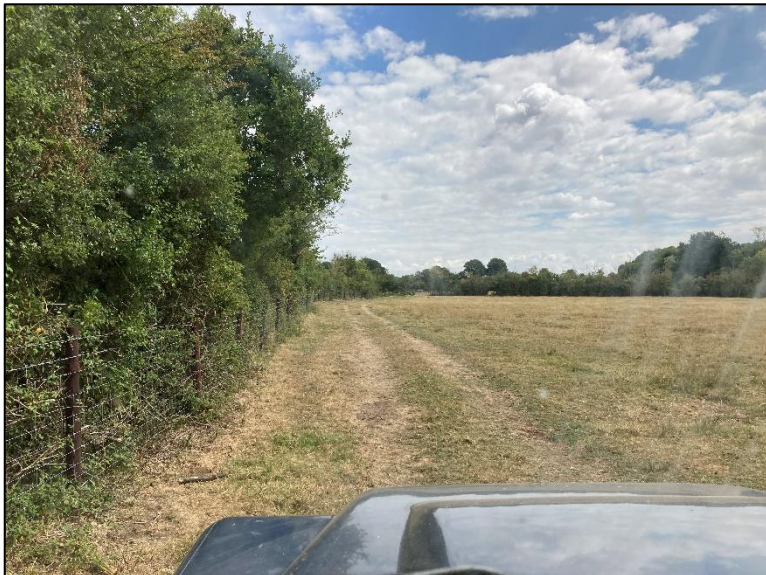
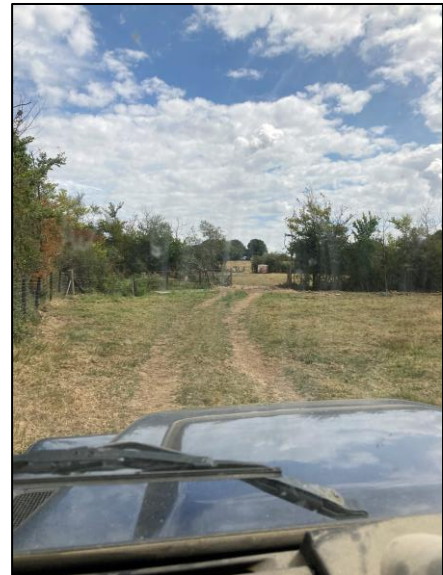
Track section 2:

Again, there was evidence of some ground damage in this area, and there is significant surface water connectivity. In the photo below left, there is a ditch adjacent to the treeline on the left (running along the edge of both parcels) and also a ditch in the treeline at the far end of the parcel (this being the boundary between 1822 and 3028, the ditch is already culverted at the parcel boundary).

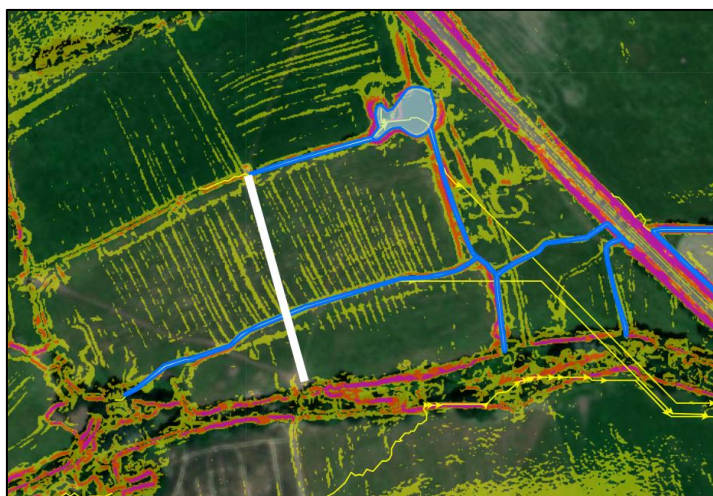
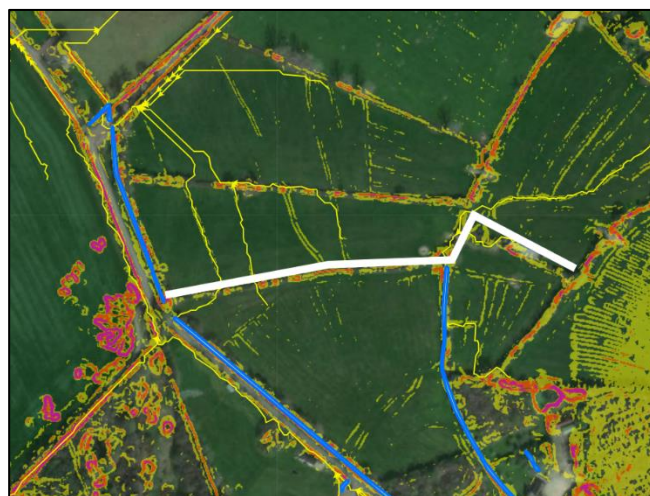
ALERT mapping has been included below for both track sections, and this provides further context of surface water connectivity in these areas of the holding. Track section 1 is shown on the left, and section 2 on the right. Both track sections are in relatively flat areas of the holding, with significant slopes limited to field features and therefore a limited number of overland flow pathways (though there are some particularly around the second track section). Some of the ditch sections described previously in this report are not included on these outputs, but despite this, there are ditch sections shown in very close proximity to both proposed tracks. These ditches create connectivity to the [Swill Brook](#), this having a moderate ecological status including high phosphate.

*Above: track sections shown with white lines ; blue lines – permanent watercourses ; yellow arrows – overland flow pathways ; yellow / red / purple areas – slope exceeding 3 / 7 / 12 degrees)*
