# THE RED LION, HIGH STREET, LACOCK

WC ROOFING WORKS

HERITAGE, DESIGN AND ACCESS STATEMENT

**Reference** : 3940 HDAS\_01

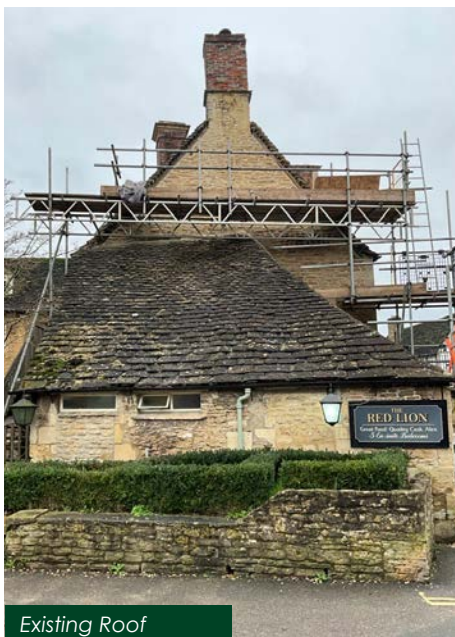
Existing Roof

- 3.1 Visual inspection of the roof confirms the following:
- That a number of tiles have lost their fixings and have slipped.
  - That the ridge of the roof is undulating
  - A number of the existing roof timbers show signs on damp and decay.
  - A number of slipped tiles have been removed from the roof this year on health and safety grounds, further opening the roof structure up to water ingress.
  - Repair in situ is no longer feasible without risking water ingress and structural failure. Their replacement is necessary for both preservation and safety.
- 3.2 The works are required due to deterioration of the existing roof timbers. The intervention has been designed as a like-for-like repair in terms of appearance, ensuring preservation of the building's character and special architectural interest.

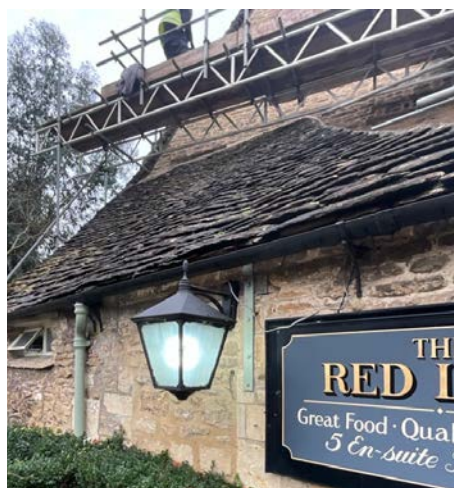
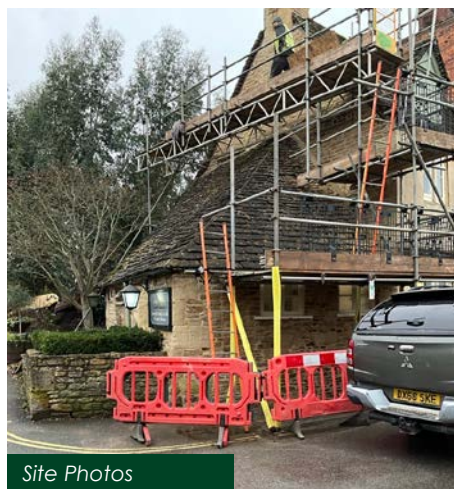
Site Photos

- 4.29 In accordance with Historic England's conservation hierarchy, repair of the existing roof structure was considered as the primary option before replacement was proposed following a detailed inspection by the National Trust's inhouse Surveyor in January 2026. Following discussions with local building contractors, it was concluded that in-situ repair is no longer a viable option.

- 4.30 The extent of decay to the roof timbers and battens, combined with the number of dislodged slates and the resultant water ingress, means that a piecemeal repair approach would not achieve a structurally sound or durable outcome. The proposed deconstruction and rebuild has therefore only been pursued as a course of last resort, consistent with the principle that replacement should only be undertaken where repair is demonstrably not feasible.

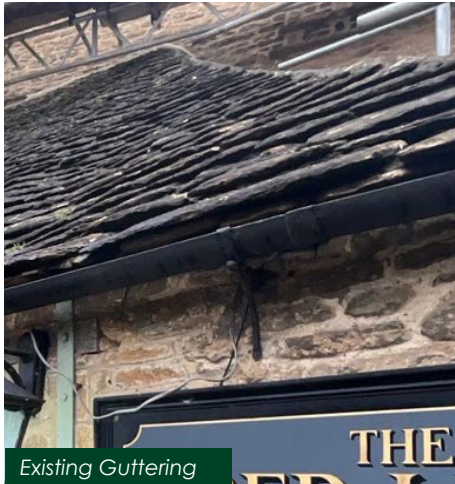
Existing Guttering

- 3.4 This application seeks the approval to add a short length of rainwater guttering on the short elevation of the extension which fronts the High Street, and to replace the existing section with a larger section of guttering.

- Preventing deterioration of historic fabric.
- 3.5 The current situation is causing water saturation of the stonework, which leads to:
- Freeze-thaw damage (water enters stone, freezes, expands, causes cracking and spalling)
  - Erosion of stone faces and mortar joints
  - Biological growth (algae, moss, lichen) which can damage the stone surface
  - Salt crystallization damage from repeated wetting and drying cycle

- 4.21 The replacement of the existing 115mm cast iron guttering with a larger-diameter 125mm half round cast iron gutters (a larger equivalent) should be regarded as a positive intervention in heritage terms. During periods of heavy rainfall, the existing guttering is insufficient and water currently overtops it, saturating the stonework below. Upgrading to a larger section will prevent this ongoing damage. In addition, a short new length of guttering is proposed on the High Street elevation of the extension, where there is currently no provision. This will protect the historic stonework from water running off the roof slope and splashing back from the ground. Both the replacement and new sections of guttering will be and detailed to match the existing installation.
- 4.22 Existing downpipes are to be retained and re-fixed unless they are found to be defective.
