# Design and Access Statement

## Listed Building Consent Application

Marlborough Pets, 5 London Road, Marlborough, Wiltshire, SN8 1PH

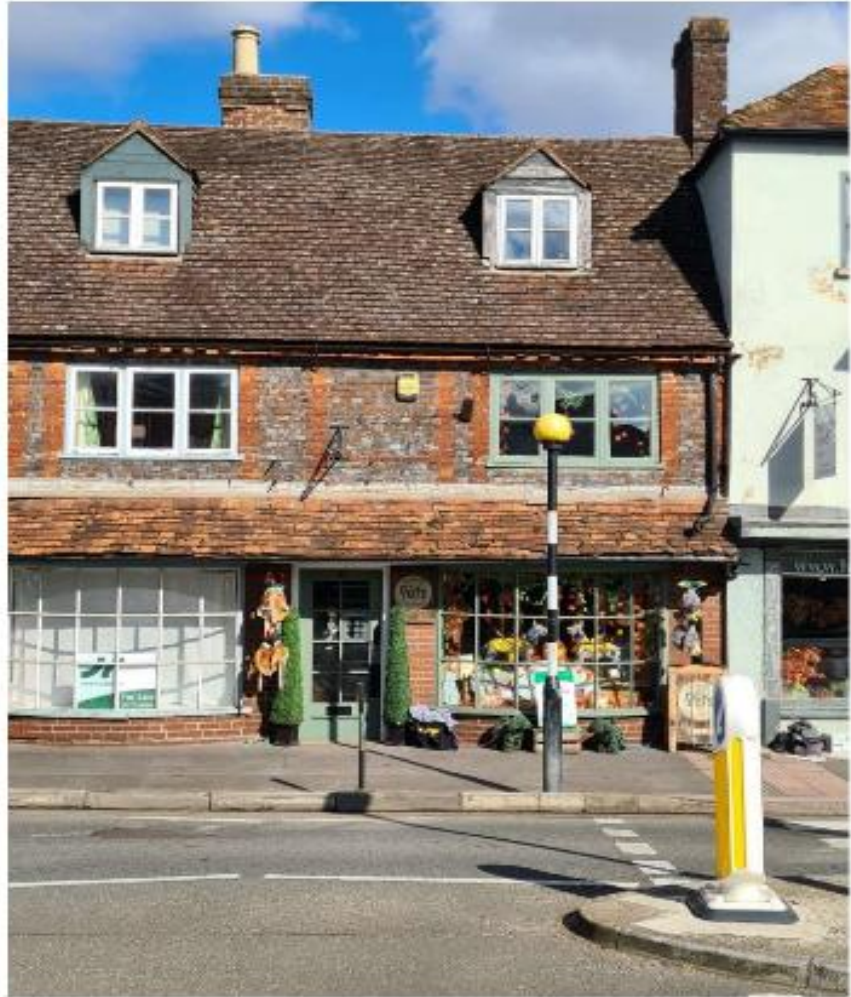
The existing shopfront, prior to the incident, consisted of a traditional single glazed display window and a single glazed entrance door, traditional tiled lean-to roof and black guttering both of which were appropriate to the age and character of the listed building.

See image of front elevation prior to the damages, below:

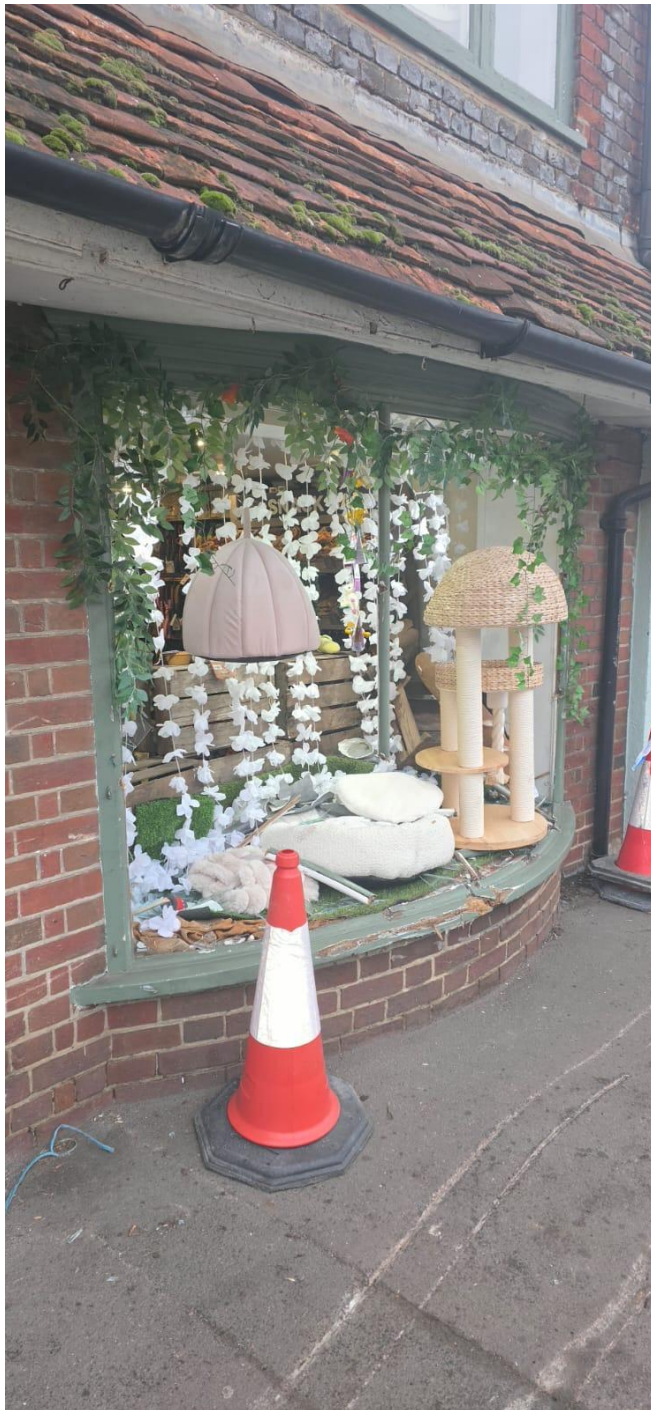
The proposed works arise as a direct result of accidental damage caused by a road traffic incident, during which a lorry struck scaffolding located several doors away and continued driving, resulting in the shopfront window being destroyed, the front door damaged and damage to a number of roof tiles on the lean-to roof on the front elevation, including damage to the guttering.

Shopfront window (showing glass and wood has been destroyed):

- The **shopfront window** will be replaced on a *like-for-like basis*, matching the original size, proportions, materials, glazing type, detailing and colour.
- The **entrance door** will also be replaced on a *like-for-like basis*, replicating the original design, materials, colour and appearance.
- The **lean-to roof** on the front elevation will have 40 damaged tiles replaced with reclaimed handmade clay tiles and 6 meters of lead installed to replace failed leadwork, to match the originals on a *like-for-like basis*.
- The damaged **guttering and downpipe** on the front elevation, attached to the lean-to roof will be replaced with Brett Martin cast iron style black guttering and downpipe, to match the original on a *like-for-like basis*.

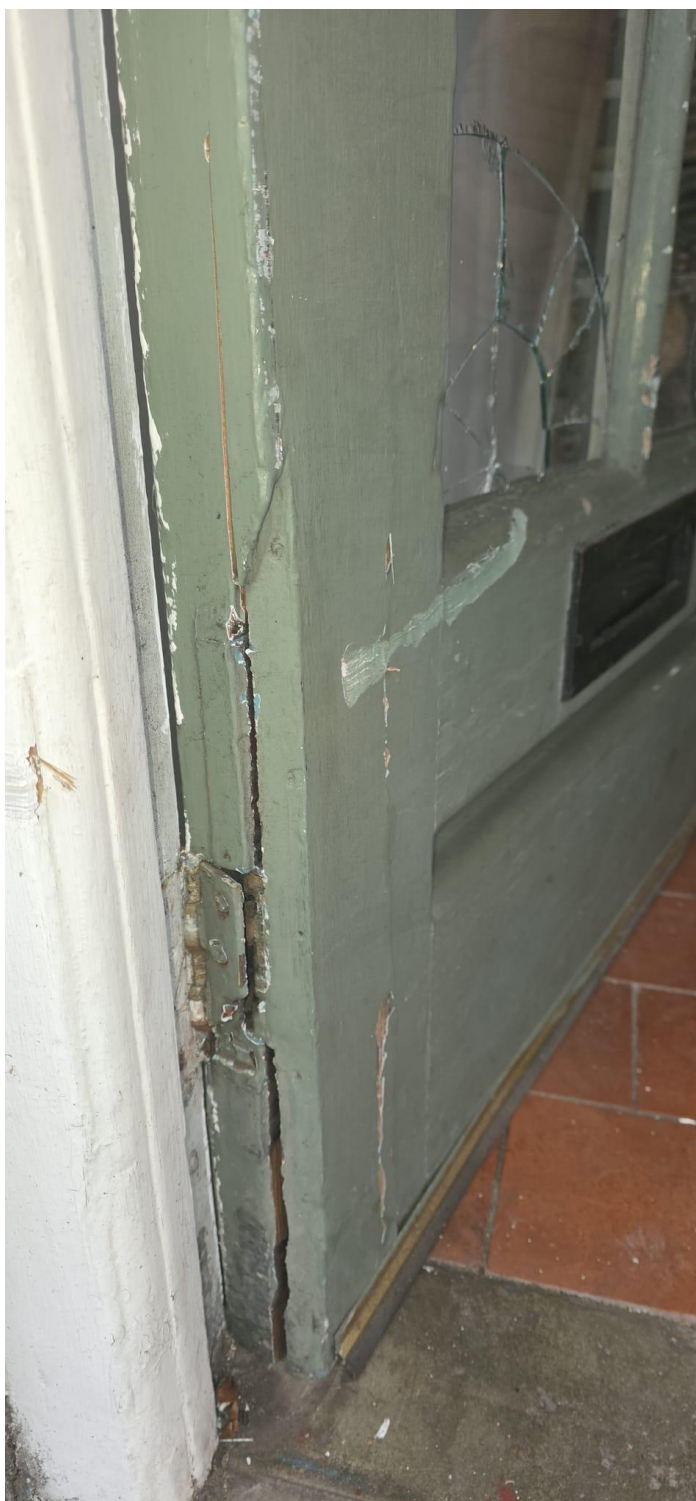
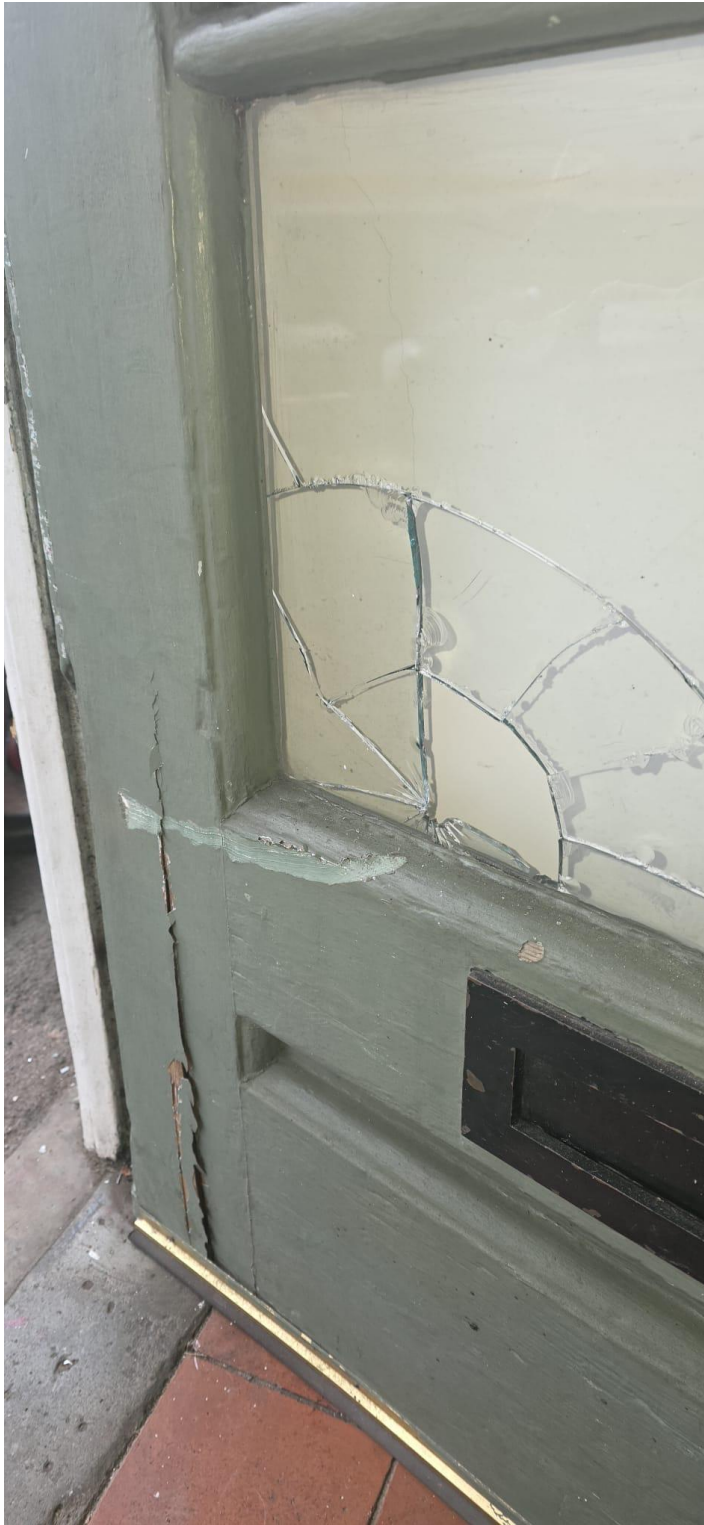
Shopfront entrance door (showing wood and glass has been damaged):

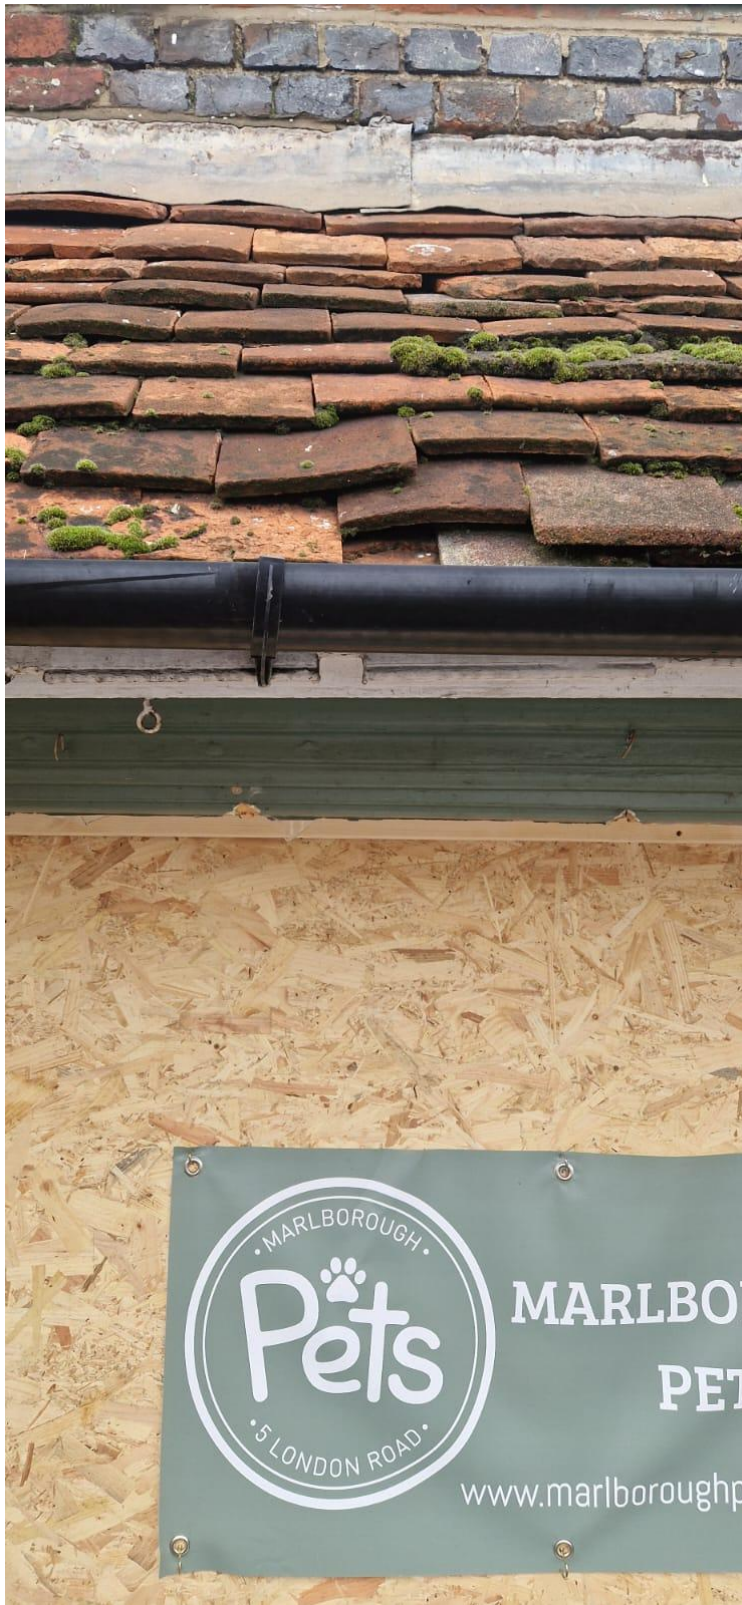
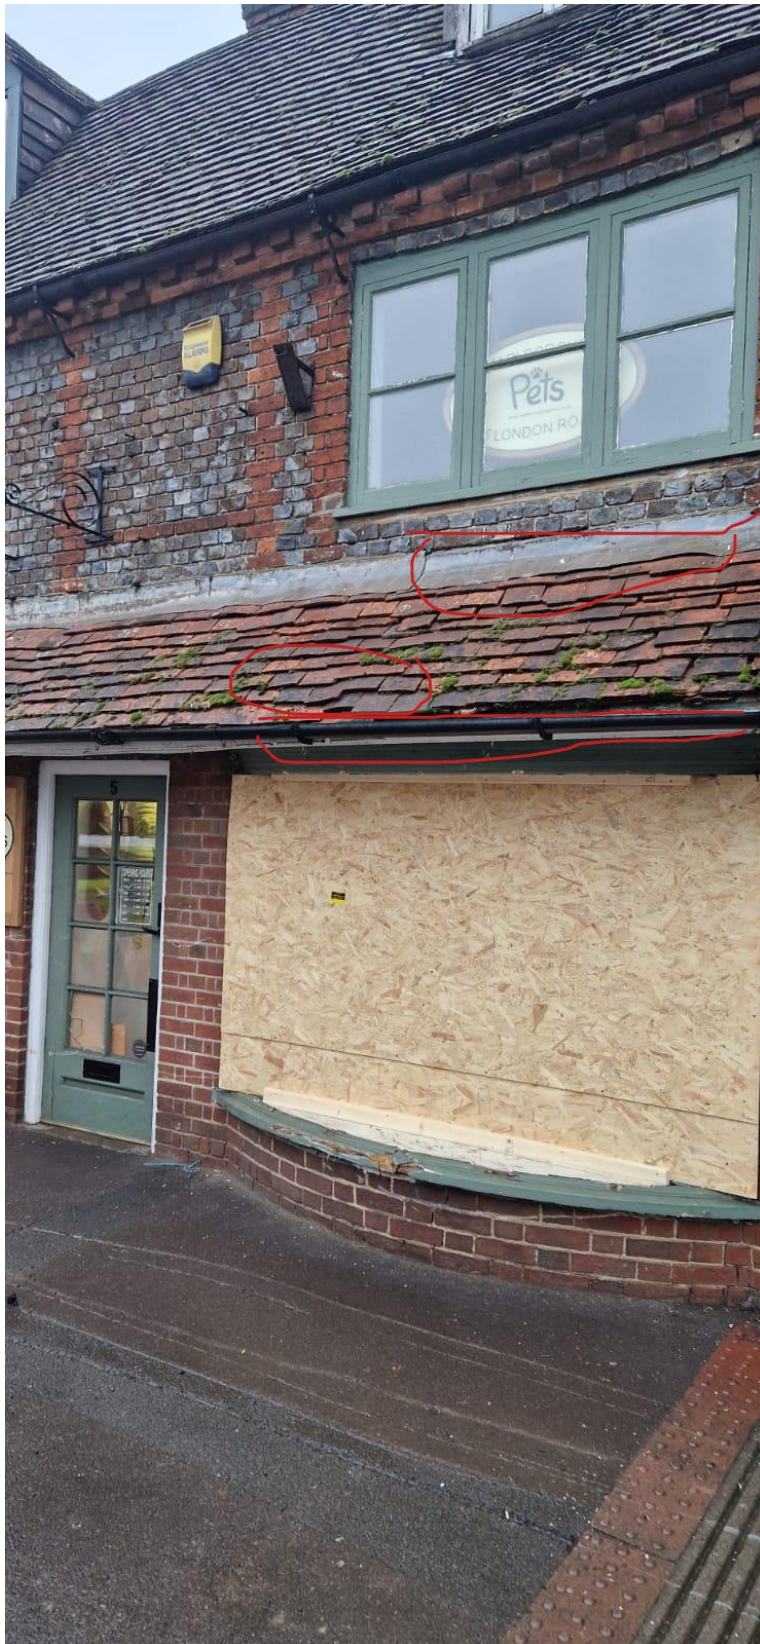
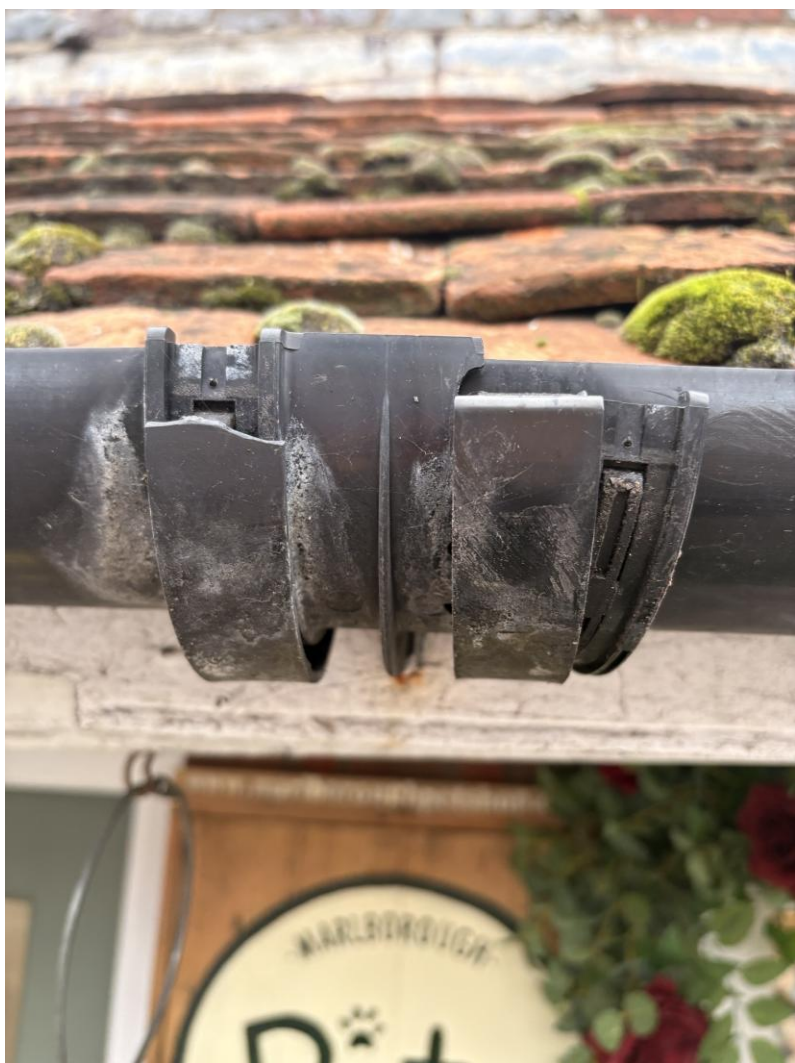
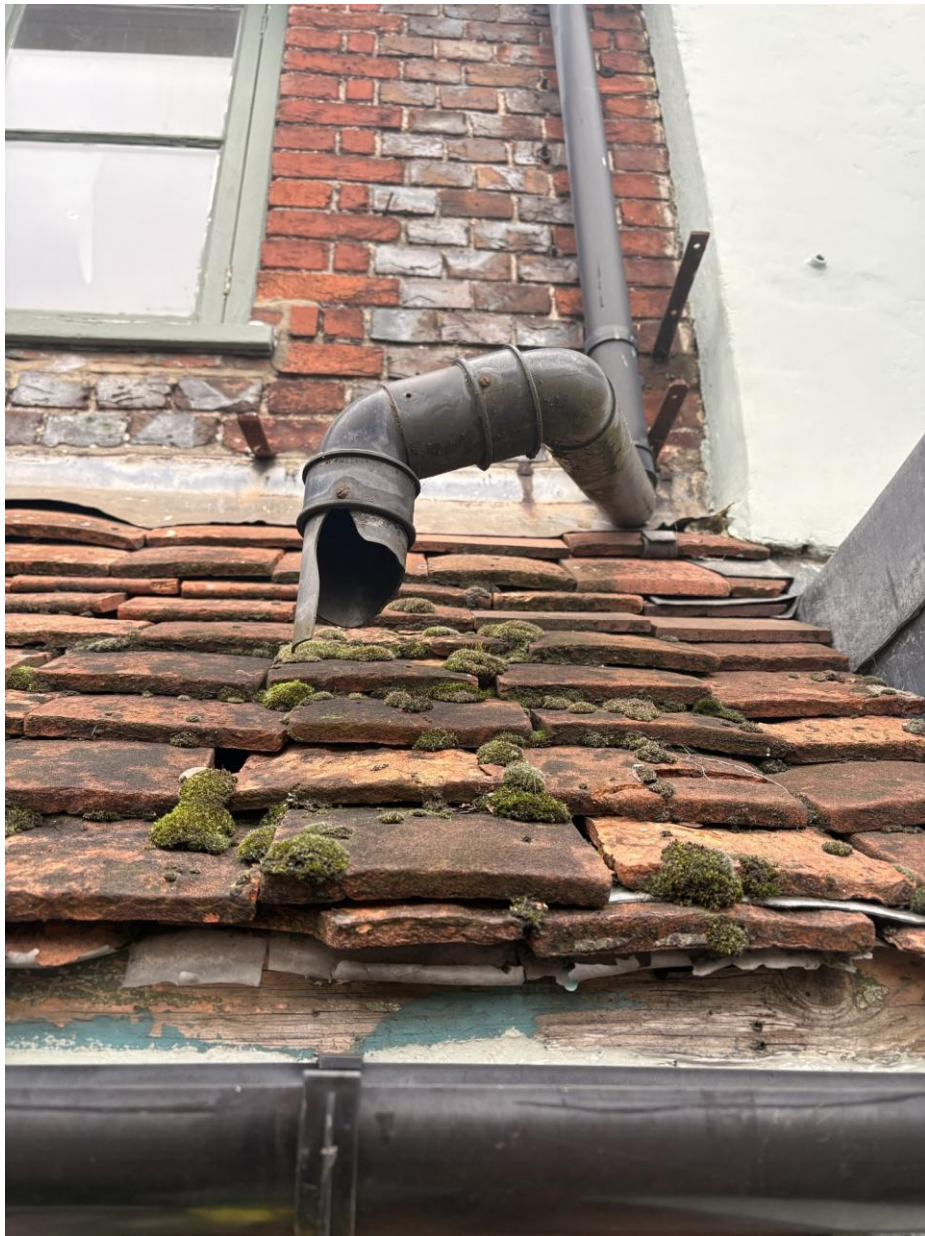
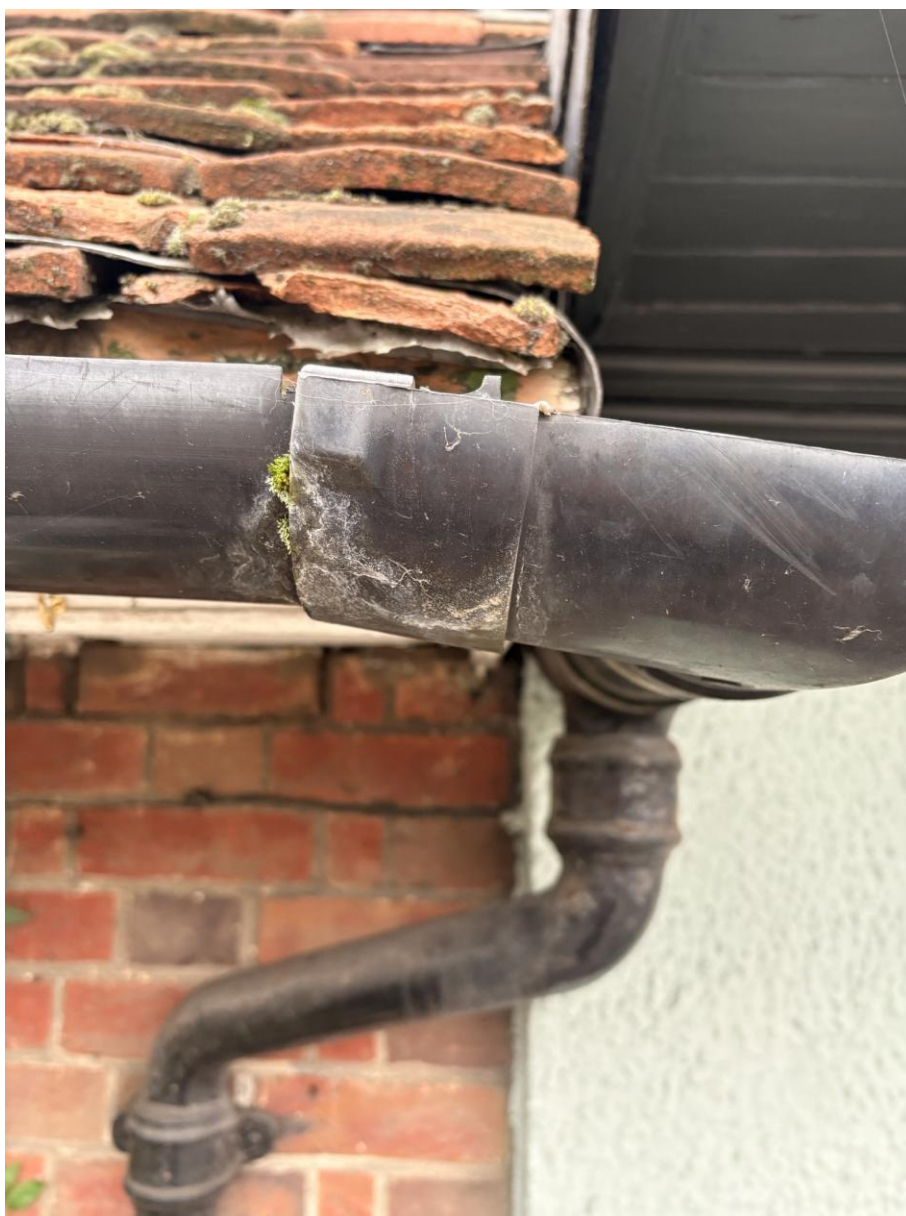
Shopfront lean-to roof (showing damage and movement to some of the roof tiles, movement of leadwork and damage from impact to the guttering/downpipe):

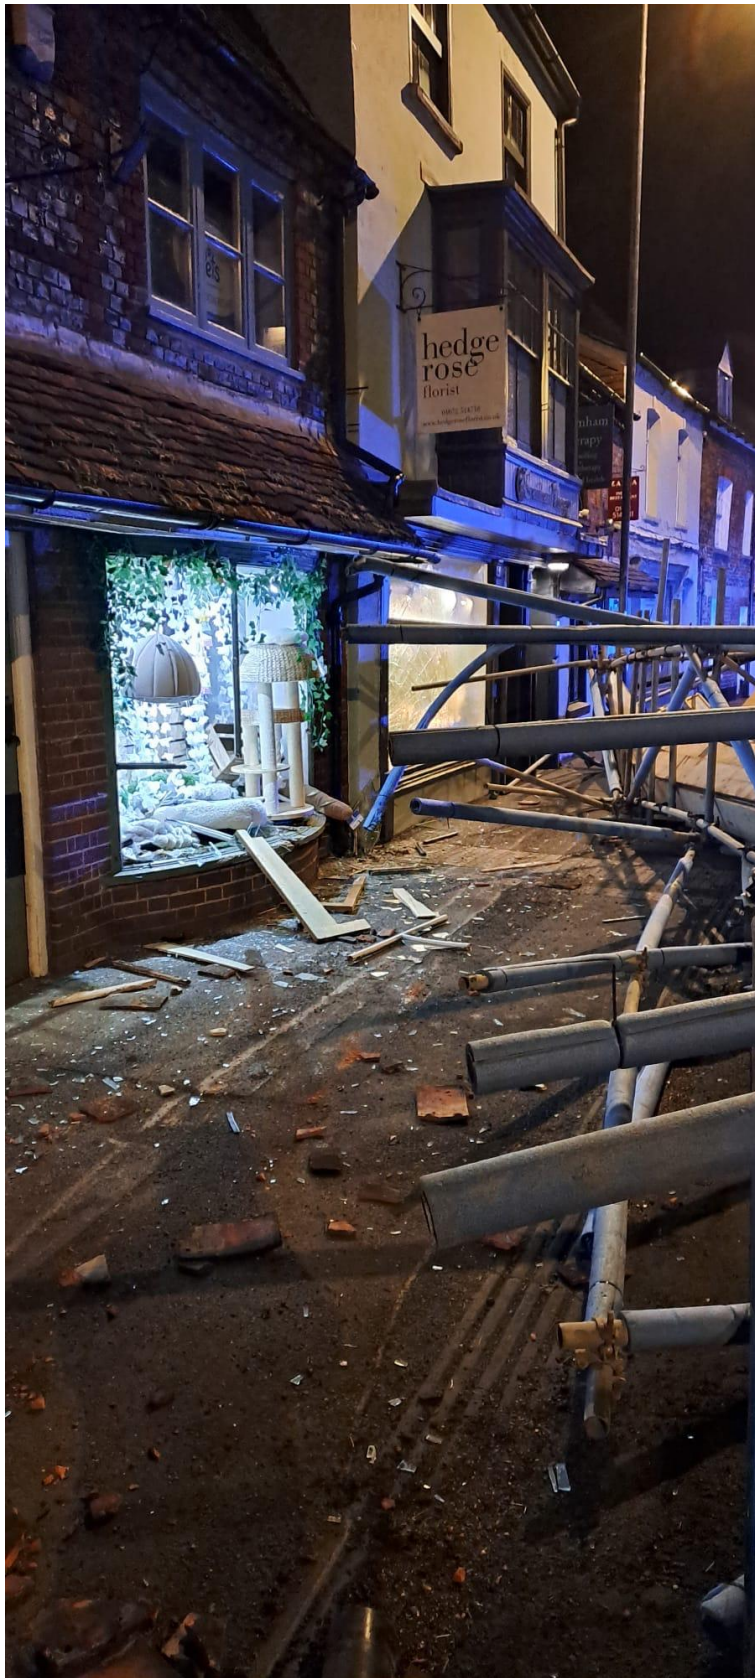
This shows some of the damaged tiles on the floor, directly after the incident:

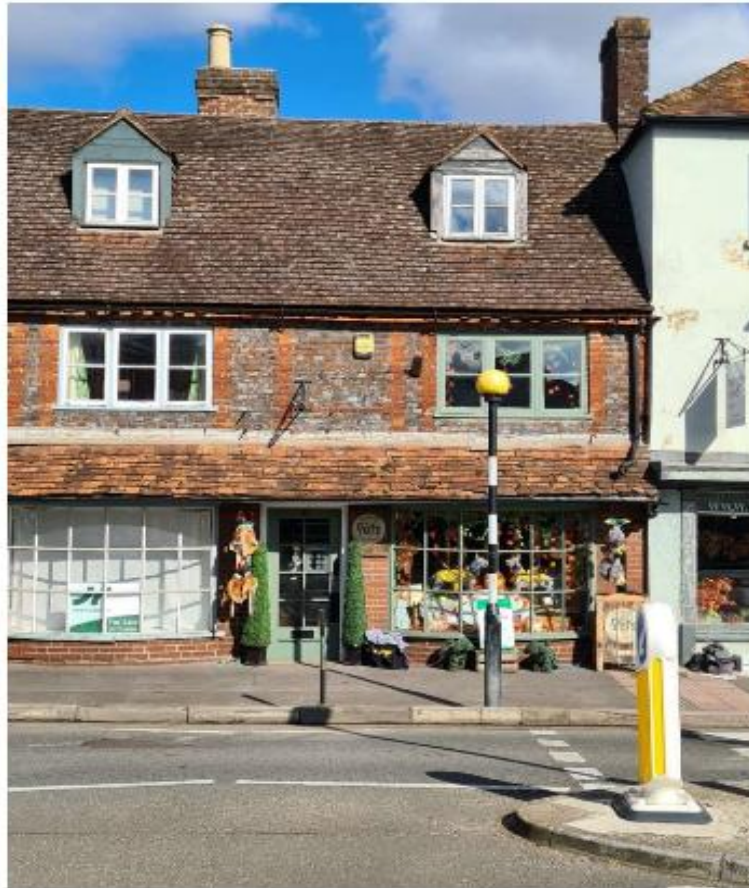
The intention is to re-instate the shop front window, entrance door and make repairs to the damaged tiles, guttering and downpipe on the lean-to roof, so that everything matches the original on a like-for like basis prior to the incident (as per the photo below):
