## BS:5837 ARBORICULTURAL REPORT

ARBORICULTURAL SURVEY, IMPACT ASSESSMENT & ARBORICULTURAL  
METHOD STATEMENT

THE OLD MANOR  
THE SQUARE  
ALDBOURNE  
MARLBOROUGH  
SN8 2DU

Ref: AIA/AMS 06898 / 2026 0.2

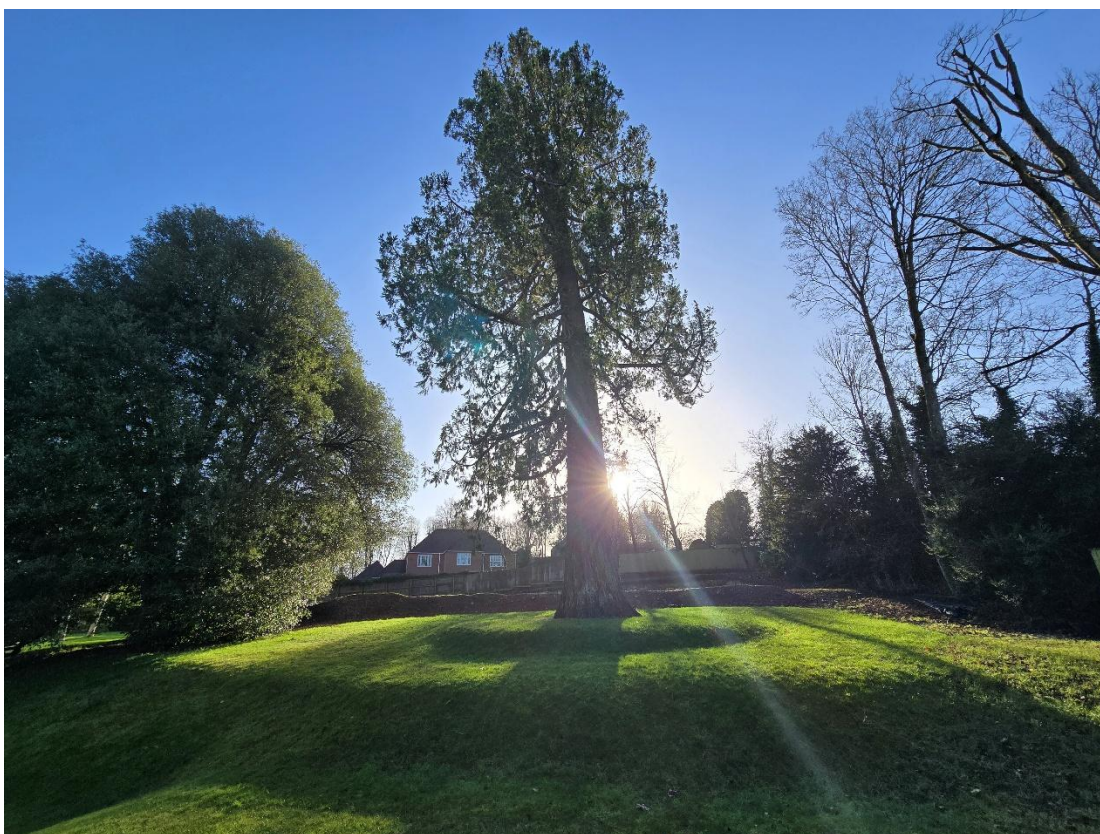
Photo 1. T001 – Wellingtonia

Collectively, all the trees provide screening around the property boundaries and enhance the amenity of the Conservation Area and setting of the Grade II Listed Building.

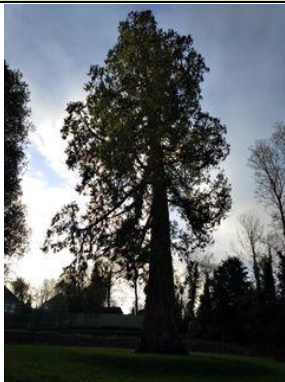
| Ref. | Species | Structure | Measurements | Spread | General Observations | Retention Category | RPA | Summary | Photos |
|---|---|---|---|---|---|---|---|---|---|
| T001 | Wellingtonia<br>( <i>Sequoiadendron giganteum</i> ) | Tree | Height (m): 28<br>Stem Diam(mm): 1900<br>Crown Clearance (m): 2<br>Life Stage: Mature<br>Rem. Contrib.: 40+ Years | N:5<br>E:6<br>S:9<br>W:5 | Topped tree with multiple leaders. Cut ivy stems remain on trunk. Minor deadwood in crown. Foliage slightly sparse. | A1 | Radius: 15.0m.<br>Area: 707 sq m. | Physiological Condition: Fair<br>Structural Condition: Fair<br>Public Amenity Value: High | |

The extent of new hard surfacing within the Root Protection Areas of the Wellingtonia (T1) equates to 150m<sup>2</sup>, or 21.2% of the existing unsurfaced area 80.5m<sup>2</sup>, or 13.6% of the existing unsurfaced area of T002 (Holm Oak). Whilst this exceeds the maximum guidelines recommended in BS 5837, the Council has previously agreed that a marginal increase of 1.2% for a tree as broadly rooting as the Wellingtonia species is, is unlikely to have any significant impact on the tree.

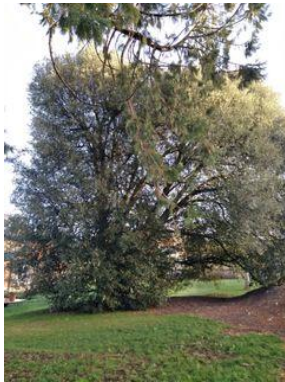
| Ref. | Species | Structure | Measurements | Spread | General Observations | Retention Category | RPA | Summary | Photos |
|---|---|---|---|---|---|---|---|---|---|
| T002 | Holm oak<br>( <i>Quercus ilex</i> ) | Tree<br>4 stems | Height (m): 14<br>4 stems (mm): 460, 550, 600, 770<br>Crown Clearance (m): 0<br>Life Stage: Mature<br>Rem. Contrib.: 20+ Years | N:5.5<br>E:11<br>S:11<br>W:5 | Multi-stem mature tree with cavity and decay at best where other stems have fallen. Adventitious roots in cavity. Previous survey noted Ganoderma brackets but none visible at the time of my survey. Cable ties around main branches. Low, asymmetrical crown to ground level. Foliage density normal. | B3 | Radius: 14.5m.<br>Area: 661 sq m. | Physiological Condition: Good<br>Structural Condition: Physical Defect<br>Public Amenity Value: Good | |

A lateral reduction to T002 (Holm Oak) has also been granted consent under a previous application ref: PL/2025/08318. T002 has a significant area of stem decay, and the proposed lateral reduction will have the added benefit of reducing the weight of the crown above the decayed stem.

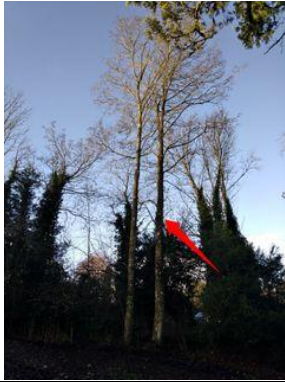
| Ref. | Species | Structure | Measurements | Spread | General Observations | Retention Category | RPA | Summary | Photos |
|---|---|---|---|---|---|---|---|---|---|
| T003 | Sycamore<br>( <i>Acer pseudoplatanus</i> ) | Tree | Height (m): 18<br>Stem Diam(mm): 470<br>Crown Clearance (m): 6<br>Life Stage: Mature<br>Rem. Contrib.: 40+ Years | N:5<br>E:3<br>S:1.5<br>W:5 | Recent works undertaken to raise crown. Slender tree, high, asymmetrical crown. | B2 | Radius: 5.6m.<br>Area: 99 sq m. | Physiological Condition: Good<br>Structural Condition: Good<br>Public Amenity Value: Good | |

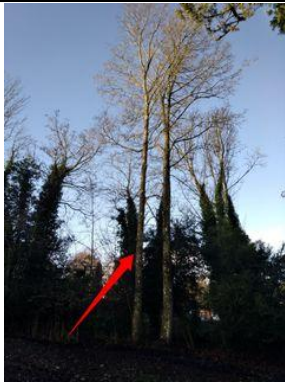
| Ref. | Species | Structure | Measurements | Spread | General Observations | Retention Category | RPA | Summary | Photos |
|---|---|---|---|---|---|---|---|---|---|
| T004 | Sycamore<br>( <i>Acer pseudoplatanus</i> ) | Tree | Height (m): 18<br>Stem Diam(mm): 340<br>Crown Clearance (m): 6<br>Life Stage: Mature<br>Rem. Contrib.: 40+ Years | N:2.5<br>E:4<br>S:4<br>W:4 | Recent works undertaken to raise crown. Slender tree, high, asymmetrical crown. | <b>B2</b> | Radius: 4.1m.<br>Area: 53 sq m. | Physiological Condition: Good<br>Structural Condition: Good<br>Public Amenity Value: Good | |

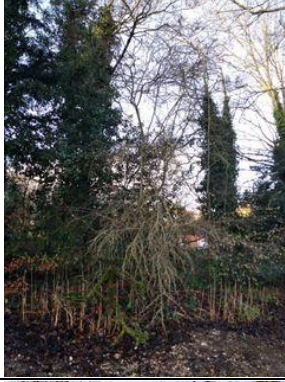
| Ref. | Species | Structure | Measurements | Spread | General Observations | Retention Category | RPA | Summary | Photos |
|---|---|---|---|---|---|---|---|---|---|
| T005 | Common hawthorn<br>( <i>Crataegus monogyna</i> ) | Tree<br>2 stems | Height (m): 5<br>2 stems, avg.(mm): 60<br>Crown Clearance (m): 0<br>Life Stage: Mature<br>Rem. Contrib.: 40+ Years | N:1.5<br>E:2.5<br>S:1.5<br>W:1 | Small twin stem tree. Asymmetrical crown. | <b>C2</b> | Radius: 1.0m.<br>Area: 3 sq m. | Physiological Condition: Good<br>Structural Condition: Fair<br>Public Amenity Value: Low | |

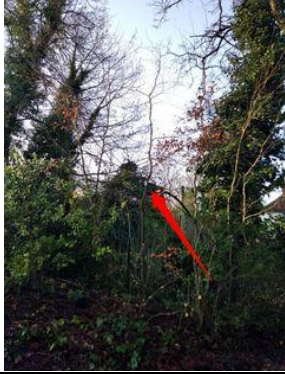
| Ref. | Species | Structure | Measurements | Spread | General Observations | Retention Category | RPA | Summary | Photos |
|---|---|---|---|---|---|---|---|---|---|
| H006 | Common beech<br>( <i>Fagus sylvatica</i> ) | Hedge | Height (m): 5<br>Stem Diam(mm): 30<br>Crown Clearance (m): 1<br>Life Stage: Young<br>Rem. Contrib.: 40+ Years | N:0.5<br>E:0.5<br>S:0.5<br>W:0.5 | Young slender trees planted to form hedge. Not maintained. Various heights, etiolated form. | <b>C2</b> | Radius: 0.4m.<br>Area: 17 sq m. | Physiological Condition: Fair<br>Structural Condition: Fair<br>Public Amenity Value: Low | |

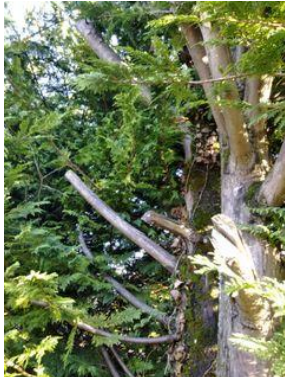
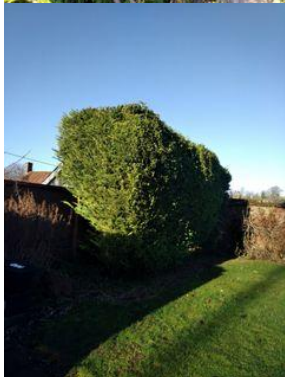
| Ref. | Species | Structure | Measurements | Spread | General Observations | Retention Category | RPA | Summary | Photos |
|---|---|---|---|---|---|---|---|---|---|
| H007 | Leyland cypress<br>( <i>X Cuprocyparis leylandii</i> ) | Hedge | Height (m): 3.5<br>Stem Diam(mm): 350<br>Crown Clearance (m): 0<br>Life Stage: Mature<br>Rem. Contrib.: 10+ Years | N:0.5<br>E:0.5<br>S:0.5<br>W:0.5 | Tight clipped hedge formed of three mature topped trees. Dead branch stubs and areas of crown. | <b>C1</b> | Radius: 4.2m.<br>Area: 122 sq m. | Physiological Condition: Fair<br>Structural Condition: Poor<br>Public Amenity Value: Low | |

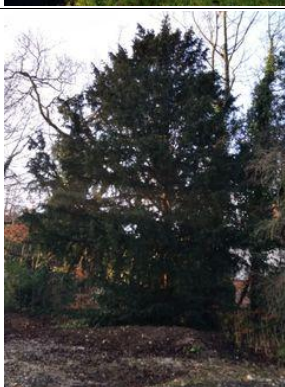
| Ref. | Species | Structure | Measurements | Spread | General Observations | Retention Category | RPA | Summary | Photos |
|---|---|---|---|---|---|---|---|---|---|
| T007 | English yew<br>( <i>Taxus baccata</i> ) | Tree | Height (m): 9<br>Stem Diam(mm): 300<br>Crown Clearance (m): 0<br>Life Stage: Mature<br>Rem. Contrib.: 40+ Years | N:3.5<br>E:3.5<br>S:3.5<br>W:3.5 | Small tree, feathered, low crown to ground level. | <b>C2</b> | Radius: 3.6m.<br>Area: 41 sq m. | Physiological Condition: Good<br>Structural Condition: Good<br>Public Amenity Value: Moderate<br>Inspection Limitations: Low crown | |

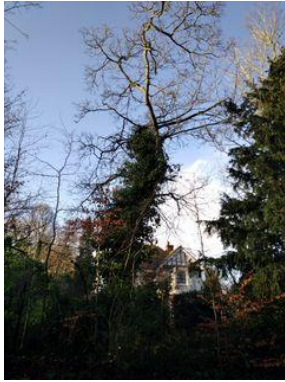
| Ref. | Species | Structure | Measurements | Spread | General Observations | Retention Category | RPA | Summary | Photos |
|---|---|---|---|---|---|---|---|---|---|
| T008 | Sycamore<br>( <i>Acer pseudoplatanus</i> ) | Tree | Height (m): 10<br>Stem Diam(mm): 350<br>Crown Clearance (m): 4<br>Life Stage: Mature<br>Rem. Contrib.: 40+ Years | N:4<br>E:3.5<br>S:1.5<br>W:5 | Off-site tree. Ivy clad irregular crown. Foliage density normal. | C2 | Radius: 4.2m.<br>Area: 55 sq m. | Physiological Condition: Fair<br>Structural Condition: Unknown<br>Public Amenity Value: Moderate<br>Inspection Limitations: Access and prolific ivy | |

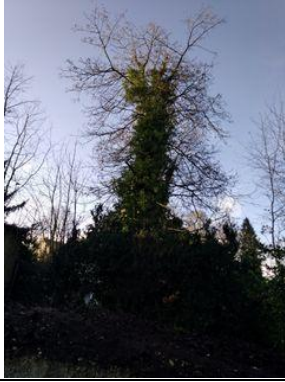
| Ref. | Species | Structure | Measurements | Spread | General Observations | Retention Category | RPA | Summary | Photos |
|---|---|---|---|---|---|---|---|---|---|
| T009 | Sycamore<br>( <i>Acer pseudoplatanus</i> ) | Tree | Height (m): 12<br>Stem Diam(mm): 350<br>Crown Clearance (m): 4<br>Life Stage: Mature<br>Rem. Contrib.: 40+ Years | N:3<br>E:3<br>S:3<br>W:3 | Off-site tree. Ivy clad crown. Lower crown cut back to boundary. Bud density normal. | C2 | Radius: 4.2m.<br>Area: 55 sq m. | Physiological Condition: Fair<br>Structural Condition: Unknown<br>Public Amenity Value: Moderate<br>Inspection Limitations: Access and prolific ivy | |

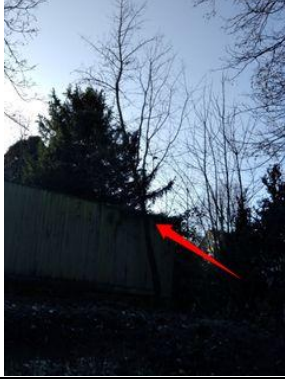
| Ref. | Species | Structure | Measurements | Spread | General Observations | Retention Category | RPA | Summary | Photos |
|---|---|---|---|---|---|---|---|---|---|
| T010 | Field maple<br>( <i>Acer campestre</i> ) | Tree | Height (m): 8.5<br>Stem Diam(mm): 120<br>Crown Clearance (m): 2<br>Life Stage: Semi Mature<br>Rem. Contrib.: 40+ Years | N:1<br>E:2<br>S:3.5<br>W:2 | Small young tree at top of bank. | C2 | Radius: 1.4m.<br>Area: 6 sq m. | Physiological Condition: Good<br>Structural Condition: Fair<br>Public Amenity Value: Low | |

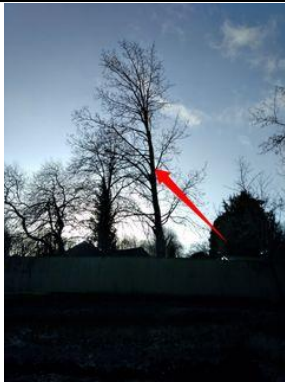
| Ref. | Species | Structure | Measurements | Spread | General Observations | Retention Category | RPA | Summary | Photos |
|---|---|---|---|---|---|---|---|---|---|
| T011 | Sycamore<br>( <i>Acer pseudoplatanus</i> ) | Tree | Height (m): 17<br>Stem Diam(mm): 440<br>Crown Clearance (m): 5<br>Life Stage: Mature<br>Rem. Contrib.: 40+ Years | N:4<br>E:5.5<br>S:3<br>W:4 | Off-site tree. No access to base. | <b>C2</b> | Radius: 5.3m.<br>Area: 88 sq m. | Physiological Condition: Fair<br>Structural Condition: Unknown<br>Public Amenity Value: Good<br>Inspection Limitations: Access | |

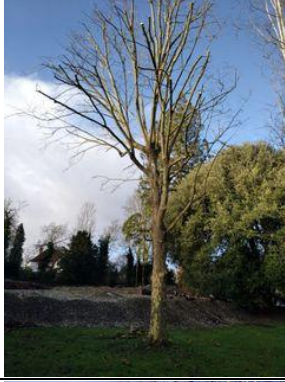
| Ref. | Species | Structure | Measurements | Spread | General Observations | Retention Category | RPA | Summary | Photos |
|---|---|---|---|---|---|---|---|---|---|
| T014 | London plane<br>( <i>Platanus x hispanica</i> ) | Tree | Height (m): 15<br>Stem Diam(mm): 460<br>Crown Clearance (m): 4<br>Life Stage: Mature<br>Rem. Contrib.: 40+ Years | N:3.5<br>E:3<br>S:5.5<br>W:4.5 | Recent works undertaken to raised and reduce crown. Lapsed Pollard. | <b>B1,2</b> | Radius: 5.5m.<br>Area: 95 sq m. | Physiological Condition: Fair<br>Structural Condition: Fair<br>Public Amenity Value: Moderate | |

Two new garden rooms north of the court will require a small encroachment into the root protection areas of T014 (London plane) of approximately 3m<sup>2</sup> (0.42%) and 2.7m<sup>2</sup> (3.4%) into the Root Protection Area of T031 (Horse Chestnut). These are early mature trees with reduced canopies and good physiological health. Such trees will be able to tolerate these minor incursions into their rooting area without detriment to their long-term health or stability. Foundations will be hand dug to minimise damage to retained roots.

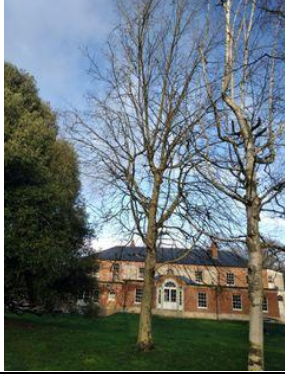
| Ref. | Species | Structure | Measurements | Spread | General Observations | Retention Category | RPA | Summary | Photos |
|---|---|---|---|---|---|---|---|---|---|
| T016 | London plane<br>( <i>Platanus x hispanica</i> ) | Tree | Height (m): 14<br>Stem Diam(mm): 400<br>Crown Clearance (m): 4<br>Life Stage: Mature<br>Rem. Contrib.: 40+ Years | N:6.5<br>E:6<br>S:4<br>W:5.5 | Lapsed Pollard. Asymmetrical crown. Bud density normal. | <b>B1,2</b> | Radius: 4.8m.<br>Area: 72 sq m. | Physiological Condition: Fair<br>Structural Condition: Fair<br>Public Amenity Value: Moderate | |

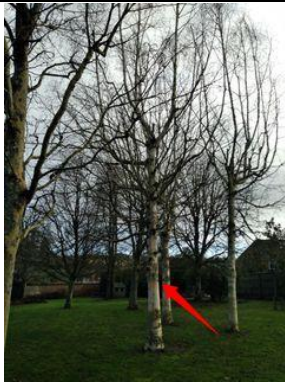
| Ref. | Species | Structure | Measurements | Spread | General Observations | Retention Category | RPA | Summary | Photos |
|---|---|---|---|---|---|---|---|---|---|
| T017 | Himalayan birch<br>( <i>Betula utilis</i> ) | Tree | Height (m): 14<br>Stem Diam(mm): 320<br>Crown Clearance (m): 2<br>Life Stage: Mature<br>Rem. Contrib.: 20+ Years | N:5<br>E:4.5<br>S:2.5<br>W:4 | Lapsed Pollard.<br>Asymmetrical crown. Dead wood in crown. Bud density normal. | <b>C1,2</b> | Radius: 3.8m.<br>Area: 45 sq m. | Physiological Condition: Fair<br>Structural Condition: Fair<br>Public Amenity Value: Moderate | |

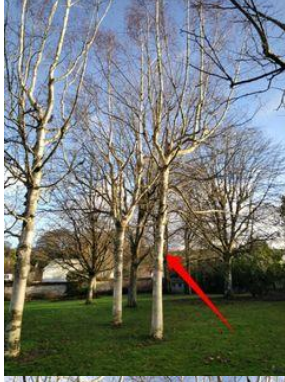
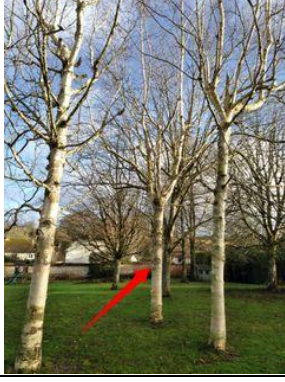
| Ref. | Species | Structure | Measurements | Spread | General Observations | Retention Category | RPA | Summary | Photos |
|---|---|---|---|---|---|---|---|---|---|
| T018 | Himalayan birch<br>( <i>Betula utilis</i> ) | Tree | Height (m): 14<br>Stem Diam(mm): 320<br>Crown Clearance (m): 2<br>Life Stage: Mature<br>Rem. Contrib.: 20+ Years | N:5<br>E:4<br>S:6<br>W:4 | Lapsed Pollard. Deadwood in crown. Bud density normal. | <b>C1,2</b> | Radius: 3.8m.<br>Area: 45 sq m. | Physiological Condition: Fair<br>Structural Condition: Fair<br>Public Amenity Value: Moderate | |

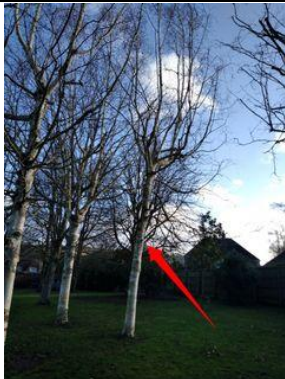
| Ref. | Species | Structure | Measurements | Spread | General Observations | Retention Category | RPA | Summary | Photos |
|---|---|---|---|---|---|---|---|---|---|
| T020 | Himalayan birch<br>( <i>Betula utilis</i> ) | Tree | Height (m): 14<br>Stem Diam(mm): 310<br>Crown Clearance (m): 2<br>Life Stage: Mature<br>Rem. Contrib.: 20+ Years | N:3<br>E:2<br>S:6<br>W:3 | Lapsed Pollard.<br>Asymmetrical crown. Dead leader. Deadwood in crown. Bud density normal. | <b>C1,2</b> | Radius: 3.7m.<br>Area: 43 sq m. | Physiological Condition: Fair<br>Structural Condition: Fair<br>Public Amenity Value: Moderate | |

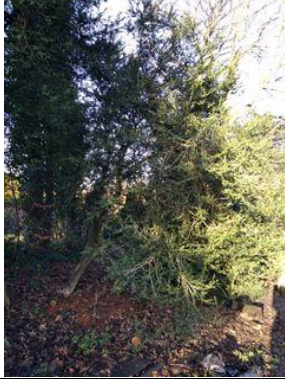
| Ref. | Species | Structure | Measurements | Spread | General Observations | Retention Category | RPA | Summary | Photos |
|---|---|---|---|---|---|---|---|---|---|
| T022 | Box<br>( <i>Buxus sp.</i> ) | Tree | Height (m): 5.5<br>Stem Diam(mm): 100<br>Crown Clearance (m): 1.5<br>Life Stage: Mature<br>Rem. Contrib.: 20+ Years | N:3<br>E:4<br>S:1.5<br>W:1 | Small box tree. Swept stem.<br>Low crown. | <b>C2</b> | Radius: 1.2m.<br>Area: 5 sq m. | Physiological Condition: Good<br>Structural Condition: Fair<br>Public Amenity Value: Low | |

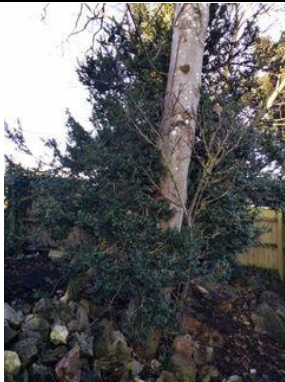
| Ref. | Species | Structure | Measurements | Spread | General Observations | Retention Category | RPA | Summary | Photos |
|---|---|---|---|---|---|---|---|---|---|
| T023 | Box<br>( <i>Buxus sp.</i> ) | Tree | Height (m): 4<br>Stem Diam(mm): 100<br>Crown Clearance (m): 1.5<br>Life Stage: Mature<br>Rem. Contrib.: 20+ Years | N:2<br>E:1.5<br>S:1<br>W:0.5 | Small box tree | C2 | Radius: 1.2m.<br>Area: 5 sq m. | Physiological Condition: Good<br>Structural Condition: Fair<br>Public Amenity Value: Low | |

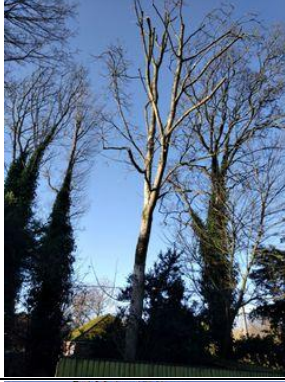
| Ref. | Species | Structure | Measurements | Spread | General Observations | Retention Category | RPA | Summary | Photos |
|---|---|---|---|---|---|---|---|---|---|
| T024 | Sycamore<br>( <i>Acer pseudoplatanus</i> ) | Tree | Height (m): 15<br>Stem Diam(mm): 360<br>Crown Clearance (m): 5<br>Life Stage: Mature<br>Rem. Contrib.: 20+ Years | N:1<br>E:4<br>S:2<br>W:0 | Swept stem, asymmetrical crown recently reduced. | C2 | Radius: 4.3m.<br>Area: 58 sq m. | Physiological Condition: Fair<br>Structural Condition: Fair<br>Public Amenity Value: Moderate | |

It is recommended that the removal of the four standard trees (T024, T025, T026 & T027) be mitigated with replacement planting of four trees of a suitable species, planted along the western boundary and adjacent to the rear site entrance on completion of the proposed access modifications and associated ground works.

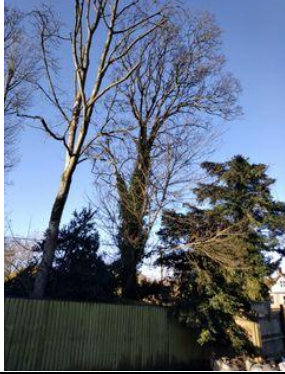
| Ref. | Species | Structure | Measurements | Spread | General Observations | Retention Category | RPA | Summary | Photos |
|---|---|---|---|---|---|---|---|---|---|
| T025 | Sycamore<br>( <i>Acer pseudoplatanus</i> ) | Tree | Height (m): 17<br>Stem Diam(mm): 560<br>Crown Clearance (m): 5<br>Life Stage: Mature<br>Rem. Contrib.: 20+ Years | N:6<br>E:6<br>S:3<br>W:5 | Ivy clad tree. High crown. Rooting area restricted by retaining wall. | C2 | Radius: 6.7m.<br>Area: 141 sq m. | Physiological Condition: Fair<br>Structural Condition: Fair<br>Public Amenity Value: Moderate | |

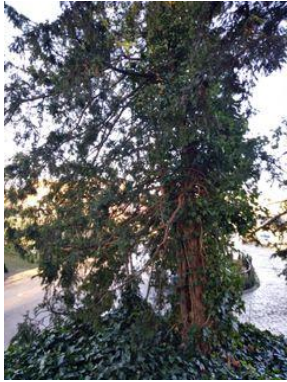
| Ref. | Species | Structure | Measurements | Spread | General Observations | Retention Category | RPA | Summary | Photos |
|---|---|---|---|---|---|---|---|---|---|
| T026 | English yew<br>( <i>Taxus baccata</i> ) | Tree<br>2 stems | Height (m): 6<br>2 stems, avg.(mm): 150<br>Crown Clearance (m): 1.5<br>Life Stage: Mature<br>Rem. Contrib.: 20+ Years | N:1<br>E:0.5<br>S:1<br>W:2.5 | Ivy clad twin stem tree.<br>Rooting area restricted by retaining wall. | <b>C2</b> | Radius: 2.5m.<br>Area: 20 sq m. | Physiological Condition: Good<br>Structural Condition: Fair<br>Public Amenity Value: Good<br>Inspection Limitations: Ivy | |

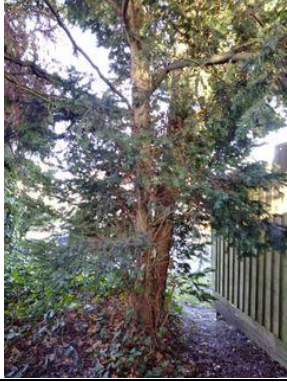
| Ref. | Species | Structure | Measurements | Spread | General Observations | Retention Category | RPA | Summary | Photos |
|---|---|---|---|---|---|---|---|---|---|
| T027 | English yew<br>( <i>Taxus baccata</i> ) | Tree<br>3 stems | Height (m): 8<br>3 stems, avg.(mm): 120<br>Crown Clearance (m): 1.5<br>Life Stage: Mature<br>Rem. Contrib.: 20+ Years | N:2<br>E:3<br>S:3<br>W:2 | Ivy clad twin stem tree.<br>Rooting area restricted by retaining wall. | <b>C2</b> | Radius: 2.5m.<br>Area: 20 sq m. | Physiological Condition: Good<br>Structural Condition: Fair<br>Public Amenity Value: Good<br>Inspection Limitations: Ivy | |

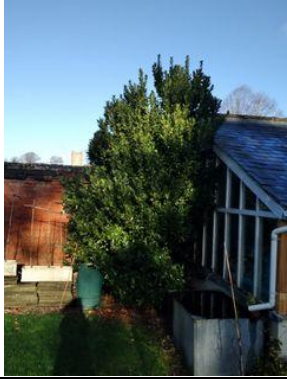
| Ref. | Species | Structure | Measurements | Spread | General Observations | Retention Category | RPA | Summary | Photos |
|---|---|---|---|---|---|---|---|---|---|
| T028 | Bay tree<br>( <i>Laurus nobilis</i> ) | Tree | Height (m): 4.5<br>Stem Diam(mm): 300<br>Crown Clearance (m): 0<br>Life Stage: Mature<br>Rem. Contrib.: 40+ Years | N:0.5<br>E:0.5<br>S:1<br>W:1 | Multi-stem large shrub | <b>C1</b> | Radius: 3.6m.<br>Area: 41 sq m. | Physiological Condition: Good<br>Structural Condition: Fair<br>Public Amenity Value: Low<br>Inspection Limitations: Dense vegetation | |

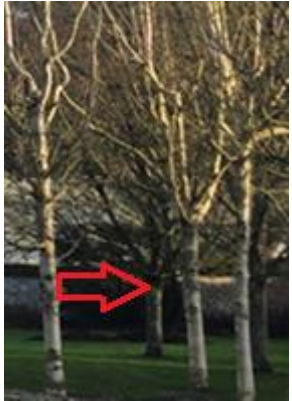
| Ref. | Species | Structure | Measurements | Spread | General Observations | Retention Category | RPA | Summary | Photos |
|---|---|---|---|---|---|---|---|---|---|
| T029 | Plane | Tree | Height (m): 15<br>Stem Diam(mm): 360<br>Crown Clearance (m): 2.5<br>Life Stage: Early mature<br>Rem. Contrib.: 40+ Years | N:4.5<br>E:4<br>S:4.5<br>W:3.5 | Previously reduced to 6m. | <b>B2</b> | Radius: 4.3m.<br>Area: 59 sq m. | Physiological Condition: Fair<br>Structural Condition: Fair<br>Public Amenity Value: Moderate | |

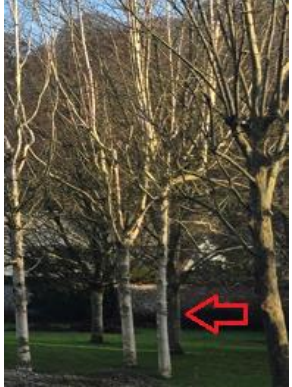
| Ref. | Species | Structure | Measurements | Spread | General Observations | Retention Category | RPA | Summary | Photos |
|---|---|---|---|---|---|---|---|---|---|
| T030 | Norway Maple | Tree | Height (m): 12<br>Stem Diam(mm): 340<br>Crown Clearance (m): 2<br>Life Stage: Early mature<br>Rem. Contrib.: 40+ Years | N:4.5<br>E:4.5<br>S:4.5<br>W:4 | Previously reduced to 6m.<br>Minor deadwood. Small patch of black exudate on lower stem. | <b>B2</b> | Radius: 4.1m.<br>Area: 52 sq m. | Physiological Condition: Fair<br>Structural Condition: Fair<br>Public Amenity Value: Moderate | |

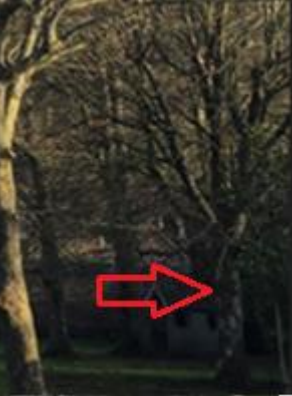
| Ref. | Species | Structure | Measurements | Spread | General Observations | Retention Category | RPA | Summary | Photos |
|---|---|---|---|---|---|---|---|---|---|
| T031 | Horse Chestnut | Tree | Height (m): 11.5<br>Stem Diam(mm): 420<br>Crown Clearance (m): 2<br>Life Stage: Early mature<br>Rem. Contrib.: 40+ Years | N:4.5<br>E:5<br>S:4<br>W:5.5 | Longitudinal bark fissures but no sign of bacterial canker. Previously reduced to 6m. Decay entering pruning wound at 2m to north. Surface roots. | <b>B2</b> | Radius: 5m.<br>Area: 80 sq m. | Physiological Condition: Fair<br>Structural Condition: Fair<br>Public Amenity Value: Moderate | |

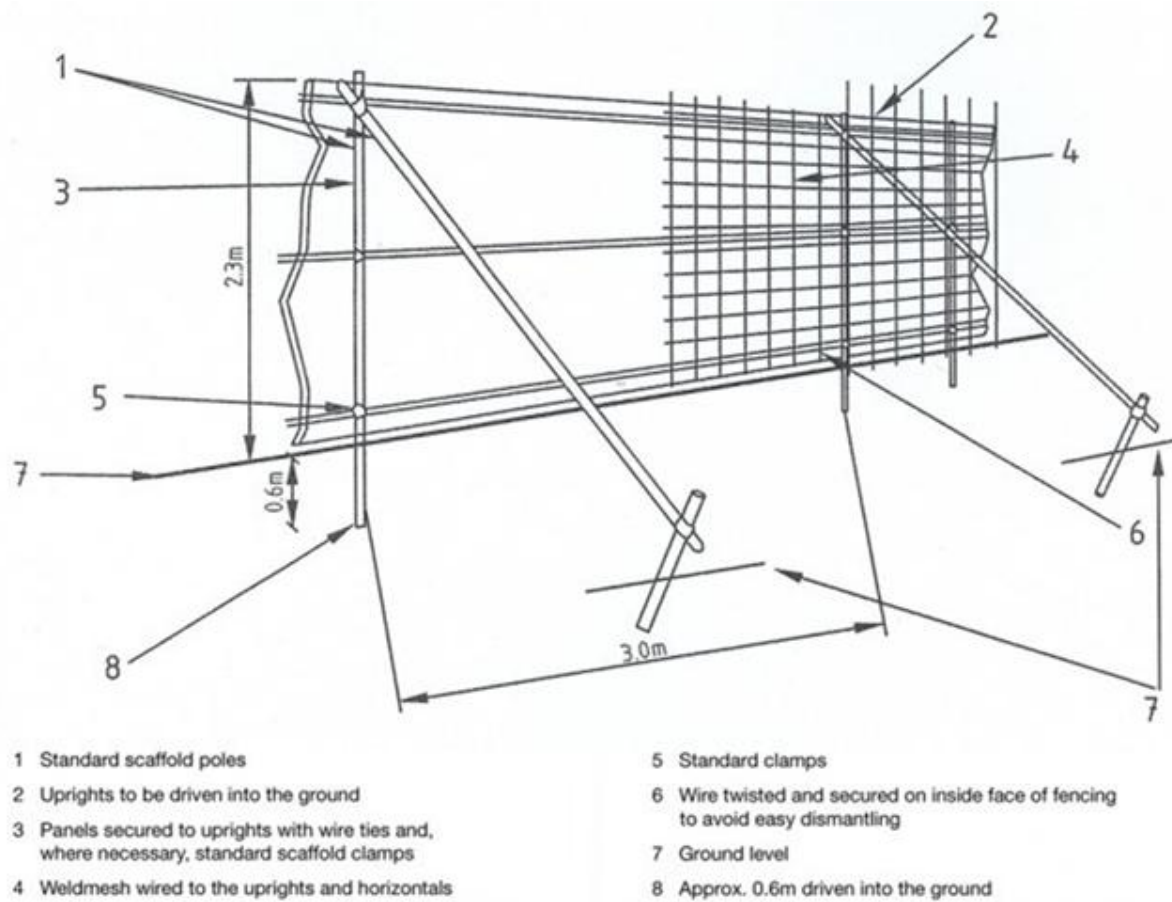
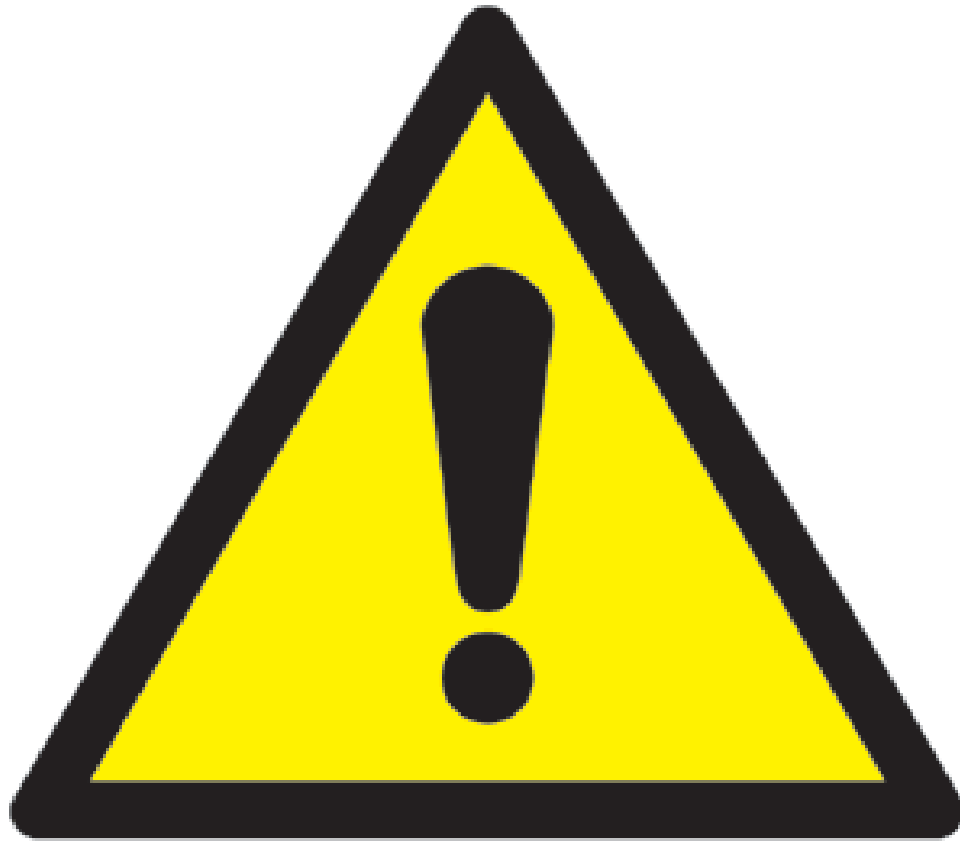
## APPENDIX H - TREE PROTECTION FENCING

The fencing will be located to protect the retained trees and their rooting areas and will remain vertical, rigid and complete during development. At no time will Tree Protection Fencing be removed or relocated contrary to the recommendations in this report, without professional arboricultural advice and without the prior consent of the Local Authority Tree Officer.
