4. Carry out like-for-like repairs to porch

| project: | The Old Court House. Court Street,<br>Sherston. SN16 0LL |
| drawing: | 4 : Proposed Works Details |

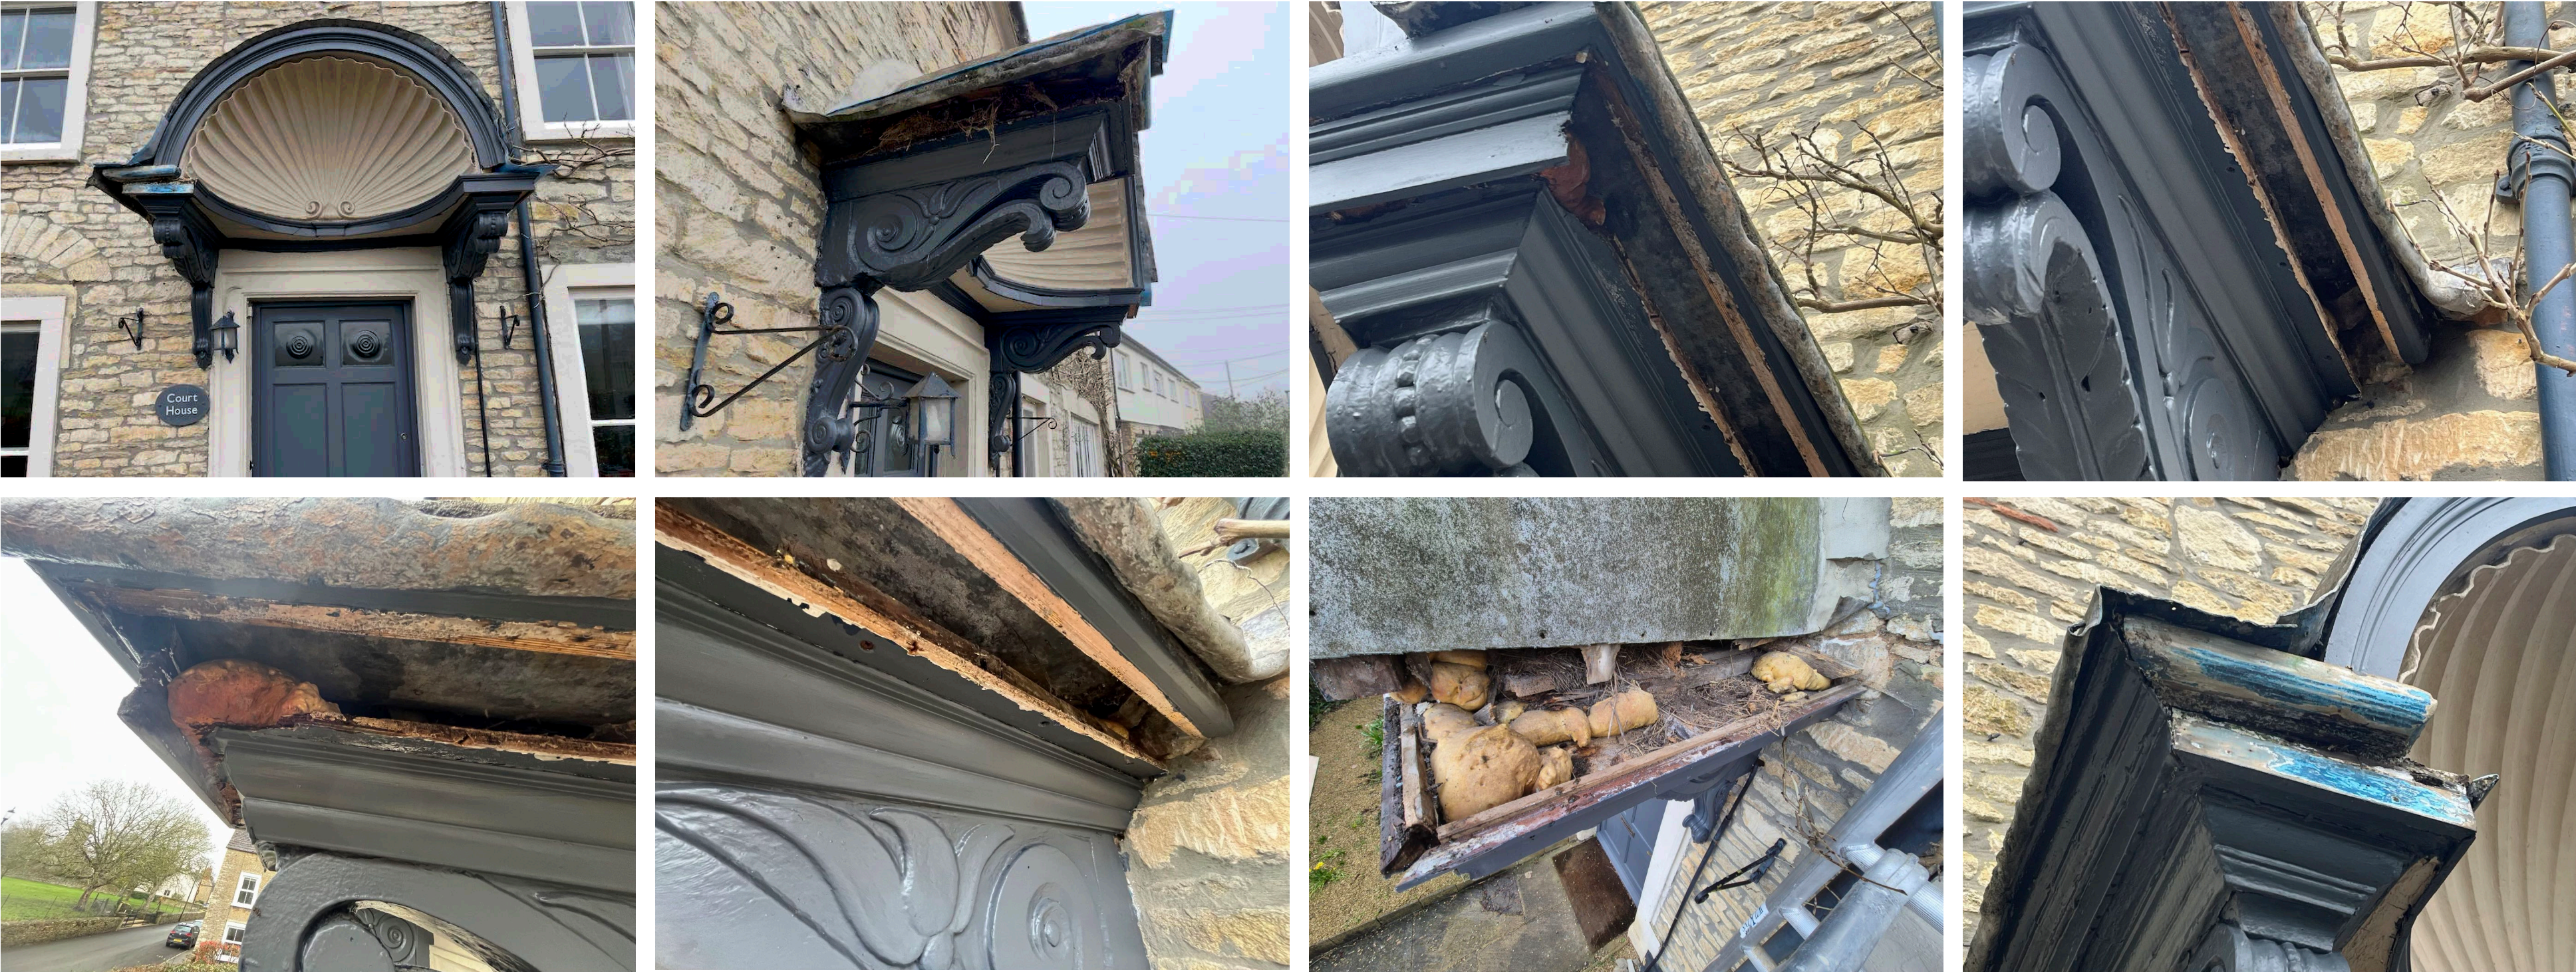
PORCH. EXISTING PHOTOGRAPHS

Existing Photographs show the porch's current condition, with rotted timber elements, failing leadwork and poor historic repairs. As a result, the porch is unstable and creating rainwater ingress into the building.

- 1. Remove the lead dome and set aside
- 2. Prop the porch supports
- 3. Renew the wall plate R/H side
- 4. Repair the rafter ends R/H side
- 5. Replace the lead over both porch supports so the lead goes further behind the lead dome to stop water ingress.
- 6. Refit the lead dome
- 7. Replace the cement cap to the wall junction. ( This would need to be removed to enable the removal of the leadwork ).
- 8. Refit the loose timber fascia to the L/H side
