## **Arboricultural Method Statement**

### **Premier Inn Hotels**

Premier Inn,  
Salisbury North Bishopdown,  
Pearce Way,  
Salisbury  
Wiltshire,  
SP1 3GU.

25 April 2024

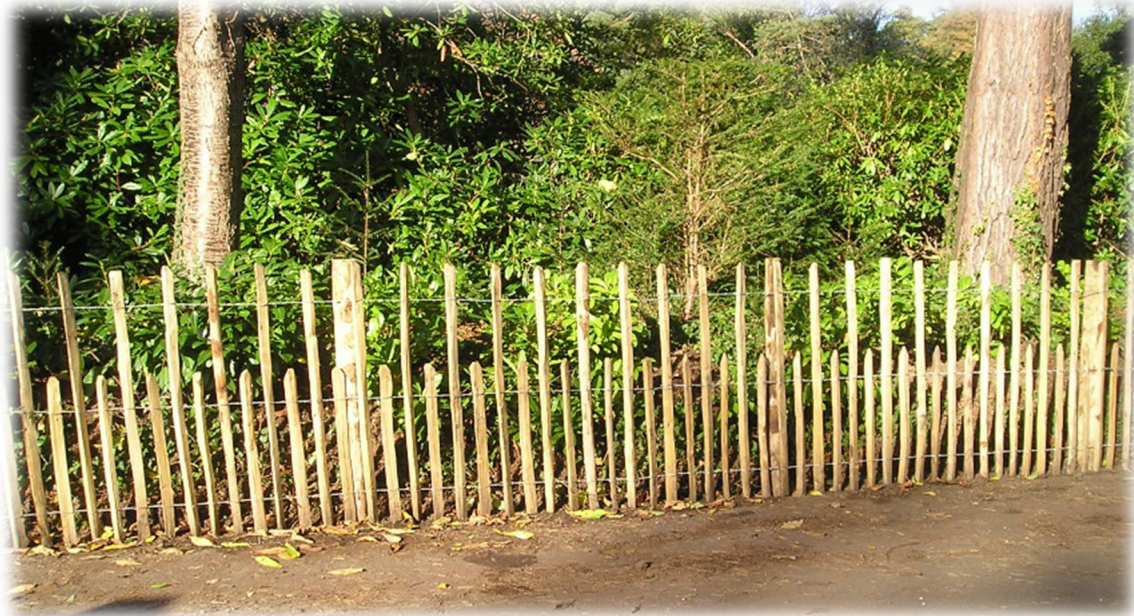
To comprise of 100mm driven round timber stakes set at 5m spacing's with a top 'straining' wire, with 1.2m to 1.4m tall cleft chestnut paling fencing affixed to the posts and straining wire.

Figure 3: Cleft chestnut paling fencing

Signage denoting the words “*tree protection area*” at 5.0m intervals should be fixed to the protective barrier fencing (See Appendix 2).
