## **LISTED BUILDING STATEMENT**

### **LIME RENDER TO THE THREE PRINCIPAL ELEVATIONS OF THATCH COTTAGE, LOWER ROAD, BRITFORD, SALISBURY, SP5 4DU.**

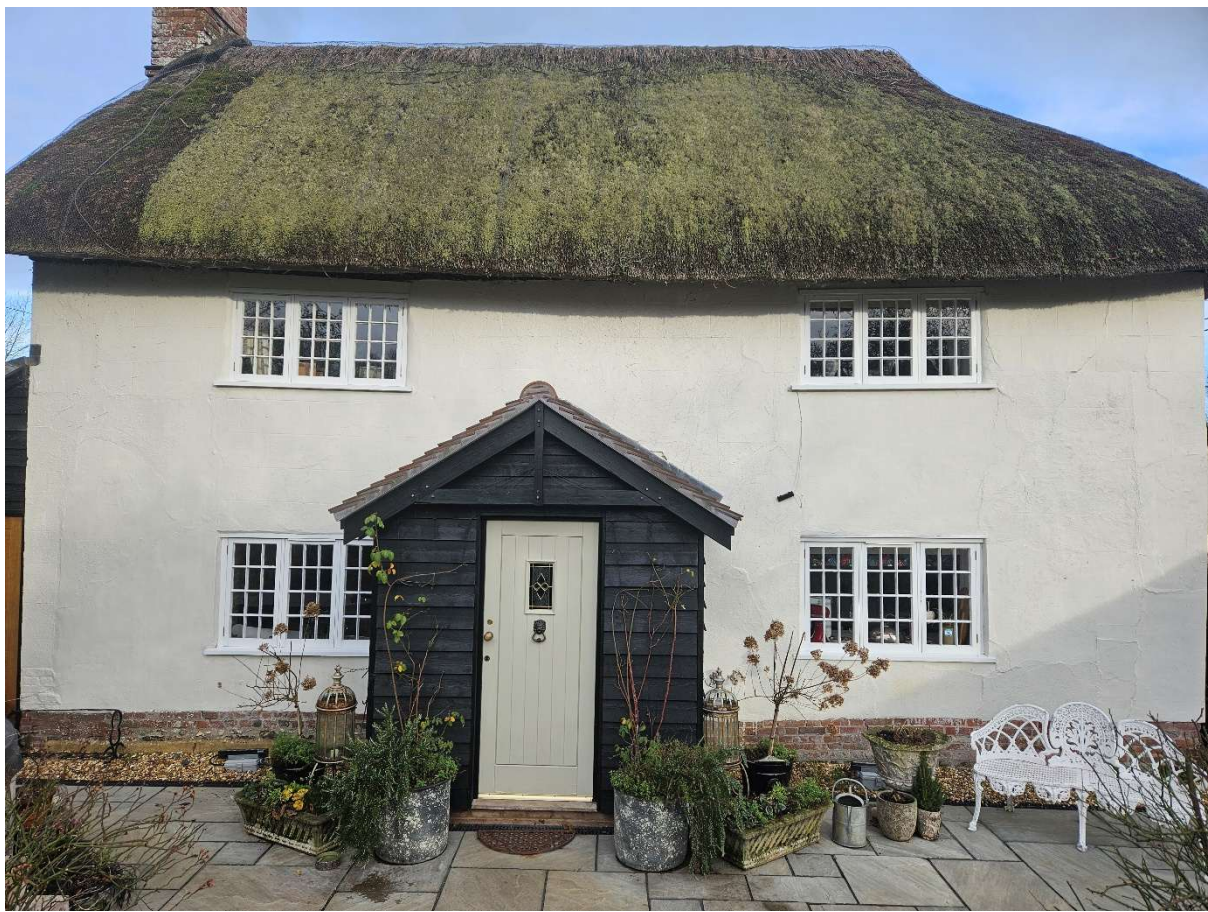
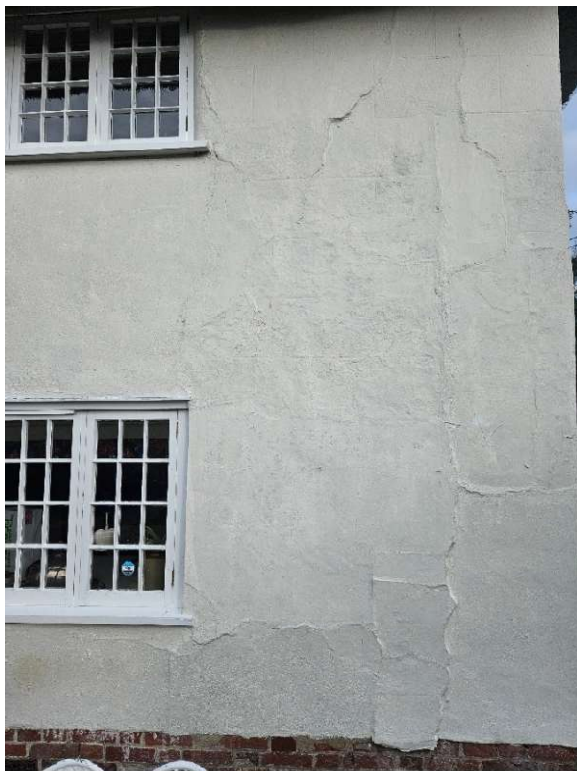
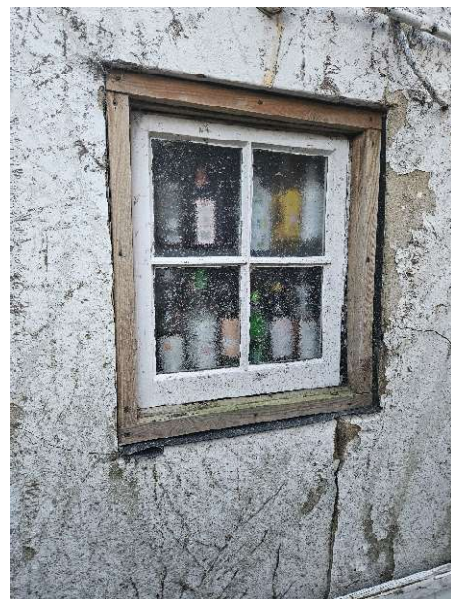
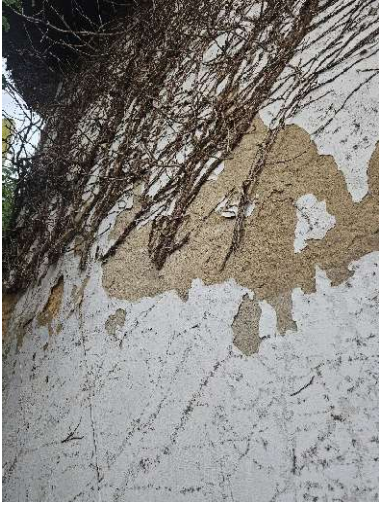
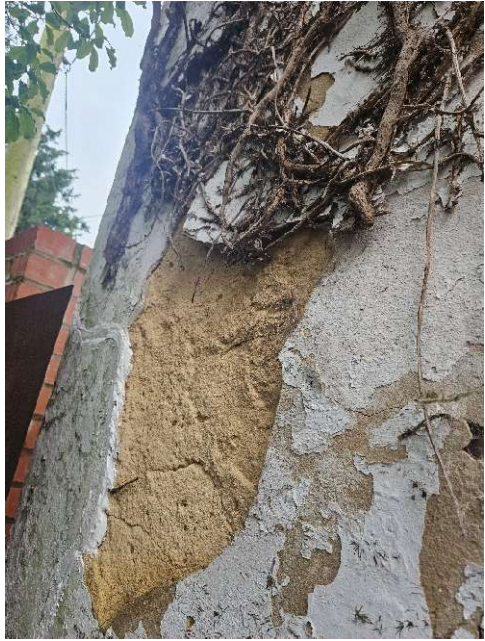
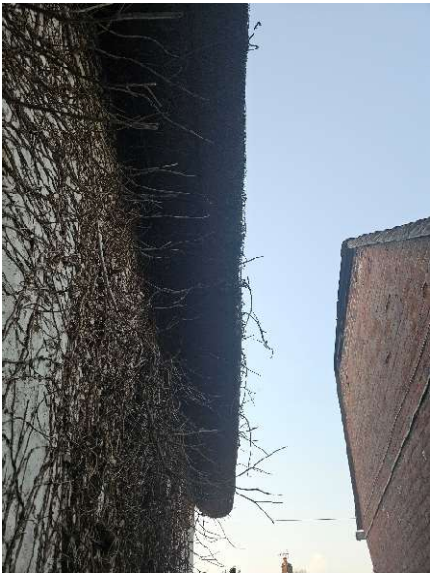
Photographs showing the poor state of existing render.

Prior to the purchase of the property, by the current owners, three of the four elevations had been coated with a cement-based render which in recent years has failed, with several areas cracking and spalling, which is unsafe.
