1306.D.21

Drawing : Detail Specifications for repair works to:

Fireplace - S.07

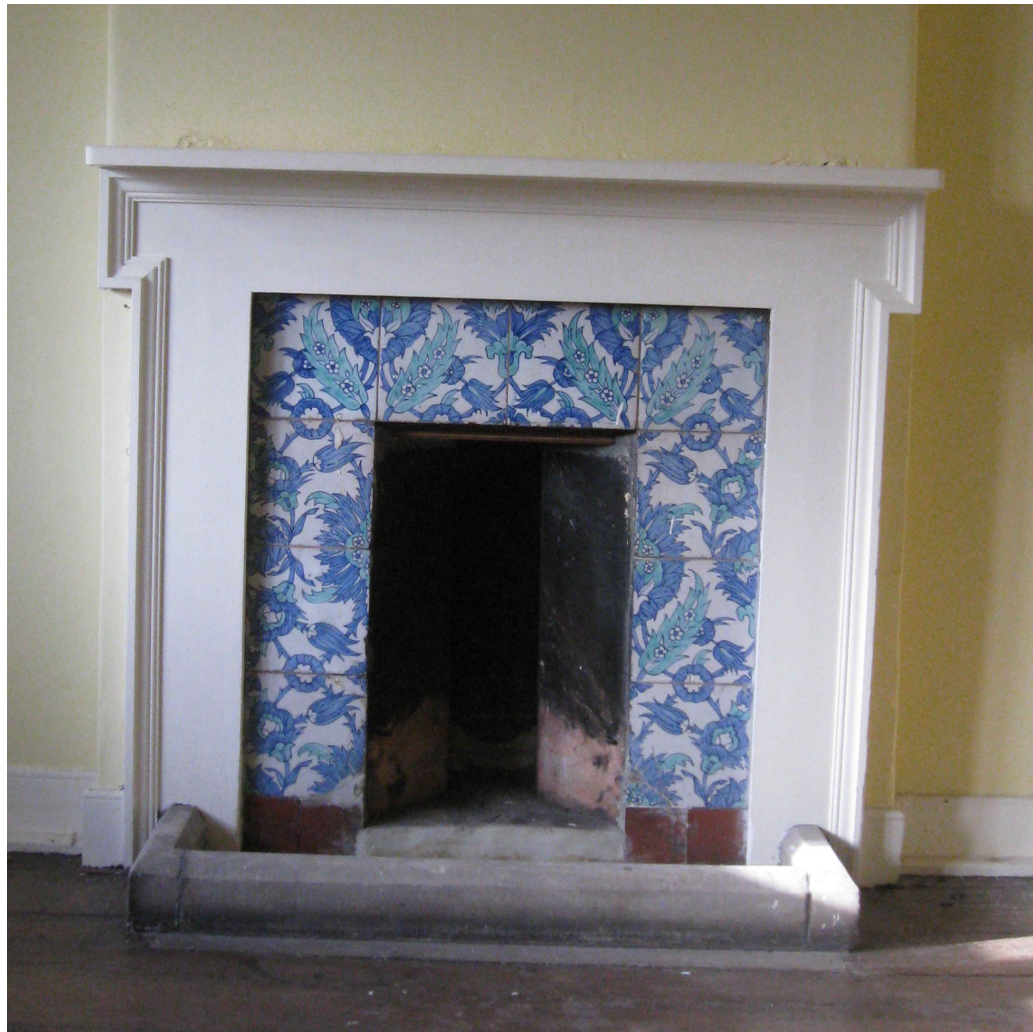
S.07 Fireplace.

Early C 19th painted wooden, bracketed surround with a later added mantle shelf.  
Plain chamfered stone kerb.  
Raised cement inner hearth.  
Floral patterned ceramic slips over terracotta base layer.  
Fire brick lining

Ensure the flue is cleaned and not blocked.

Remove the later mantle shelf and make good the surround to match existing.
