# Conservation Elements

| Itemref | Quantity | Title/Name, designation, material, dimension etc | | | Article No./Reference | |
|---|---|---|---|---|---|--|
| PEI | | | Blue Boar Row | | | |
| | | | Conservation Elements | Edition<br>0 | Sheet<br>1/1 | |

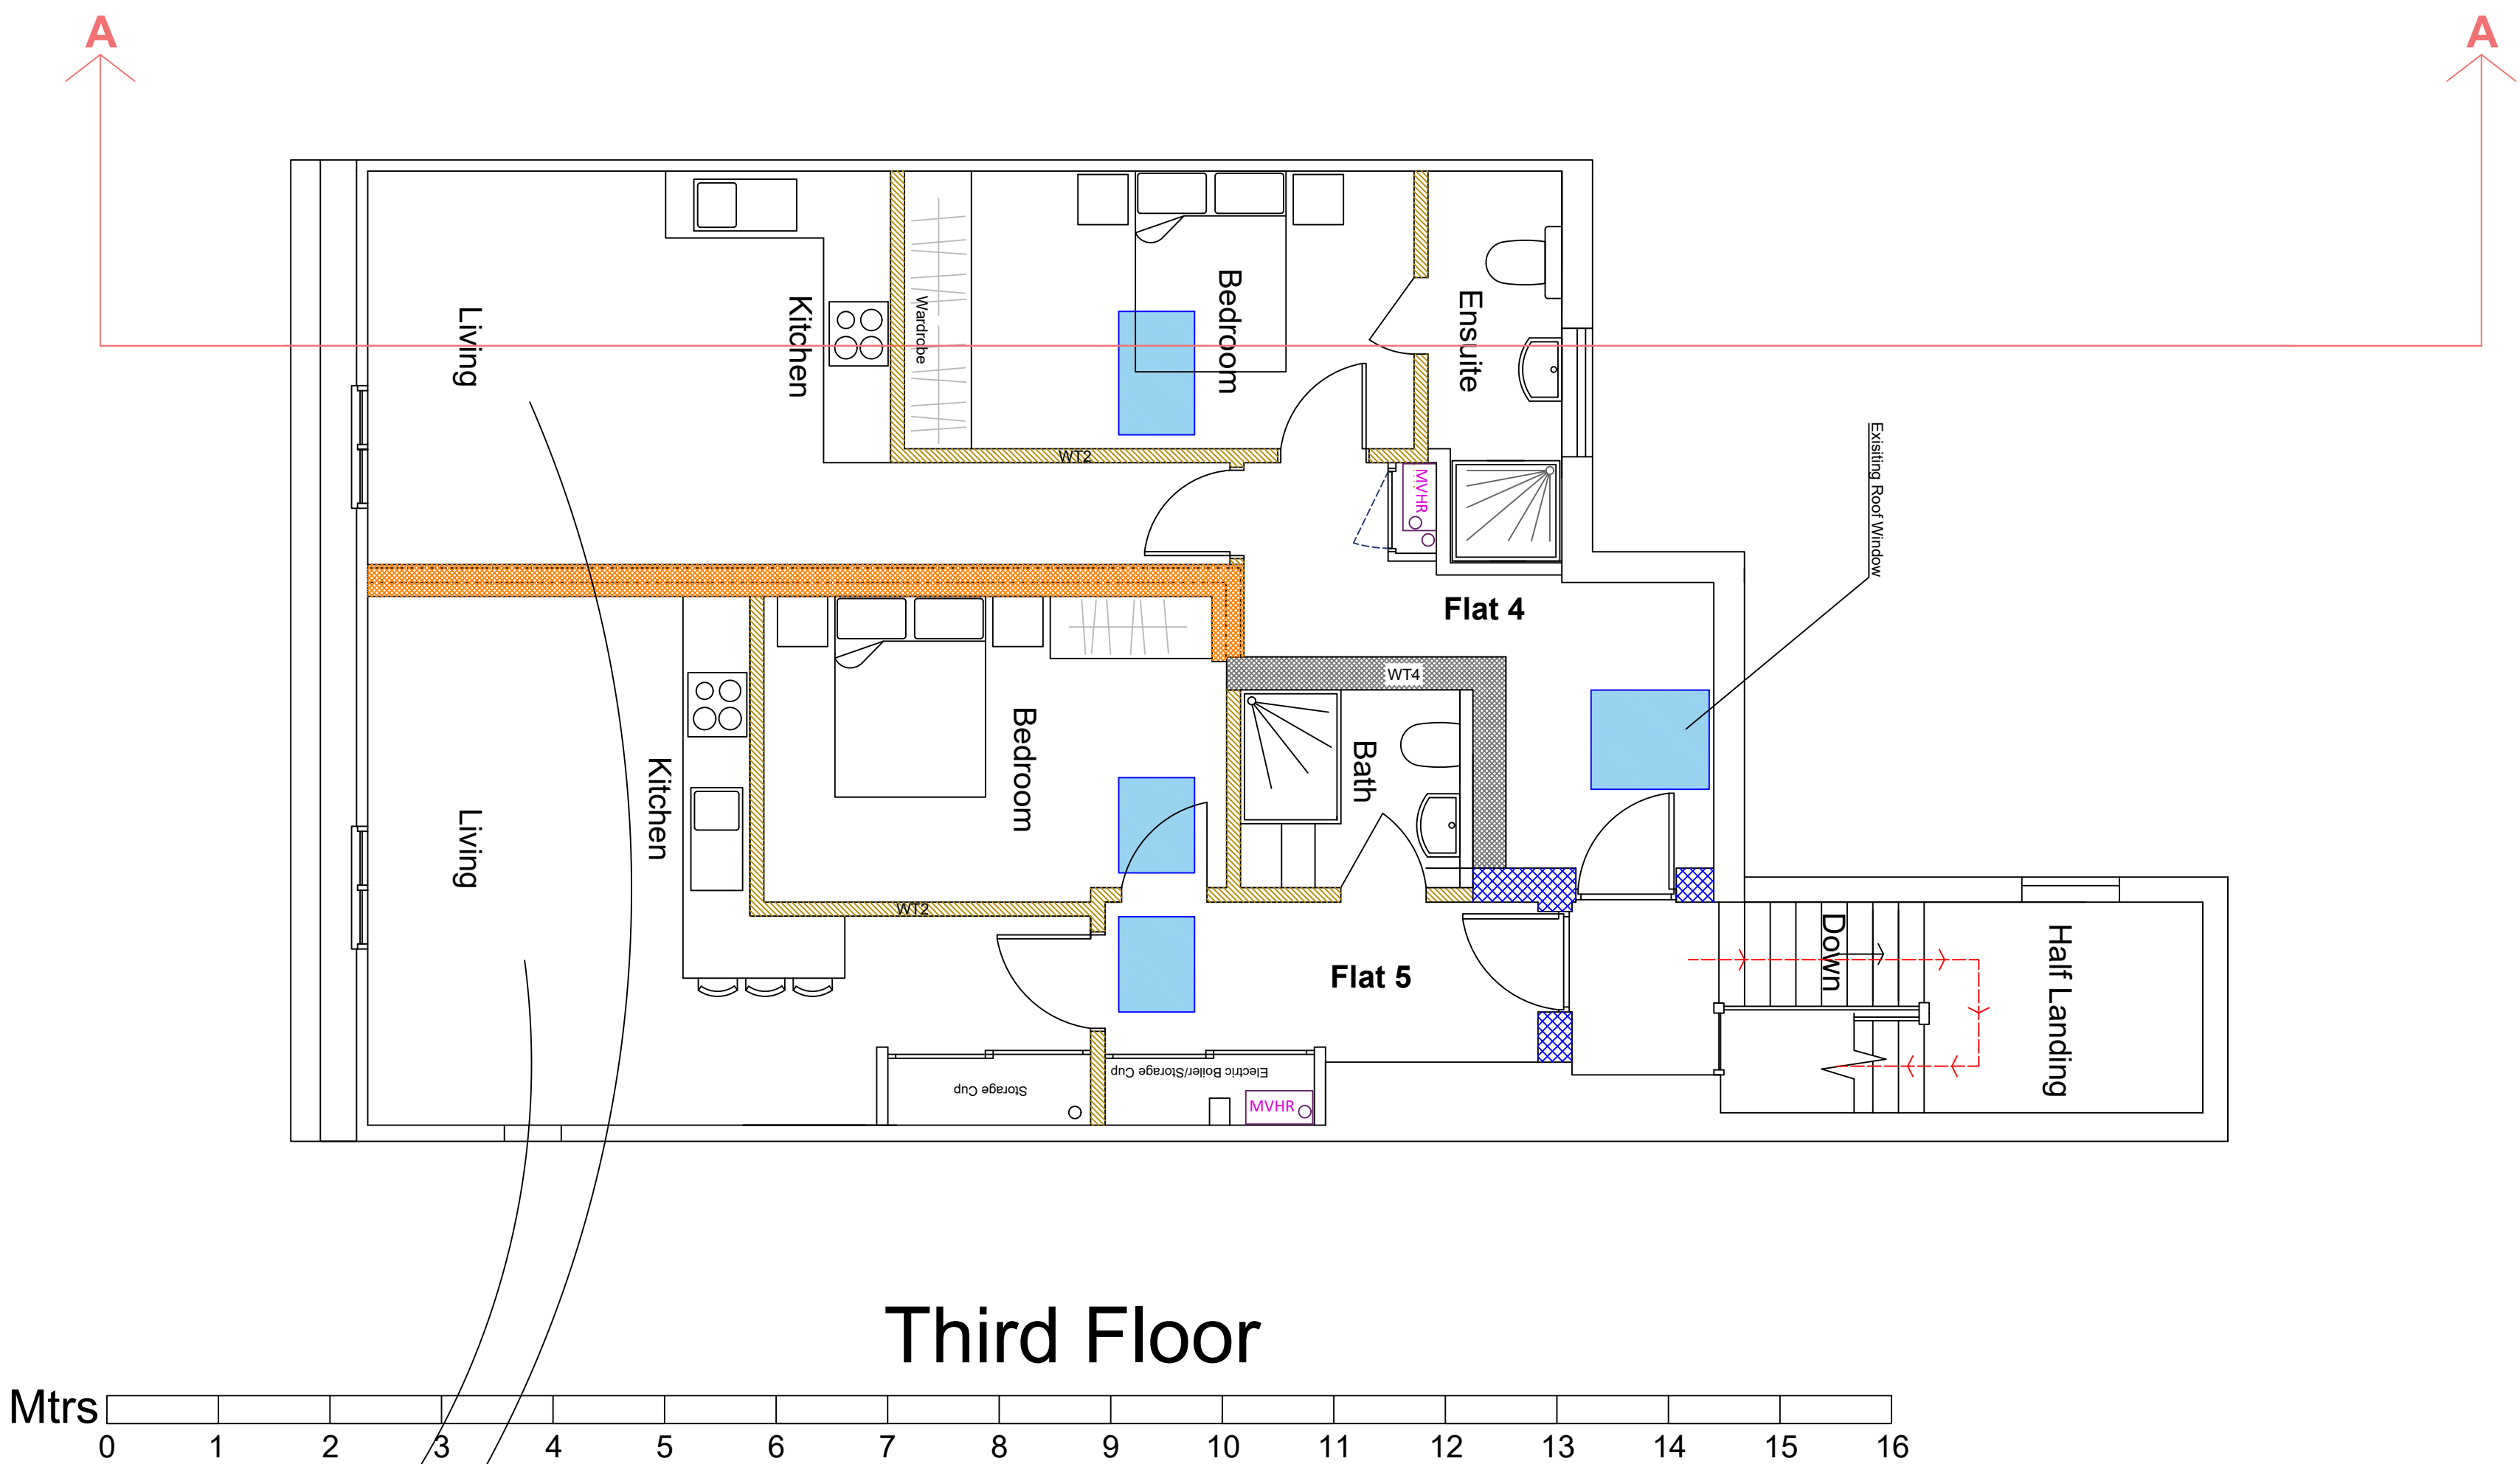
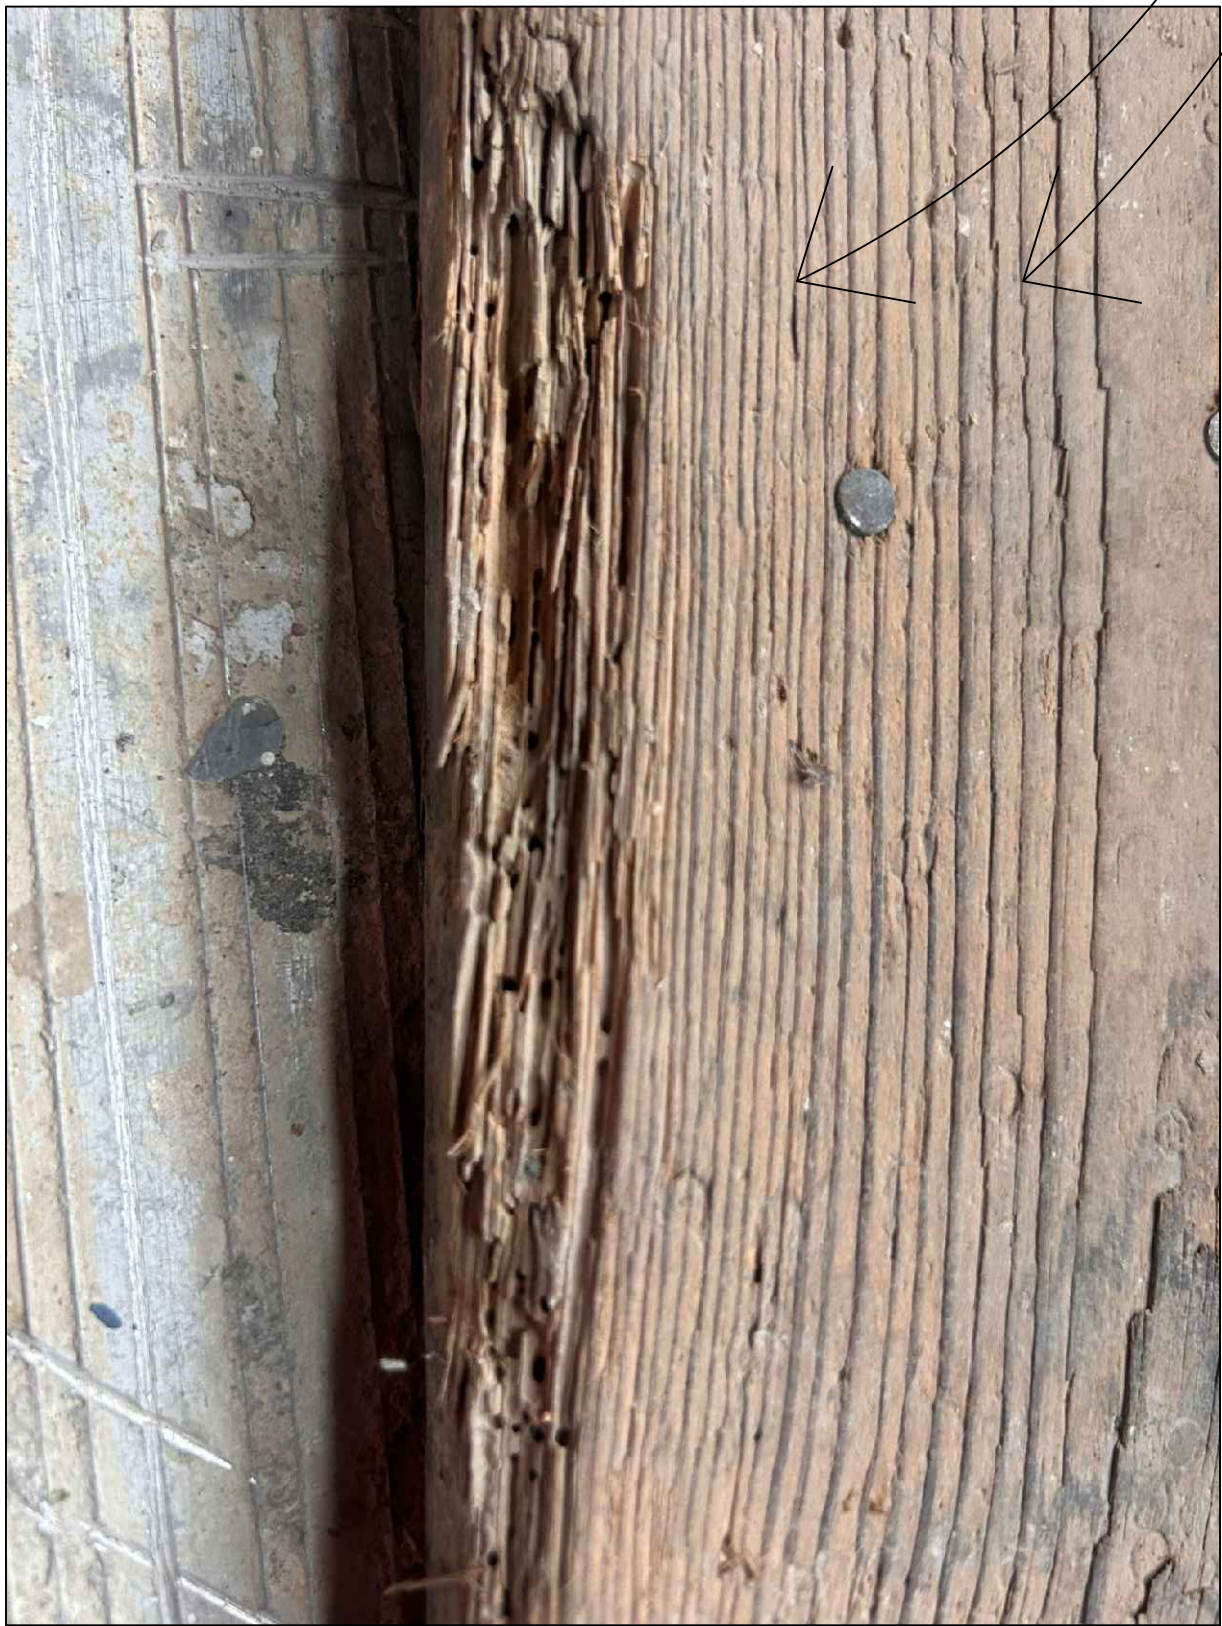
The request to retain parts of the flooring on the third floor that were assumed to be pieces of the original flooring, has unfortunately not transpired due to the discovery of woodworm and sadly the degradation of the cell structure within the boards, has created a structural weakness within the floorboard, making the board unfit for purpose

**Retained Lath & Plaster Ceilings**  
The existing lath and plaster ceiling has been stabilised and overboarded to meet building regulation compliance

**Retained Skirting**  
A very small amount of period skirting was uncovered and this will be retained, it has been photographed and the location will be recorded
